# **TEXAS REALTORS®** **SELLER'S DISCLOSURE NOTICE**

CONCERNING THE PROPERTY AT 859 Fountain View Court, Allen, Texas 75013

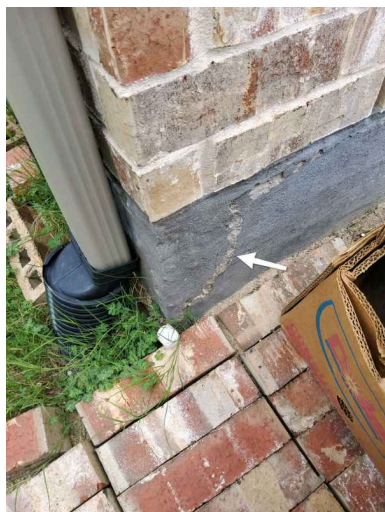
*FYI - Corner Cracking:*

The concrete corners have some cracking at one or more locations. This is a common condition caused by the lack of a bond break between the concrete and the masonry mortar which would allow for the thermal expansion. Repairs and monitoring are recommended.

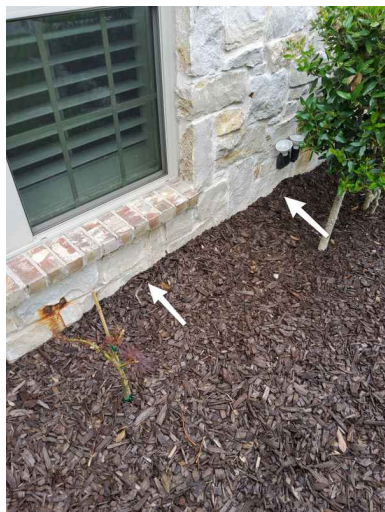
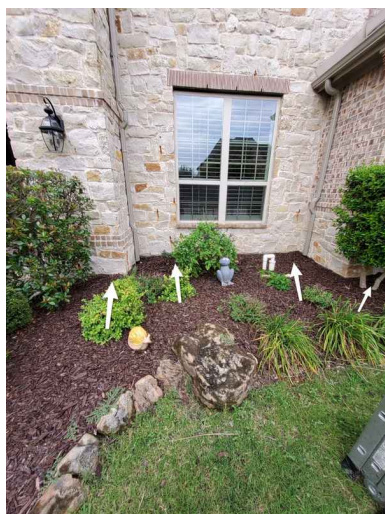
North Side

The soil line is too high along the foundation walls. Under current building standards there should be at least 4 inches of foundation visible below masonry veneer and 6 inches of foundation visible below wood type veneer.

It is recommended installing additional soil along the foundation walls (yet expose the foundation walls, ideally, six to eight inches ). Inconsistent soil levels can undermine the foundation and cause damage, including settling cracks in the walls and ceilings. The addition of top soil in low areas will improve this condition. Two to four inches of clearance between the bottom of the wall and the ground should be maintained to help prevent the wall from absorbing moisture from the ground, to allow moisture to drain from the wall, to help prevent infestation by wood-destroying pests and organisms.

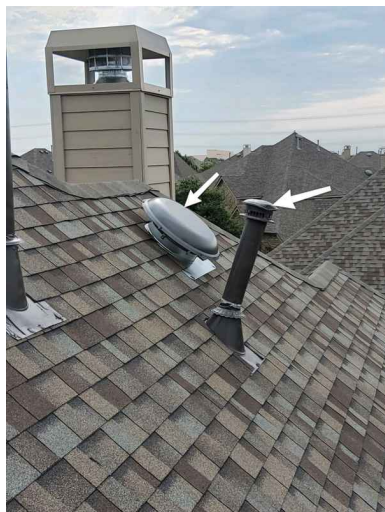
### 3: Shingles - Traffic Wear

Evidence of foot traffic/wear was observed on the roof cover. This appeared to be from installation of new roofing material and foot traffic damage. Consult the roofing contractor for any warranty information and necessary repairs.

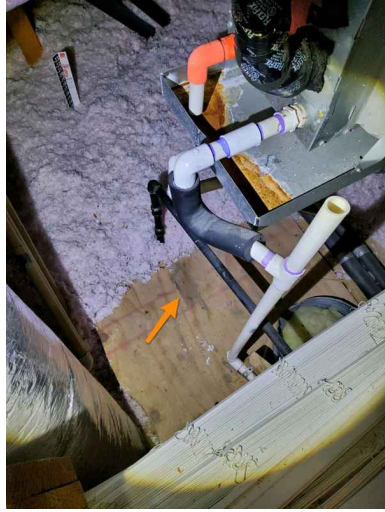
Below The West Unit In The Attic

**1: Attic Floor Decking - Staining (Not Wet)****➔Recommendation**

Staining to the attic floor decking was observed. It is recommended any affected areas be repaired and/or replaced as necessary. It is not known if this is an active condition, further investigation is recommended.

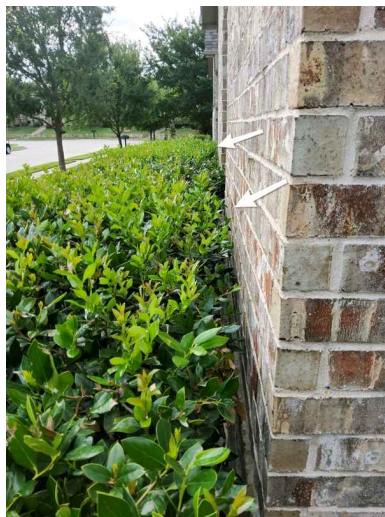
### 1: Exterior - Foliage

The foliage growing on or around the exterior walls of the structure should be trimmed back at least 12 to 18-inches. The foliage limits the visual observation of the exterior surfaces.

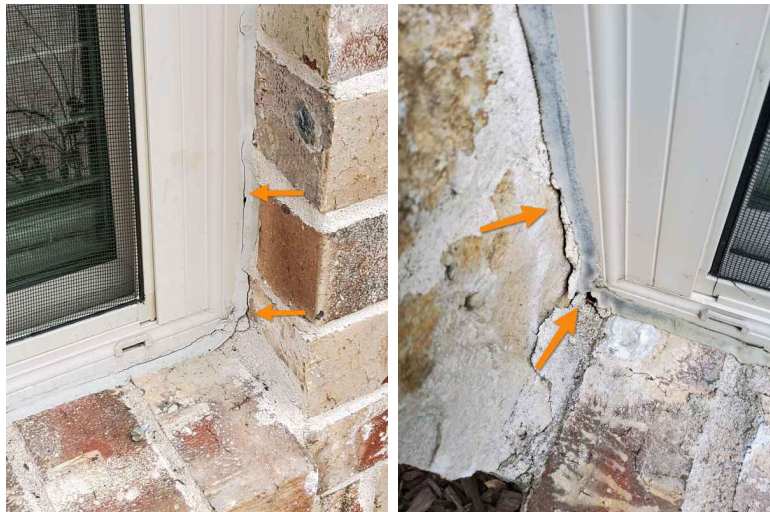
### 3: Exterior - Sealing + Window Frames

It is recommended sealing any openings between the exterior sides of the window frames and the exterior surfaces to prevent possible water penetration at these areas.

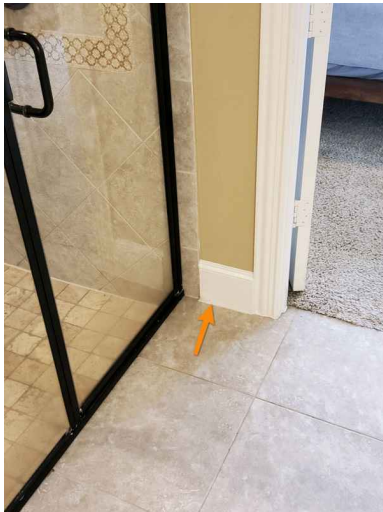
Master Bathroom

Evidence of damage to the base board was observed. It is recommended the cause be further investigated and corrected, any affected areas be repaired or replaced.

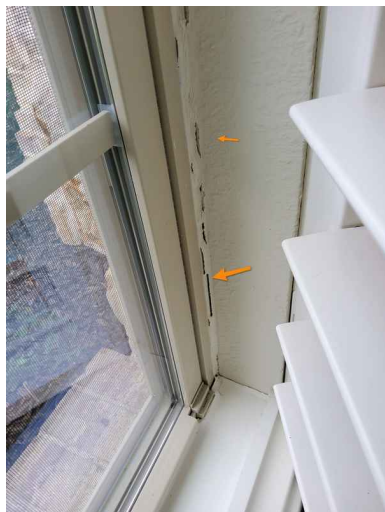
Formal Dining Room

It is recommended sealing any openings between the window frames and interior walls.

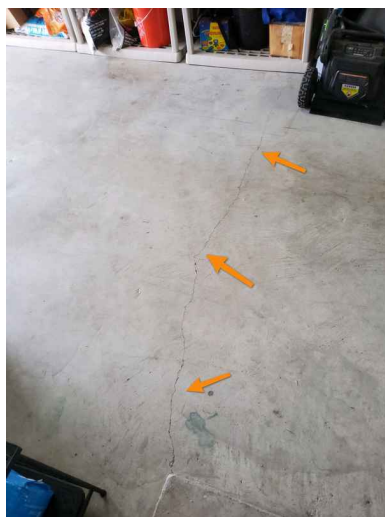
Garage

Cracking was observed at the garage flooring in one or more locations, it is recommended any affected areas be repaired/sealed and monitored.

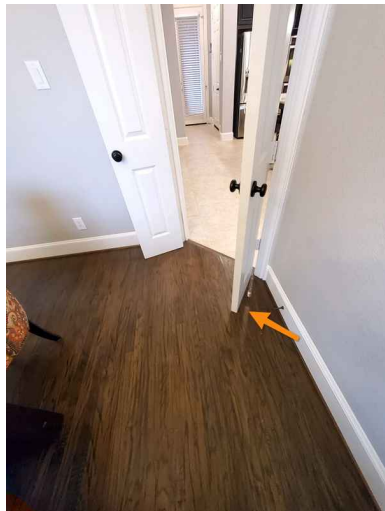
Formal Dining Room

The door appears to be rubbing on the floor, adjustments are recommended as necessary to correct this condition.

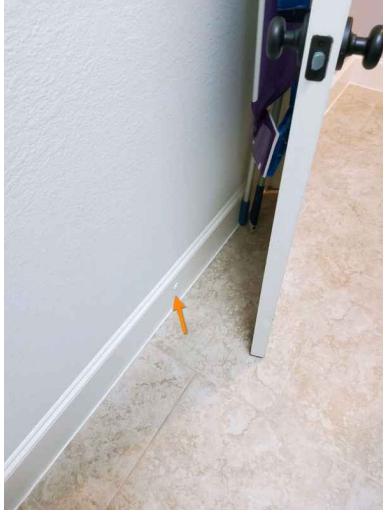
Missing door stoppers were observed. Installation is recommended where necessary to prevent door handle damage to the interior walls.

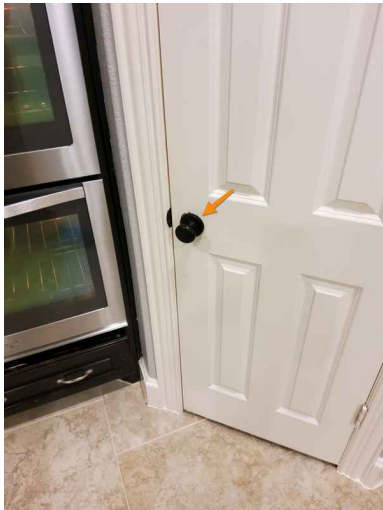
Kitchen Pantry

It is recommended that any loose door handles be secured.

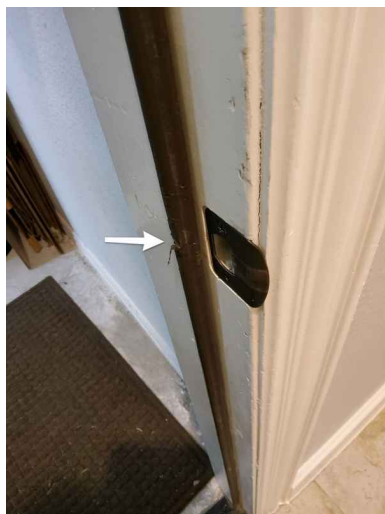
Garage Entry

### 5: Weather Stripping - Damaged

It is recommended that any damaged weather stripping be replaced.

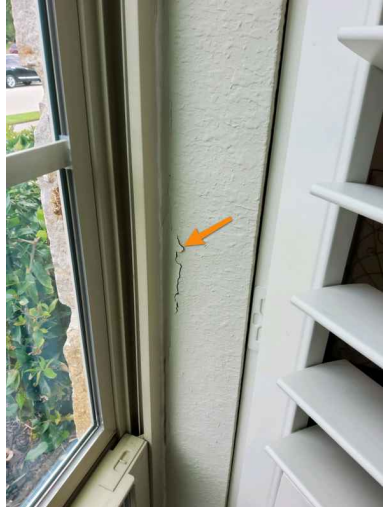
Study

The interior window jamb(s) show evidence of water intrusion (where wall meets window) in one or more locations. Further evaluation to determine the cause and remedy along with making any necessary repair/replacement to any affected areas is recommended.

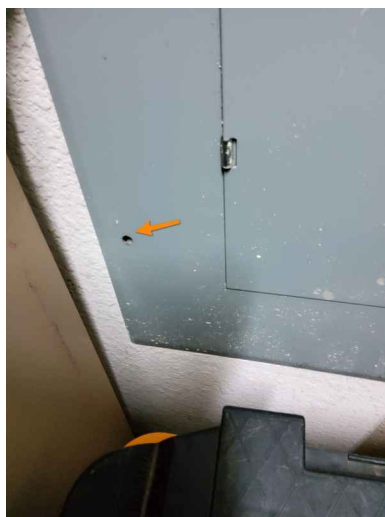
Main Panel

One or more of the cover screws are missing at the dead front cover and should be replaced (with flat tipped screws).

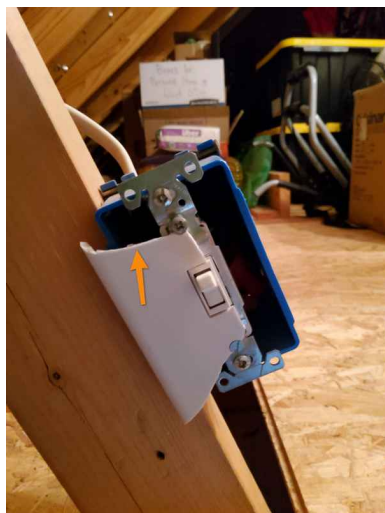
Damaged cover plates should be replaced to provide protection and prevent access to the electrical connections. This is usually a simple and inexpensive repair.

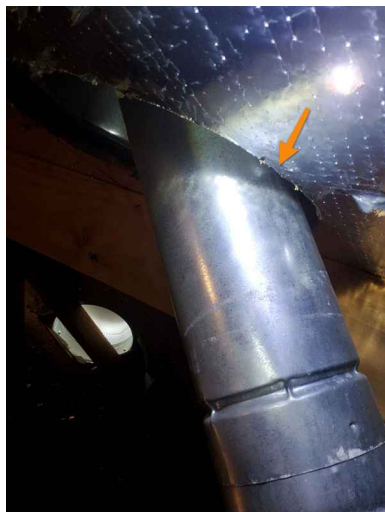
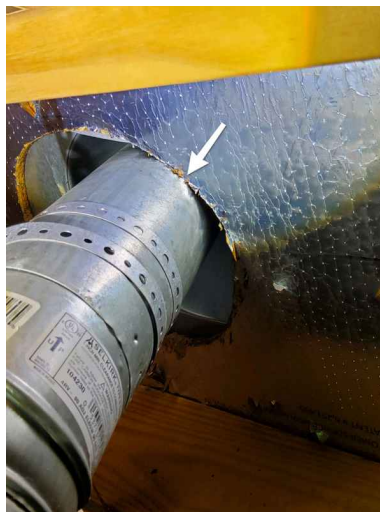
**1: Gas Furnace - Flue + Too Close To Combustibles**

The furnace exhaust flue should be a minimum of one inch between the flue and combustible materials, this did not appear to be the case at the time of the inspection. *Corrections are recommended as this is considered a potential safety hazard.*

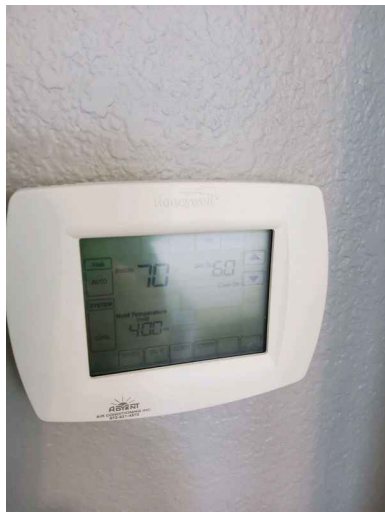
Lower Level

As is not uncommon for homes of this age and location, portions of the cooling systems appears older. Older systems may require a slightly higher level of maintenance, and may be more prone to major component breakdown. Predicting the frequency or time frame for repairs on any mechanical device is virtually impossible. Consideration should be given to budgeting for a new more efficient units.

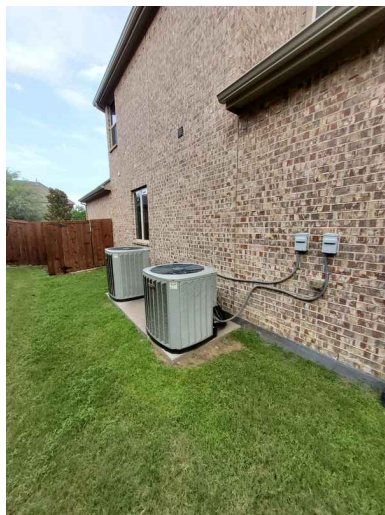
The exterior AC condensers are not labeled to indicate, i.e. #1,#2, etc... This is recommended to identify each unit for servicing and/or emergency shut off.

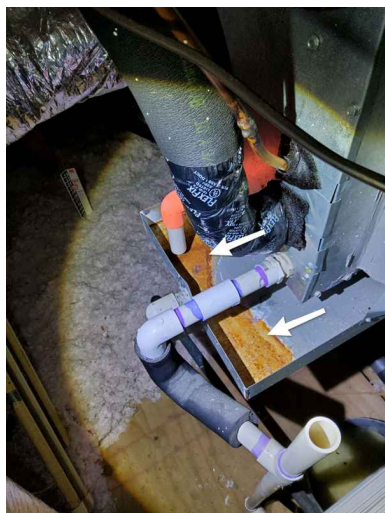
West Unit In The Attic

### 2: Drain Pan - Rust

Rust in the auxiliary drain pan was observed, it is recommended any affected areas be treated/repared to prevent the spread of rust and deterioration. In addition it is recommended that the cause of this be evaluated/verified and any repairs necessary to correct this condition be made.

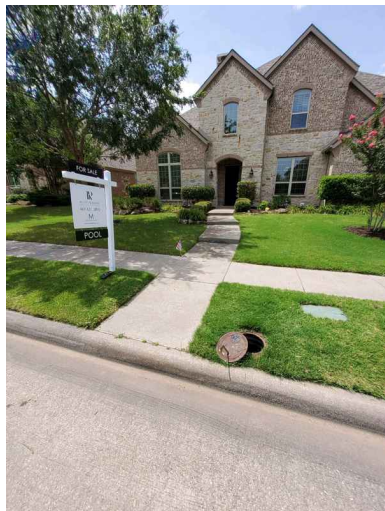
*Location of Water Meter: Side Walk*

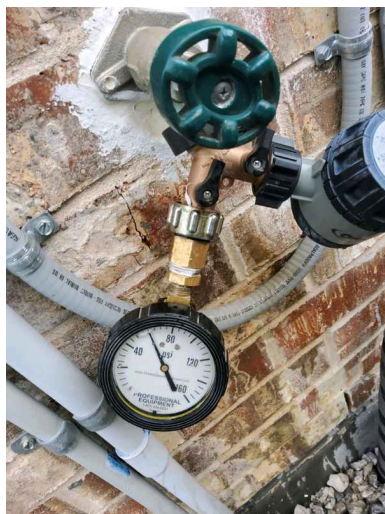
*Static Water Pressure Reading: 60-70 PSI*

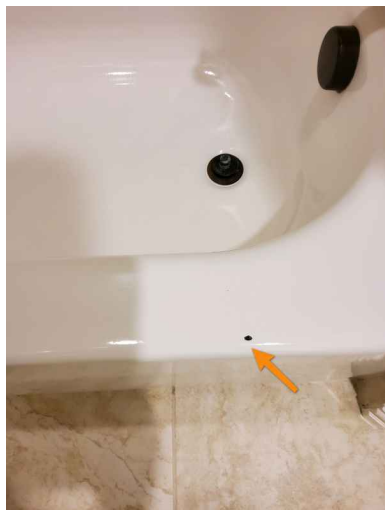
Jack and Jill Bathtub

### 1: Bathtub - Finish Damage

Damage to the bathtub finish was observed in one or more locations. It is recommended any affected areas be repaired.

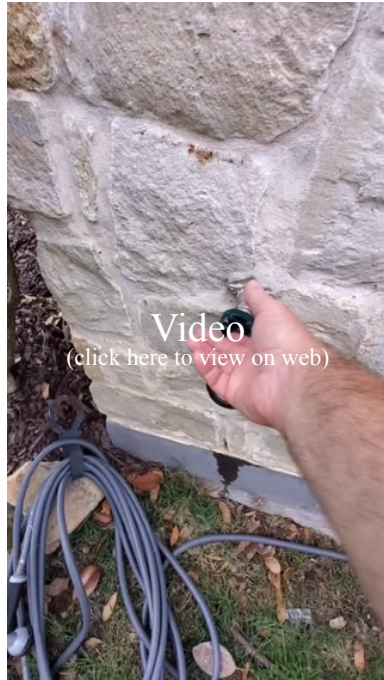
### 2: Hose Bibs - Leaks Behind Exterior Wall Under Pressure

When the exterior hose bib was activated, and under pressure, water leakage was observed to be coming from behind the exterior wall. This is indicative that this exterior faucet is leaking/damaged. Further evaluation to determine the cause and remedy along with making any necessary repair/replacement to any affected areas is recommended.

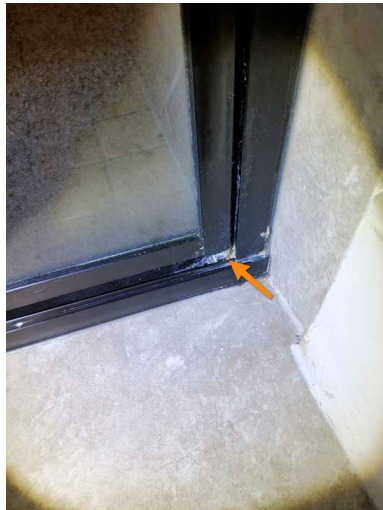
Master Bathroom Shower

### 3: Shower - Mineral Build Up

Evidence of mineral build up at the shower was observed in one or more locations, this can be a factor that leads to water leakage at these areas. Further investigation to determine what repairs (if any) are necessary to correct this condition.

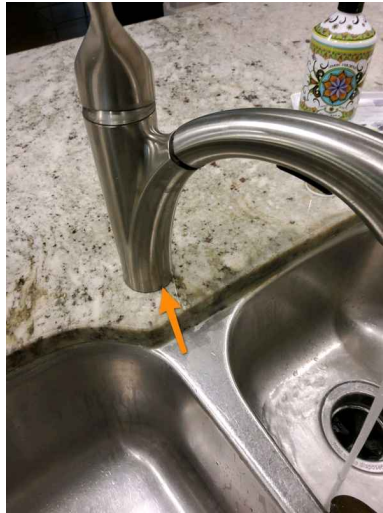
Kitchen Sink

### 4: Sink - Faucet Loose At Countertop

The faucet is loose where it mounts to the countertop, repairs are recommended.

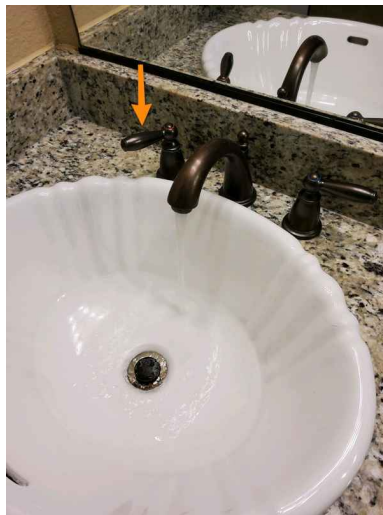
Left Master Bathroom Sink

At least one valve at the sink is stiff to use, it is recommended improvements or replacement be made. This could be caused by a buildup of sediment and hard water deposits in the faucet cartridge.

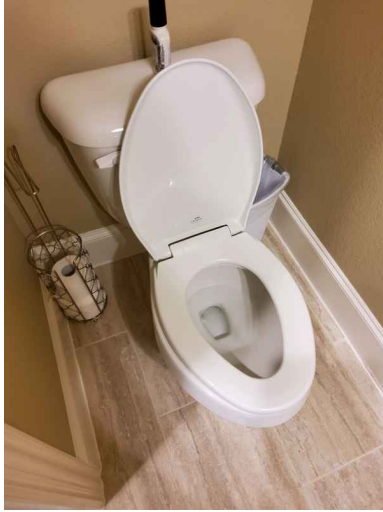
Powder Room

**6: Toilet - Loose At Base**

It is recommended any loose toilets be secured. This is may be a simple as tightening the floor mount bolts on the side. Sometimes pulling the toilet and replacing the wax ring is necessary.

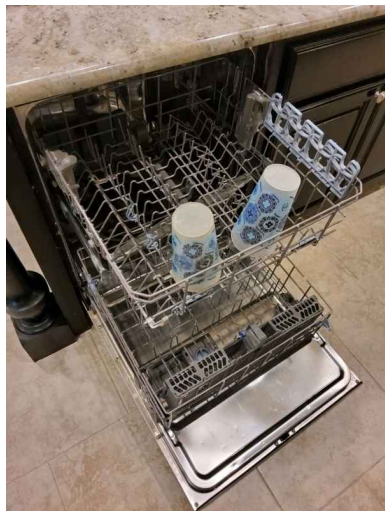
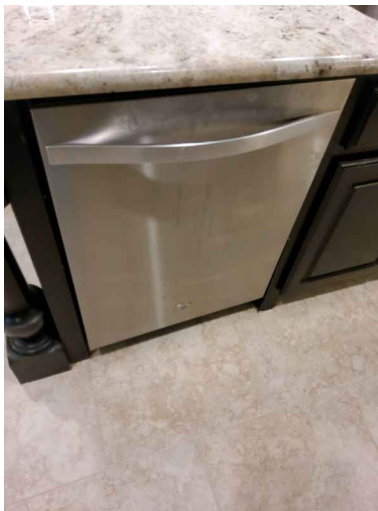
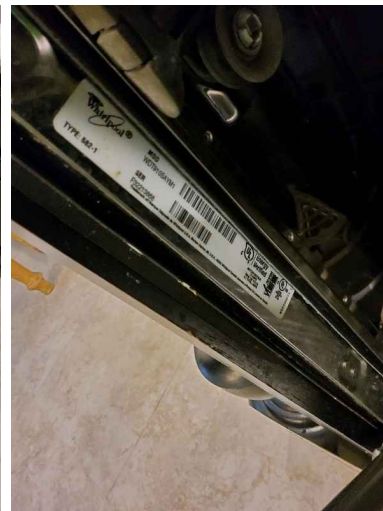
☐ ☐ ☐ ☒ **A. Dishwashers**

The dishwasher appears to be an older unit. While replacement is not needed right away, it would be wise to budget for a new unit. In the interim, a higher level of maintenance can be expected.

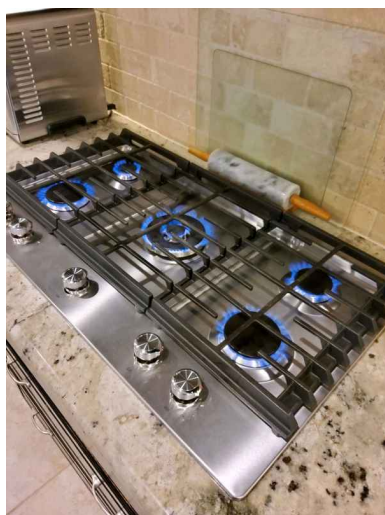
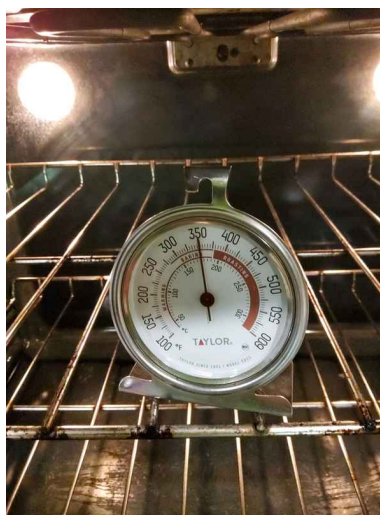
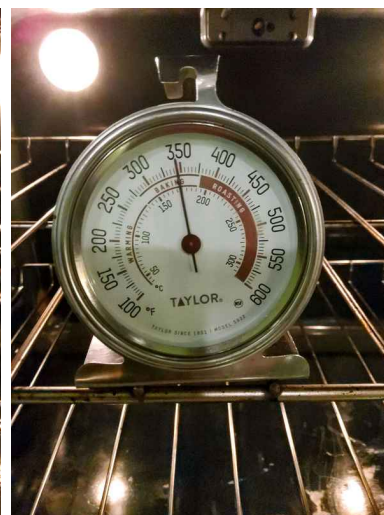
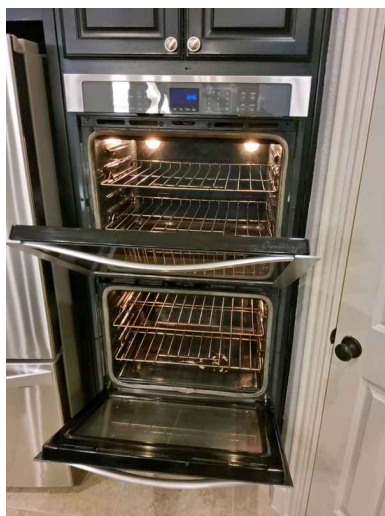
☐ ☐ ☐ ☒ **D. Ranges, Cooktops, and Ovens**

It is recommended that the oven be professionally cleaned prior to the next use.

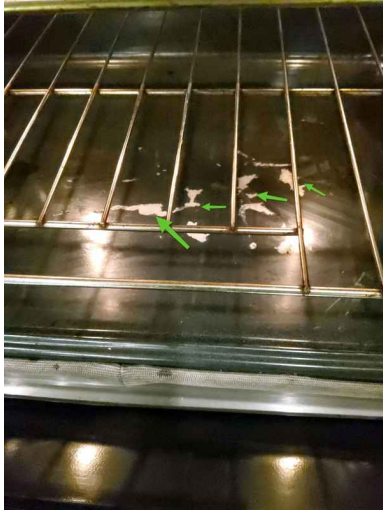
**1: Oven - Interior Finish Damaged**

Damage to the interior of the oven was observed in one or more locations. It is recommended any affected areas be professionally repaired and / or replaced.

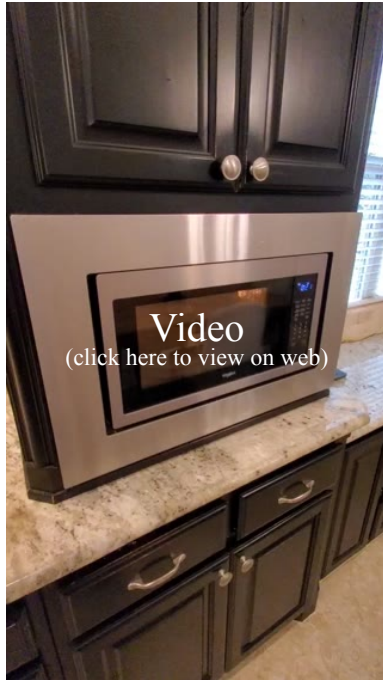
#### 1: Rust/Deterioration

Rust/deterioration was observed at the microwave. Repairs may be available, if not then replacement of this unit is recommended.

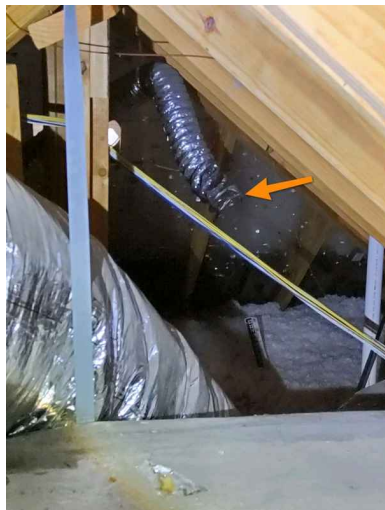
East Side Of The Upper Level Attic

#### 1: Duct - Damaged

Damage to the duct (of what would appear to be for an exhaust vent) was observed in one or more locations. Replacement is recommended.

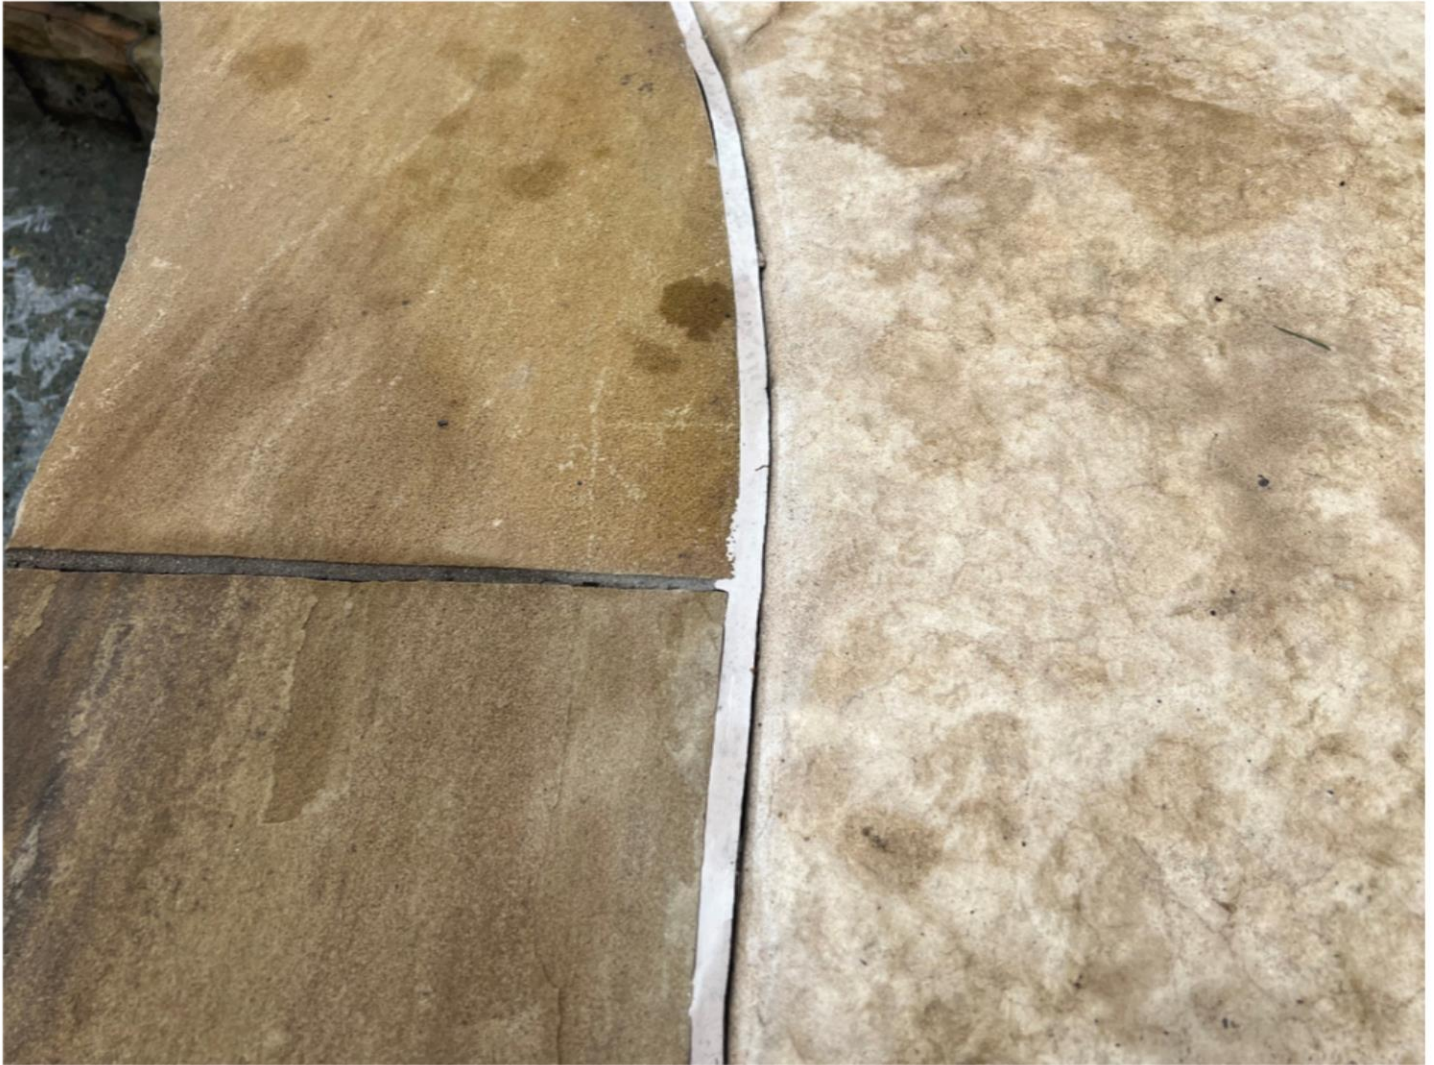
1.4 Mastic/Expansion Joints: Mastic allows the pool to expand and contract with changes in the environment while maintaining a flexible waterproof seal to prevent water from slipping between the coping and deck. Without mastic, water can erode away at supporting soil and encourage structural damage to the pool. Mastic should be replaced every few years when separation exceeds 50% of the total application area. This mastic has exceeded the 50% separation mark and is due for replacement. Replacement costs typically run between \$5 and \$7 per linear foot of application. Joints that are excessively wide may cost more due to higher material consumption. Vertical joints (stairs) use a different material and are priced per joint at between \$7 and \$10 each. Expect to pay around \$300 to replace all the mastic around this pool and spa. Costs and options can vary somewhat.

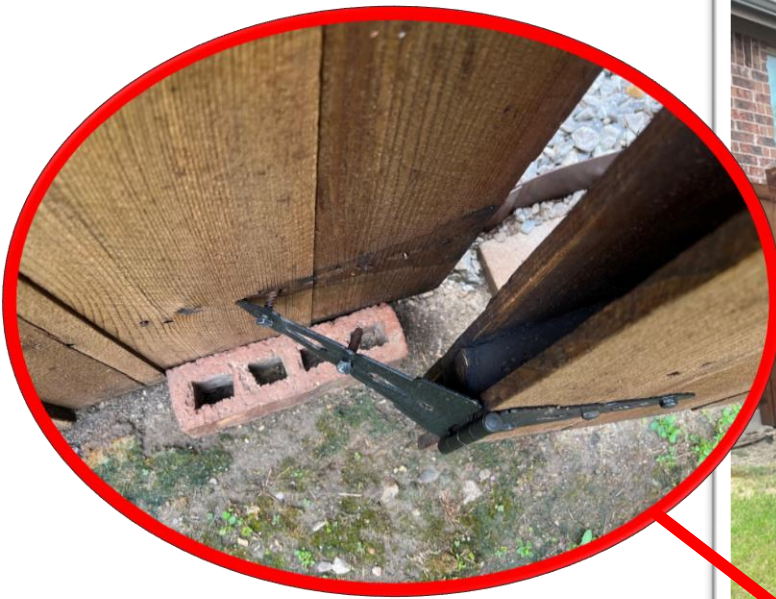
2.6 Barrier (Fence, Gates, Door Alarms): All pools are required to have a secure boundary to prevent unsupervised persons (children) from accessing the pool. This requirement is as much to protect the pool owner from liability as it is to protect the public. To paraphrase the International Code Council, a fence/gates/structure must provide an uninterrupted barrier around the pool, be at least 48" in height above grade facing the pool, not be easily climbable, and have no gaps greater than 4" wide. The gates need lockable self-closing & self-latching mechanisms installed and must open away from the pool yard to meet the boundary requirement. Adequate gate hardware is inexpensive and can be acquired at most home improvement stores. Fence repairs come in a variety of options to meet the minimum requirements. Fencing companies and "handyman" businesses can provide repair or installation services at varying rates. ***(Note: The requirements and standards for door/window alarms vary by location (city/county). Contact your public safety office to determine the requirements for your particular dwelling.)***

Adjust, repair, or improve gates to self-close and self-latch when opened and released. The lower hinge will require specific attention.

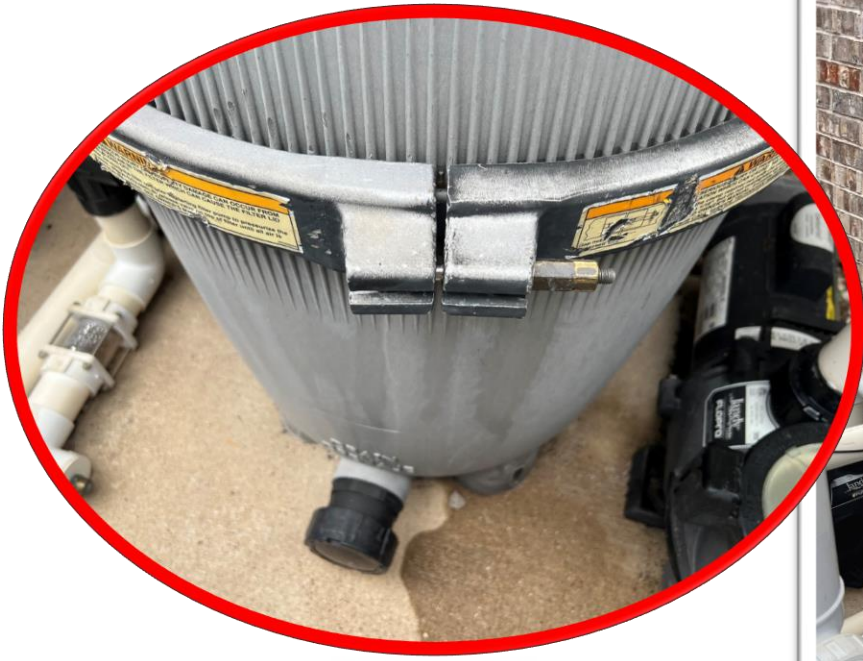
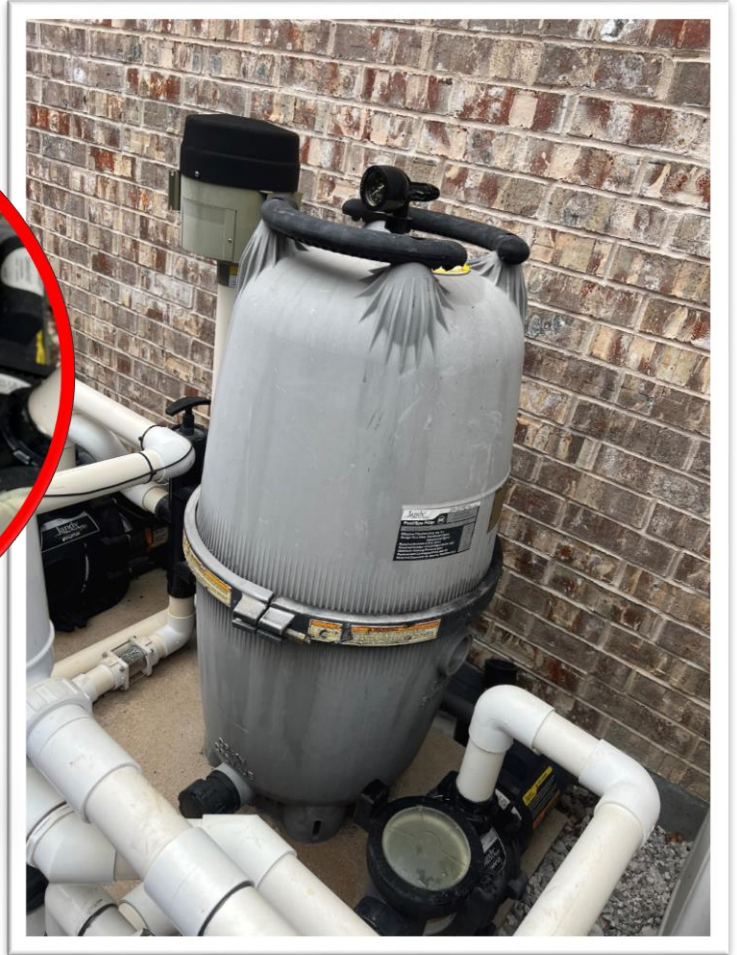
3.2 Pool Water Filter: This filter is in fair condition, but the main housing seal is leaking. Have filter serviced to address the leak. Expect to pay around \$85 - \$135 on average. Costs and options vary somewhat.

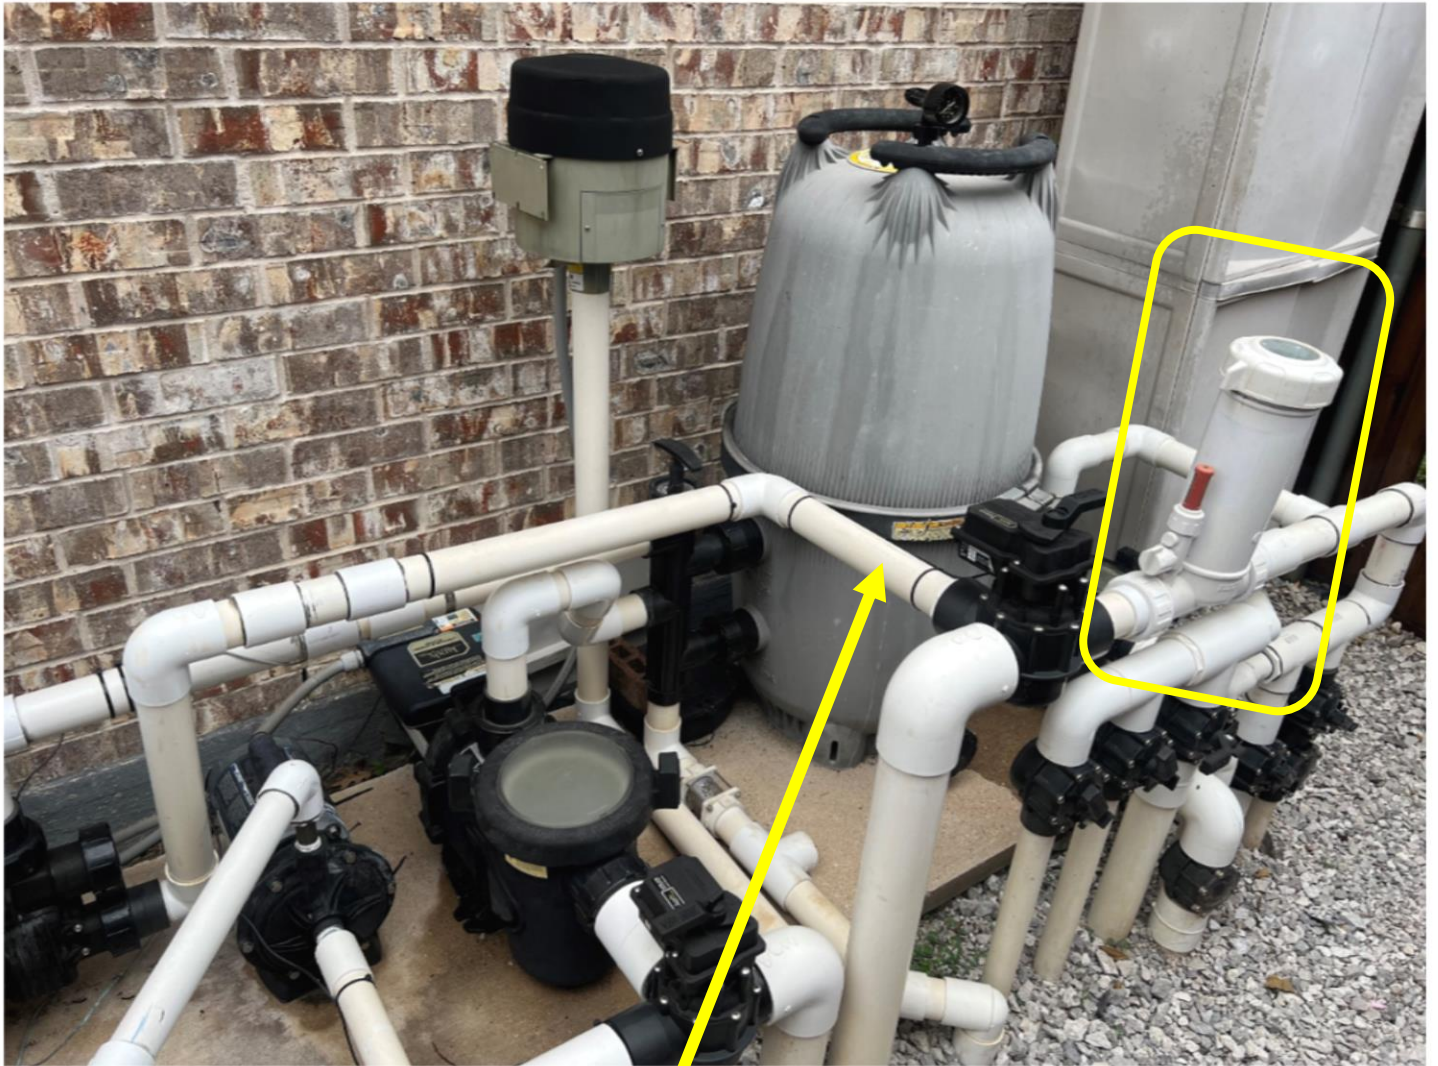
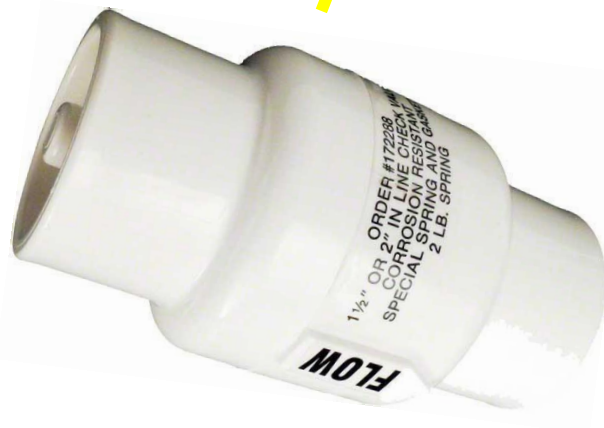
3.7 Chemical Feed (in-line): This in-line chlorinator is in excellent condition. It is recommended that a check valve be installed before an in-line chlorinator to prevent high concentrations of chlorine from settling backwards into the equipment (heater/pumps) while the system is off. Expect to pay \$190 - \$250 to have a check valve in the location suggested below. Costs and options can vary.

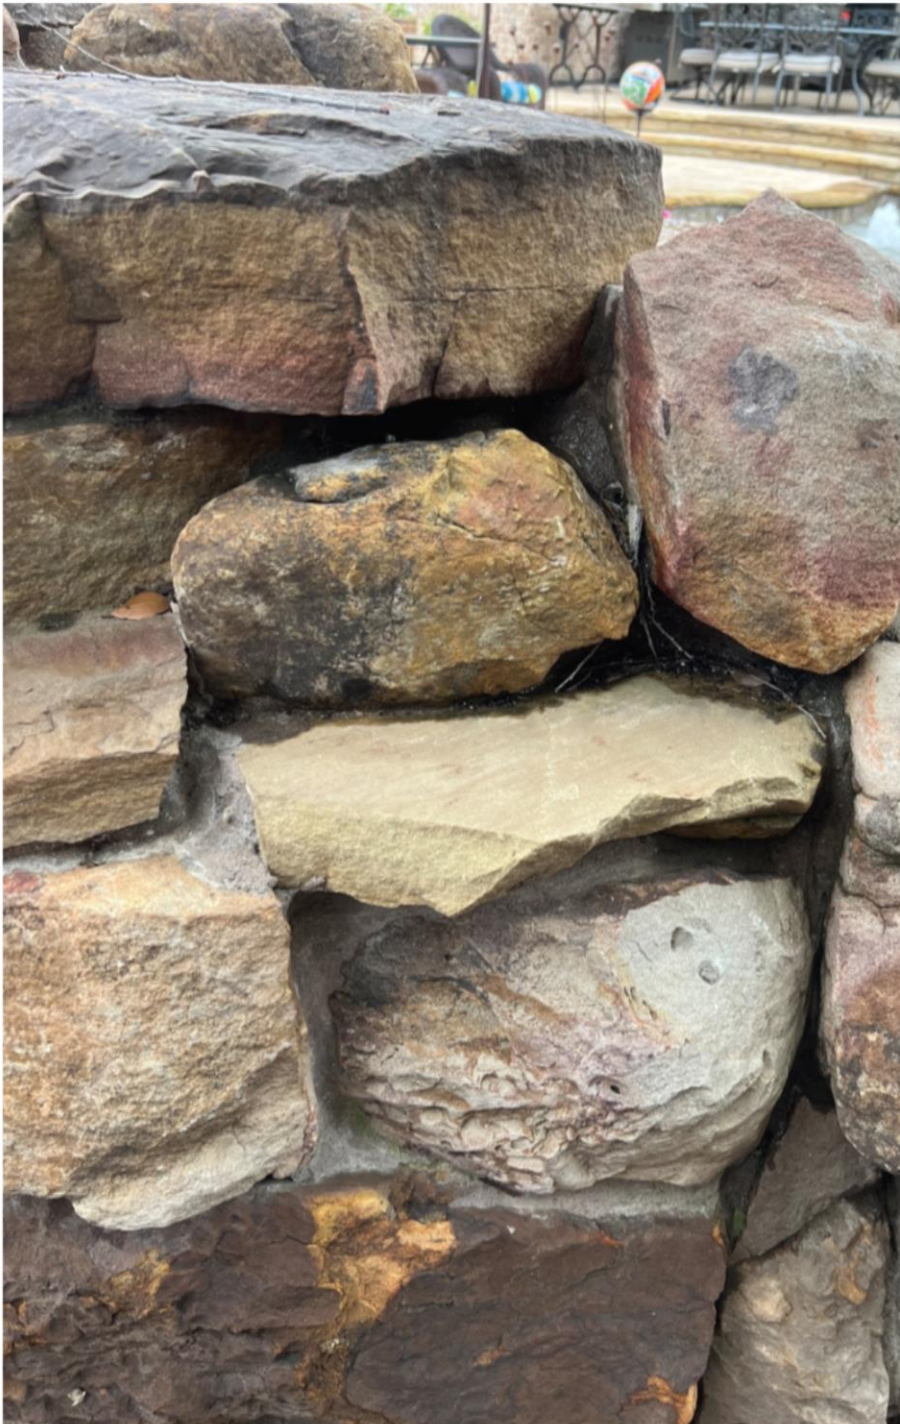
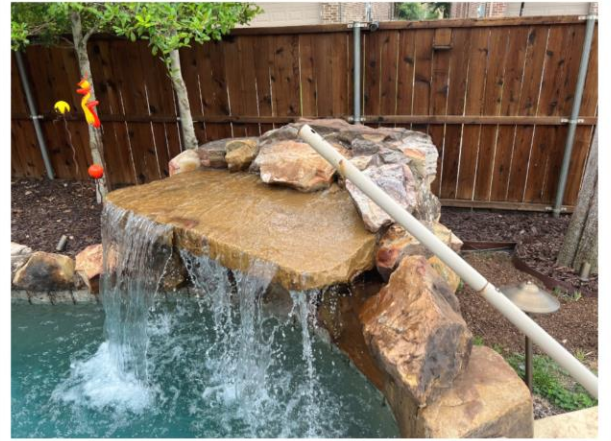
5.0 Waterfall Feature: This waterfall feature works very well, but there appears to be some water slipping between failed mortar joints along the side of this feature. This is a very small leak presently, but erosion will often make leaks like this worse over time. While sealants have been used with varied degrees of success, the most reliable way to address leaks like this is to replace the failing mortar by partially rebuilding the feature. Expect to pay \$450 - \$1200 depending how much of the feature is rebuilt. Costs and options vary.
