BEAR LAKE REGIONAL PARK

MARCH 2022 DRAFT MASTER PLAN - PHASE 1 SHORELINE FOCUS AREAS

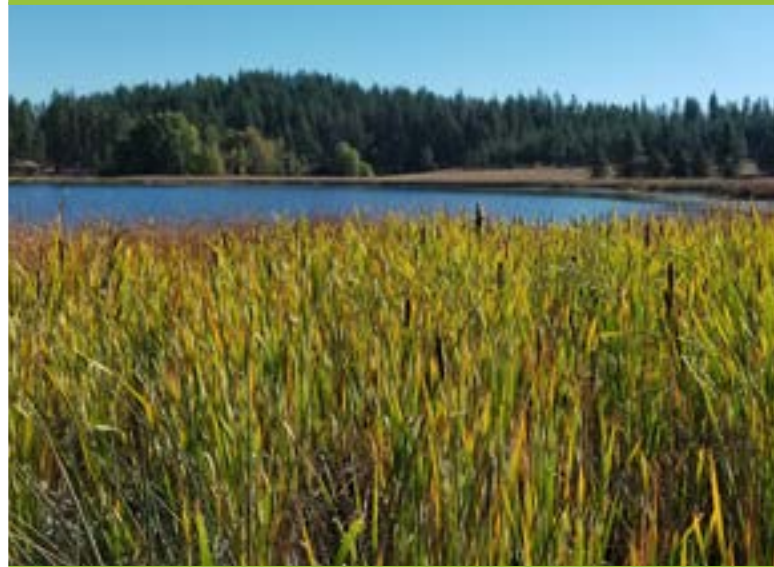
13 55 70 PARKING LOTS

There are five (5) existing gravel parking lots in the park providing roughly 175 parking spaces including designated ADA stalls. There is strong evidence that at peak seasonal use, the number of parking stalls is inadequate.

- Year Built / Renovated:
- Condition Assessment: The ADA stalls on the west and east sides of the lake may not meet Access Board requirements. These should be graded and paved if necessary.

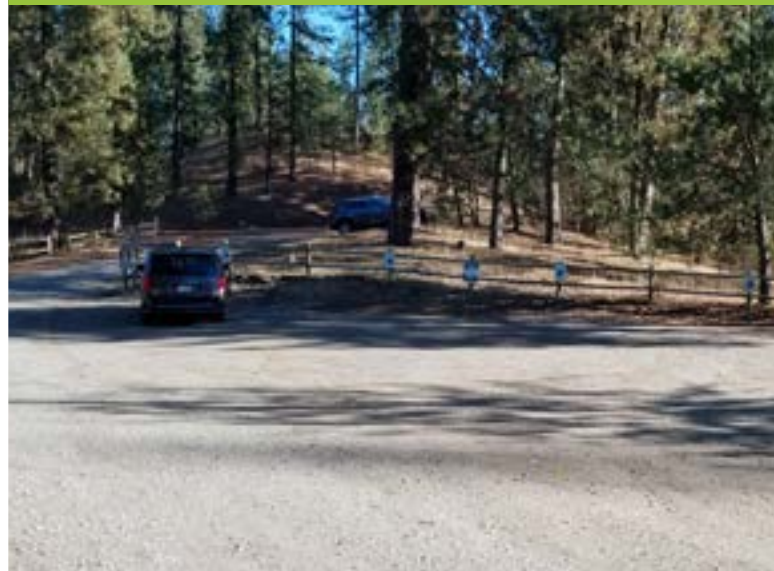
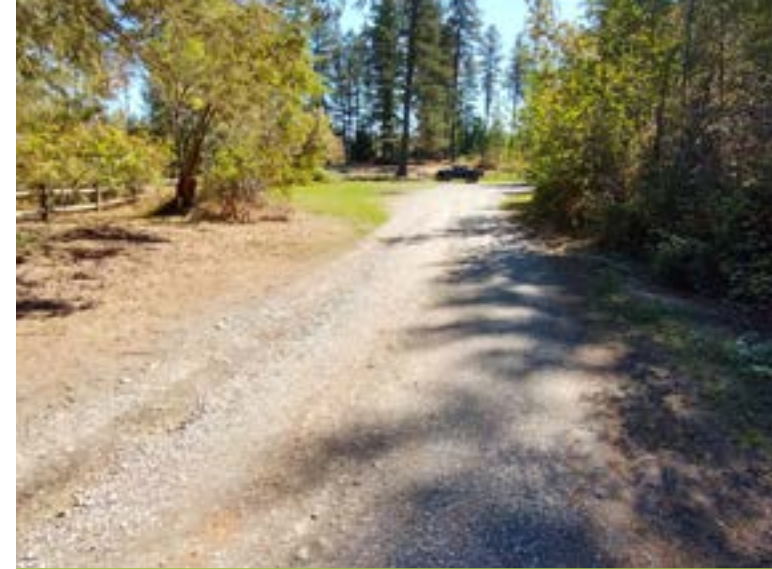
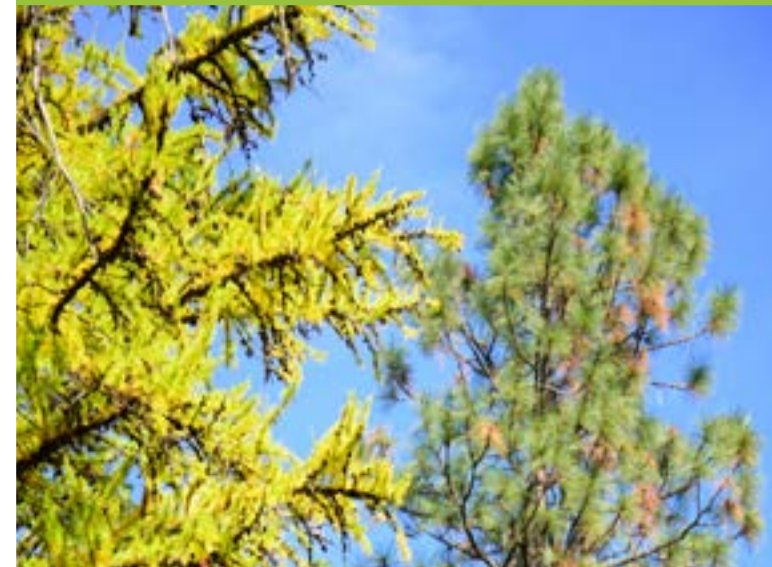
10 44 57 GRAVEL ROADWAYS

Existing roadways on site are gravel and the conditions of the roads vary throughout the site depending on the amount of traffic. Some sections, such as the roads near the entrance may require some regrading and graveling.

- Year Built / Renovated:
- Condition Assessment: All roads could use grading and gravel refreshing.

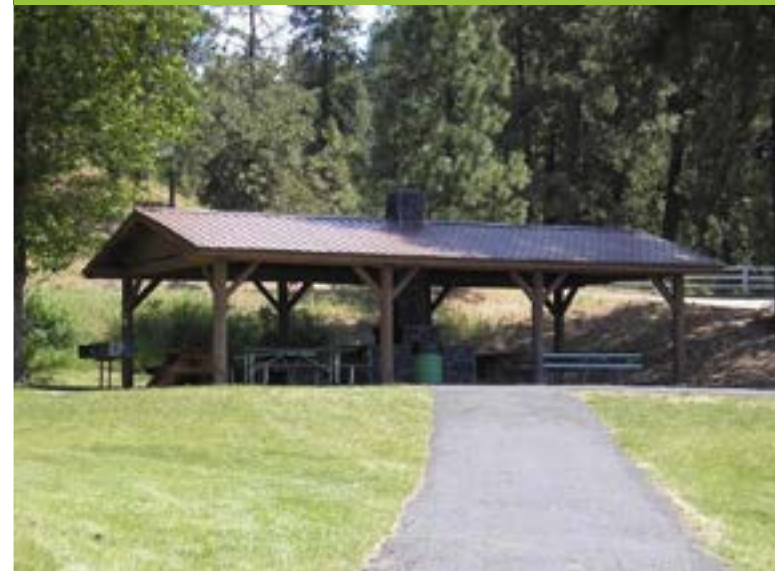
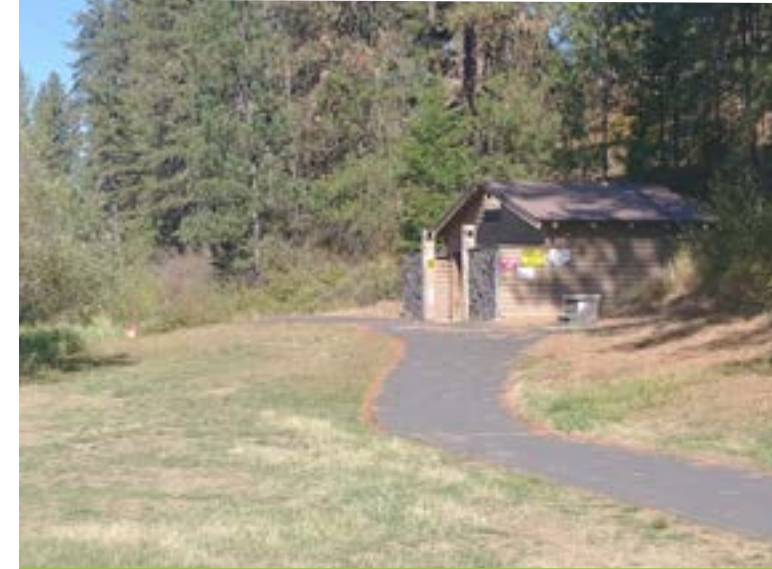
4 NORTH RESTROOM

This fully accessible restroom is located on the northeast shore of the lake along a paved pedestrian path. These restrooms are in working order but would benefit from some minor repairs and cosmetic work.

- Year Built / Renovated: 1976-1977
- Condition Assessment: Siding and stone work, along with new lights would greatly improve the appearance of these buildings. Given their age, an interior refresh is warranted.

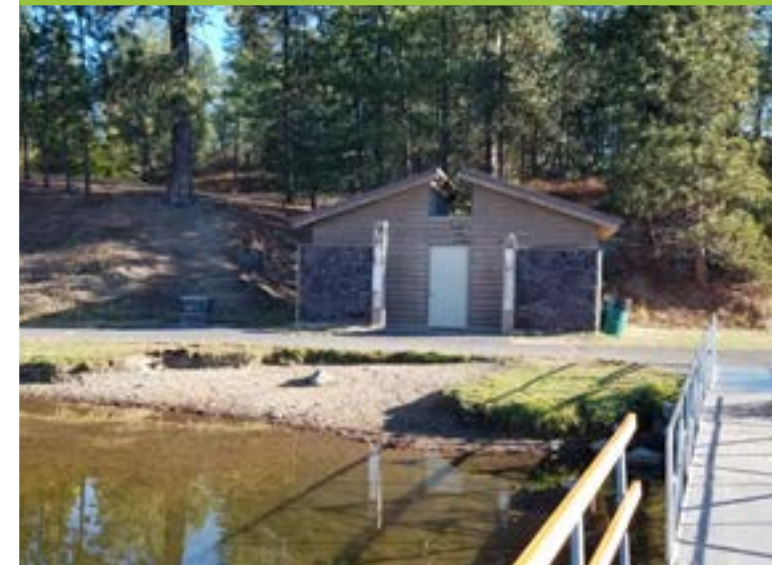
5 SOUTH RESTROOM

Located near the fishing dock on the southeast shore of the lake, this fully accessible restroom is in a convenient location from the dock and east side picnic shelter. This building is functional but needs some minor repairs and cosmetic work.

- Year Built / Renovated: 1976-1977
- Condition Assessment: This structure could be expanded on to serve higher intensity uses near the launch and dock.

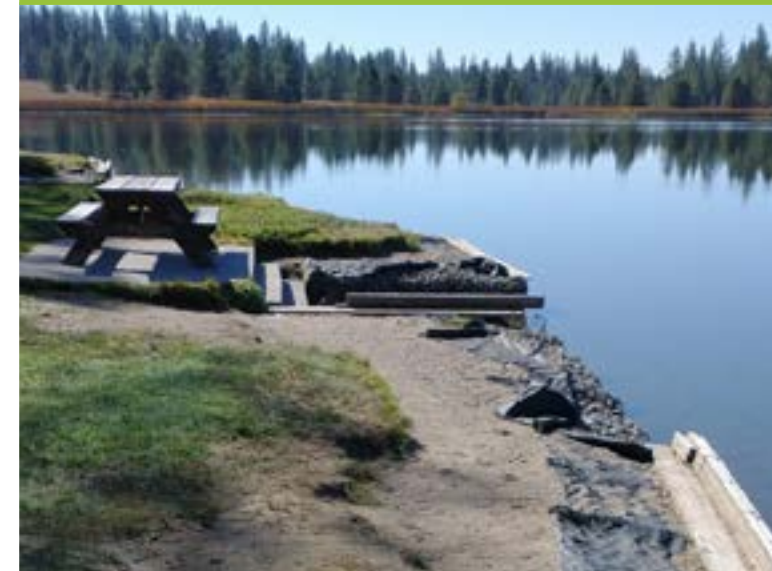
9 GABION WALL

Gabion baskets are in poor condition with tops that are typically exposed where the landscape fabric has pulled back exposing wire. Wood plank edging is attached to gabions in some locations but no longer serve any purpose due to erosion of lawn area on gabion tops. This is creating a hazardous condition due to exposed wire baskets.

- Year Built / Renovated: 1991-1922
- Condition Assessment: The gabions are collapsing and need removed or replaced.

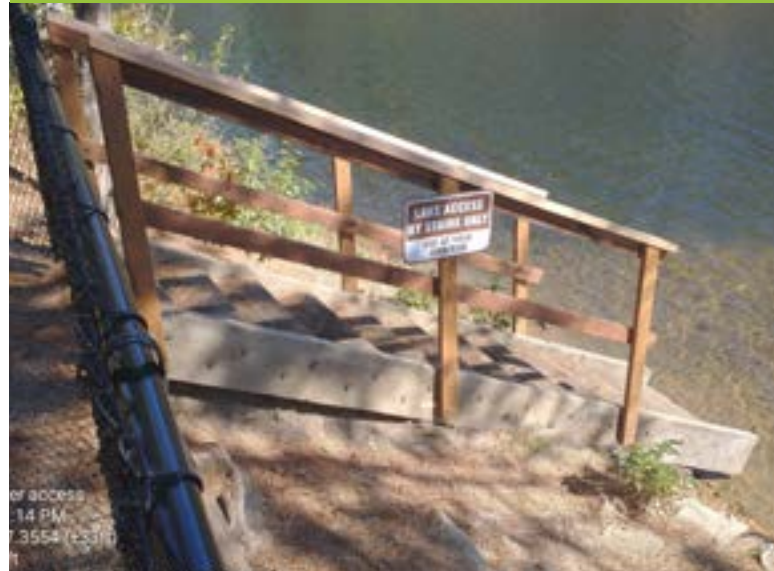
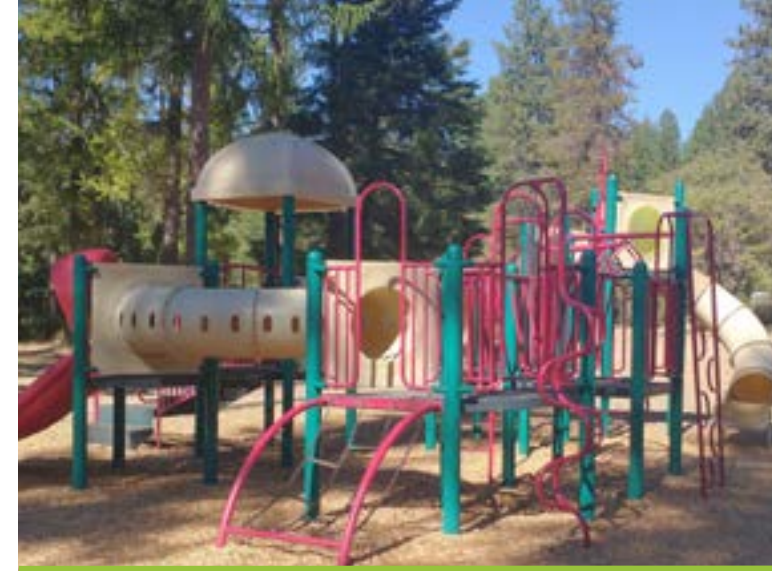
34 PLAYGROUND

A playground structure replete with slides and climbing features is located on the northwest side of the lake near the swim area and a picnic shelter. The playground equipment appears in good condition.

- Year Built / Renovated: 1987
- Condition Assessment: Wood fiber fall zone material needs replenish and/or raking daily to ensure proper depths for safety.

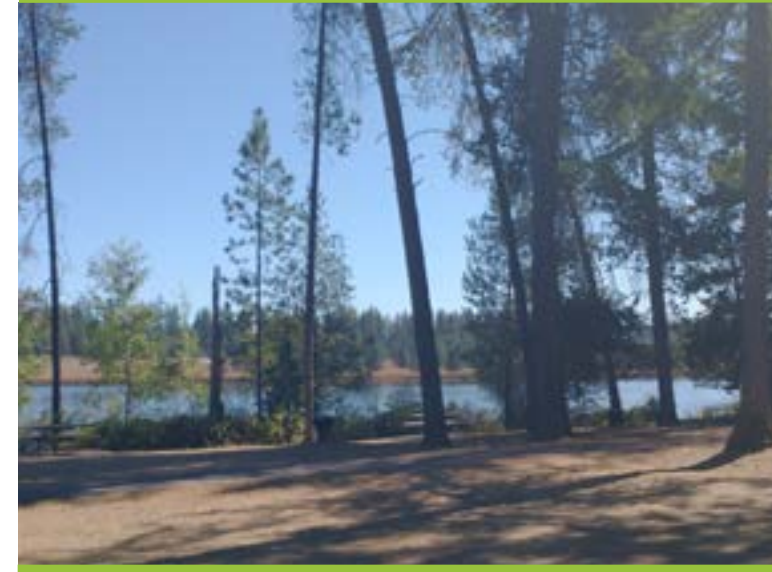
54 PICNIC AREAS

- Year Built / Renovated:
- Condition Assessment: These areas are under irrigated, resulting in scorched, brown lawn. A regular lawn and irrigation maintenance regime is warranted.

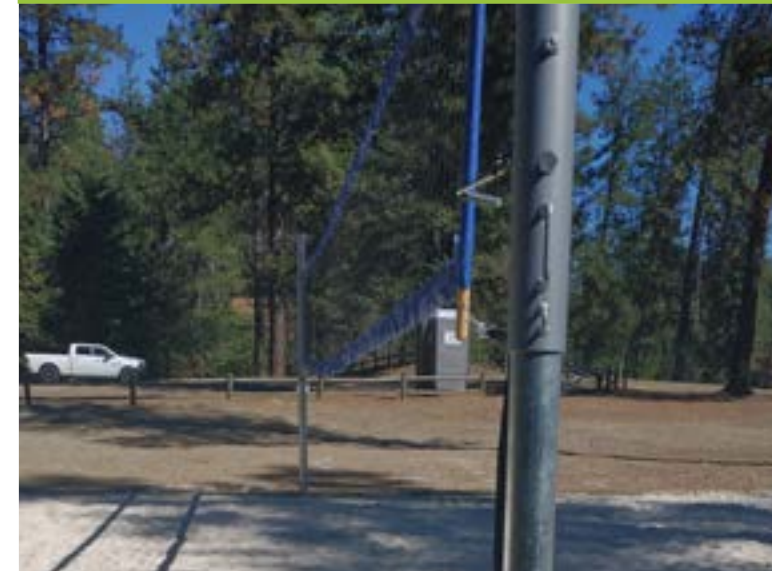
35 VOLLEYBALL COURT

Nothing says summer like a game of beach volleyball. This sand volleyball court located near the playground, swimming and picnic areas will tempt you to re-enact the Top Gun volleyball scene.

- Year Built / Renovated: 1974
- Condition Assessment: Poles, net, and sand field appear in good condition.

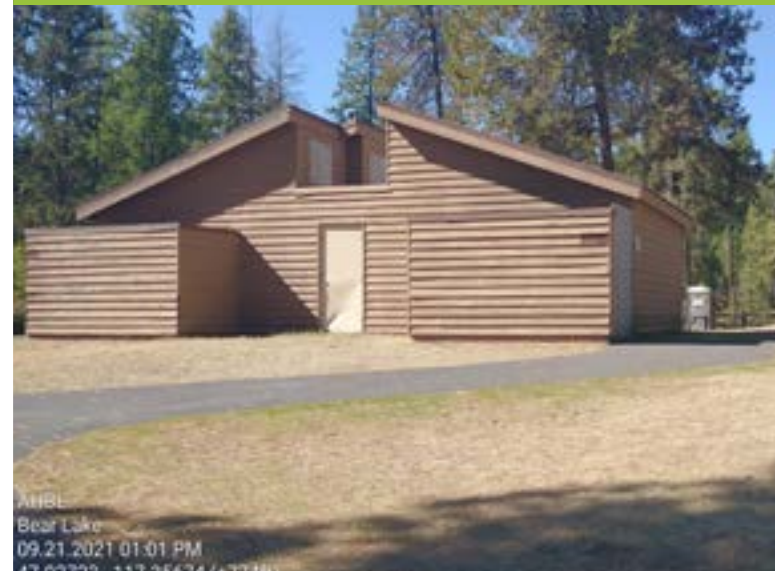
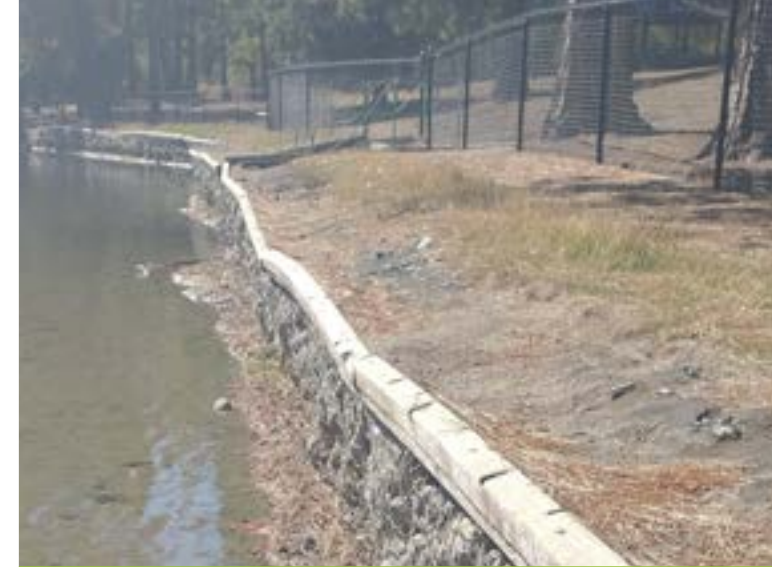
46 GABION WALL

Gabion baskets are in poor condition with tops that are exposed in several locations where the landscape fabric has pulled back exposing wire. Wood plank edging is attached to gabions in most locations due to erosion of lawn area on gabion tops. This is creating a hazardous condition due to exposed wire baskets.

- Year Built / Renovated:
- Condition Assessment: As noted above. These gabions need removed and replaced, or a different beach option investigated.

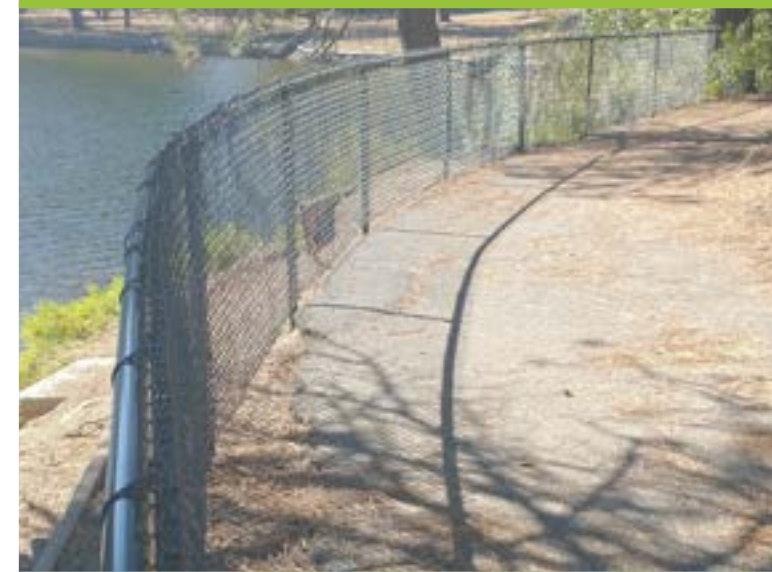
56 ASPHALT PATH

The asphalt loop path around the lake continues on the west side. The path is only near the lake on the northern half of this side. Other areas wind through the picnic lawn and through wooded areas offering a different experience.

- Year Built / Renovated:
- Condition Assessment: The condition of the asphalt pathways varies with certain areas in need of repair.

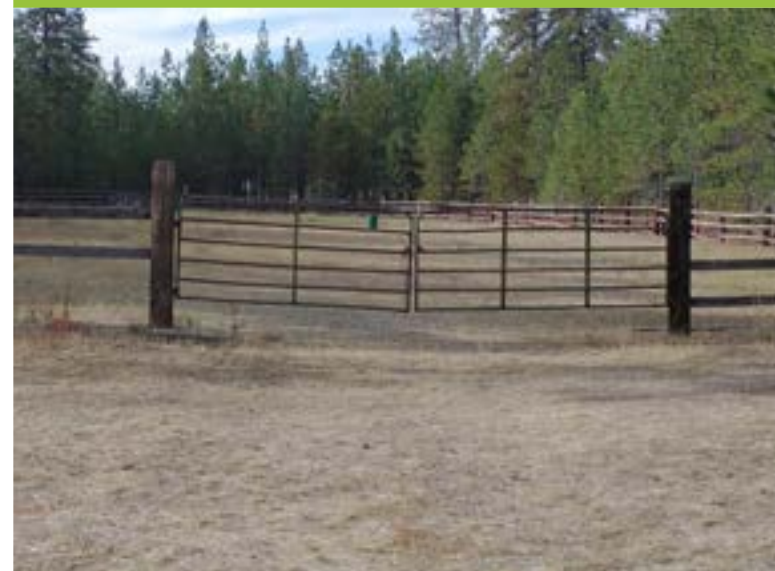
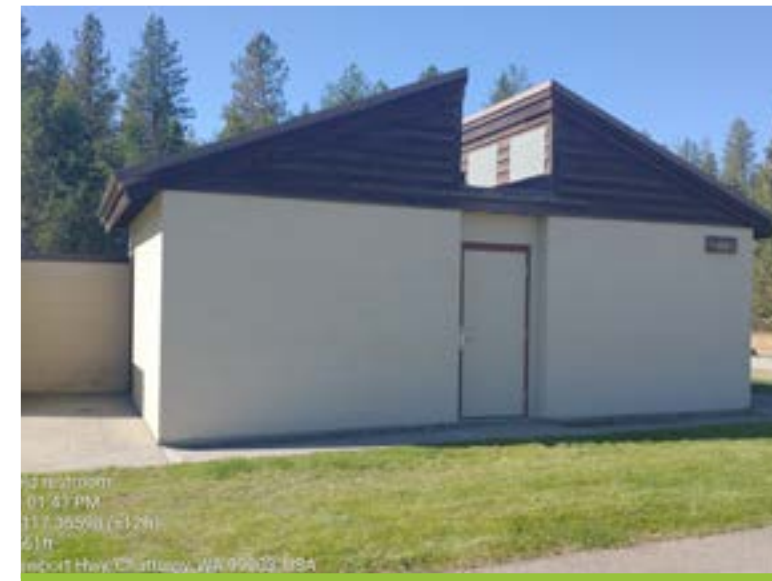
61 RESTROOMS

This concrete masonry unit constructed restroom is in good condition. Located south of the lake this fully accessible men's and women's restroom serves the southern half of the park site.

- Year Built / Renovated:
- Condition Assessment: The building appears to be in fair condition.

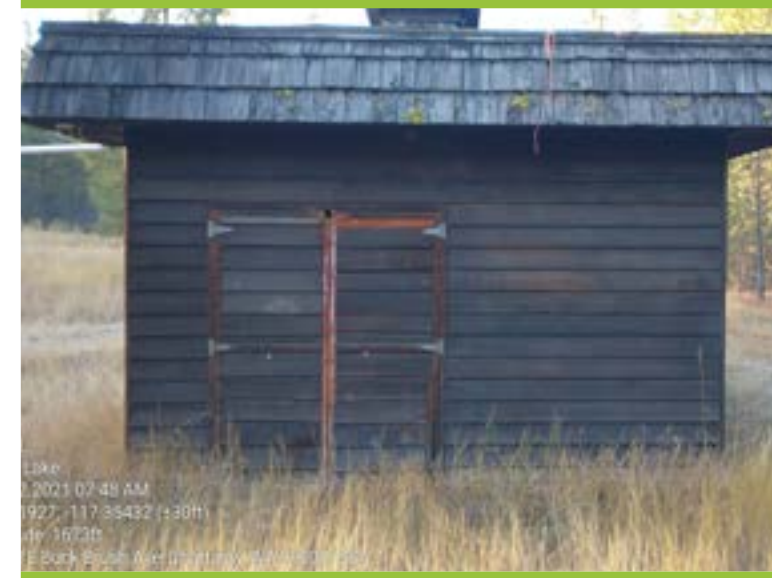
68 WELL HOUSE

This building is located off the beaten path, on the edge of a native forest. Wood siding and a shake roof are deteriorating.

- Year Built / Renovated: Pre-1974
- Condition Assessment: This building should be considered for replacement with a pre-fabricated con-crete structure.

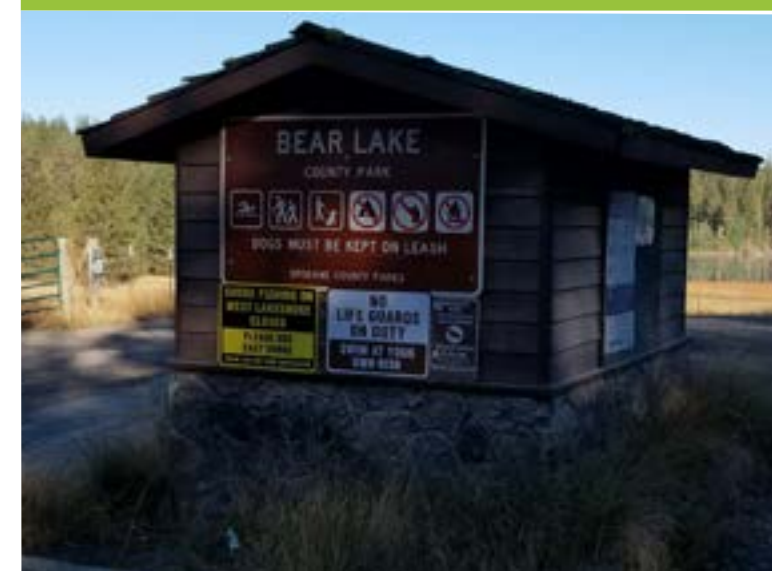
62 PARK ENTRANCE BOOTH

- Year Built / Renovated: 1976-1977
- Condition Assessment: This building is in need of masonry, siding and roofing repairs. The existing entry sign is located on the park entrance building.

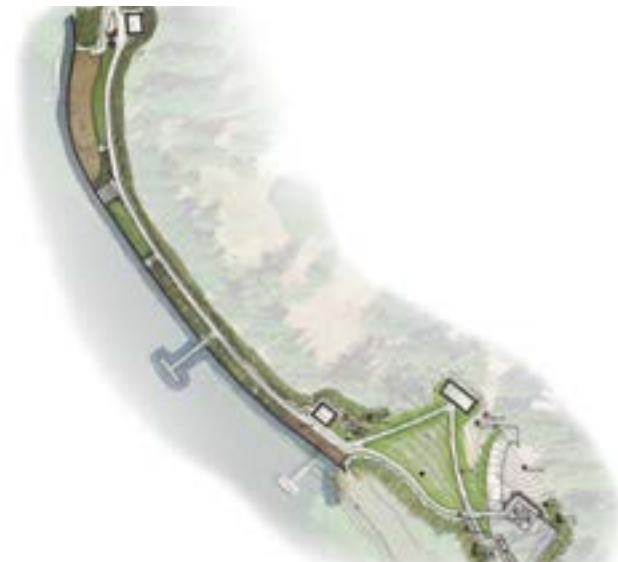
CONCEPT A

East Shore Concept Alternatives A and B.

There did not appear to be a clear preference between the two concepts. But, reactions to specific features indicated support for two features as shown on Concept A; 1) a larger contiguous sandy beach on the north side, and 2) a new fishing dock further north to replace the existing fishing dock.

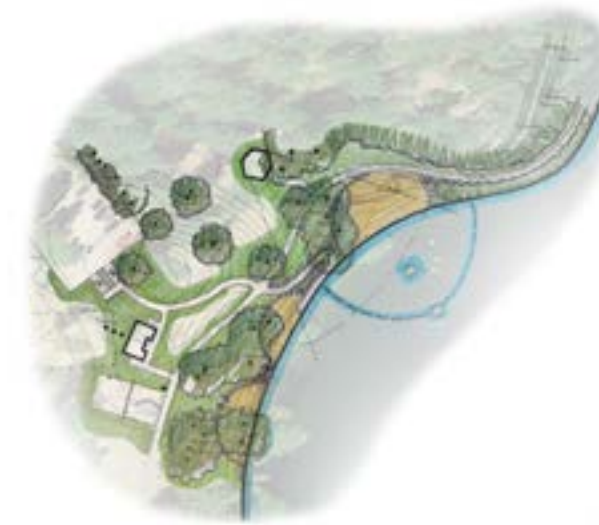
CONCEPT A

West Shore Concept Alternatives C and D.

Similar to the east side, there did not appear to be a clear preference between these two concepts. However, reactions to specific features indicated support for the swimming and beach areas shown on Concept C and the fishing dock shown on Concept D.

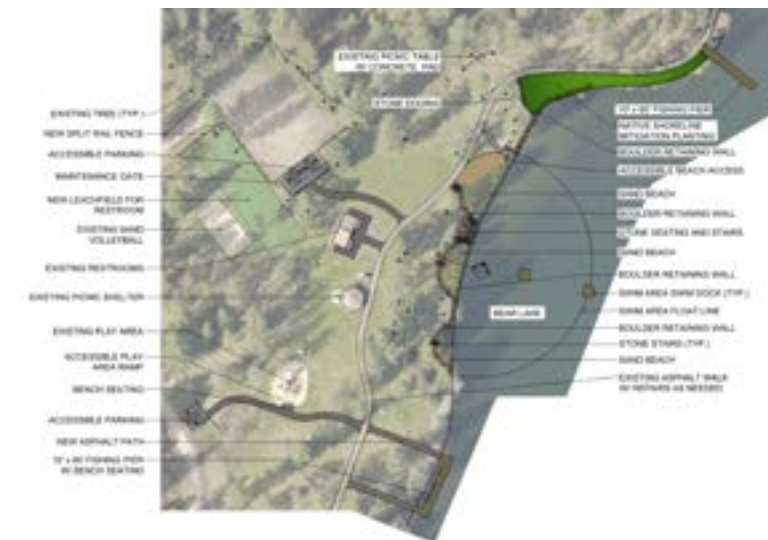
The concept alternative for the West Shore considers public input received on Westside Concepts C & D as outlined in the previous section. It includes the following features:

- Expanded swimming and beach areas,
- Shaded areas for picnic tables and lawn (the design team will work around existing trees where possible),
- Two new fishing piers,
- Improved accessible parking areas and pathways,
- A septic leachfield so the restroom facility can be re-opened, and
- Native plantings.
