Inspection Report

Property Address:
263 Dainton
Peterborough

Paul Galvin Residential Home Inspections

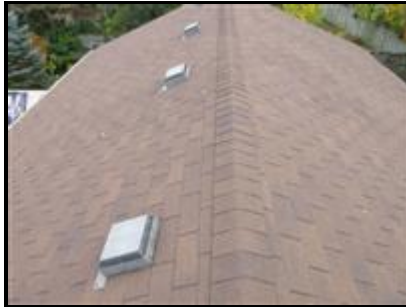
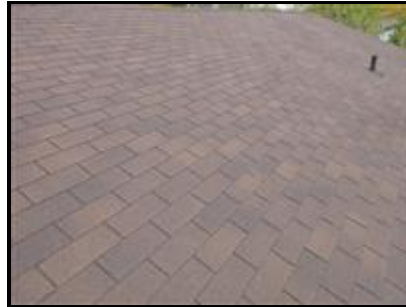
1.0 Picture 1

The entire roof surface is asphalt shingles. The shingles appear to be in good overall condition. They are installed well with all of the necessary caps and flashings.

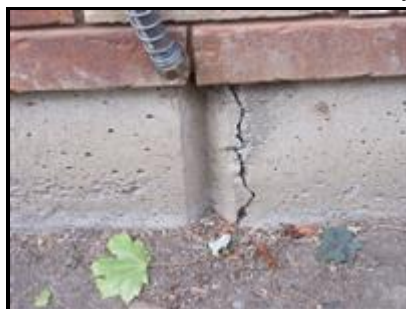
2.1 Picture 1

There is a very minor exterior foundation crack at the left side. This is typical and not a structural concern.

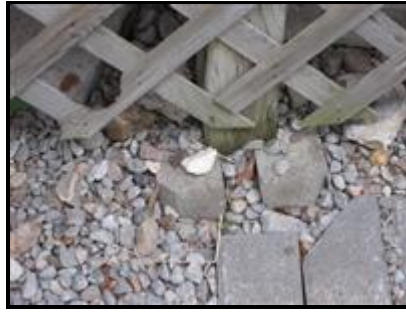
2.4 Picture 1

(1) One of the deck support posts is sitting on a deck blocks (floating) although the deck is secured to the house. Technically these posts should extend four feet into the ground. This is a minor concern.

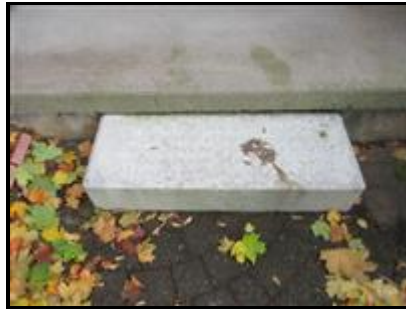
2.4 Picture 2

(2) The top front step is smaller than usual. An odd size step can pose a trip hazard. Care should be taken or this should be corrected.

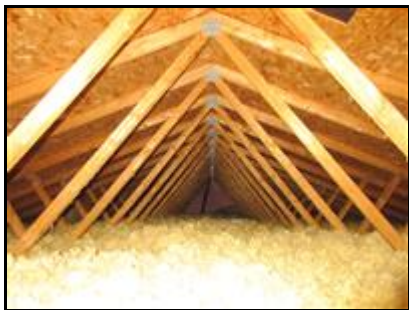
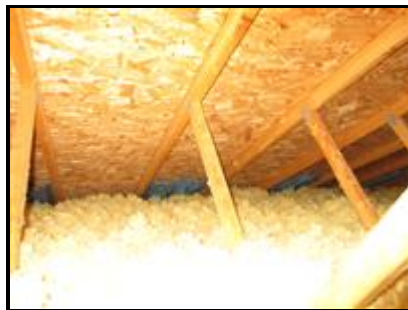
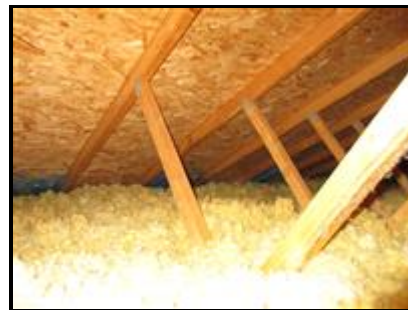
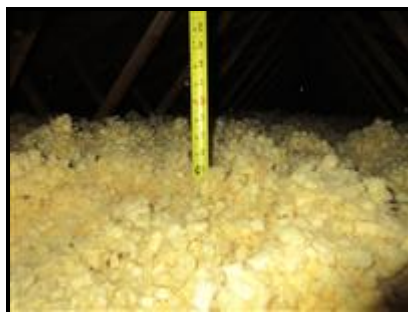
4.0 Picture 1

The attic contains blown in fiberglass insulation. This insulation appears to be well placed and installed in more than adequate amounts.

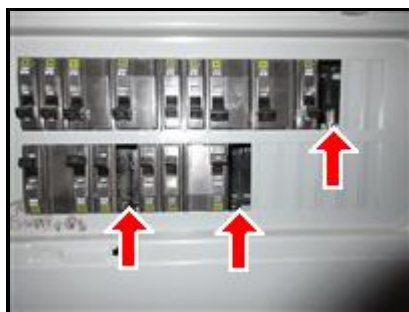
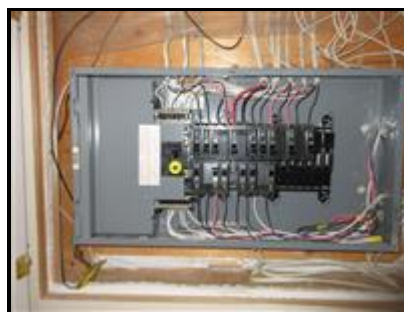
5.2 Picture 1

The main electrical panel was inspected and found to be installed properly and wired correctly. All of the proper sized breakers were present. There are several openings on the front of the panel which should ideally be covered.

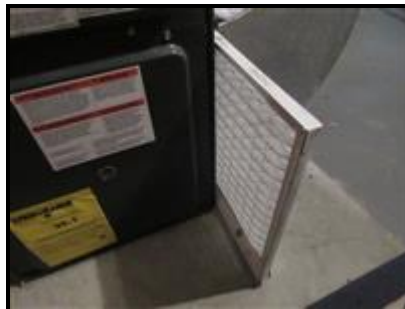
6.0 Picture 1

(1) The furnace was tested and inspected and found to be installed properly and working well. All the necessary safety features were present.

(2) The furnace filter should be changed on a regular basis.

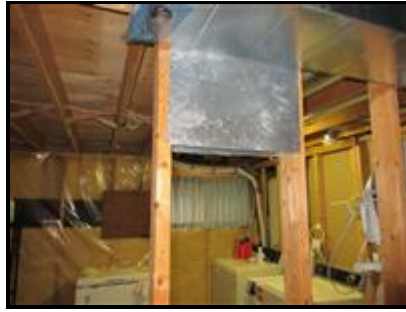
6.4 Picture 1

Ideally the cold air return in the basement should be finished down to the floor level.

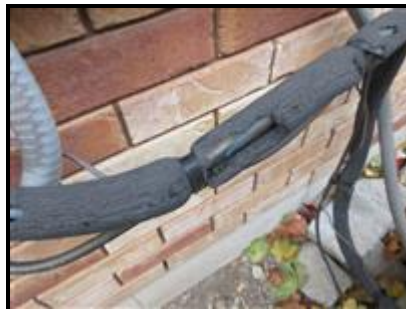
6.9 Picture 1

(2) The foam sleeve on the copper suction line outside at the AC line is deteriorated. Ideally a new foam sleeve should be installed.

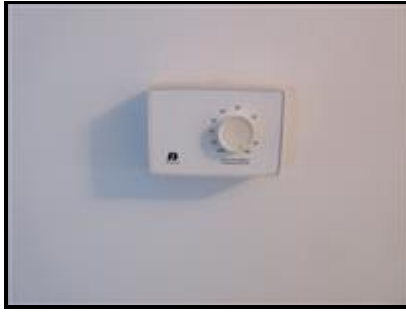
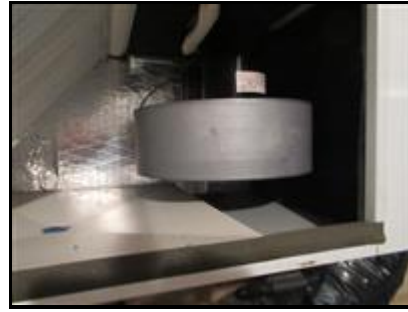
6.13 Picture 1

(1) The heat recovery ventilator located in the basement is a mechanical device that exchanges stale indoor air with fresh outdoor air. Heat is transferred from the outgoing air to incoming air by passing the two air streams through a heat exchange core. Stale air is removed from the bathrooms and kitchen and then fresh air from outside is delivered to the cold air return which then circulates through the house. This device controls air quality and condensation levels in a well sealed house. This is controlled by a humidistat located beside the thermostat. However the motor inside the HRV is seized. Repair or replacement will be needed if this device is to be used.

Estimated replacement cost \$2,867.94 for HRV re Edgar Simmons Heating quote 705-734-1381

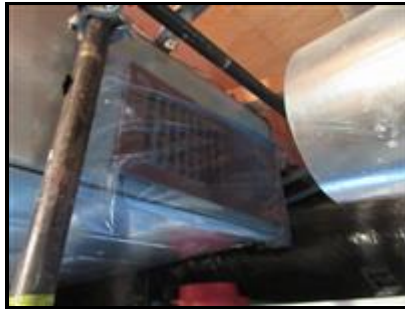
6.13 Picture 3

(2) The vent on the cold air return where the HRV adds fresh air into is covered with plastic. If the HRV is to be repaired / used this plastic should be removed.

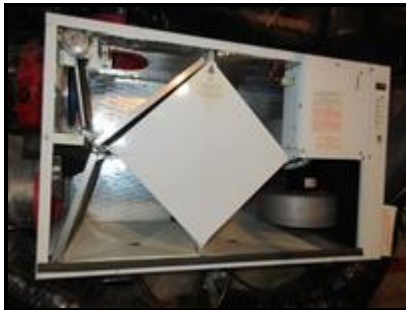
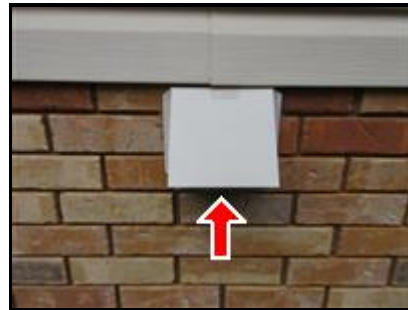
6.13 Picture 4

(3) The heat recovery ventilator filters including the outside fresh air intake screen will require cleaning on a regular basis (see manufacturers recommendations).

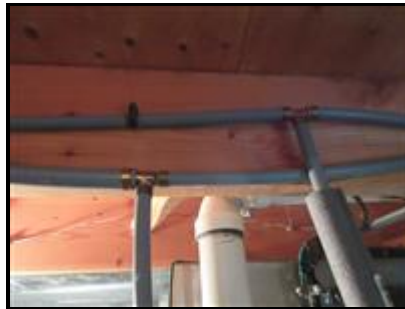
7.2 Picture 1

The distribution piping through the home is Poly B plastic. Poly B plastic has been found to be some what prone to leakage over time particularly at the plastic fittings. There has been class action lawsuits against the manufacturer. However the better copper fittings were used here. This plumbing should be monitored over time and repaired or replaced if needed.

Berardi Plumbing quote to replace all Poly B
\$3,322.20
This quote does not include repairs to to drywall and paint.

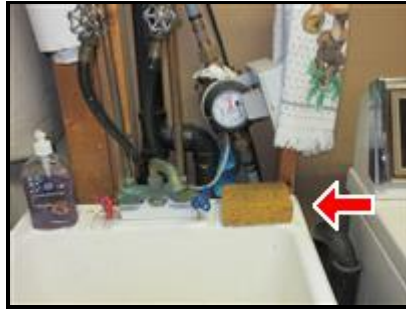
7.4 Picture 1

Just under the back of the laundry tub.

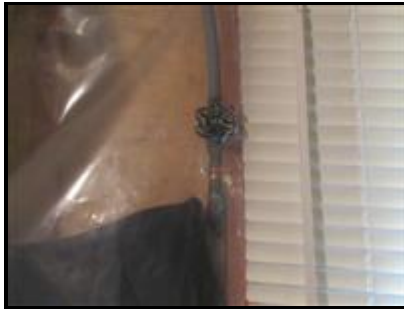
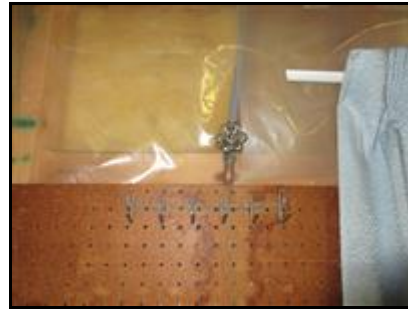
7.12 Picture 1

The outside taps should be shut off and drained before winter.

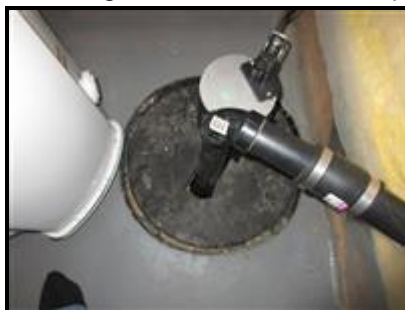
7.13 Picture 1

(1) The sump pump appeared to be seized. This should be replaced.

(2) The sump pump should be tested on a regular basis to ensure its proper operation.
