# Inspection Report

736 Wilson Line  
Cavan

**Paul Galvin Residential Home Inspections**

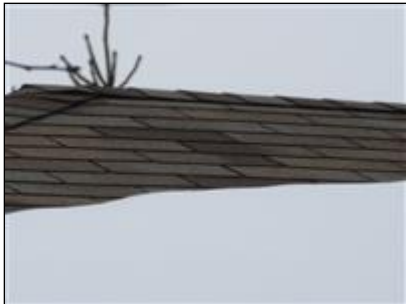
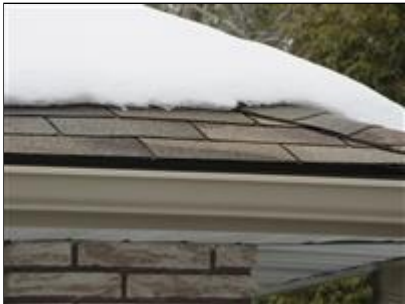
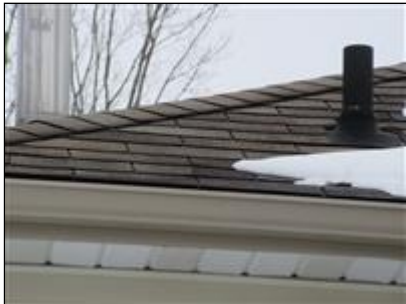
1.0 Picture 1

The entire roof surface appears to be asphalt shingles. The roof was snow covered at the time of the inspection. Therefore no exact comment can be made on it's condition or life expectancy. However the small areas that could be seen appeared to be in good condition.

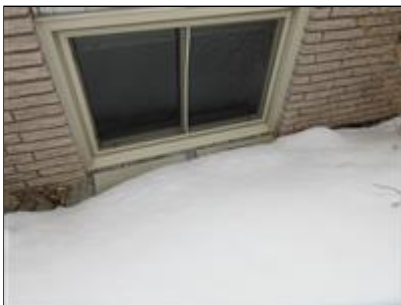
2.5 Picture 1

It is very important to keep an eye on the grading around the house to ensure a positive slope away. If needed any low areas should be raised up to achieve a positive slope away. This is very important in keeping water away from the house and out of the basement. The ground appears to be very close or possibly touching the brick. Any soil / brick contact should be avoided. A basement window well or two may be a good idea.

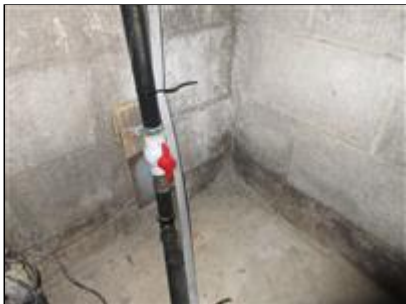
3.0 Picture 1

- (1) Structurally the house appears to be in good overall condition. All visible framing members appear to be adequately sized and free from damage or wear. There were no signs of any unusual settlement or shifting.
- (2) There were no signs of any recent moisture entry into the basement although there was some slight older evidence (slight stains). I would not anticipate any real concerns under normal conditions but I cannot offer any guarantee of a dry basement. Attention must always be paid to grading, downspouts and the exterior flow of water.

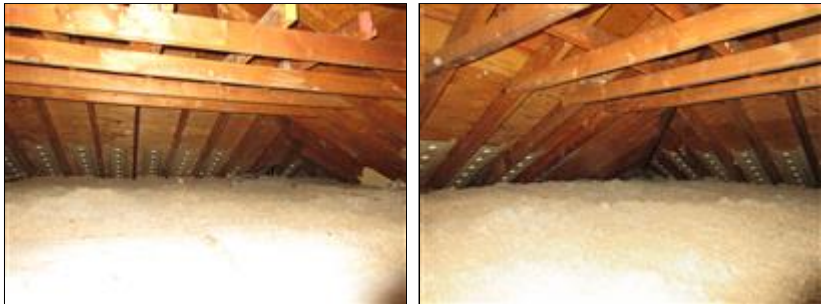
4.0 Picture 1

The attic contains blown in cellulose insulation installed in the floor of the attic. This insulation appears to be well placed and installed in reasonable amounts. (approx. R20) More can easily be added if desired.

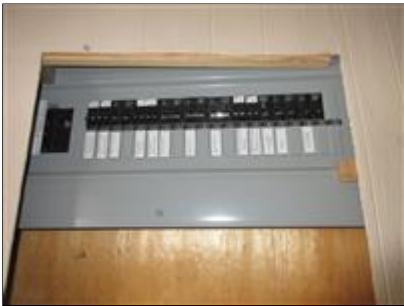
5.2 Picture 1

I was not able to inspect the main electrical service as I was not able to open the panel. The panelling should be removed from around the panel so the cover can be installed.

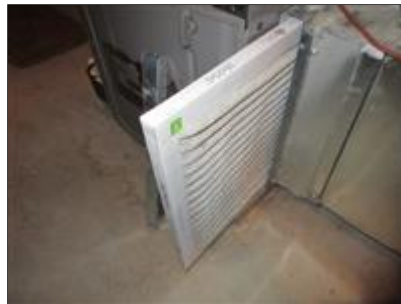
6.0 Picture 1

- (1) The furnace / heat pump were tested and inspected and found to be installed properly and working well. All the necessary safety features were present.
- (2) The furnace filter should be changed on a regular basis.

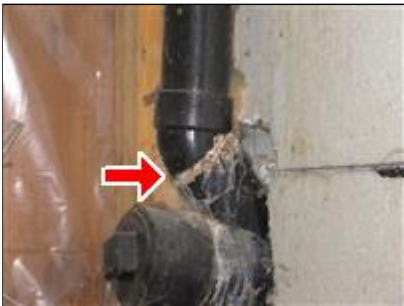
7.1 Picture 1

There is a fitting just before the main drain exits the building which appears to have leaked in the past. This should be monitored over time and repaired if needed.

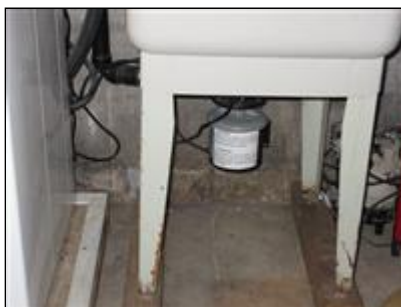
7.10 Picture 1

There is a pump under the laundry tub which automatically comes on to pump the water up and over to the septic outlet.

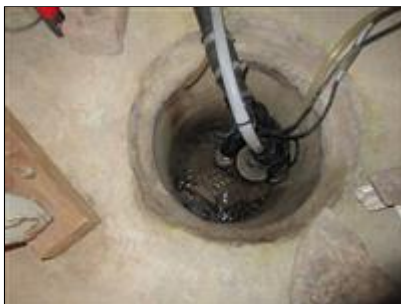
7.11 Picture 1

The sump pump should be tested on a regular basis to ensure its proper operation. The sump pump was a little noisy.

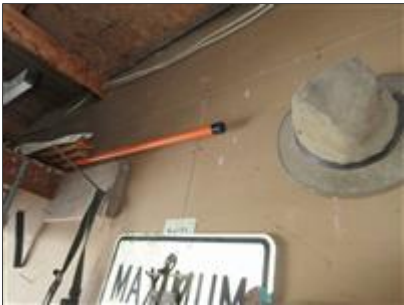
8.1 Picture 1

Technically the seams in the drywall between the garage and the house should be sealed with one coat of drywall tape and compound. (for proper gas proofing)

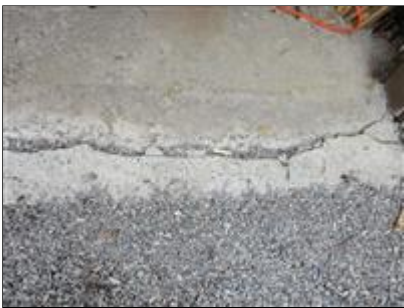
8.2 Picture 1

The concrete at the mouth of the garage is cracked / deteriorated. This is a minor concern and can be patched when desired.

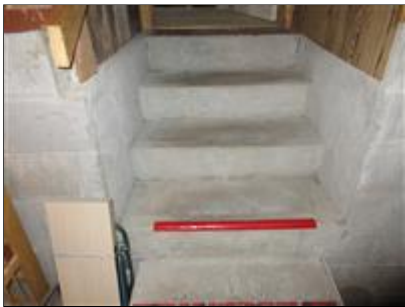
9.4 Picture 1

The basement steps do not meet the current code for safety. Care should be taken.

A proper handrail should be installed on the basement stairs.
