Home report

511 3rd Street, Paso Robles, San Luis Obispo County, California,  
United States, 93446

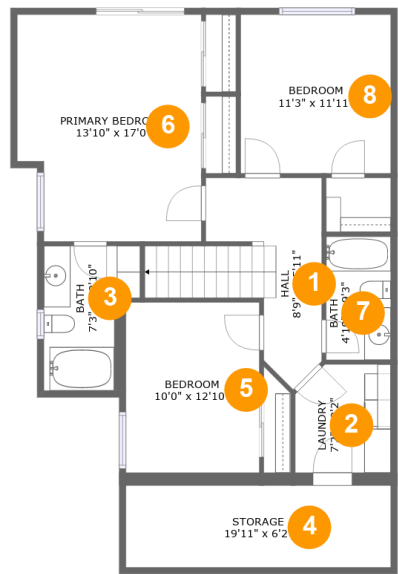
Room dimensions

Floor 1 Total sqft: 1094    Living area: 955

#		Dimensions	sqft	Counted as living area
1	Hall	8'9" x 15'11"	121 sq. ft	Yes
2	Laundry	7'2" x 8'2"	56 sq. ft	Yes
3	Bath	7'3" x 10'10"	65 sq. ft	Yes
4	Storage	19'11" x 6'2"	123 sq. ft	No
5	Bedroom	10'0" x 12'10"	128 sq. ft	Yes
6	Primary Bedroom	13'10" x 17'0"	224 sq. ft	Yes
7	Bath	4'10" x 9'3"	45 sq. ft	Yes
8	Bedroom	11'3" x 11'11"	135 sq. ft	Yes

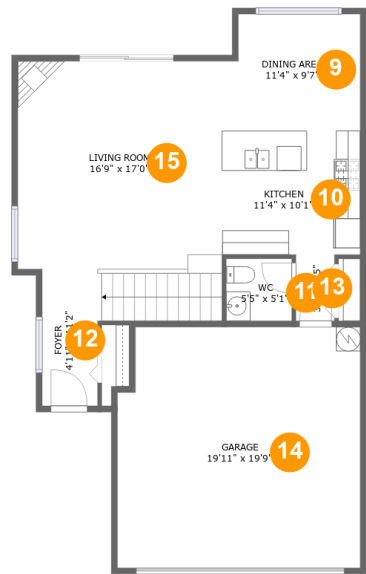
Room dimensions

Floor 2 Total sqft: 1148    Living area: 736

#		Dimensions	sqft	Counted as living area
9	Dining Area	11'4" x 9'7"	103 sq. ft	Yes
10	Kitchen	11'4" x 10'1"	115 sq. ft	Yes
11	WC	5'5" x 5'1"	27 sq. ft	Yes
12	Foyer	4'11" x 11'2"	94 sq. ft	Yes
13	Hall	3'2" x 5'5"	17 sq. ft	Yes
14	Garage	19'11" x 19'9"	385 sq. ft	No
15	Living Room	16'9" x 17'0"	286 sq. ft	Yes
