**SUMMARY**  
 11 Craven St, Greenville, SC 29611  
 Brian Marlow  
 06/24/2026

Daniel Lusk  
 Advantage Inspection  
 864-298-0405  
[gvlofc@advantageinspection.com](mailto:gvlofc@advantageinspection.com)

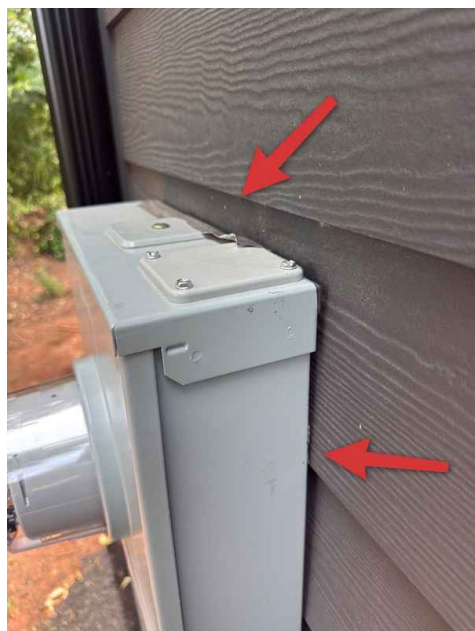
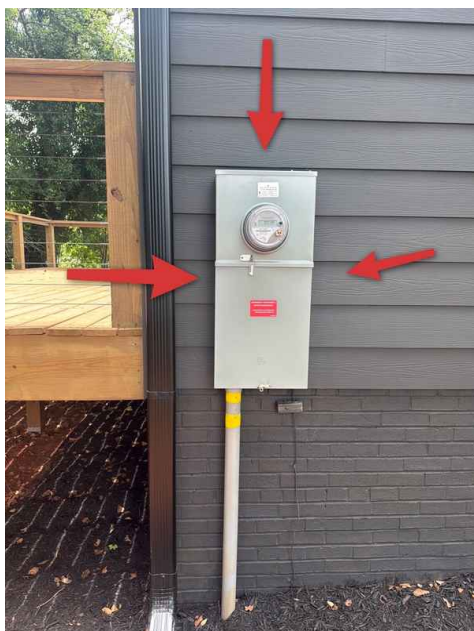
### 2.1.1 Siding & Flashing

#### **GAPS TOP/SIDE METER BASE**

LEFT SIDE

Recommend sealing gaps along top/side of the electrical meter base as required to prevent water penetration behind and around electrical meter and siding

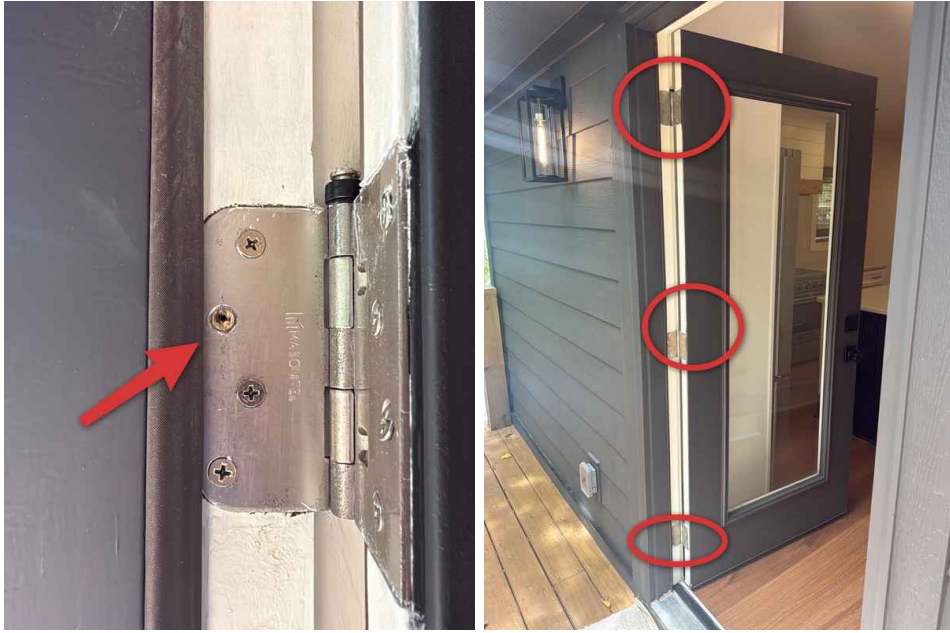
### 2.4.1 Rear Entry Door

#### **MISSING HINGE SCREWS**

REAR

Missing hinge screws need to be installed at the rear entry door.

**Missing Screws Installed**

**7/7/26**

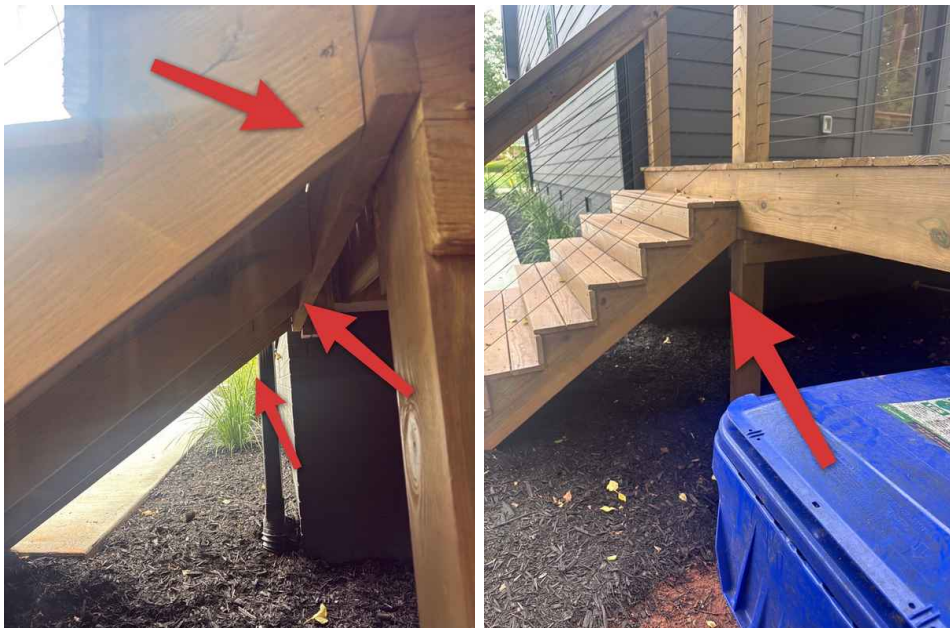
### 2.7.1 Decks and Railings

#### NO JOIST HANGERS AT DECK STAIRS

REAR

Joist hangers or ledger boards are not present at the stringers for the deck stairs. A licensed contractor needs to install joist hangers or ledger boards.

**Joist hangers  
installed 7/7/26**

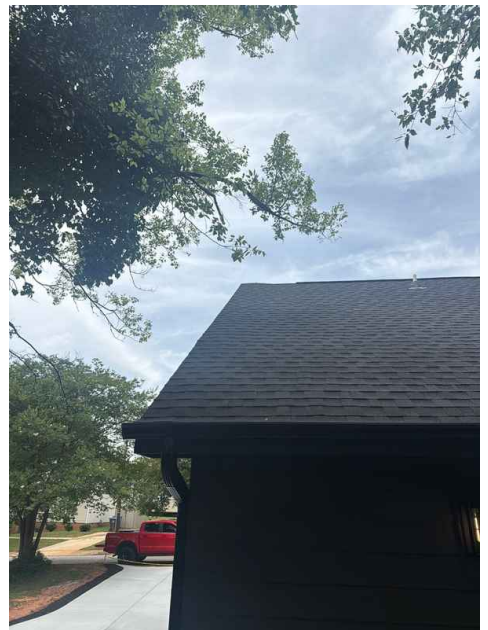
## 2.14.1 Vegetation, Trees

**TREE OVERHANG**

REAR

Recommend having branches trimmed that are overhanging the roof to prevent possible damages to roof covering

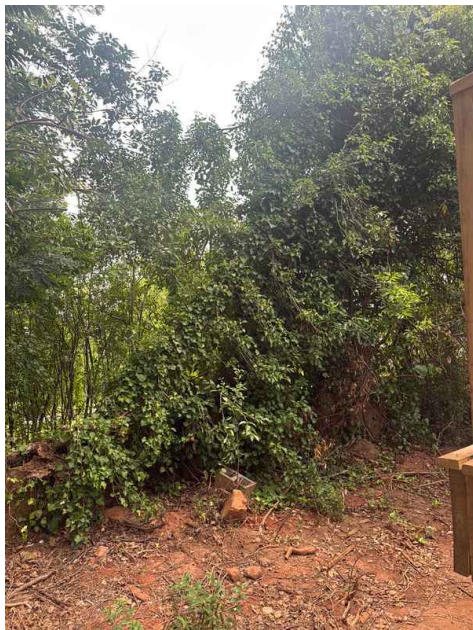
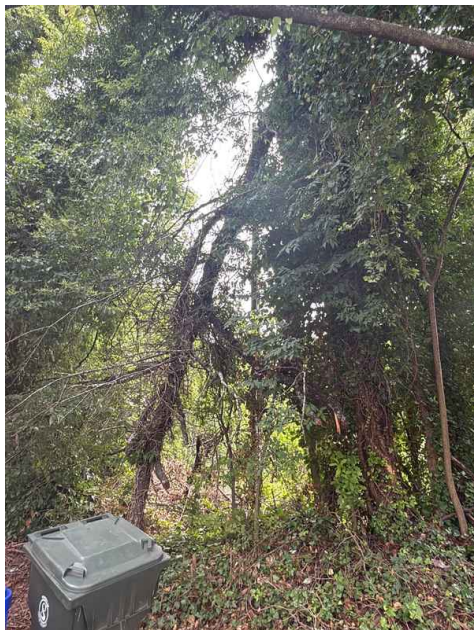
## 2.14.2 Vegetation, Trees

**LEANING AND FALLEN TREES AND LIMBS**

REAR

leaning and fallen trees and limbs at rear yard. Recommend a removing leaning tress and limbs to prevent damage to the home.

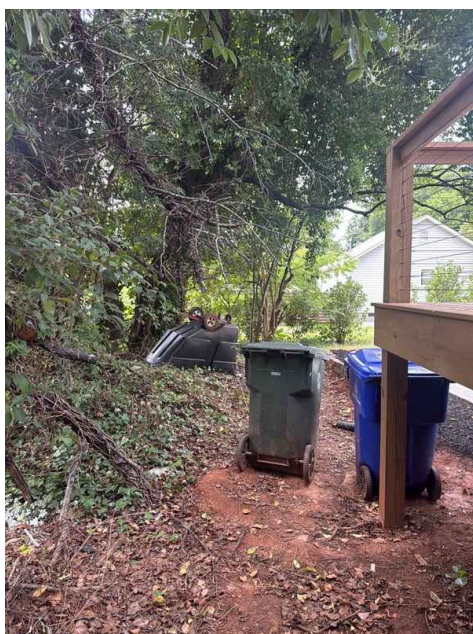
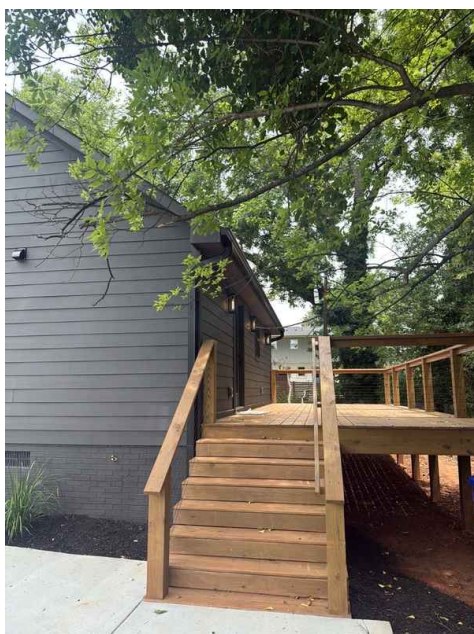
### 2.14.3 Vegetation, Trees

## LOW HANGING TREE LIMBS

MULTIPLE LOCATIONS

Recommend trimming low hanging tree limbs at rear yard and deck stairs.

**Low tree limbs trimmed  
7.7.26**

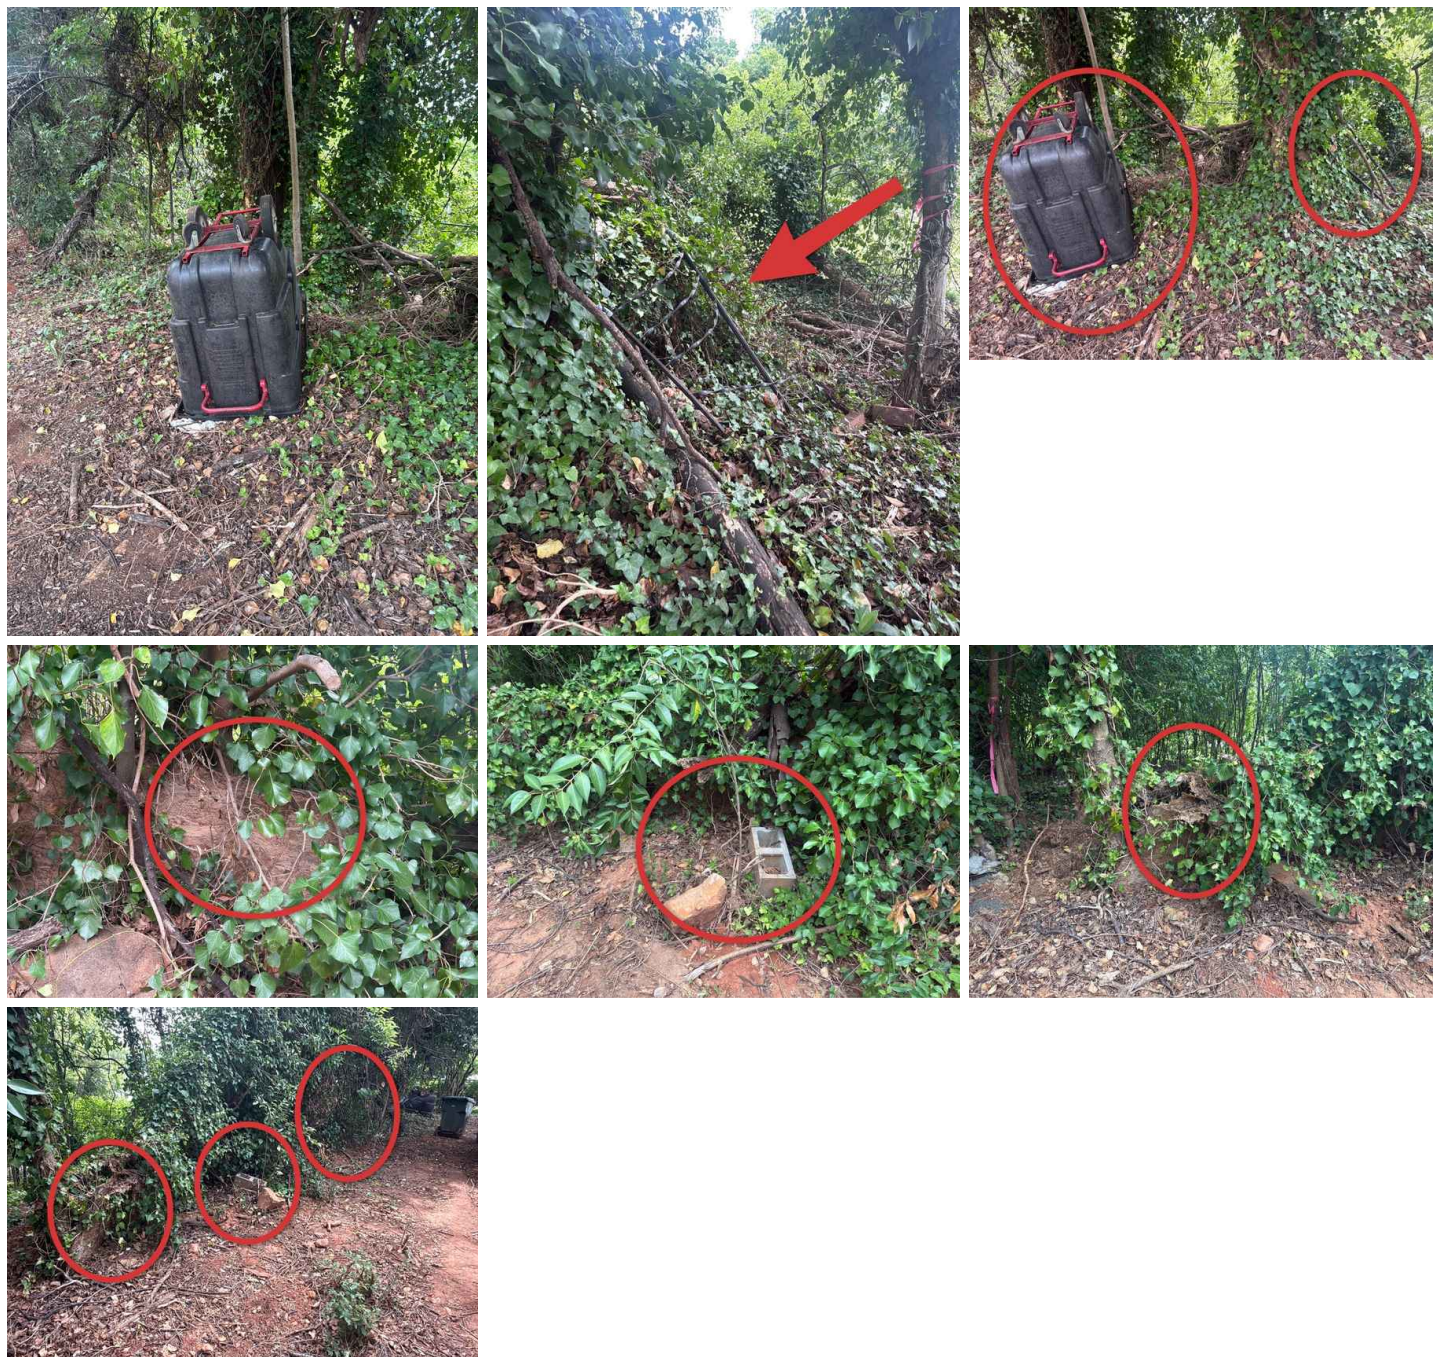
### 2.15.1 Grade, Drainage

## CONSTRUCTION DEBRIS IN YARD

REAR

Construction debris noted in the yard at the time of inspection. Debris needs to be removed.

**Construction debris removed 7/7/26**

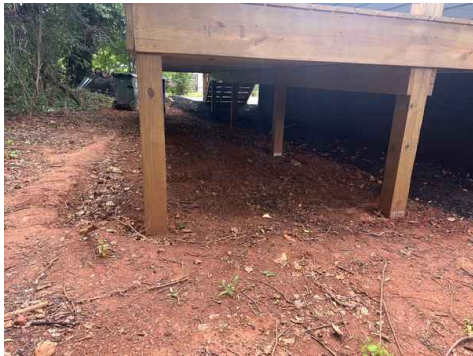
### 2.15.2 Grade, Drainage **DRAINAGE IN YARD**

Areas of the yard may not drain adequately and may allow water to stand. A licensed contractor needs to evaluate grading and landscaping around the home and repair as needed to ensure moisture is diverted away from the foundation of the home.

## **Gutter extenstions installed**

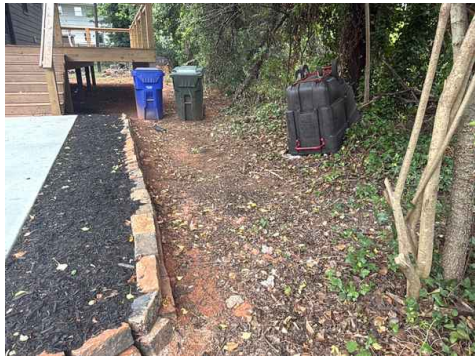
Rear

2.16.1 Retaining Wall  
**HAND STACKED STONES**

Loose, hand stacked stones noted at restraining wall. Recommend a licensed contractor evalaute and repair as needed to secure each stone in place.

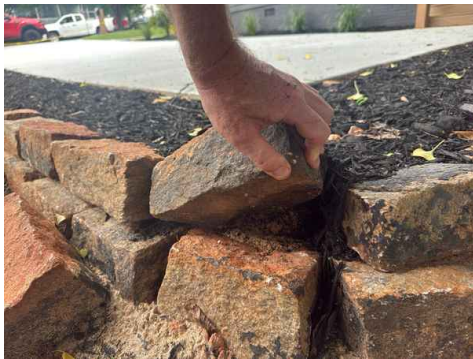
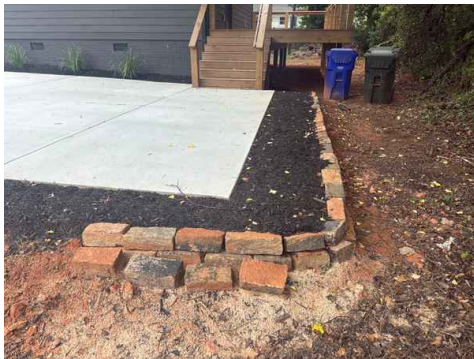
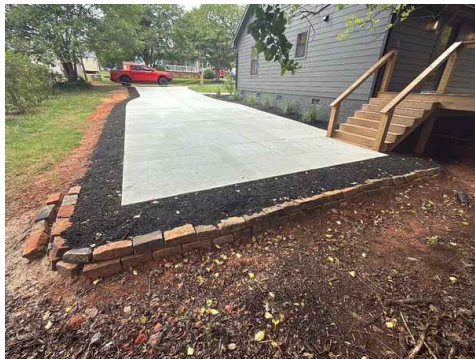
REAR RIGHT

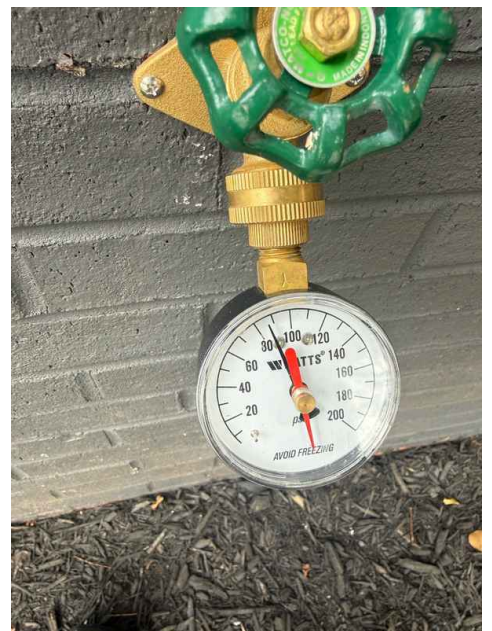
## 5.1.1 General

**EXCESSIVE WATER PRESSURE**

The water pressure is higher than the standard 40 - 80 PSI which can cause leaking in fixtures or pipes. A licensed contractor needs to install/adjust/replace pressure regulating valve to reduce household pressure.

**Water pressure adjusted to within  
normal range 7/7/26**

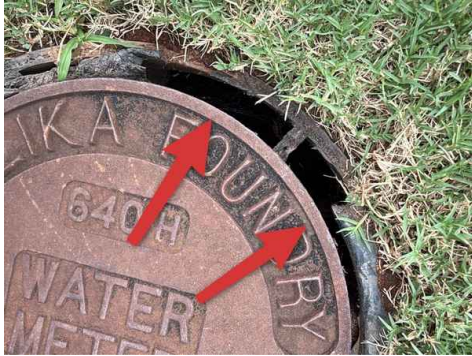
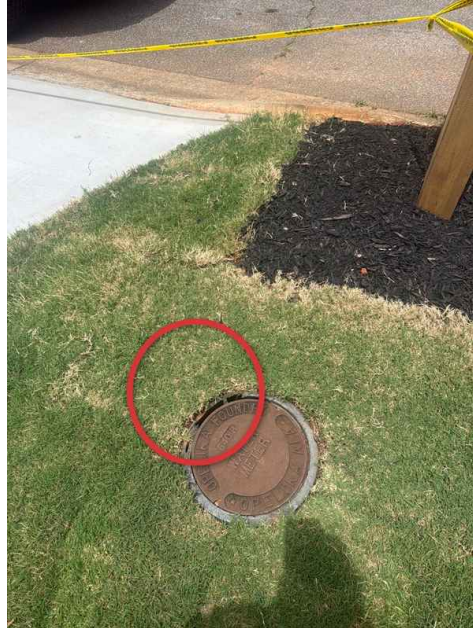
#### 5.2.1 Water Meter

### DAMAGED METER BOX

FRONT

Water meter box is damaged. A licensed contractor needs to replace the box.

**Seller has contacted  
Greenville Water**

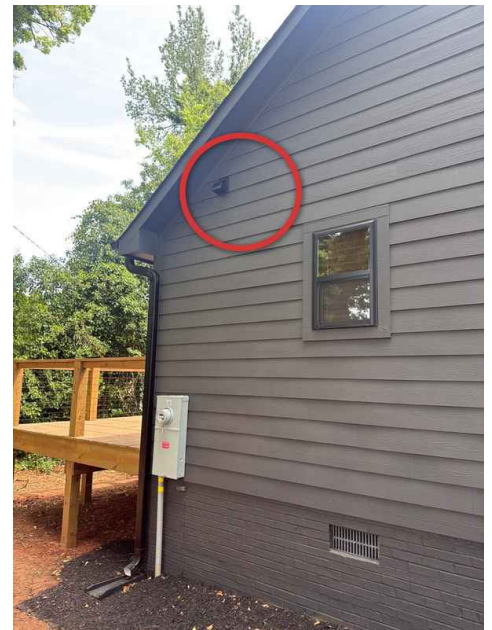
#### 5.6.1 Laundry Plumbing

### LAUNDRY AND BATHROOM EXHAUST VENT TERMINATION

1ST FLOOR LAUNDRY ROOM, HALF BATHROOM AND MASTER BATHROOM

Unable to determine locations of dryer vent, half bathroom exhaust fan vent and master bathroom exhaust fan vent along exterior of the home.

Vent cover on left side of home appears to be dryer vent. Dryer vent and bathroom exhaust vents should be vented to the exterior of the home. Recommend a licensed contractor evaluate and repair as needed.

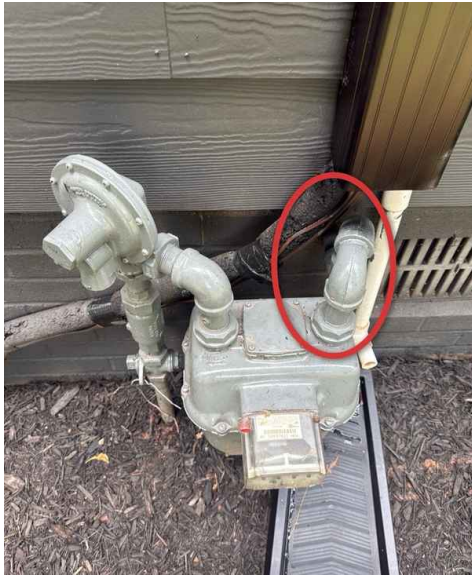
Left Side

CSST style gas piping is present in the home. When CSST piping is in use the solid gas piping must be bonded before the first CSST connection or at the gas meter with a bonding/grounding rod. The gas piping needs to be properly bonded by a licensed contractor.

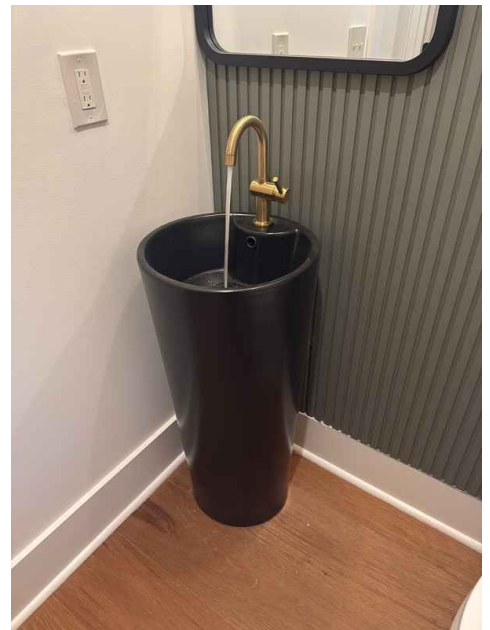
## 7.1.1 Half Bathroom

**PEDESTAL LOOSE SINK**

Pedestal sink is loose. Recommend a licensed contractor secure sink in place.

**Base of sink caulked to secure****7/7/26**

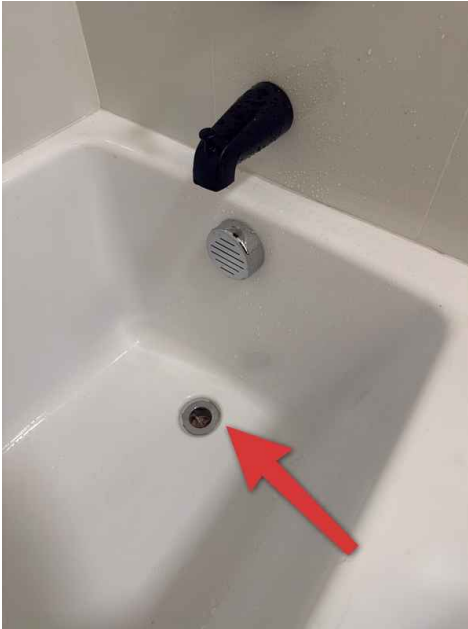
## 7.2.1 Second Floor Hall Bathroom

**MISSING BATHTUB STOPPER**

Stopper is missing at the second floor hall bathroom bathtub. Recommend replacing stopper to allow the bathtub to hold water.

**Bathtub stopper installed****7/7/26**

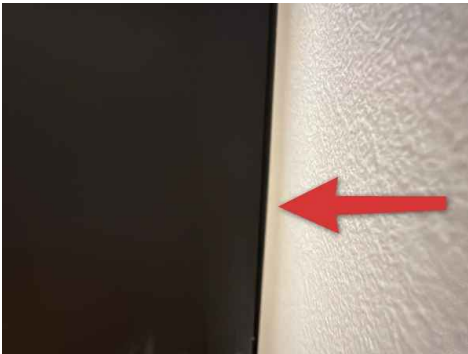
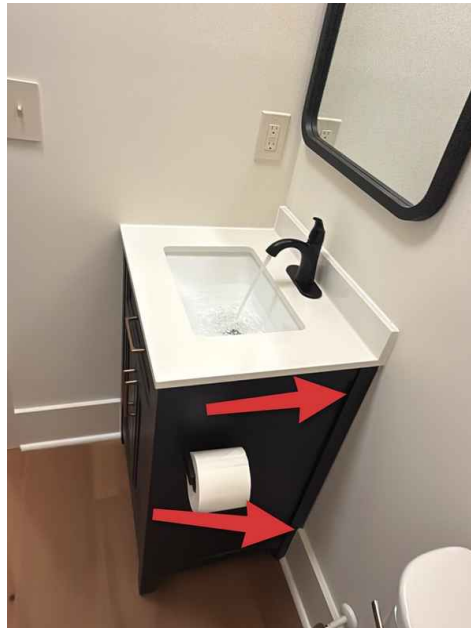
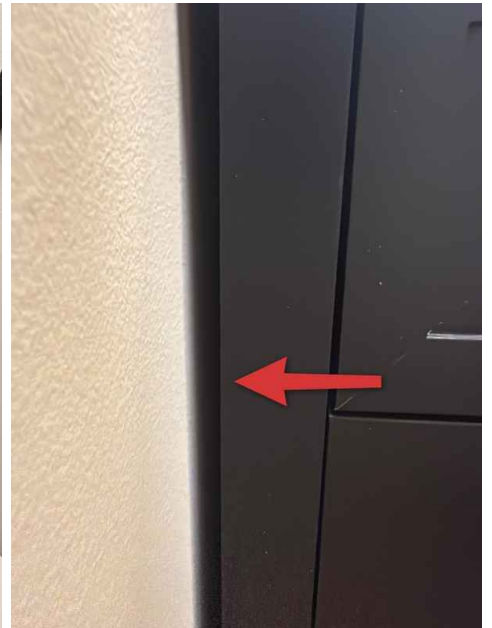
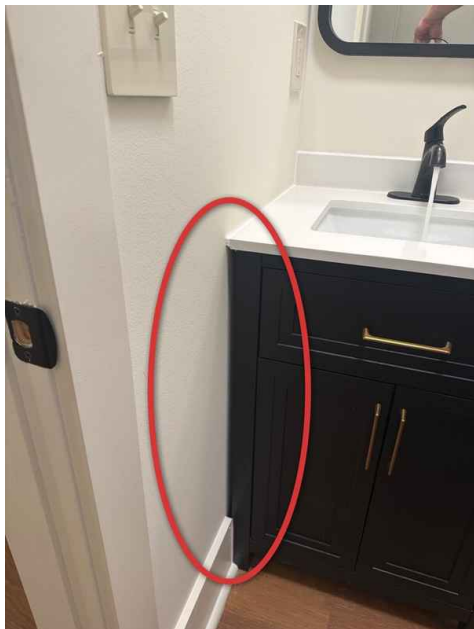
### 7.2.2 Second Floor Hall Bathroom

#### **GAP BETWEEN CABINET AND WALL**

Gap noted between the cabinet and wall in the bathroom. Trim needs to be installed or the gap needs to be sealed to prevent small items from falling between the cabinet and wall.

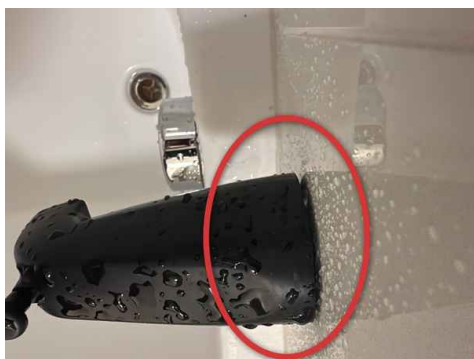
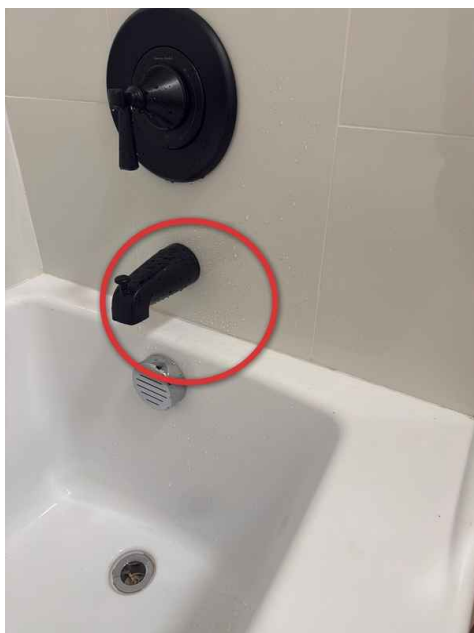
### 7.2.3 Second Floor Hall Bathroom

#### **GAP FAUCET**

Gap between faucet(s) and bathtub/shower surround needs to be sealed in the bathroom to prevent water penetration

**Gap has been sealed  
7/7/26**

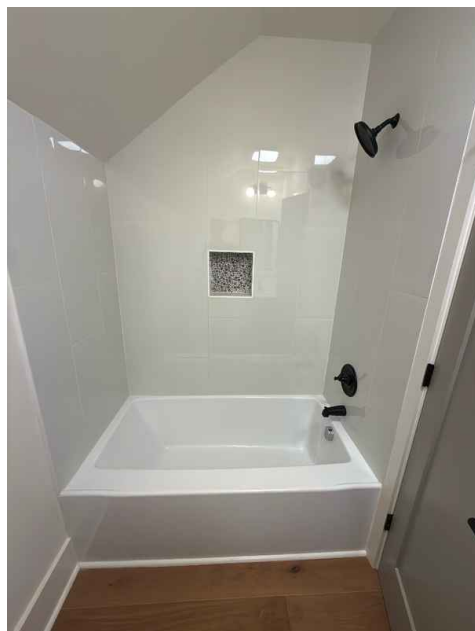
### 7.2.4 Second Floor Hall Bathroom

#### **NO SHOWER CURTAIN**

No shower curtain, glass walls or door installed at shower.  
Recommend a licensed contractor install shower curtain, walls and/or door.

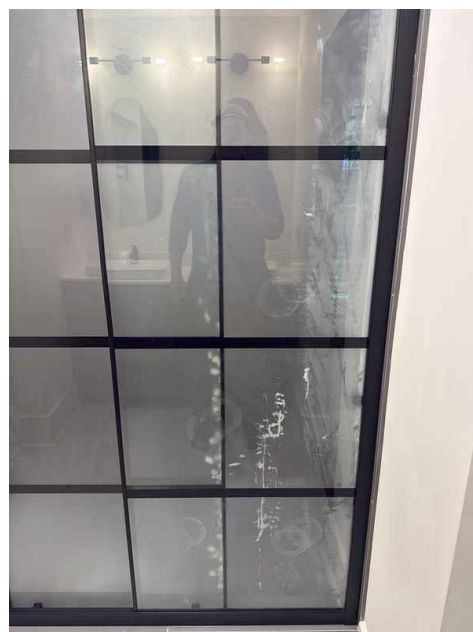
### 7.3.1 Master Bathroom **CLEAN SHOWER GLASS**

Recommend cleaning glass door and walls in master bathroom shower.

**Shower glass cleaned 7/7/26**

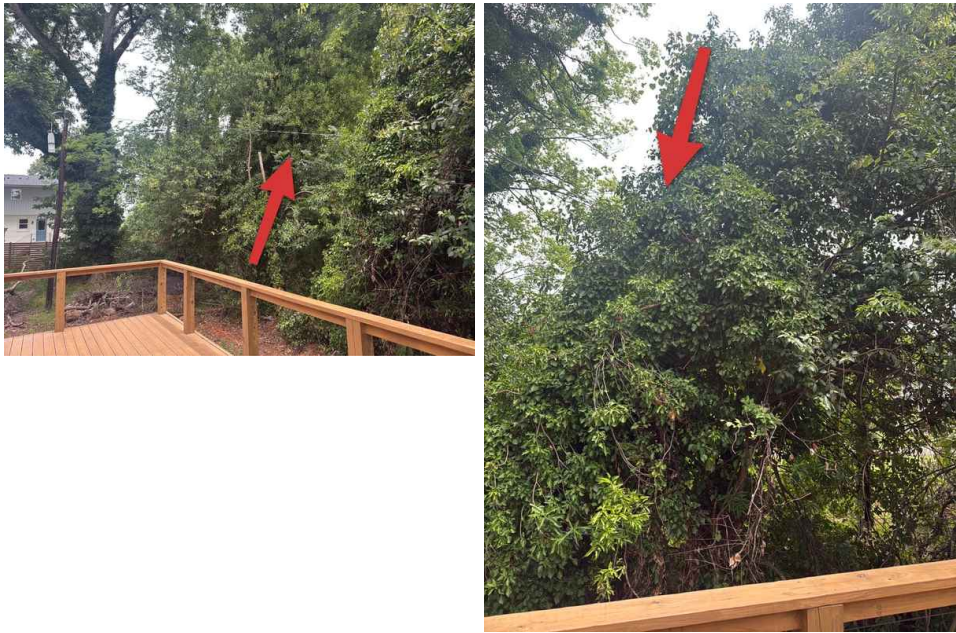
### 8.1.1 Service Entrance **TREE - NEAR POWER LINES**

A licensed contractor needs to trim tree branches away from over head power lines for safety.

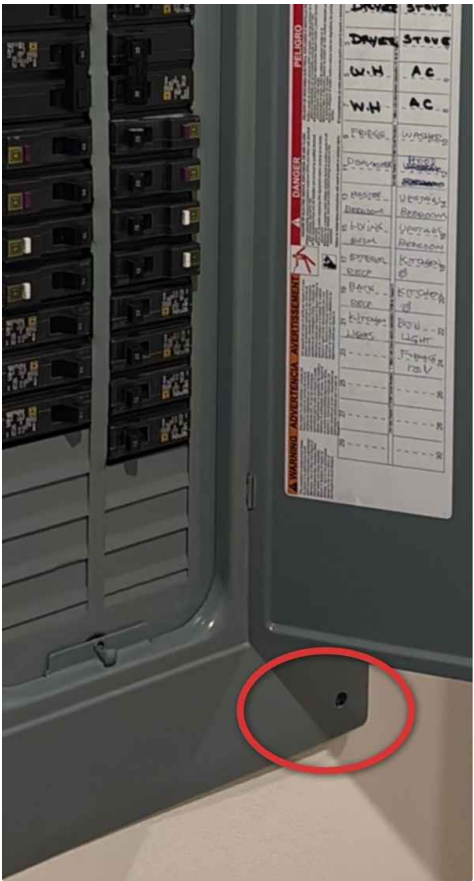
8.3.1 Sub Panels  
**MISSING COVER SCREWS**  
LAUNDRY ROOM

Recommend replacing missing cover screws at the sub electrical panel.

**Screws in panel box cover installed**  
**7/7/26**

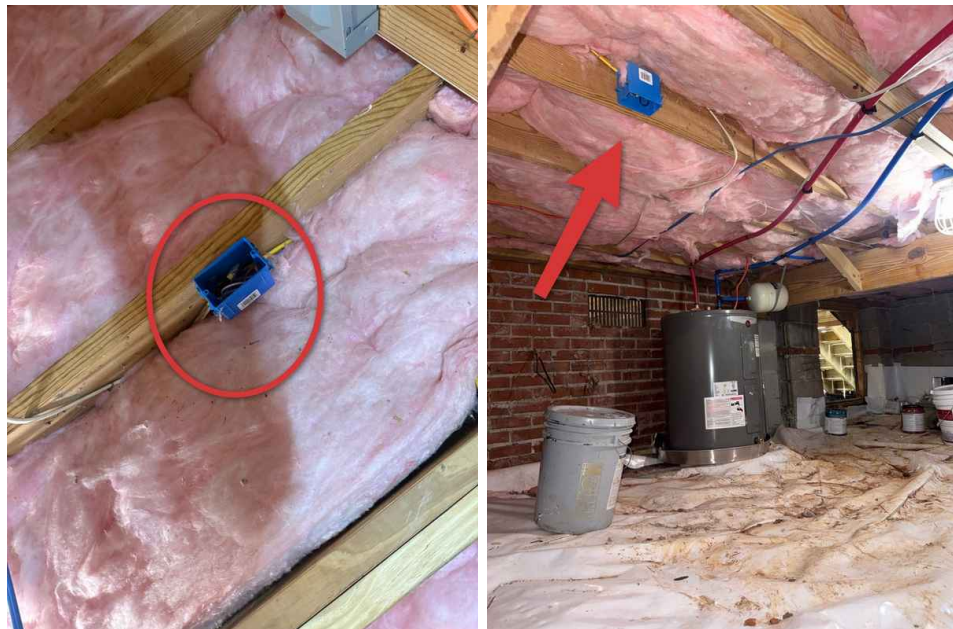
#### 8.6.1 120/240v Circuits

### OPEN ELECTRICAL JUNCTION BOXES

Open electrical junction boxes need to have blank cover plates installed.

**Covers installed on  
open electrical junction  
boxes - 7/7/26**

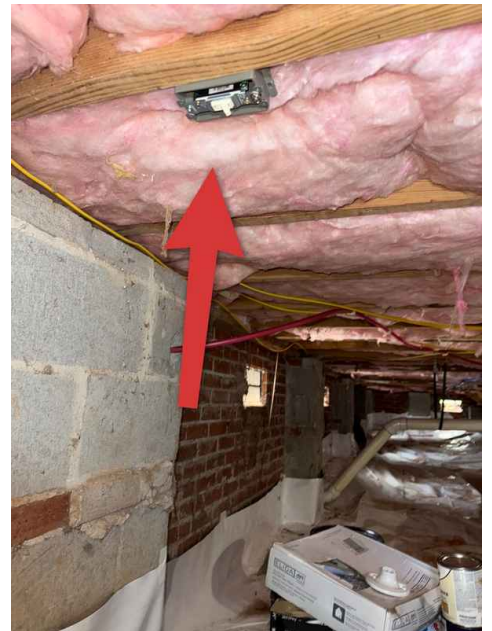
#### 8.8.1 Lighting Fixtures, Ceiling Fans & Switches

### MISSING LIGHT SWITCH COVER PLATES

Recommend replacing missing light switch cover plates to promote safety. Not all May have been documented

**Light switch cover plate replace-7/7/26**

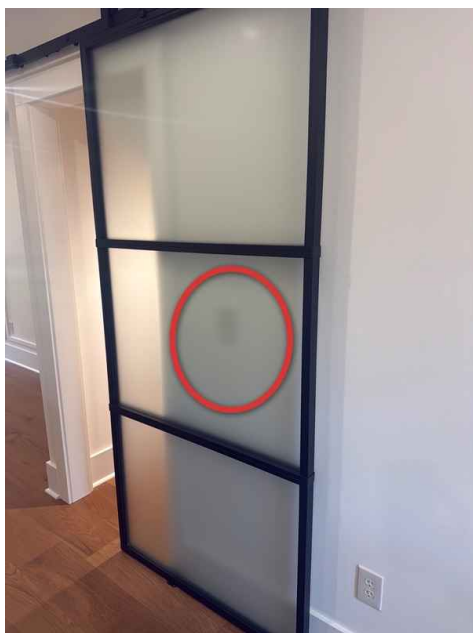
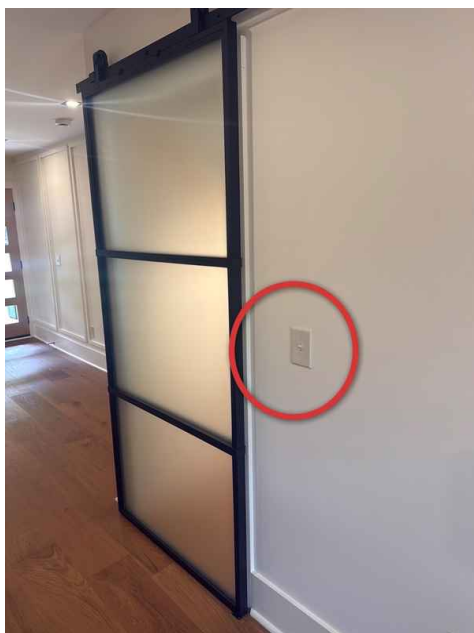
### 8.8.3 Lighting Fixtures, Ceiling Fans & Switches

#### LIGHT SWITCH BEHIND BARN DOOR

Light switch noted behind a barn door on the interior of the house at the time of inspection. Recommend relocating light switch or replacing barn door to ensure access to light switch.

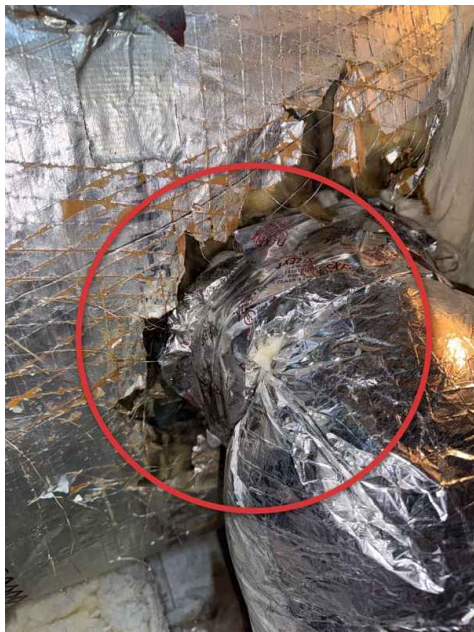
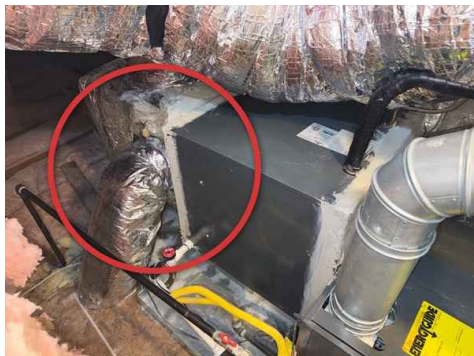
### 10.4.1 Distribution Systems

#### AIR LEAKS

Air leaks noted along ductwork. Have a licensed contractor evaluate for and repair any air leaks.

**Air leaks evaluated and sealed - 7/7/26**

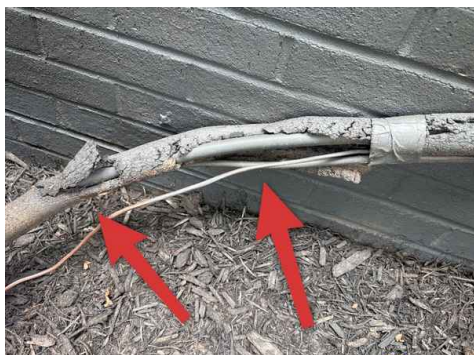
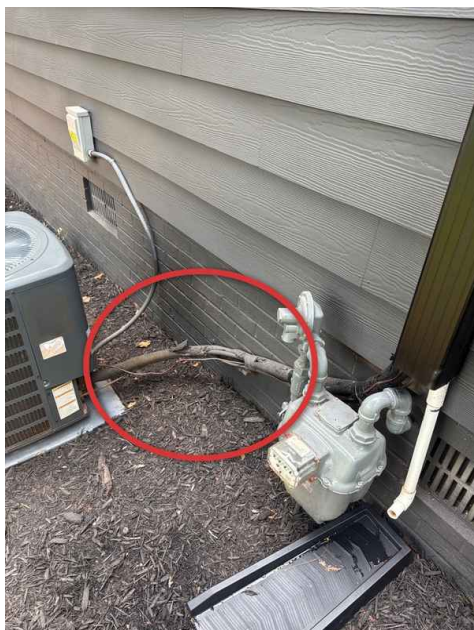
#### 11.1.1 Cooling Unit

##### INSULATION MISSING OR DAMAGED AT AC UNIT

Missing or damaged lineset insulation noted at the suction line at the AC unit. Have a qualified person repair or replace the lineset insulation as needed.

**Lineset insulation  
replaced - 7/7/26**

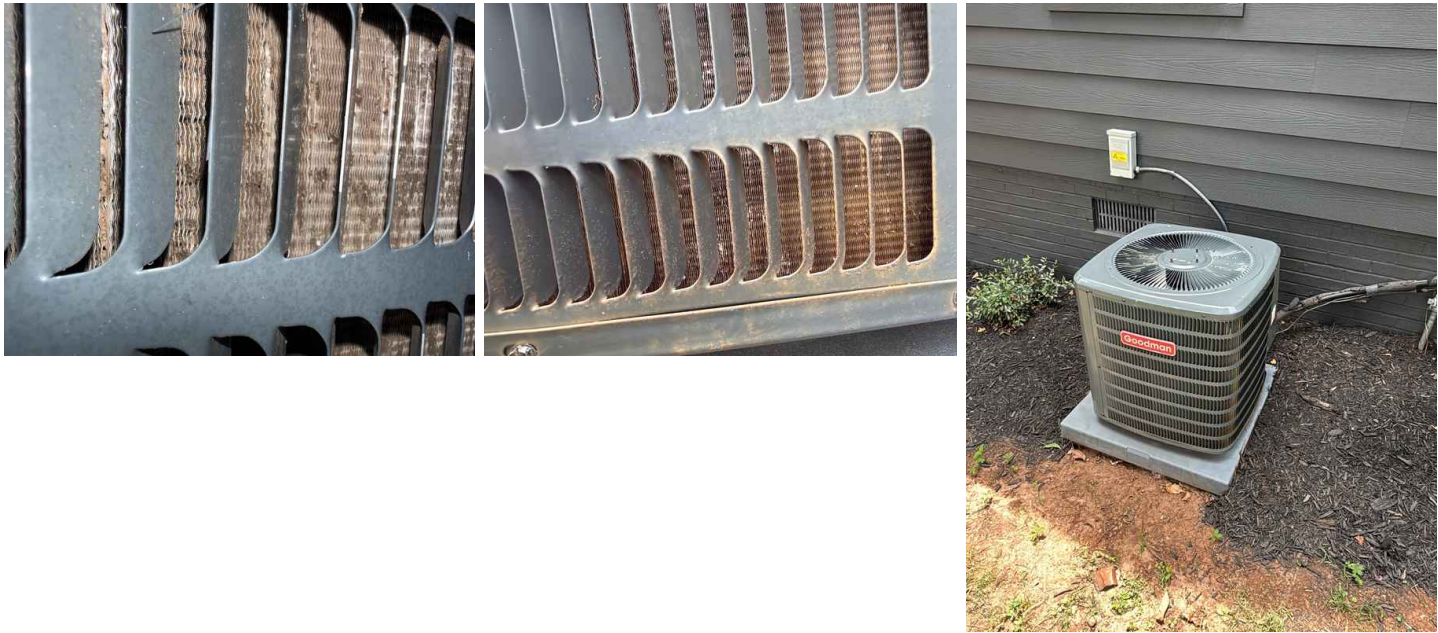
#### 11.1.2 Cooling Unit

##### DIRTY COILS

The AC condensing unit coils are dirty. Have a licensed HVAC contractor service and clean to maximize performance.

**AC condensing unit coils cleaned -7/7/26**

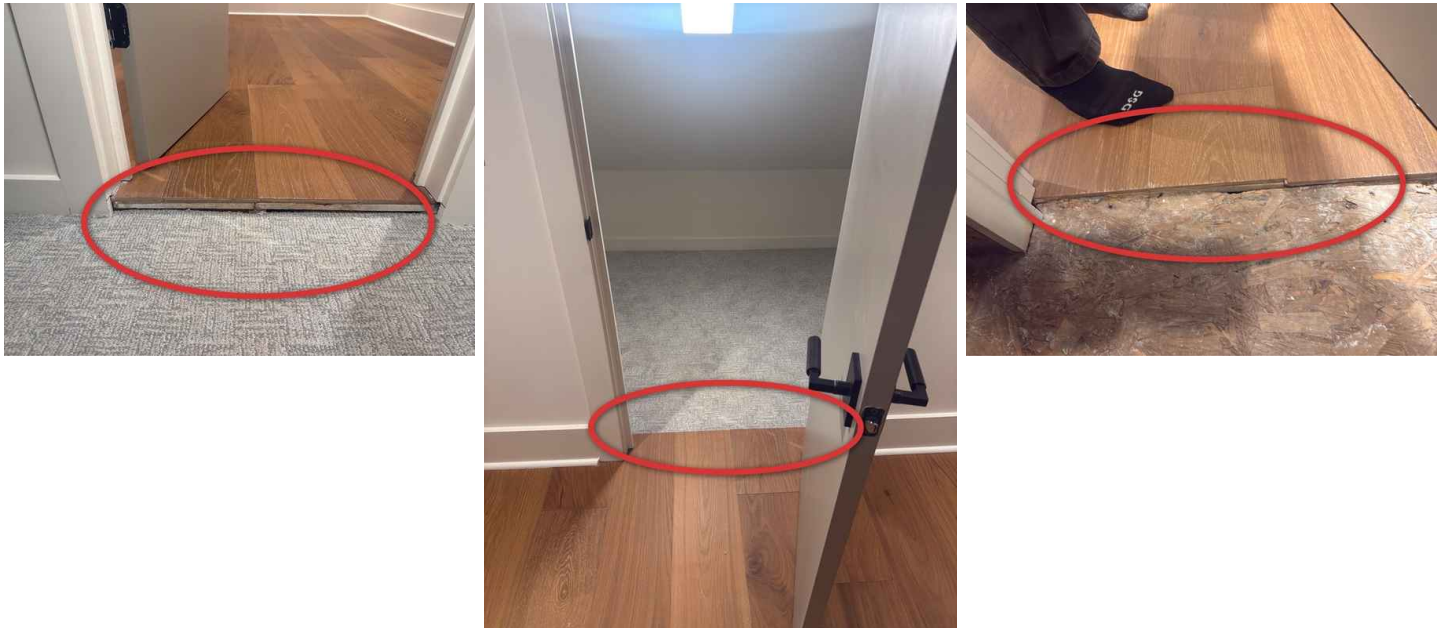
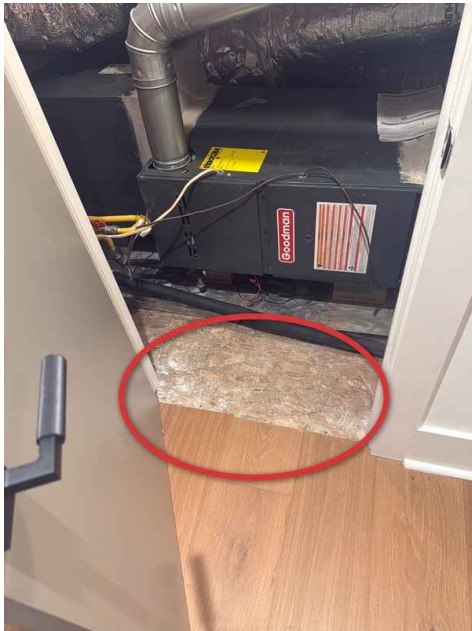
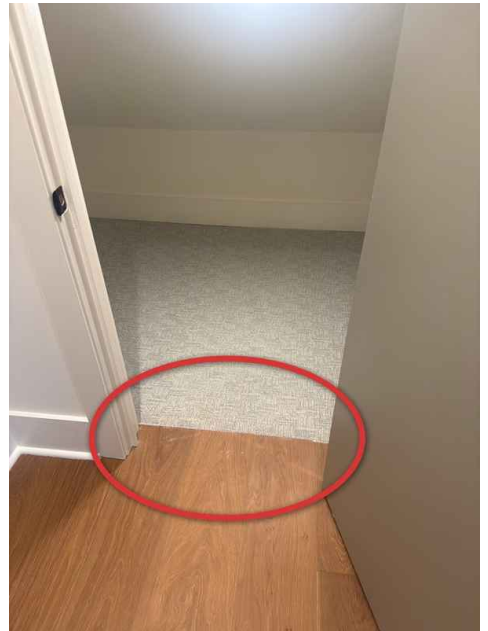
12.2.1 Floors  
**TRANSITION STRIP - MISSING**  
MULTIPLE LOCATIONS

Missing transition strip noted between two rooms' flooring on the interior of the house. Have a licensed contractor install a transition strip.

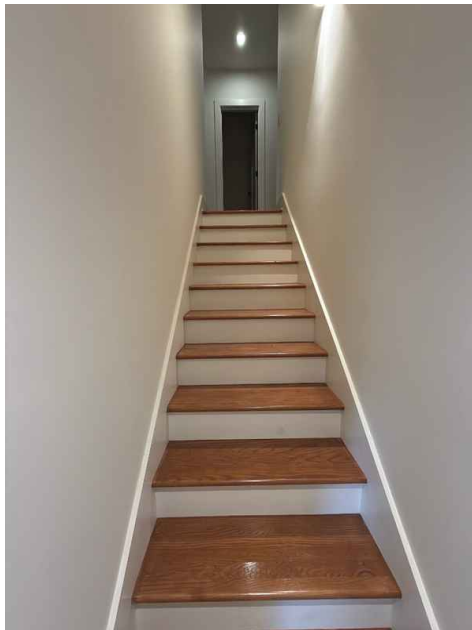
### 12.3.1 Stairways & Railings **GRASPABLE HANDRAIL**

A graspable handrail is not present at the stairs. Have a licensed contractor install a graspable handrail for personal safety.

**Handrail Installed to Code**

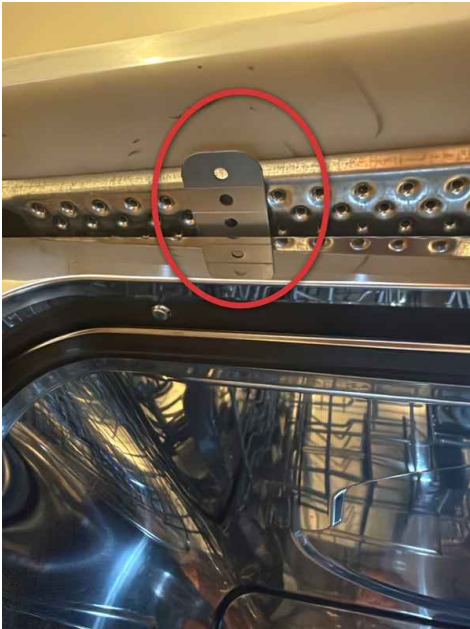
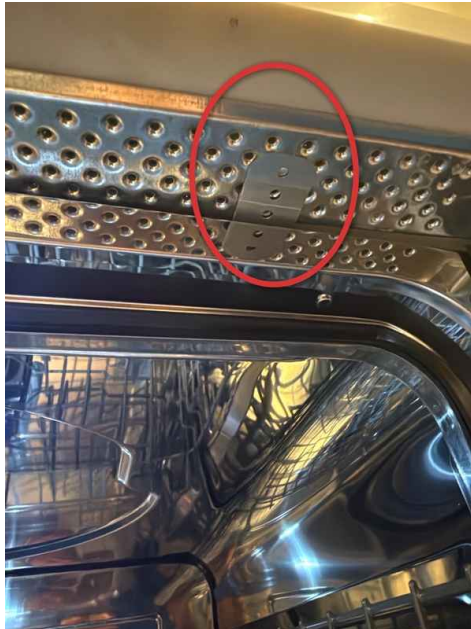
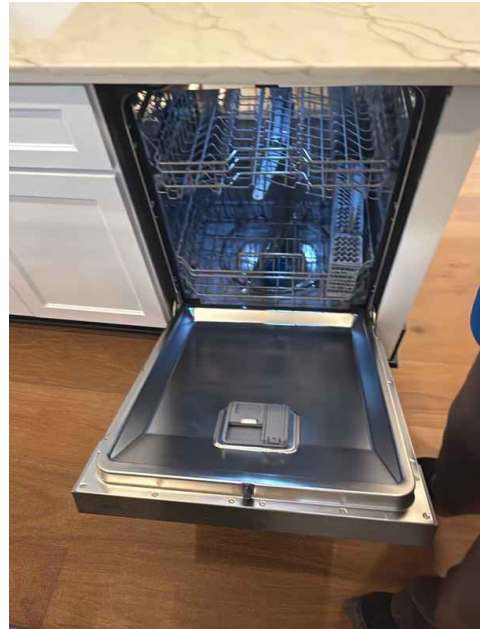
13.1.2 Dishwasher  
**DISHWASHER LOOSE**  
KITCHEN

Dishwasher is loose and needs to be properly secured in place by a licensed contractor.

**Dishwasher secured-7/7/26**

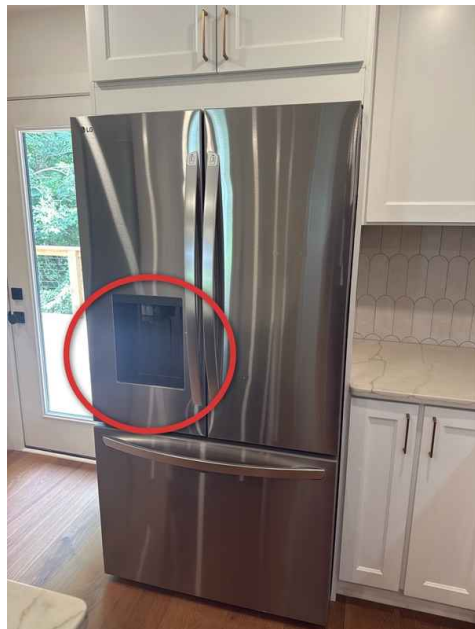
13.7.1 Refrigerator  
**ICE DISPENSER INOPERABLE**  
KITCHEN

The refrigerator ice dispenser is not working properly. Recommend a licensed contractor repair the ice dispenser.

**Refrigerator is disconnected because home is vacant, will connect refrigerator prior to a buyer inspection**

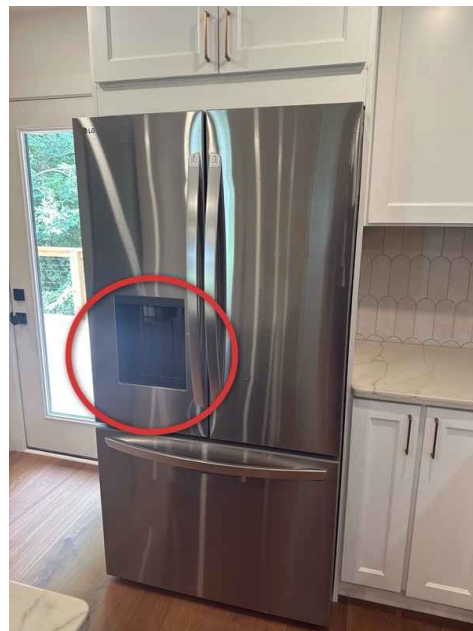
## 13.7.2 Refrigerator

**WATER DISPENSER INOPERABLE**

Water dispenser was not operational at the refrigerator. A licensed contractor needs to repair the dispenser.

**Refrigerator is disconnected because home is vacant, will connect refrigerator prior to a buyer inspection**

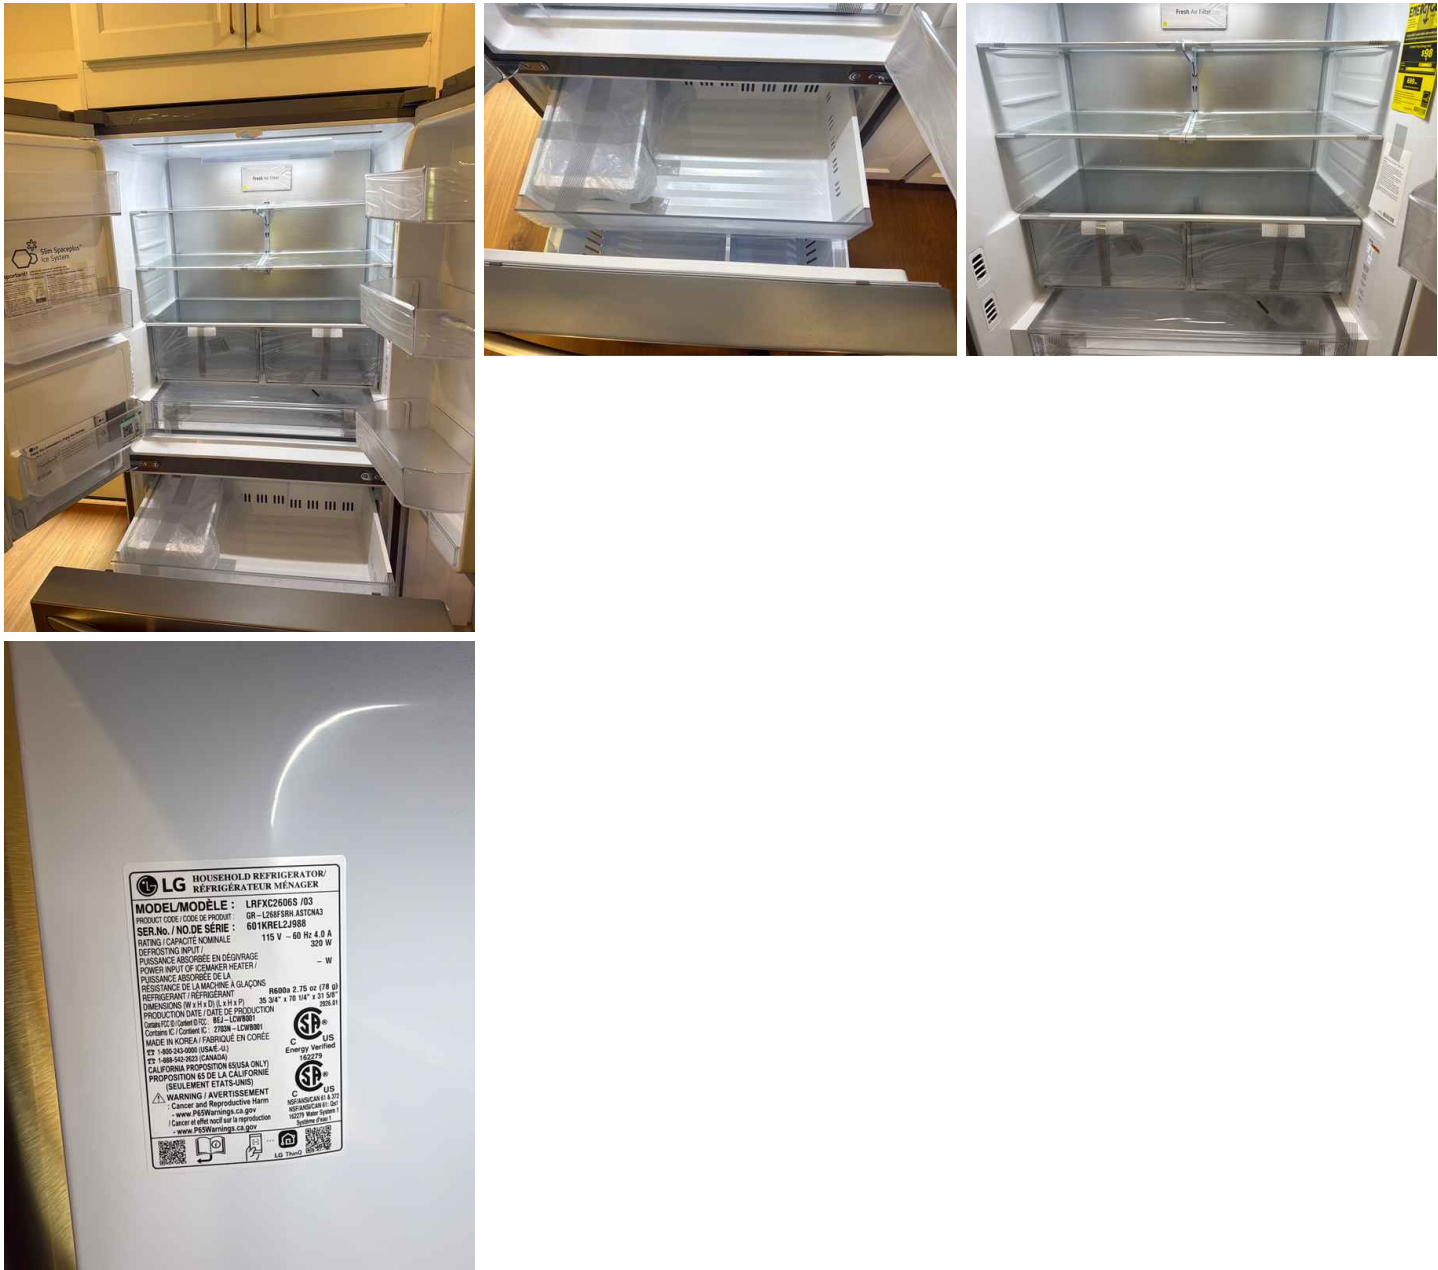
## 13.7.3 Refrigerator

**REFRIGERATOR IS NOT FULLY INSTALLED**

Refrigerator has not been fully installed. A qualified contractor needs to remove the manufacturer installed shipping plastic, foam and tape.

**Refrigerator is disconnected because home is vacant, will connect refrigerator prior to a buyer inspection**

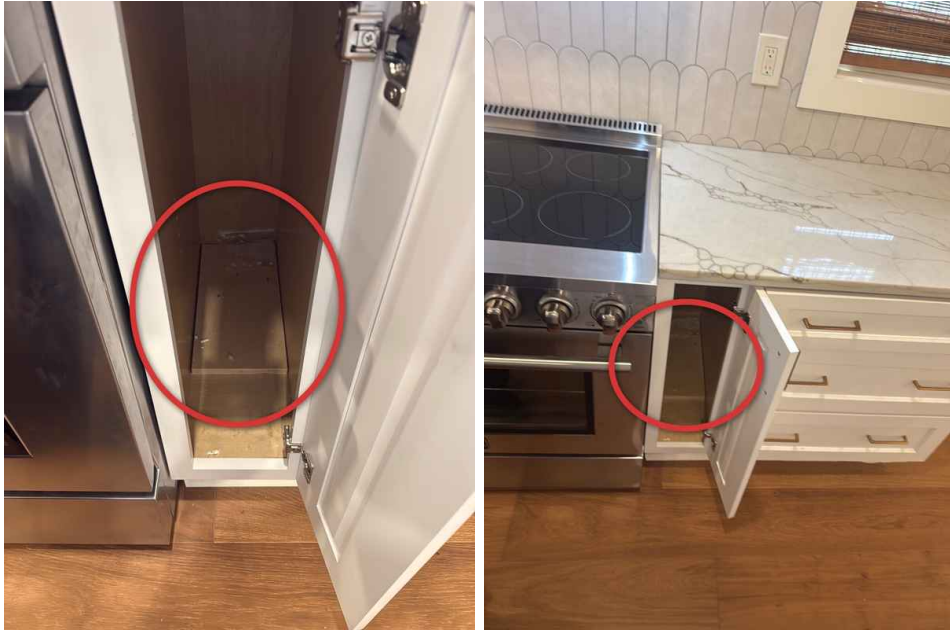
13.8.1 Cabinets & Countertops

**SHELVES NOT INSTALLED**

Shelves are not installed in kitchen cabinets. Shelves need to be installed.

**Shelf present, but left in case buyer wants to use this space for baking pans (intended use of cabinet)**

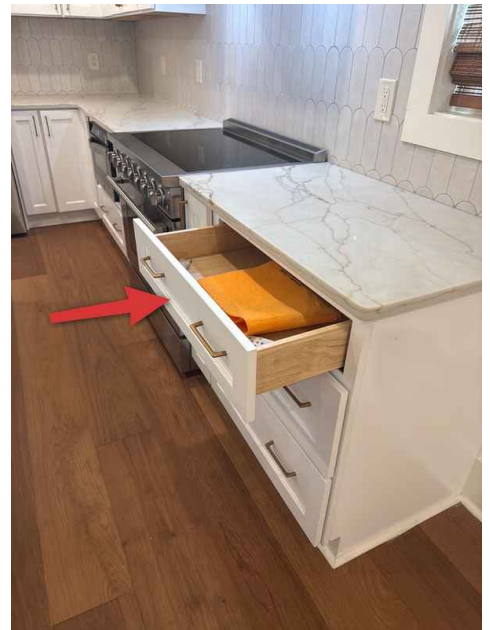
### 13.8.2 Cabinets & Countertops **DIFFICULT TO OPEN/CLOSE** KITCHEN

Drawers and cabinet doors are difficult to open and close. Recommend a licensed contractor evaluate and repair as needed.

## **Drawer adjusted for smooth operation**
