**SUMMARY**  
 11 Craven St, Greenville, SC 29611  
 Brian Marlow  
 06/24/2026

Daniel Lusk  
 Advantage Inspection  
 864-298-0405  
[gvlofc@advantageinspection.com](mailto:gvlofc@advantageinspection.com)

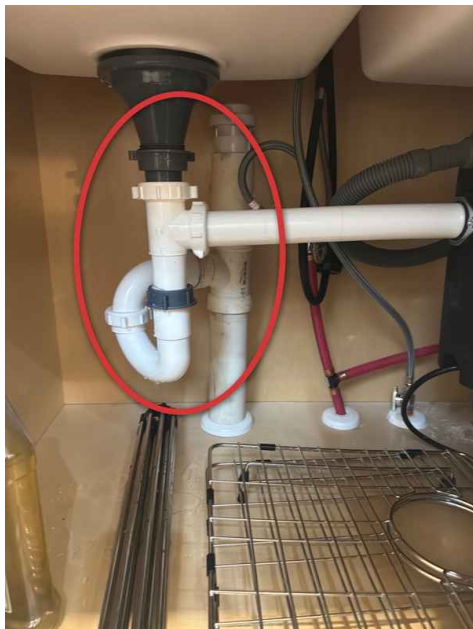
### 13.9.1 Sink(s) **ACTIVE LEAK - DRAIN** KITCHEN

Active leak noted under the kitchen sink. It is possible hidden moisture damages may exist. A licensed contractor needs to further evaluate and repair the sink plumbing to eliminate the leak and any moisture damaged present.

## **Plumber has addressed and repaired-7/7/26**

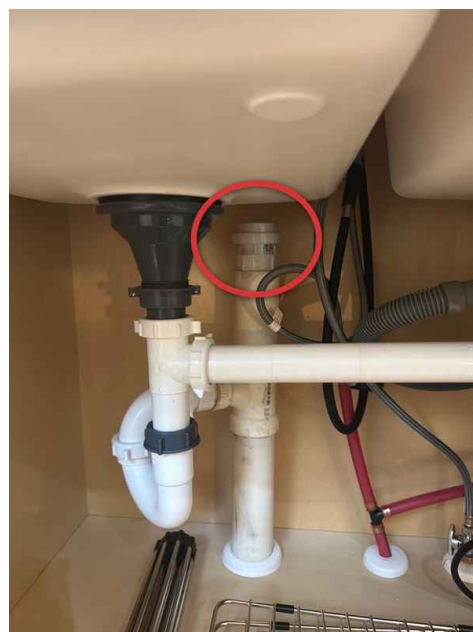
### 13.9.2 Sink(s)

#### SHORT STODOR/AAV VENT

Studor vent / AAV under kitchen sink should be situated higher than bowl drain. A licensed contractor needs to evaluate and raise vent as needed.

**Plumber has evaluated and this is done to code, unable to raise vent higher-7/7/26**

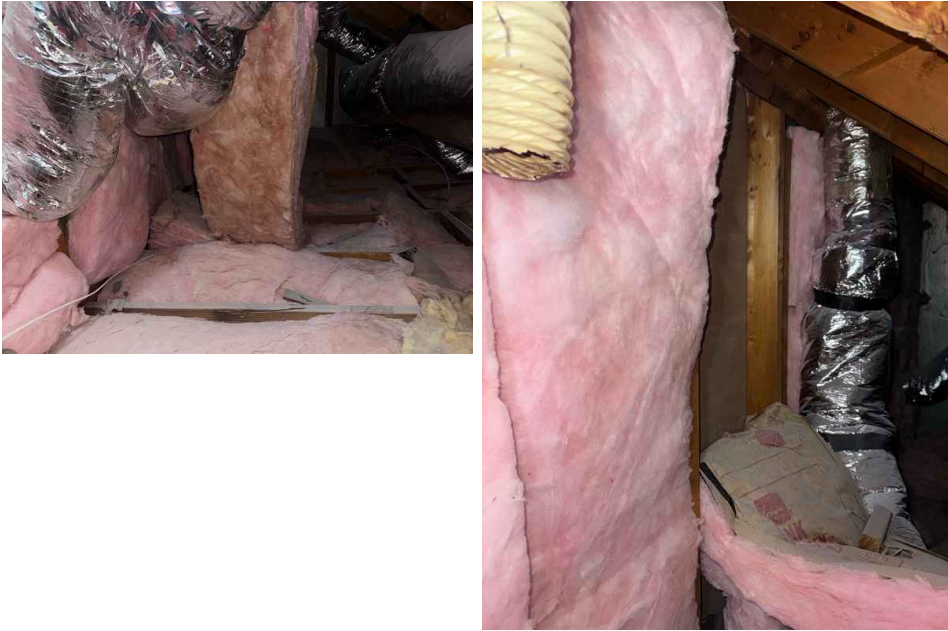
### 14.3.1 Attic Insulation

#### WALL HUNG INSULATION FALLING

Wall hung insulation is falling from the back side of finished walls as seen from inside the attic. Recommend securing the attic wall insulation in place to prevent heat and air loss.

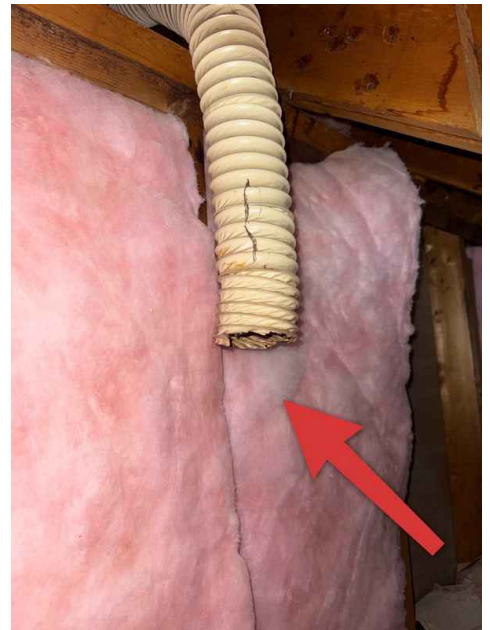
#### 14.4.1 Ventilation

### BATHROOM EXHAUST VENTS

Bathroom exhaust fans vent to the attic which can produce unnecessary moisture. Vents need to be repaired / installed to vent to the exterior of the home.

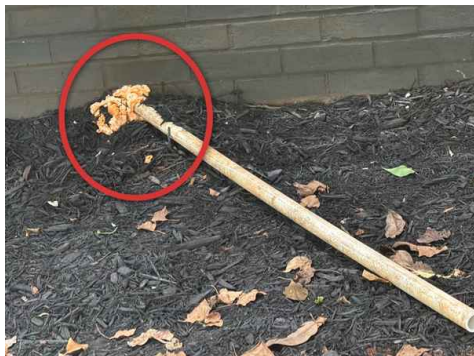
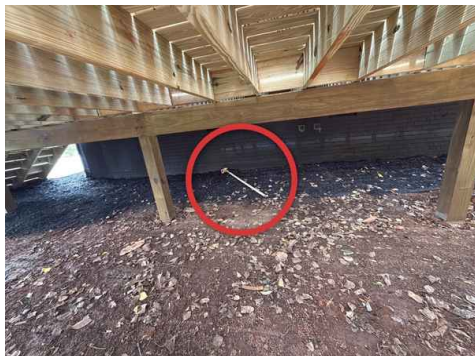
#### 15.3.1 Pier/Column/Foundation Wall

### GAPS - SPRAY FOAM

Spray foamed gaps noted in the foundation wall at the time of inspection. Spray foam is not rated for exterior use and will deteriorate over time. A licensed contractor needs to remove spray foam and properly seal openings in foundation wall with an exterior rated material.

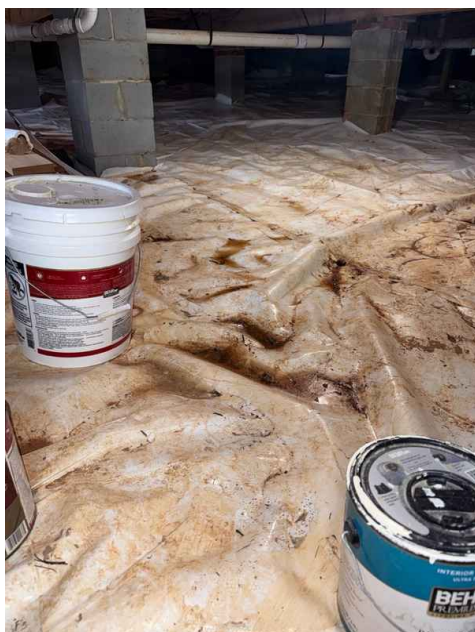
### 15.6.1 Moisture

## PREVIOUS AND CURRENT STANDING WATER

Standing water noted in the crawlspace at the time of inspection with signs of previous water (mud stained plastic and/or foundation walls). A licensed contractor needs to evaluate the crawlspace for recommendations to remove water such as a french drain and sump pump. A licensed contractor needs to evaluate finish grading, gutters and downspouts for recommendations to prevent moisture penetration into the crawlspace.

**Crawlspace door open a lot during construction; currently, no standing water present-7/7/26**

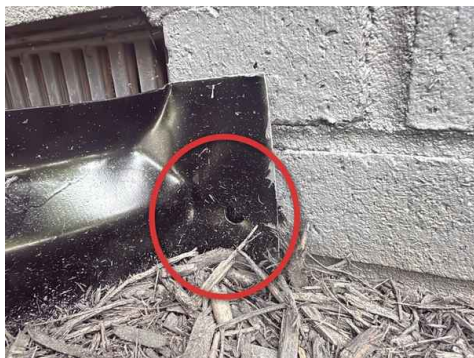
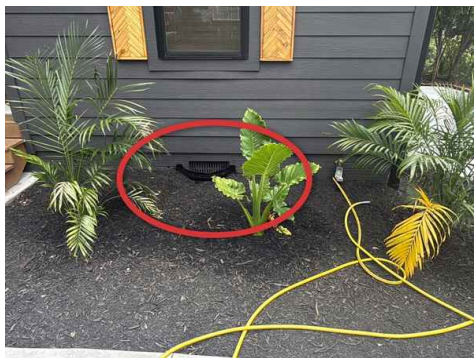
## 15.9.1 Crawlspace Ventilation

**LOOSE VENT WELLS**

Crawlspace vent wells are loose and need to be secured to the foundation wall by a licensed contractor to reduce the chances of surface water penetrating into the crawlspace.

**Crawlspace vent wells  
secured-7/7/26**

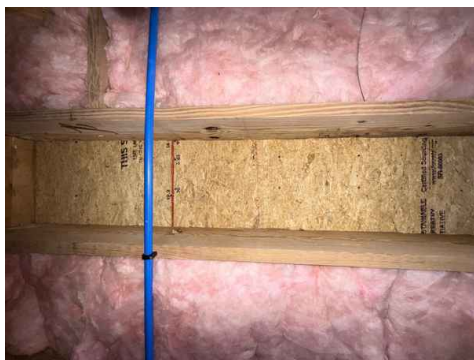
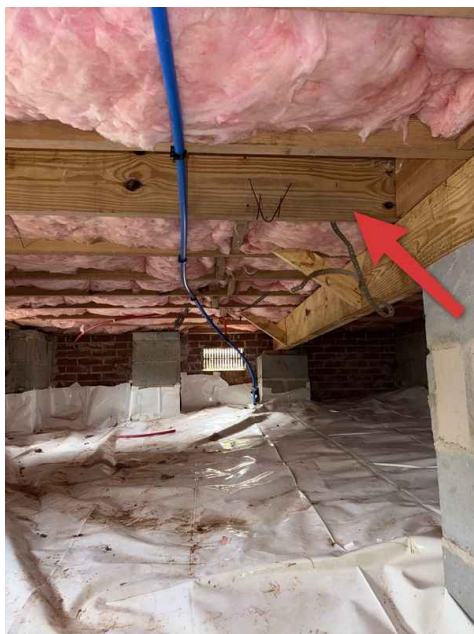
## 15.10.1 Crawlspace/Basement Insulation

**MISSING INSULATION**

Areas of missing insulation noted in the basement/crawlspace. Have a licensed contractor replace missing insulation where needed.
