INSPECTION REPORT

3018 Huntington Dr
Dubuque, Iowa 52001

10/29/2025

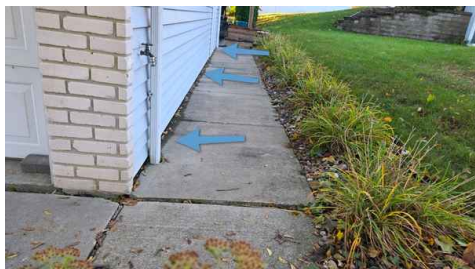
3.5.1 General Grounds

SIDEWALK, NEGATIVE GRADE

Walkway shows negative grade towards home. This can force moisture back towards the foundation.

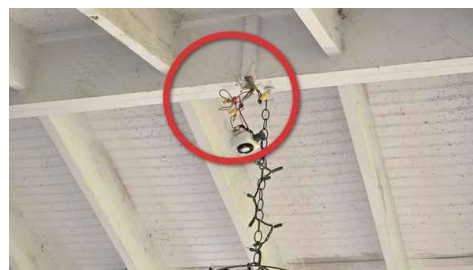
EXTERIOR, ELECTRICAL, EXPOSED SPLICES

Exposed electrical splices were observed on the exterior of the home that were not properly contained within a junction box. Electrical splices must always be enclosed in an approved weather-resistant junction box with a secured cover to protect the connections from moisture intrusion, corrosion, and physical damage. Leaving conductors exposed to the elements increases the risk of electrical shock, arcing, and potential fire hazards. Recommend evaluation and correction by a qualified electrician to ensure all exterior wiring is properly enclosed and compliant with safe installation practices.

Sellers have resolved this issue 3.8.1

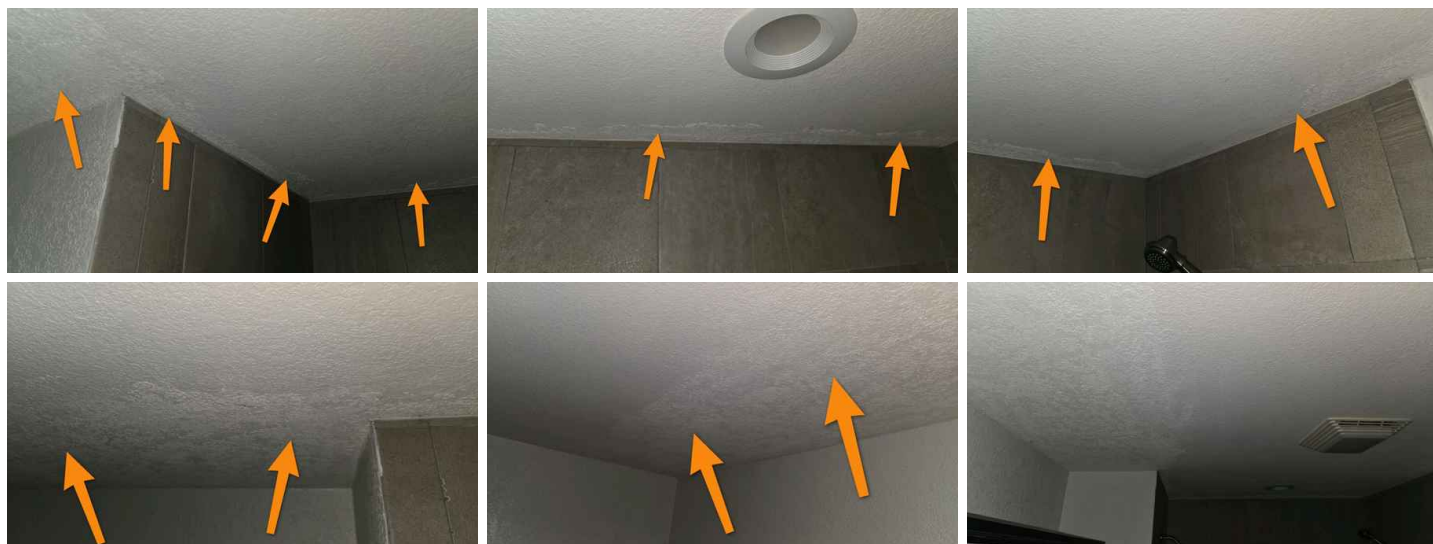
MASTER BATHROOM, CEILING, EVIDENCE OF PREVIOUS AND POSSIBLE ONGOING MOISTURE DAMAGE

The ceiling in the master bathroom shows visible signs of previous moisture intrusion, particularly around the perimeter near the shower where a faint white, efflorescence-like coating is present. This discoloration is often caused by moisture movement through drywall or joint compounds, leaving behind mineral deposits as the water evaporates. Although no elevated moisture levels were detected at the time of inspection using a moisture meter or thermal imaging, the presence of this residue indicates that past or intermittent moisture exposure has occurred and may still be active under certain conditions. Recommend monitoring the area for recurrence and ensuring proper ventilation during and after showers. If the staining expands or reappears, further evaluation by a qualified contractor is advised to identify and repair any potential hidden sources of moisture.

Contact a qualified professional.

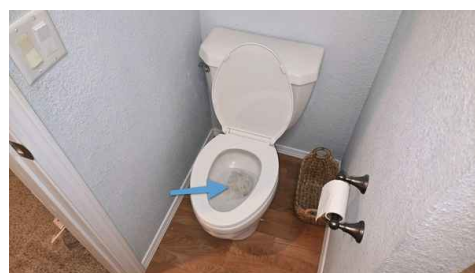
Basement Bathroom Clogged By Toilet Paper

BATHROOM TOILET, WEAK OR INCOMPLETE FLUSH

The toilet exhibited a weak or incomplete flush, potentially caused by low water levels, a clogged siphon jet, or blockages in the trap. Recommend cleaning the siphon jet, adjusting the water level, or addressing any blockages to restore proper functionality.

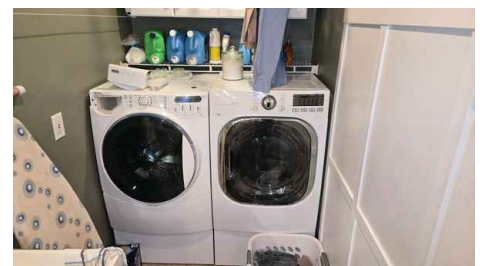
Hook-up Photo

Washer and dryer hookups location.

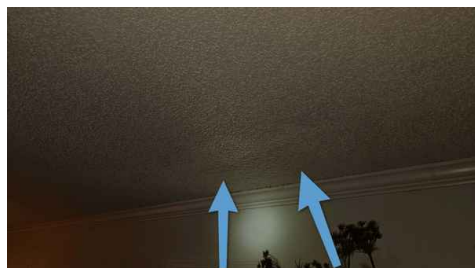
Livingroom

GYPSON BOARD CEILING, PREVIOUS WATER DAMAGE OR STAINING

Evidence of water damage or staining was observed on the drywall, indicating a possible leak or moisture intrusion. Moisture meter showed no heightened moisture levels at the time of the inspection. Recommend repairing or replacing the affected drywall to prevent further issues.

Contact a qualified professional.

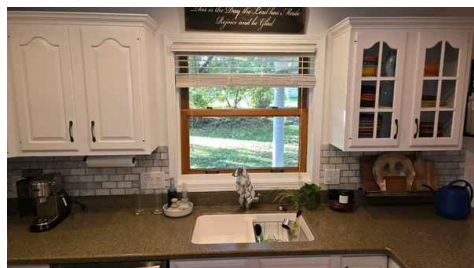
1st Floor Kitchen

Several interior windows were observed where the top sash drops approximately one inch when the window is unlocked. This condition is typically caused by worn or broken sash balance mechanisms, weakened tension springs, or loose fittings within the window frame. When the top sash does not remain securely in place, it can lead to drafts, water intrusion, and difficulty maintaining a proper seal, reducing the overall energy efficiency of the home. Additionally, the sudden dropping of the sash may pose a minor safety concern if it falls unexpectedly. It is recommended that a qualified window repair specialist or contractor evaluate and repair the affected windows to restore proper operation and ensure they remain secure when opened or closed.

Contact a qualified professional.

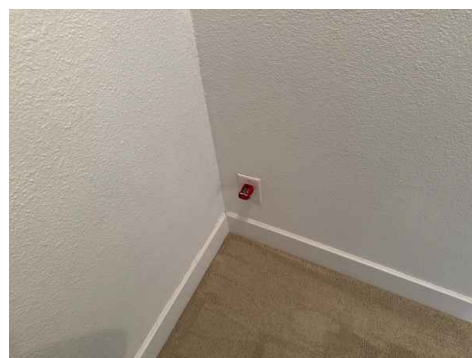
1st Floor To 2nd Floor Staircase

INTERIOR OUTLETS, NON-FUNCTIONAL OUTLETS

Contact a qualified electrical contractor.

Sellers have resolved these issues 8.7.2 & 8.7.3

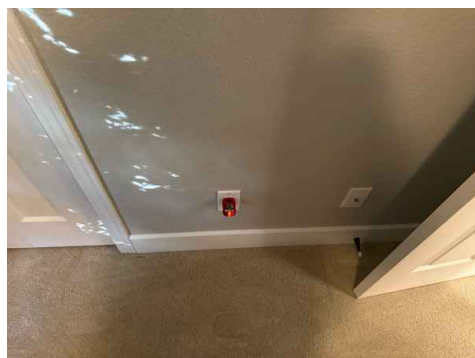
2nd Floor Bedroom

An outlet with an open ground lacks a proper ground connection, which is critical for safely redirecting excess current in case of a fault. This issue can increase the risk of electrical shock and is common in older homes. Recommend upgrading or repairing the outlet to include a proper ground wire.

Contact a qualified professional.

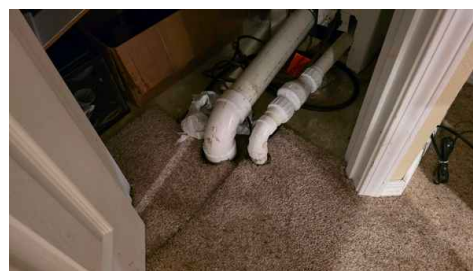
LIMITED INSPECTION DUE TO SEALED SUMP PUMP COVER

The sump pump was not fully inspected because it was enclosed with a sealed cover. This limited our ability to evaluate the pump's operation, condition, and the interior of the sump pit. Sealed covers are often used to reduce odors or radon gas emissions, but they restrict visual access. Recommend consulting a qualified professional to confirm the pump's functionality and assess the system as needed.

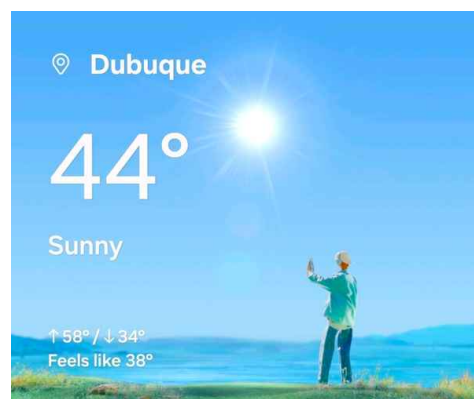
Limited Inspection on the central air conditioning system. The central air conditioning system was not tested during the inspection due to outdoor temperatures being below 65°F. Operating an air conditioning system in cooler weather can potentially cause damage to the compressor, as the system is designed to function optimally under warmer conditions. Running the system when it is too cold may result in improper lubrication of the compressor and can lead to system failure.

For accurate testing and evaluation of the air conditioning system, it is recommended to operate the system only when outdoor temperatures are consistently above 65°F for at least 24 hours. If further evaluation is needed, testing should be conducted under appropriate conditions by a qualified HVAC technician.
