Home Inspection Report

Property Address:
515 River Downs Ave
Belle River ON N8L 0A4

Redmond Home Inspections

Date: 3/4/2026	Time: 11:00 AM	Report ID: 20260304-515-River-Downs-Ave
Property: 515 River Downs Ave Belle River ON N8L 0A4	Customer: John Rossi	Real Estate Professional: John Rossi

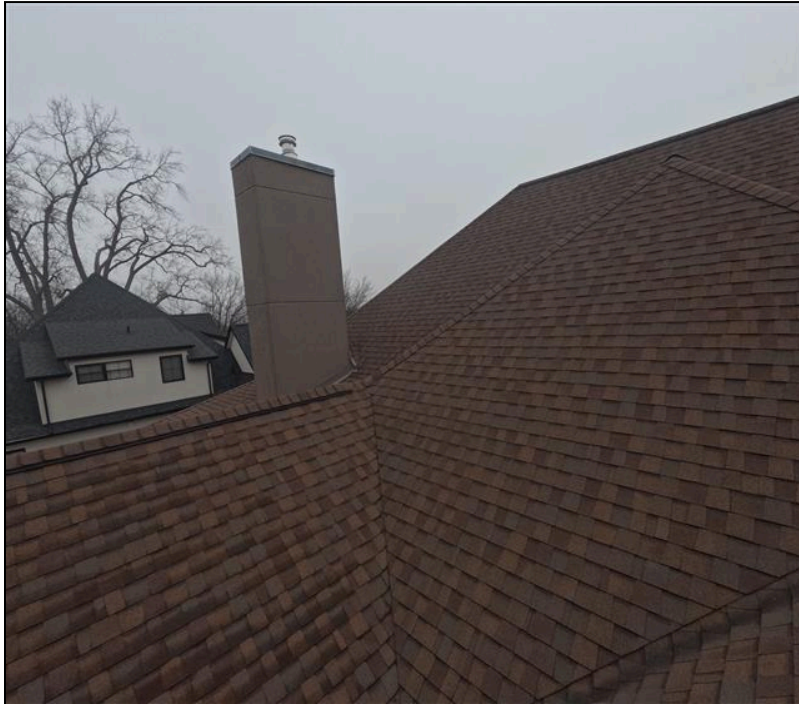
1.6 Item 1(Picture)

The Inspector observed no deficiencies in the condition of the asphalt composition shingle roof-covering material. The estimated age of the shingles is 8 years. The average lifespan is 25-30 years.

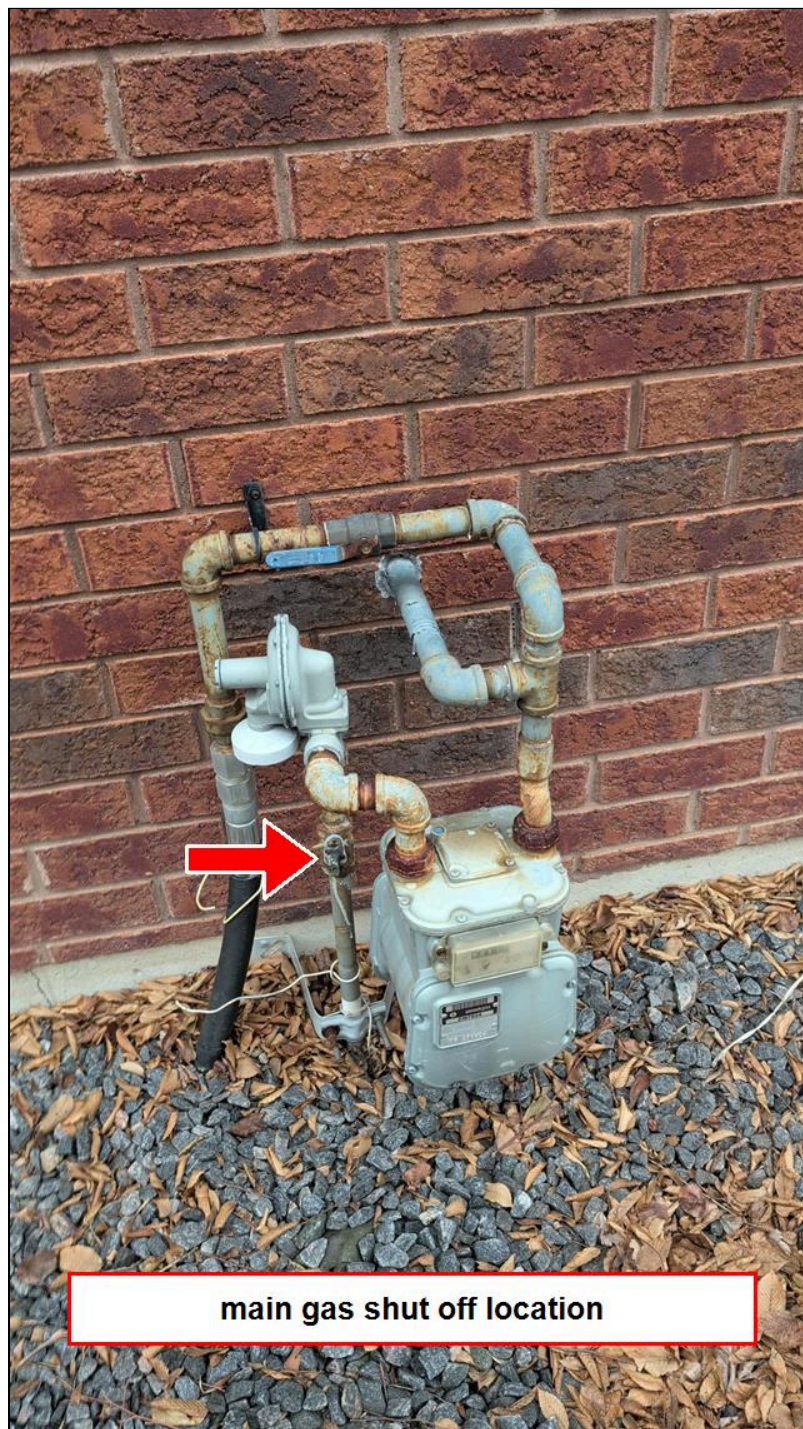
2.6 Item 1(Picture)

The gas shut-off appeared to be in serviceable condition at the time of the inspection. Shut-offs were not operated, but were visually inspected.

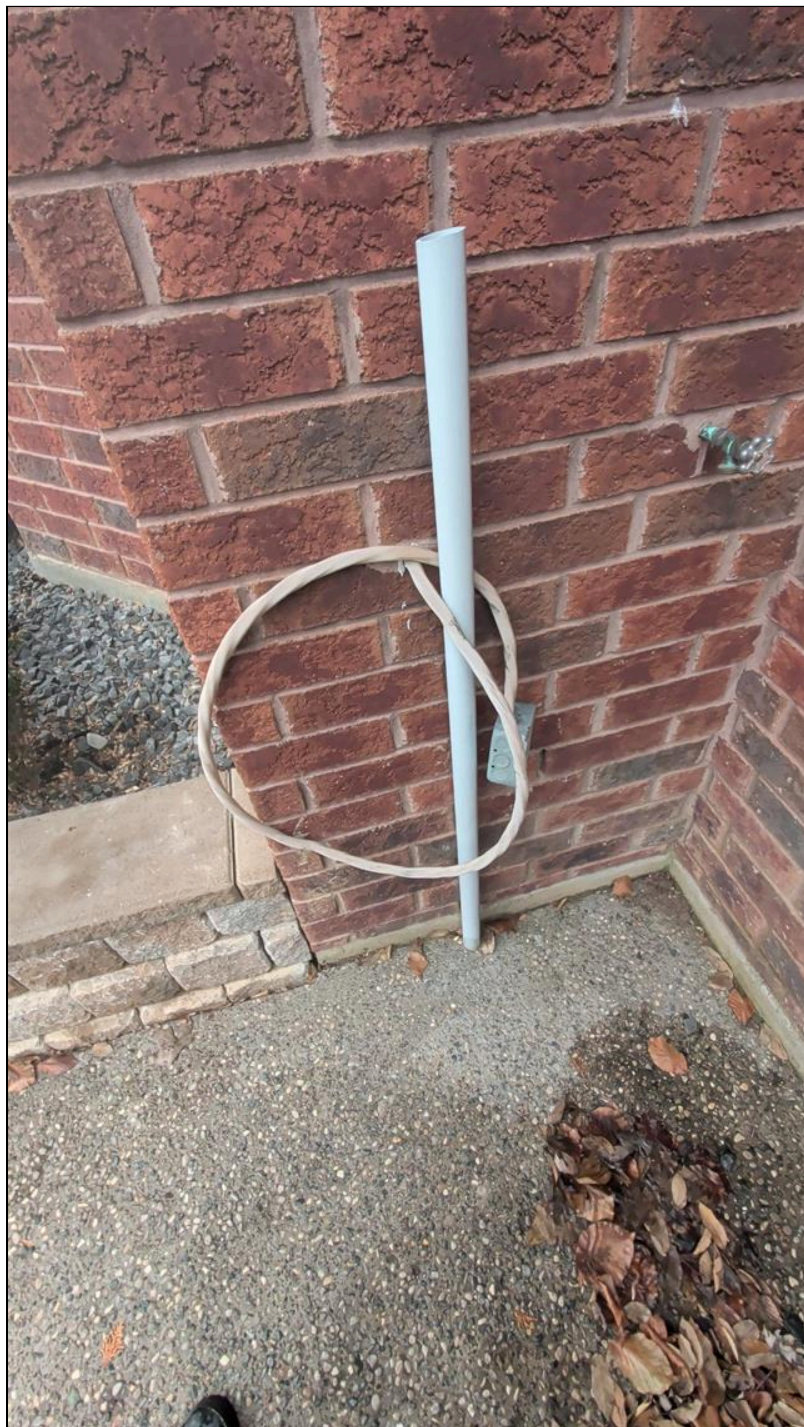
2.7 Item 1(Picture)

At the rear of the home was this electrical junction box that should be properly secured and in a weatherproof enclosure. If this isn't needed I would have it removed.

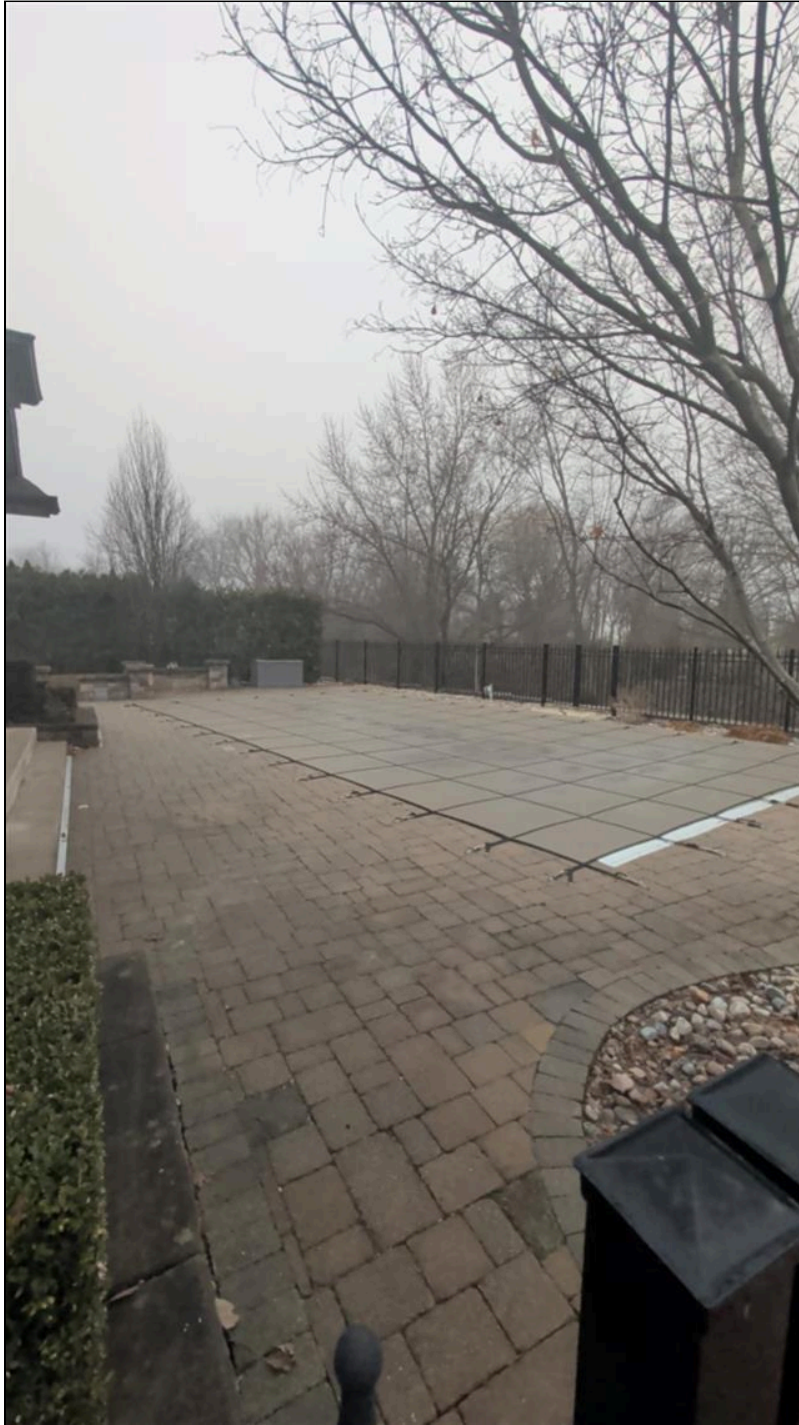
2.15 Item 1(Picture)

Inspection of swimming pools and spas lies beyond the scope of your standard home inspection.

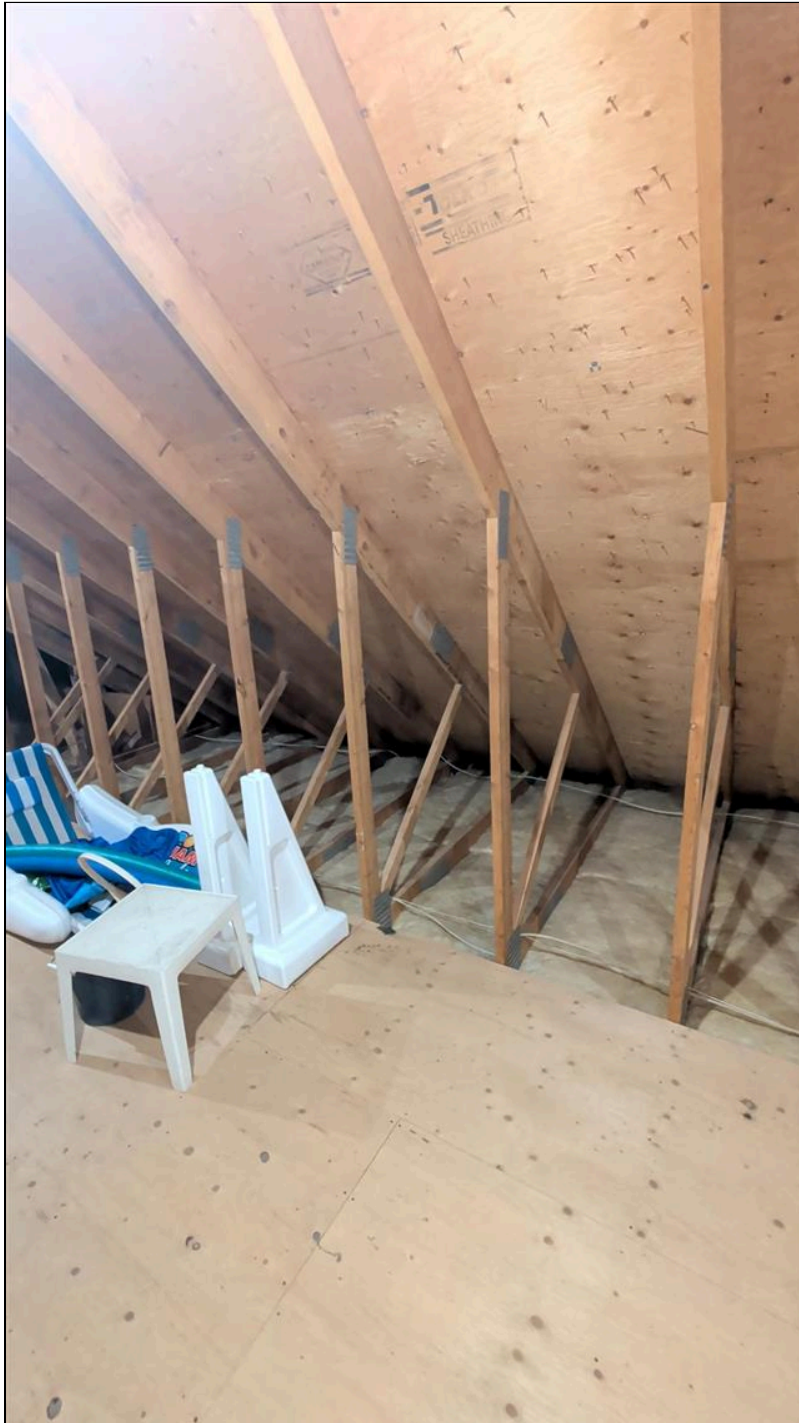
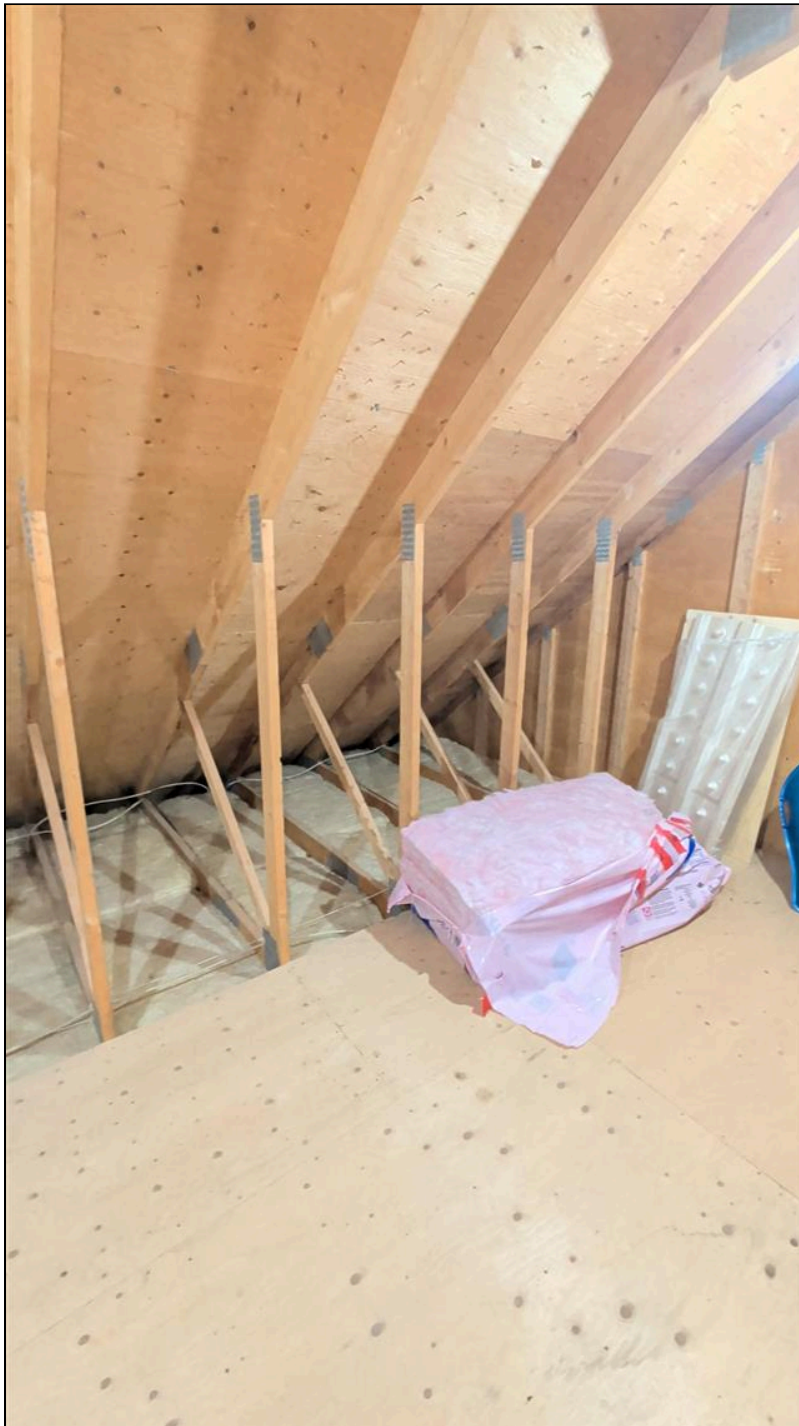
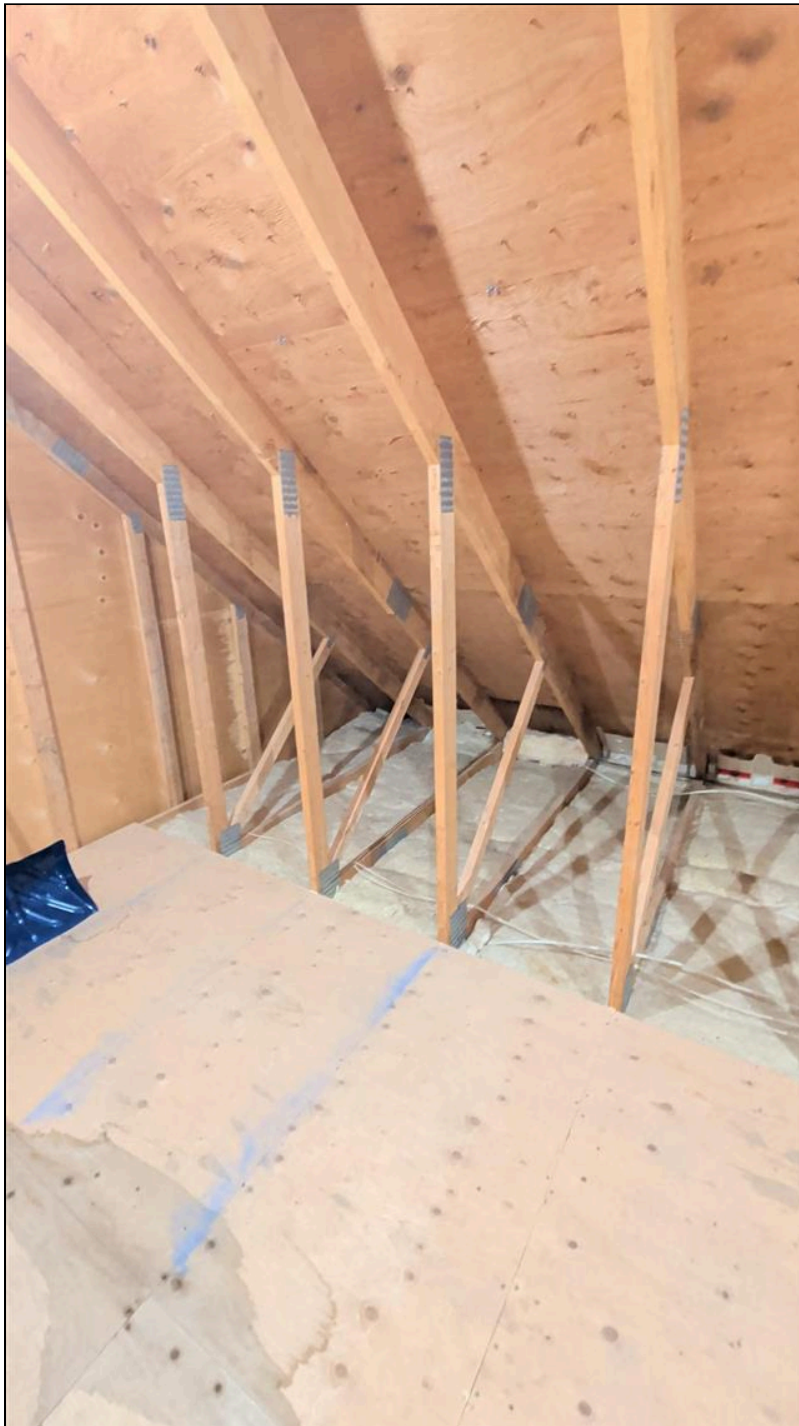
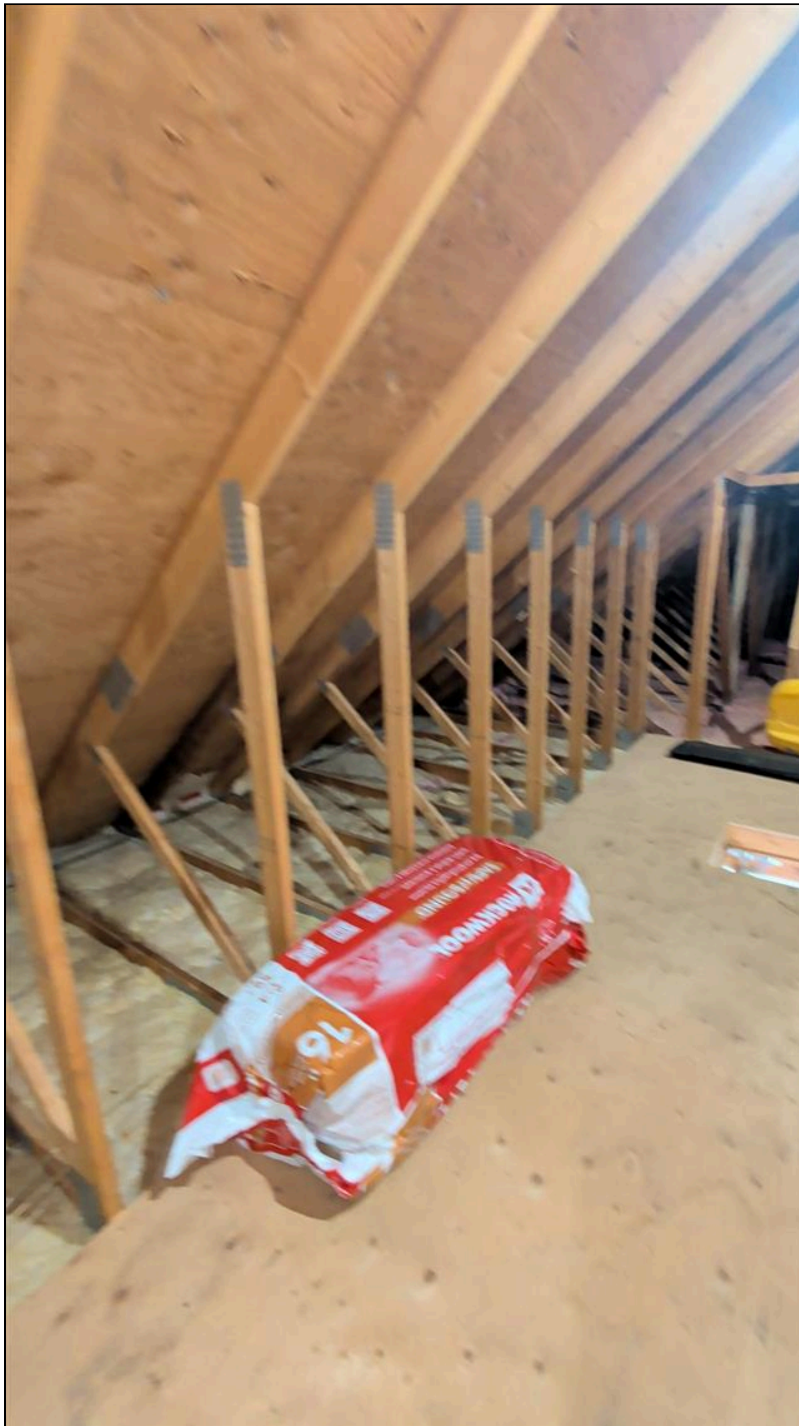
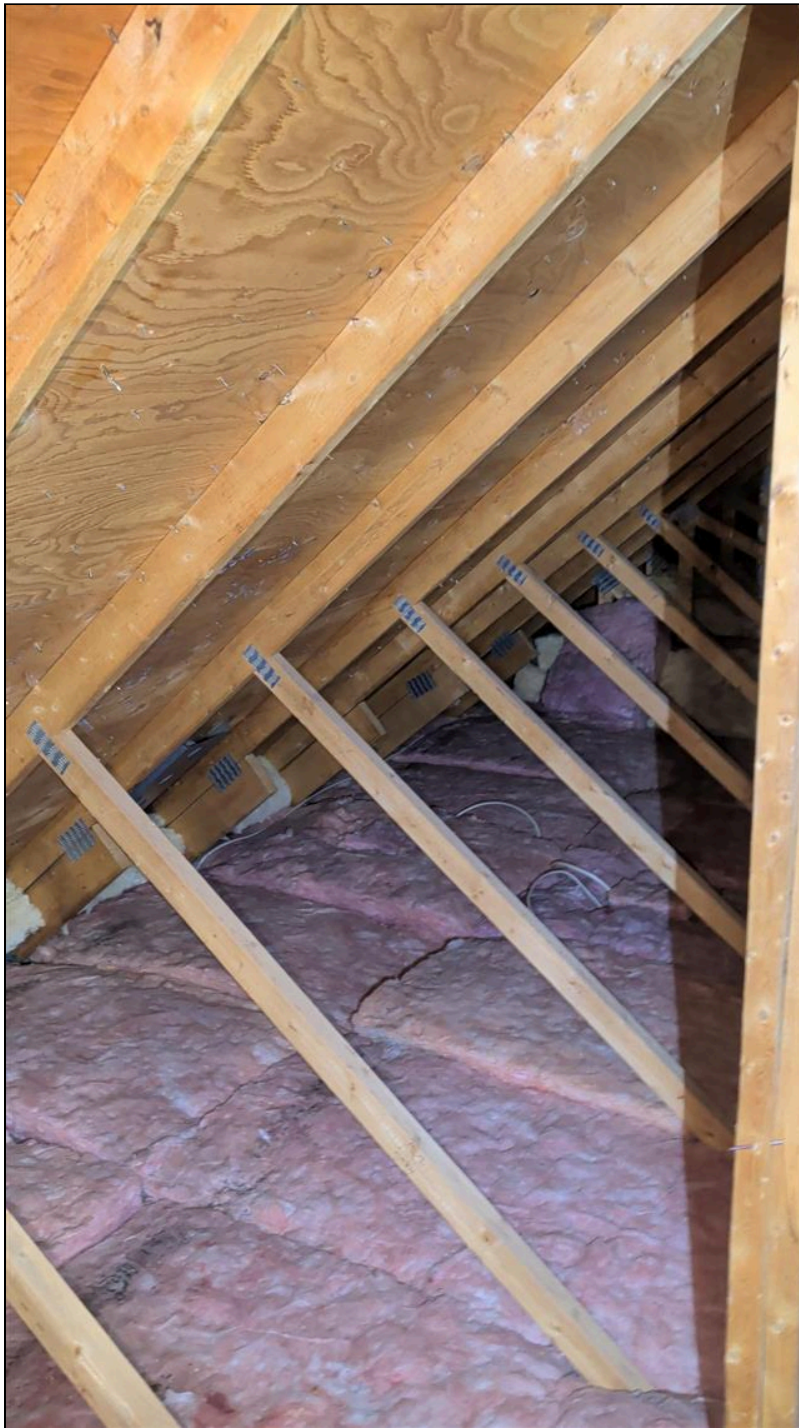
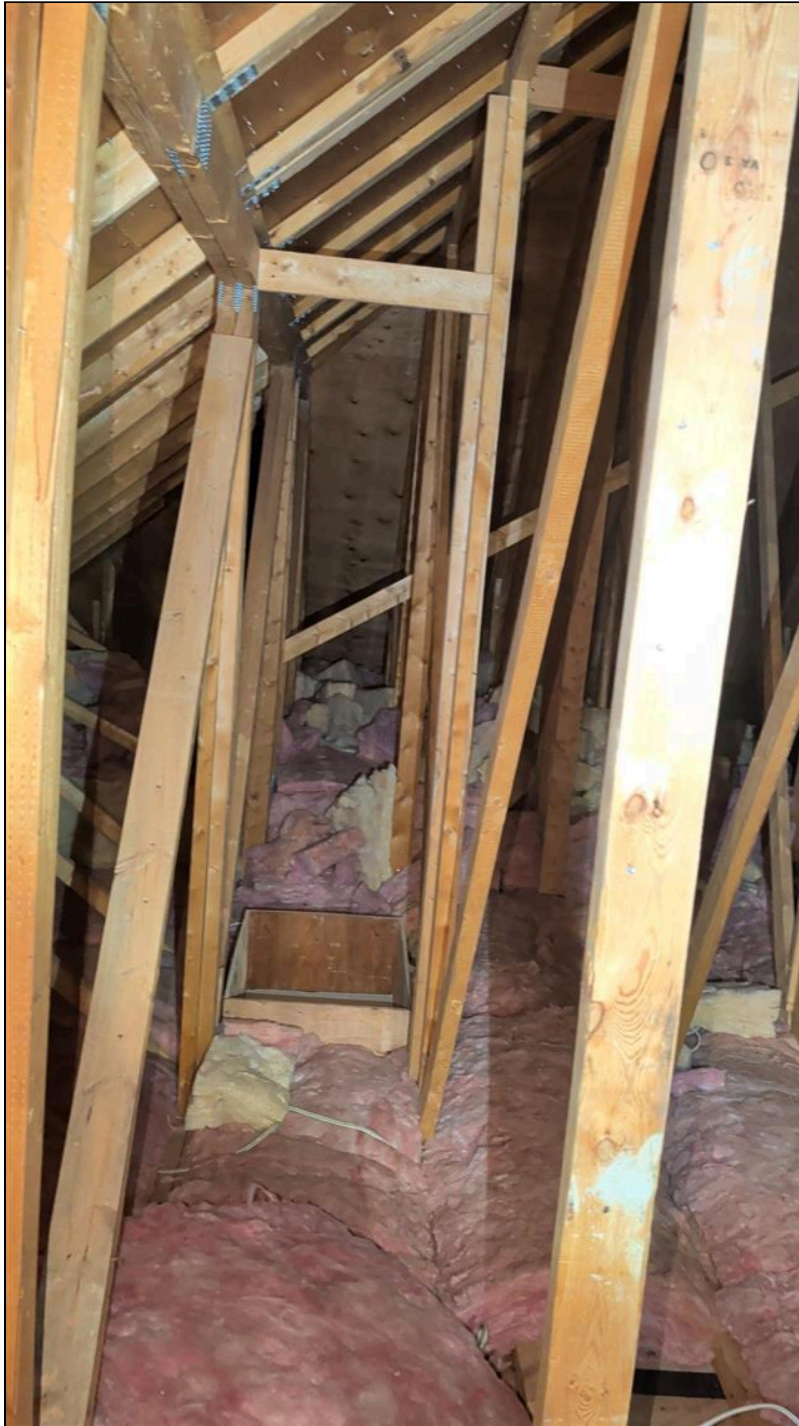
3.5 Item 1(Picture)

The inspector observed no deficiencies in the condition of the visible portions of the roof trusses. At the time of the inspection, portions of the trusses were hidden beneath thermal insulation.

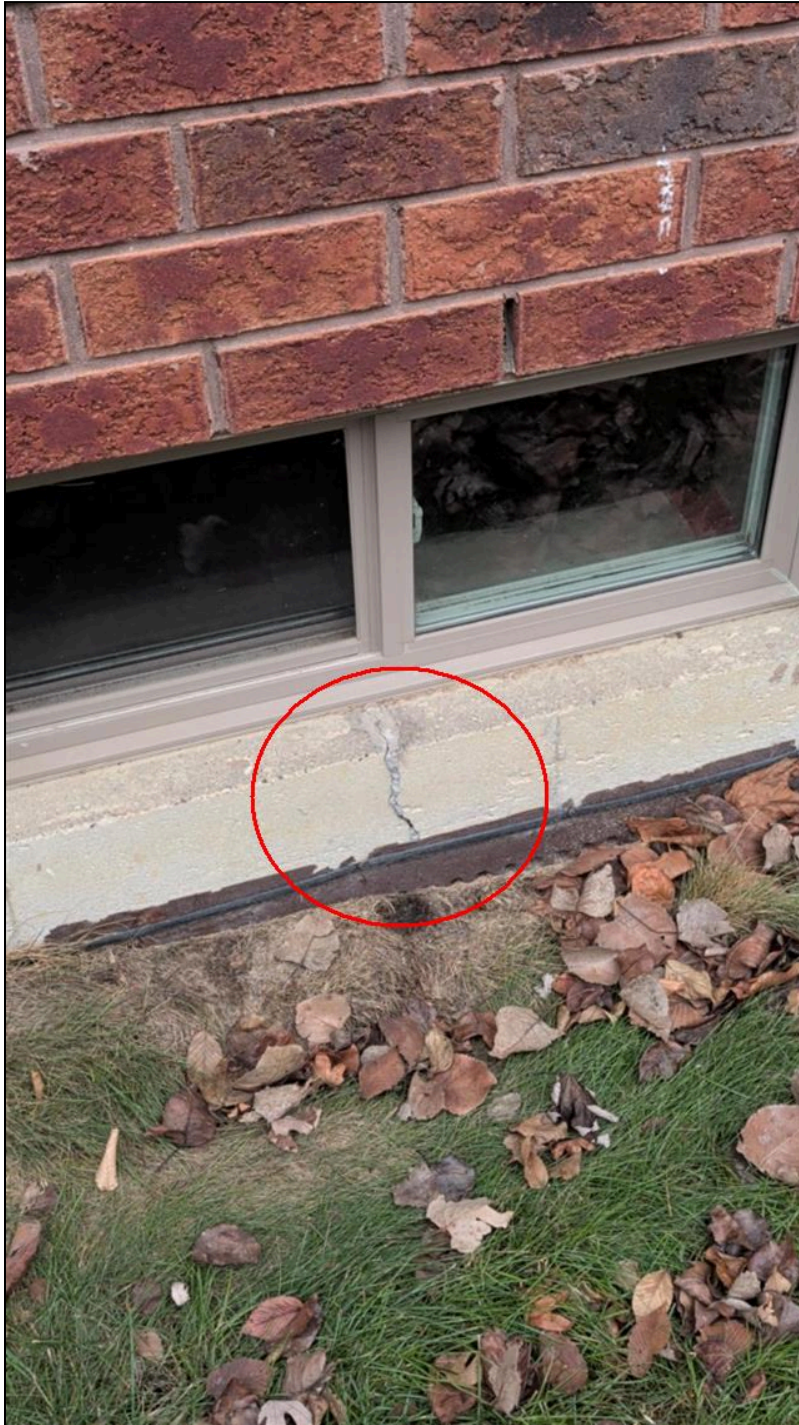
4.2 Item 1(Picture)

Typical shrinkage cracks visible in the foundation wall are not a structural concern. Shrinkage is a natural part of the curing process of concrete and surface cracking is common. These cracks should be sealed with an appropriate sealant to prevent water intrusion.

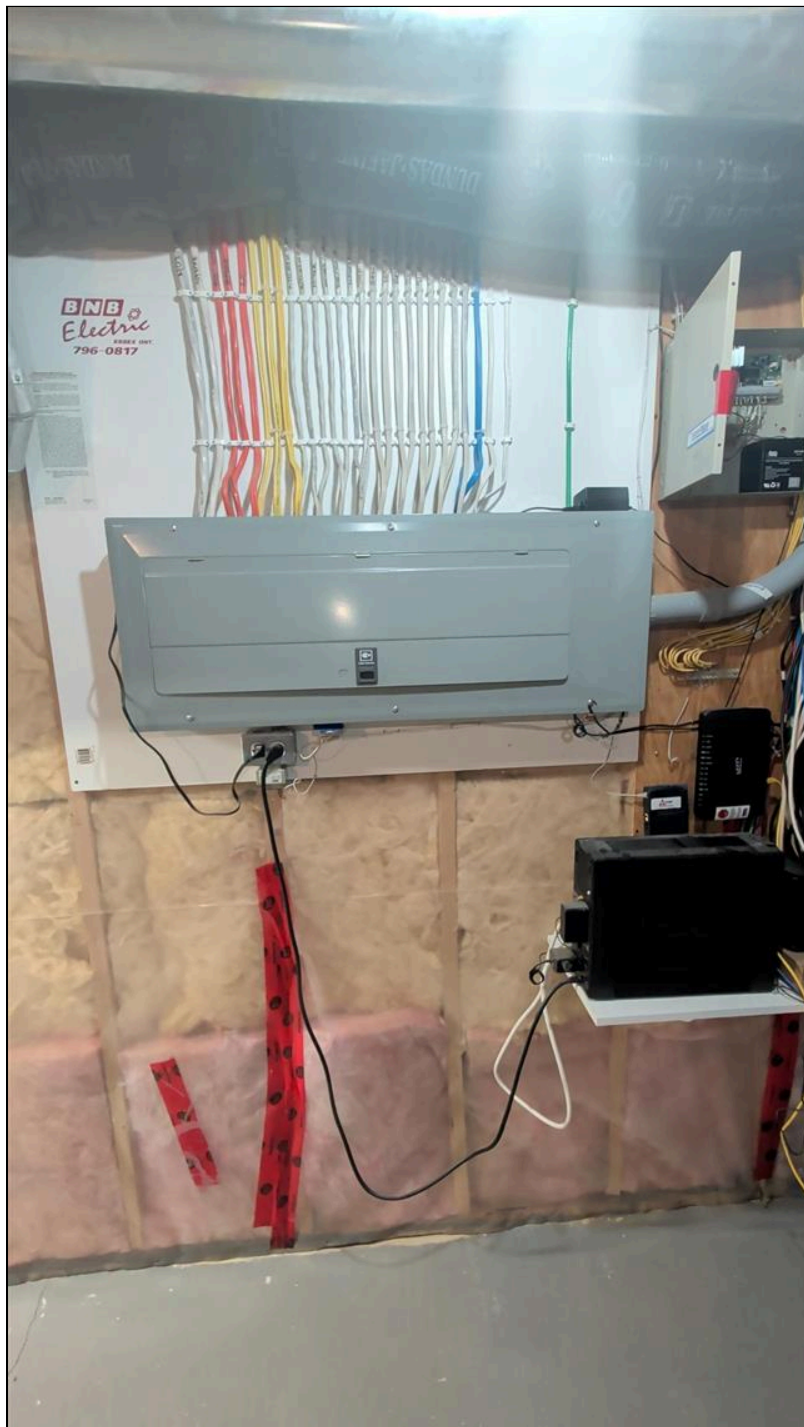
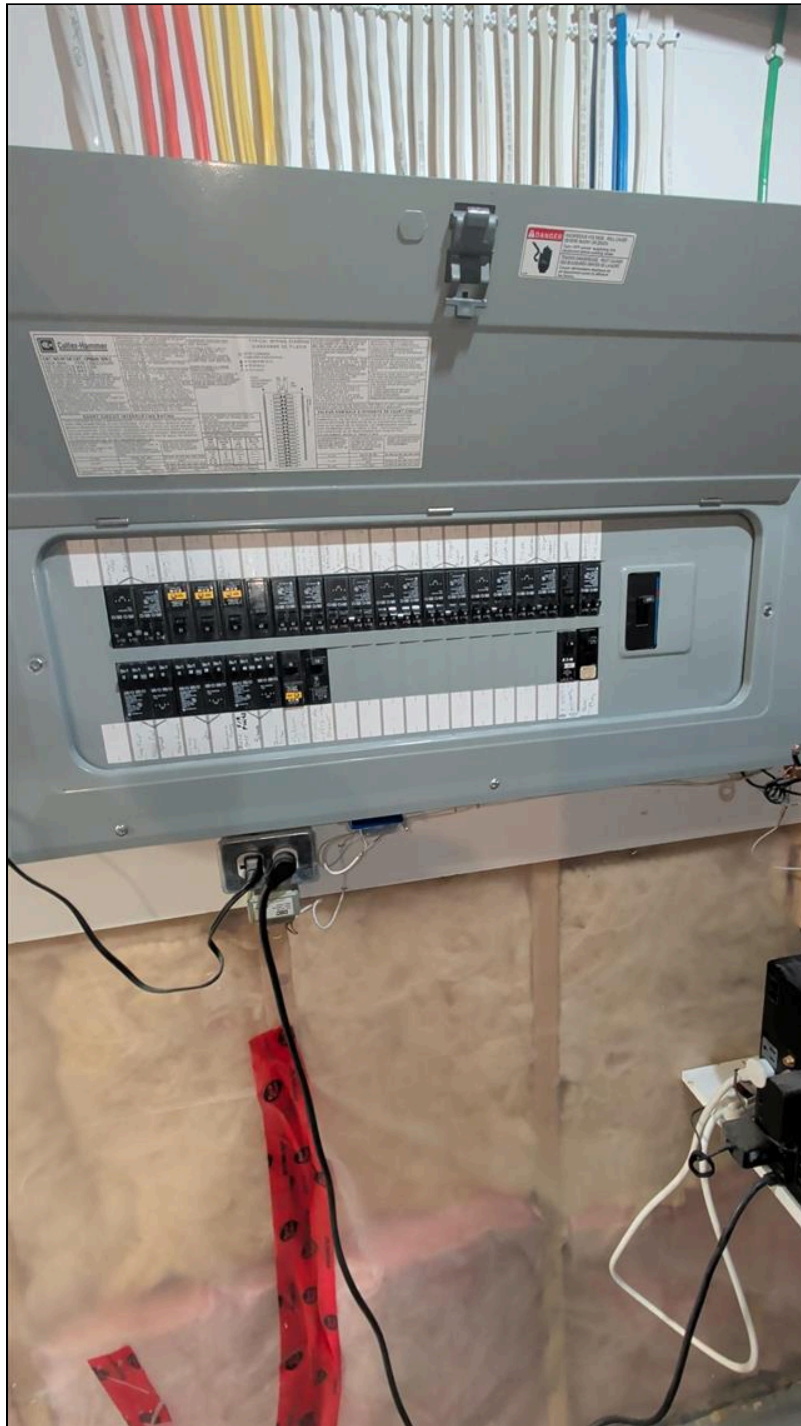
5.0 Item 1(Picture)

Power company service cables fed a load center service panel containing a main disconnect and breakers that protected and controlled power to branch circuits.

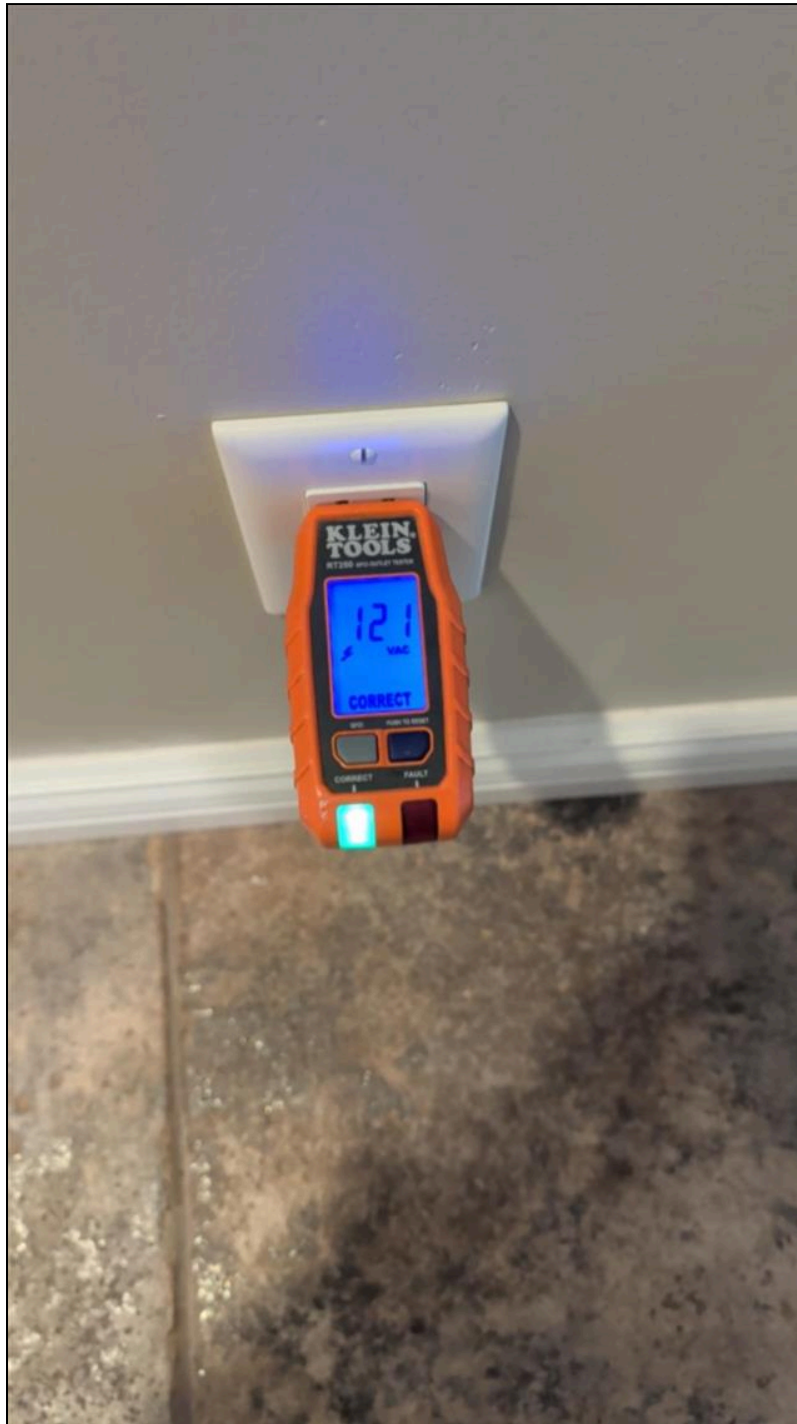
5.6 Item 1(Picture)

One receptacle in the hallway to the bedrooms was improperly secured and moved when tested. Receptacles should be securely installed to prevent fire, shock and/or electrocution hazard. The Inspector recommends correction by a qualified electrical contractor.

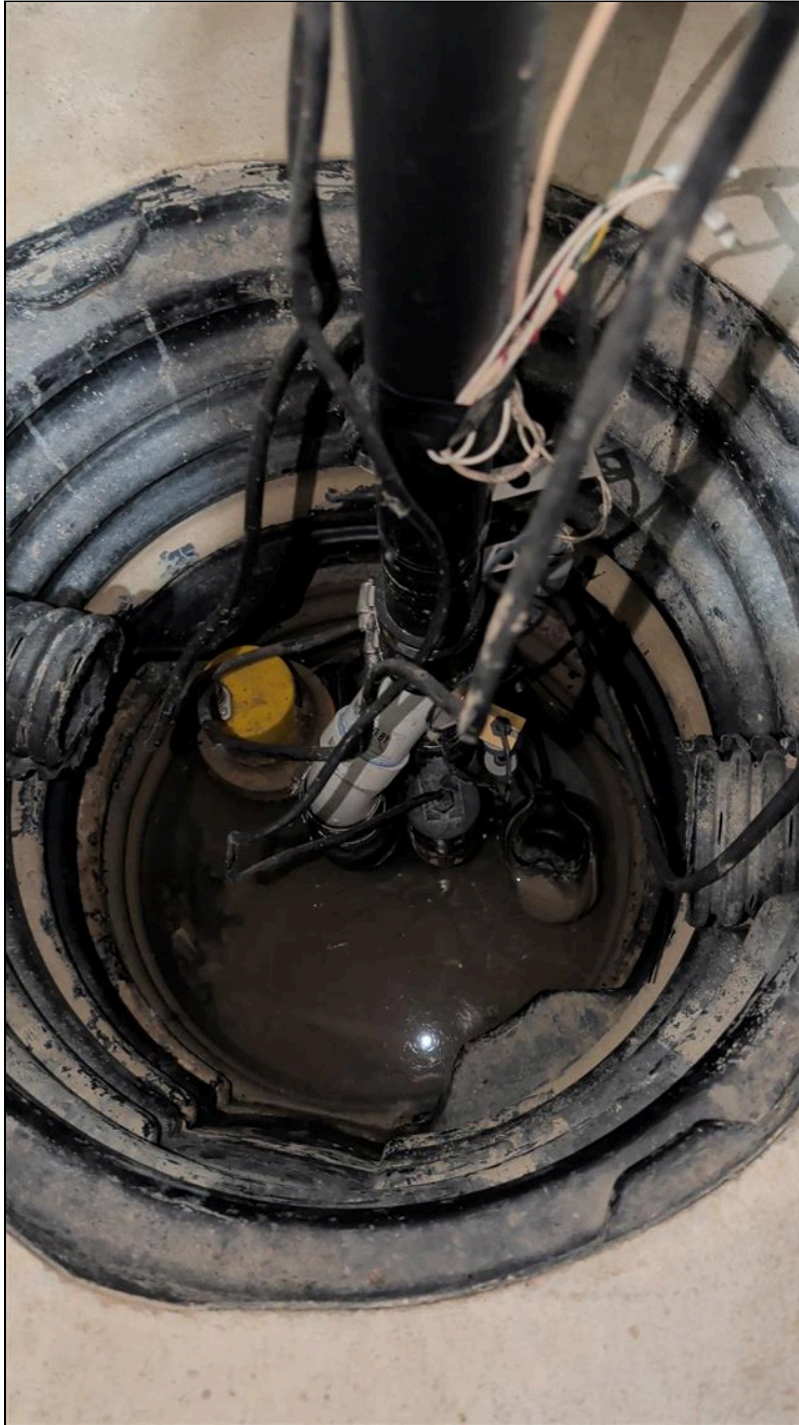
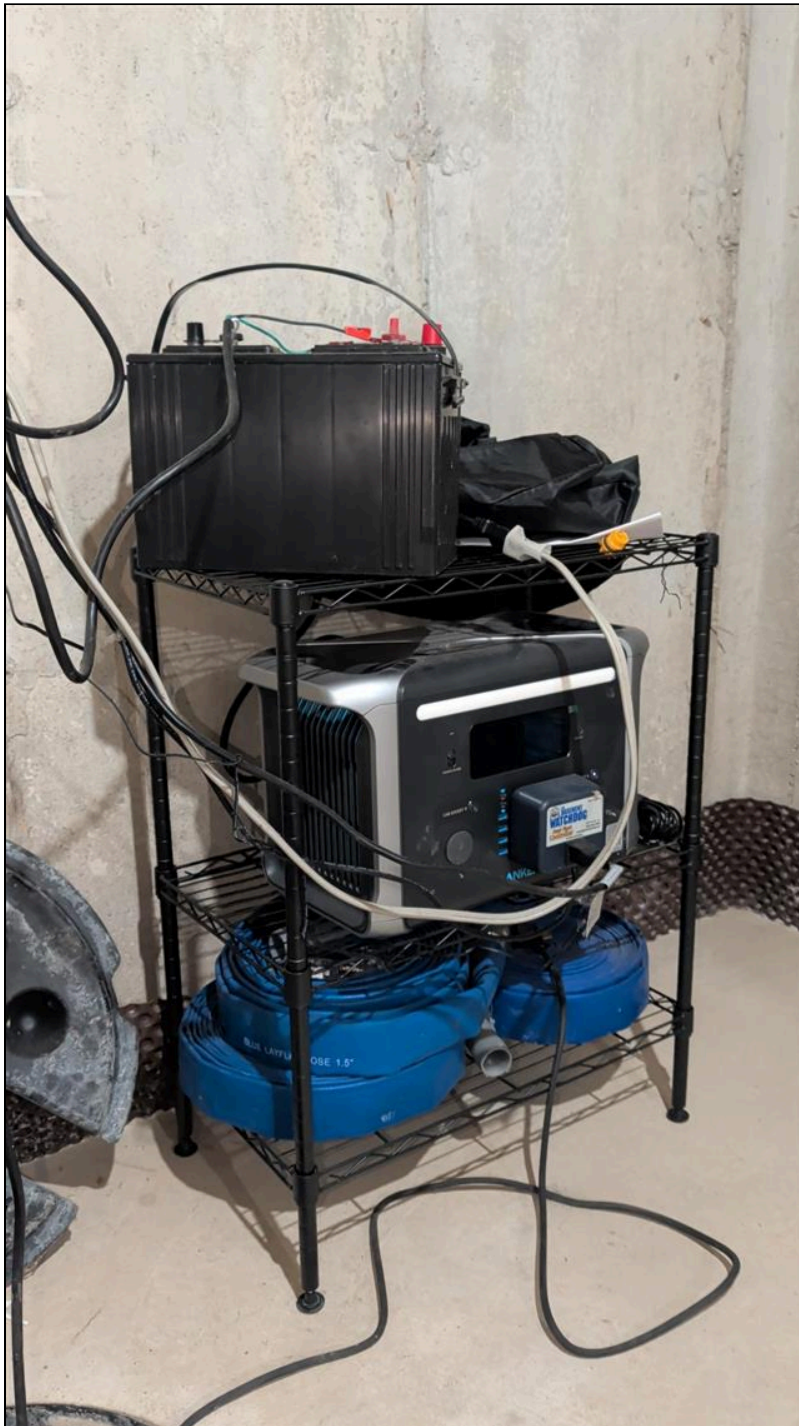
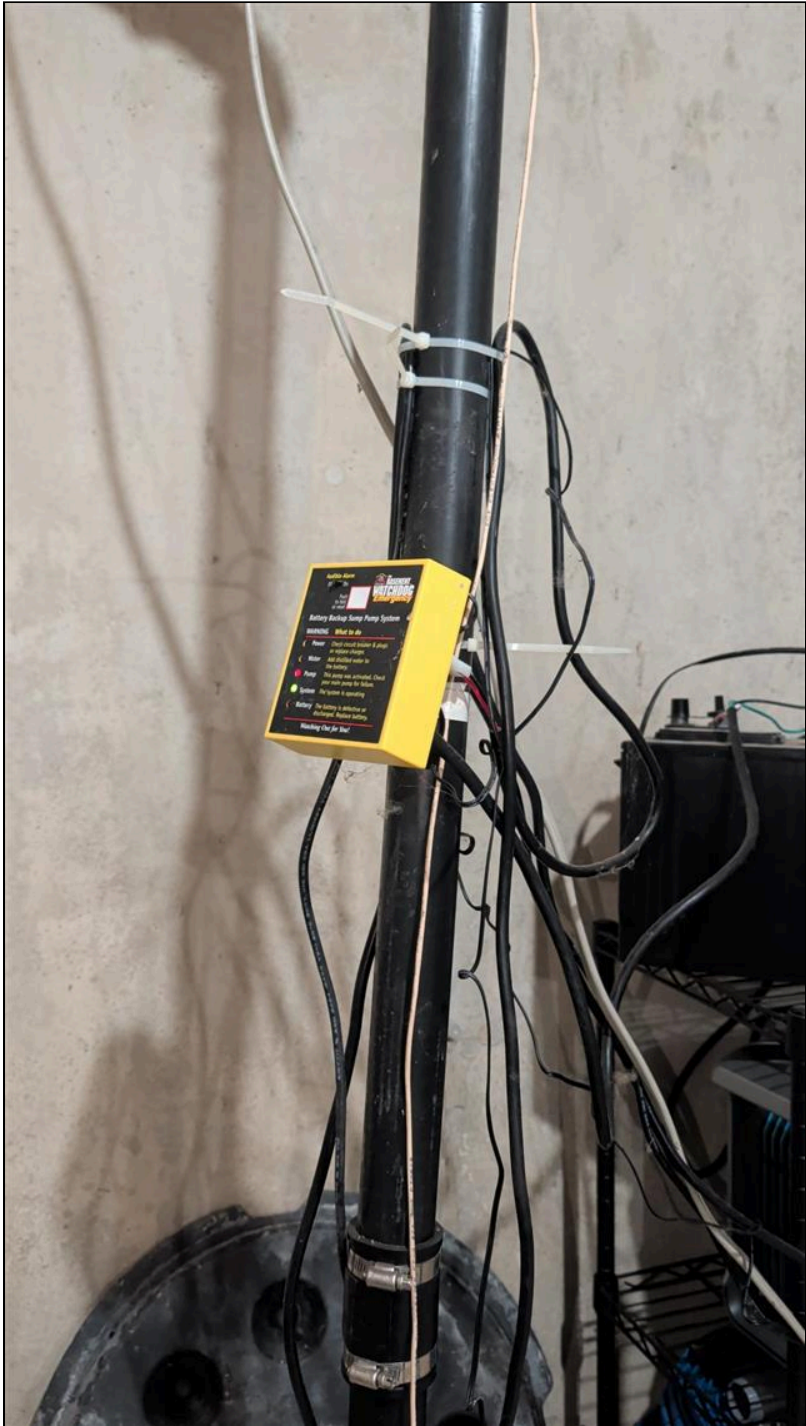
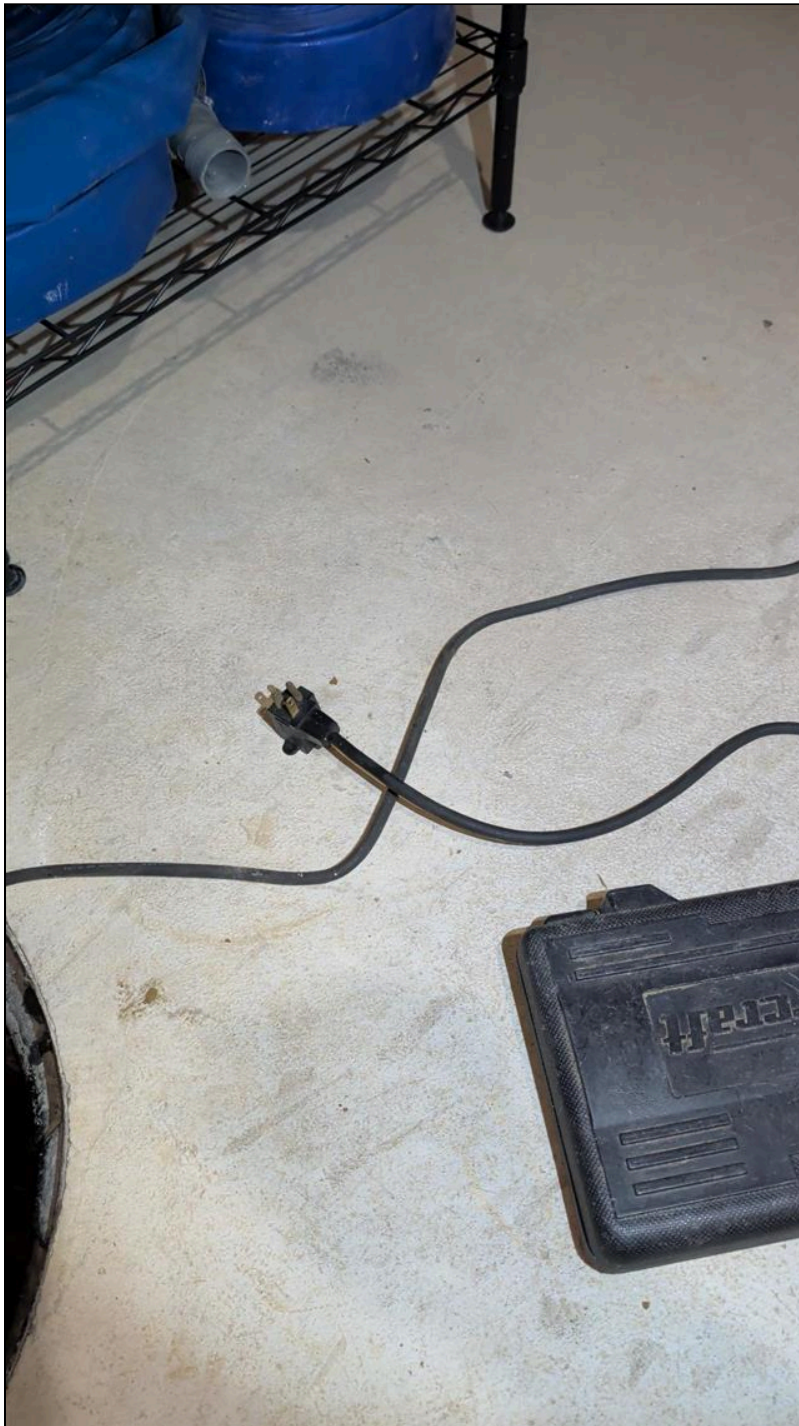
7.6 Item 1(Picture)

that had its own power cord that was not plug in.

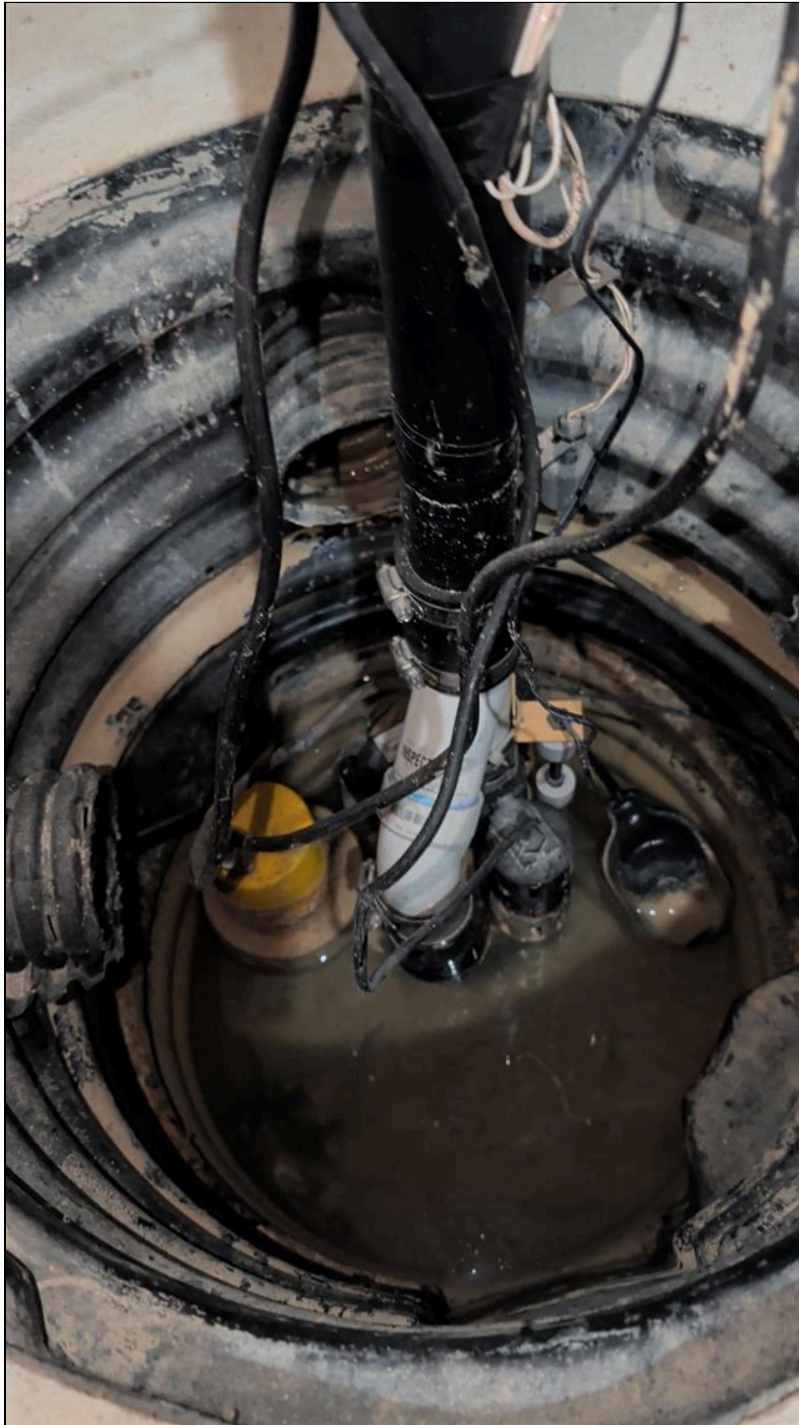
7.6 Item 5(Picture)

(2) The sump pump discharge pipe had no backwater or checkvalve installed. The Inspector recommends correction by a qualified plumbing contractor.
