Home Inspection Report

Property Address:
515 River Downs Ave
Belle River ON N8L 0A4

Redmond Home Inspections

Date: 3/4/2026	Time: 11:00 AM	Report ID: 20260304-515-River-Downs-Ave
Property: 515 River Downs Ave Belle River ON N8L 0A4	Customer: John Rossi	Real Estate Professional: John Rossi

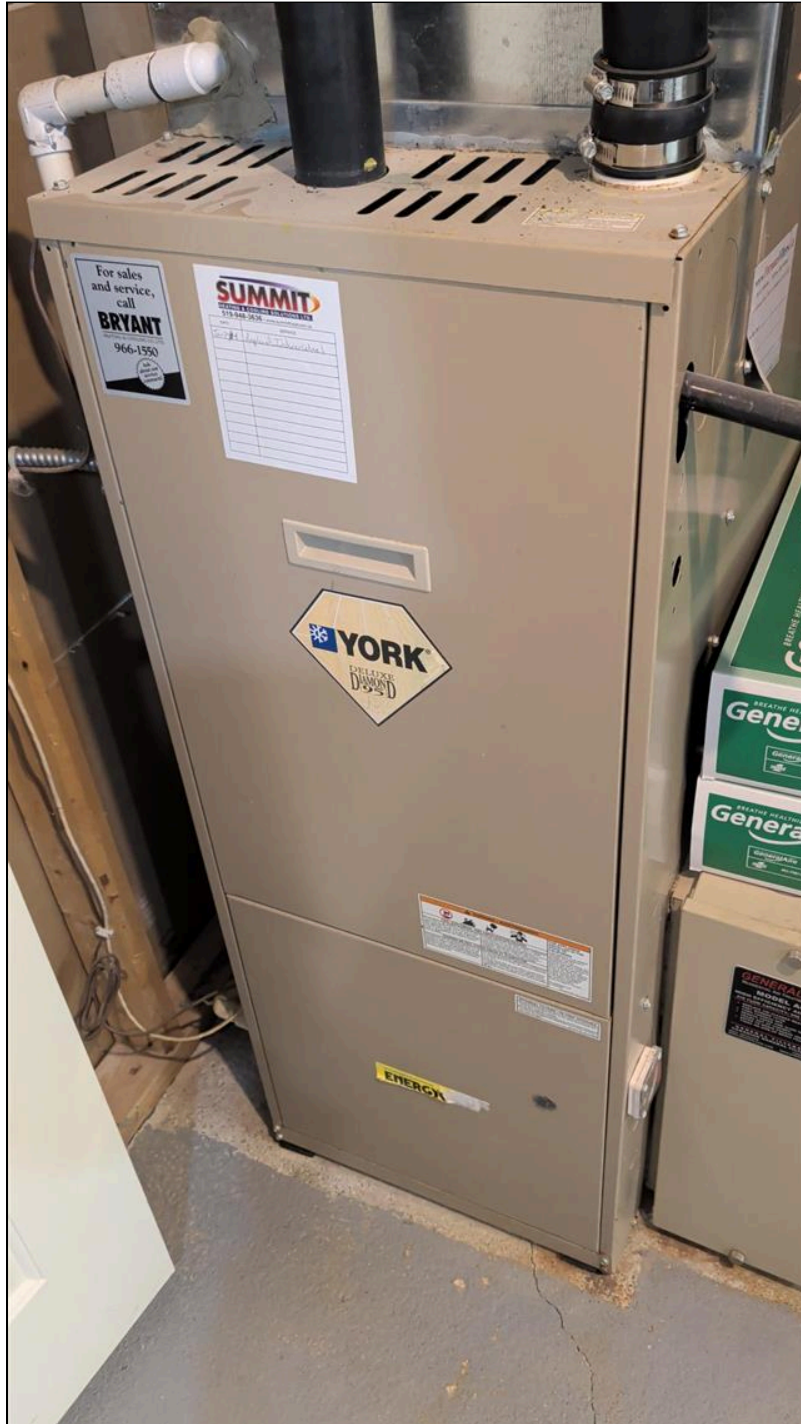
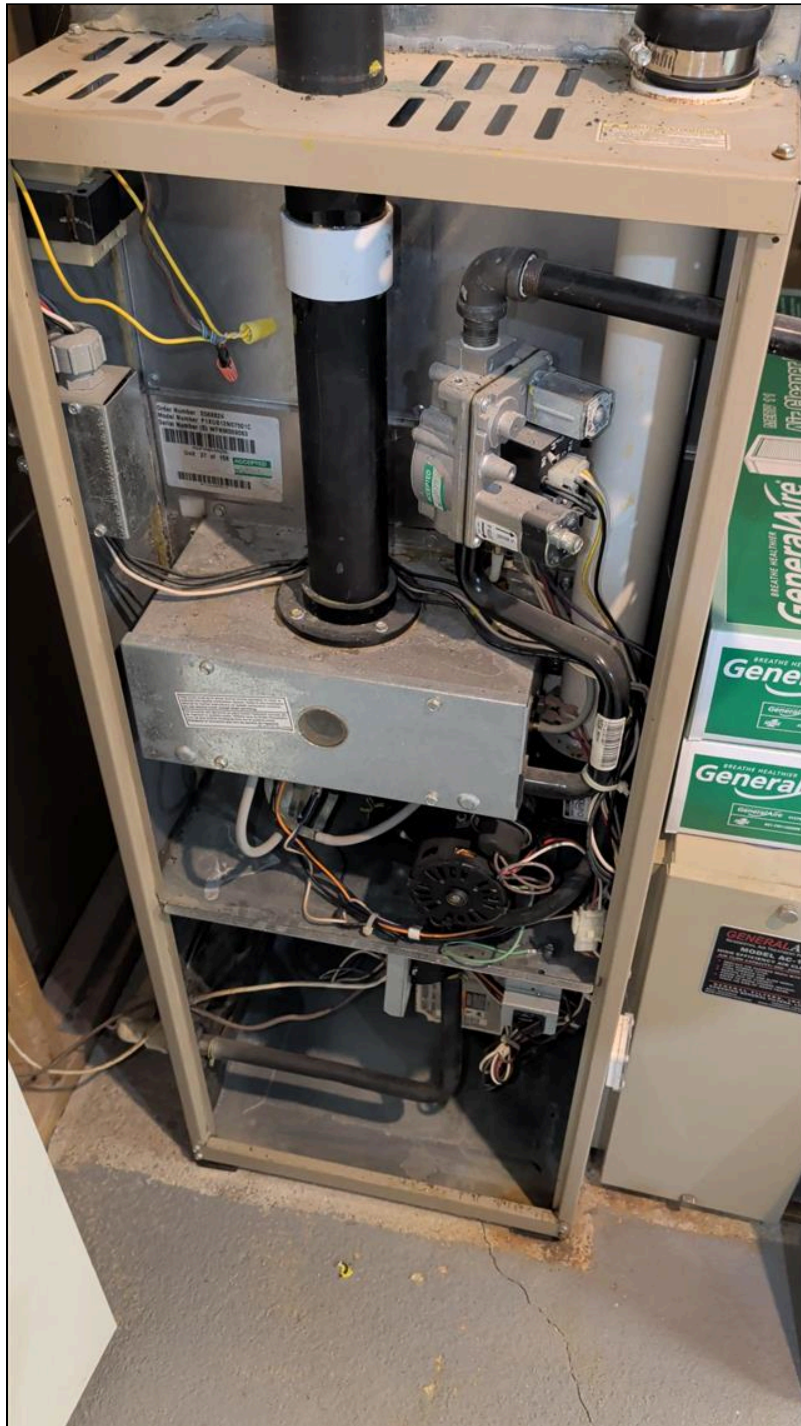
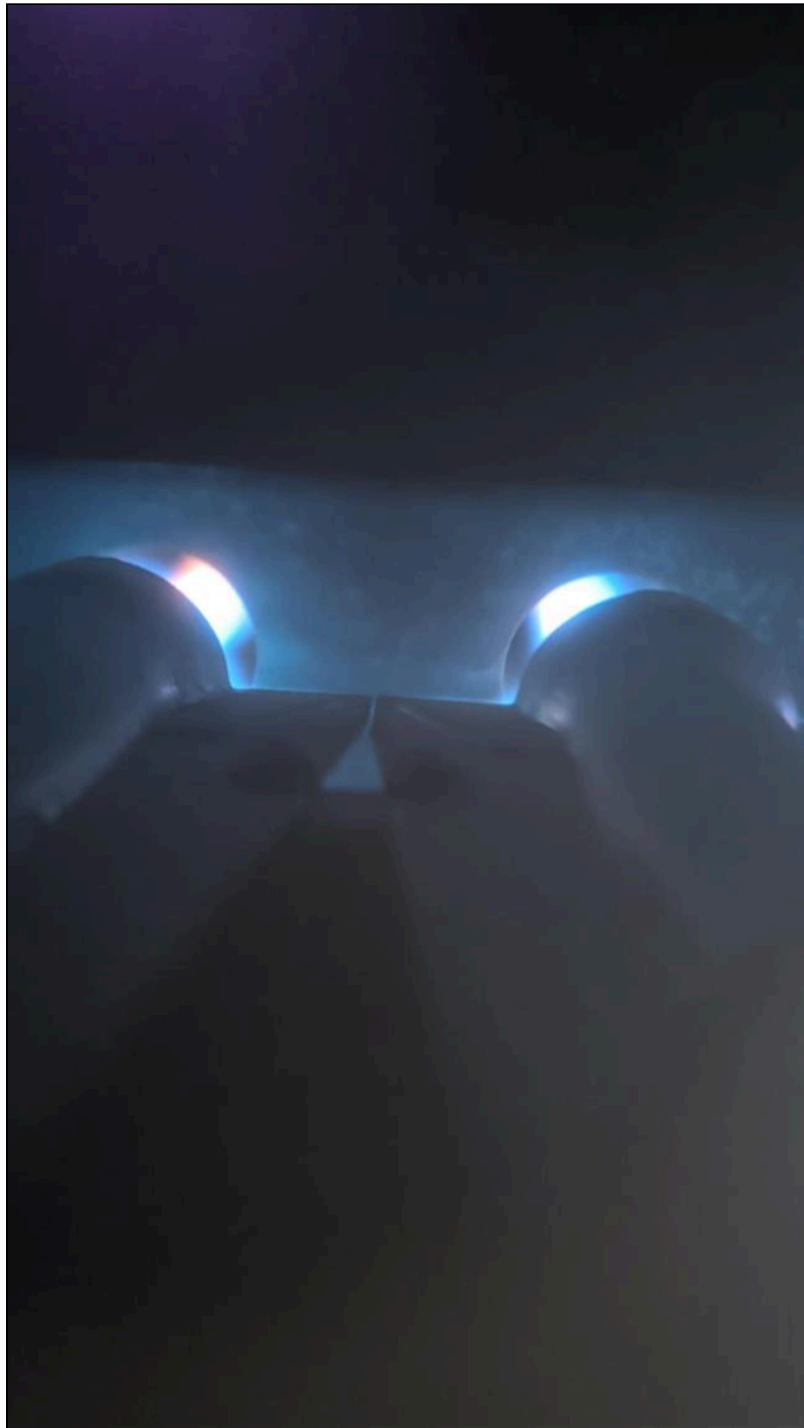
8.1 Item 1(Picture)

This furnace responded adequately to the call for heat.

The furnace was old and appeared to be past its typical life expectancy. The Inspector recommends that the unit be serviced annually by a qualified HVAC contractor. Due to its age, the unit could fail any anytime and budgeting for replacement is recommended.

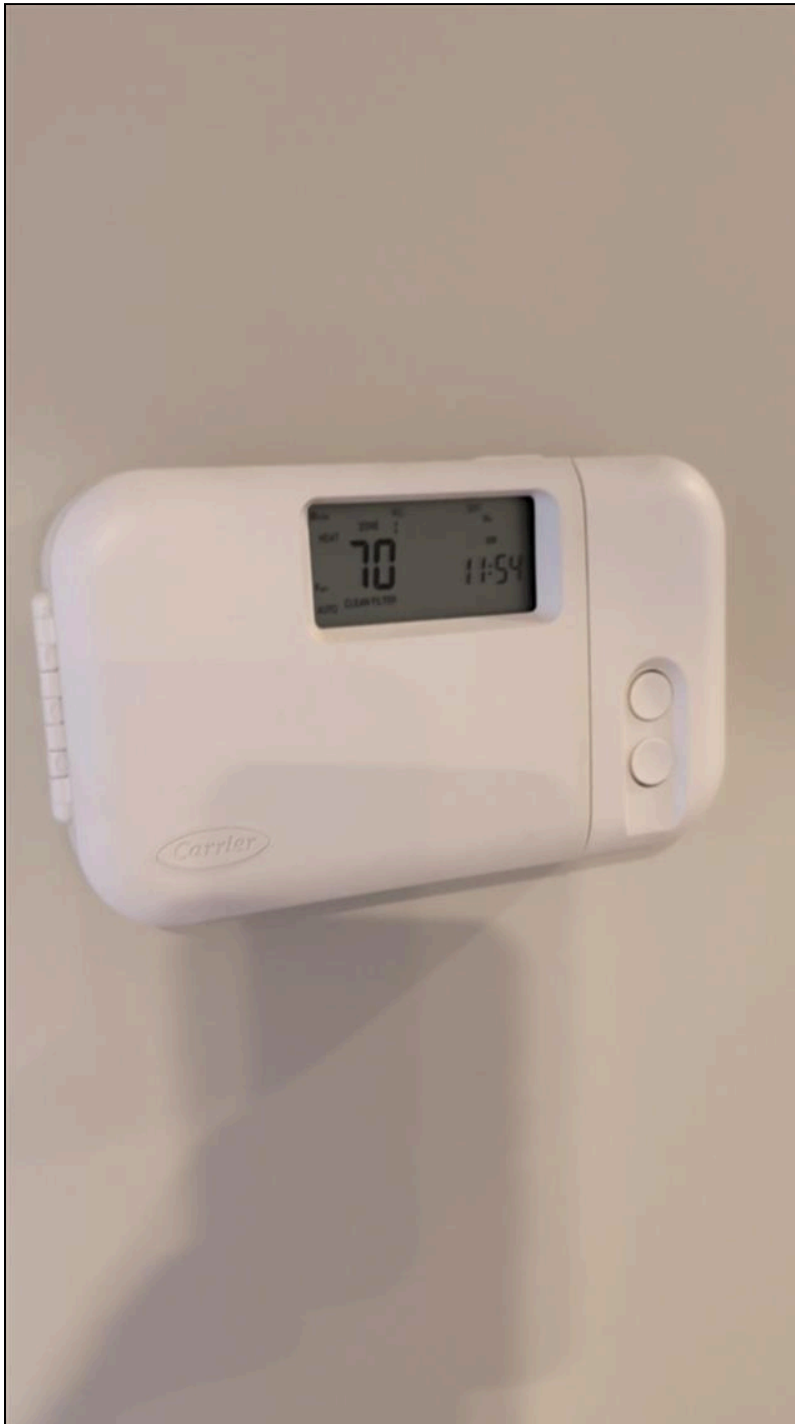
8.2 Item 1(Picture)

The furnace and the air-conditioning were controlled by a programmable thermostat. Heating and cooling costs can be reduced by programming the thermostat to raise and lower home temperatures at key times.

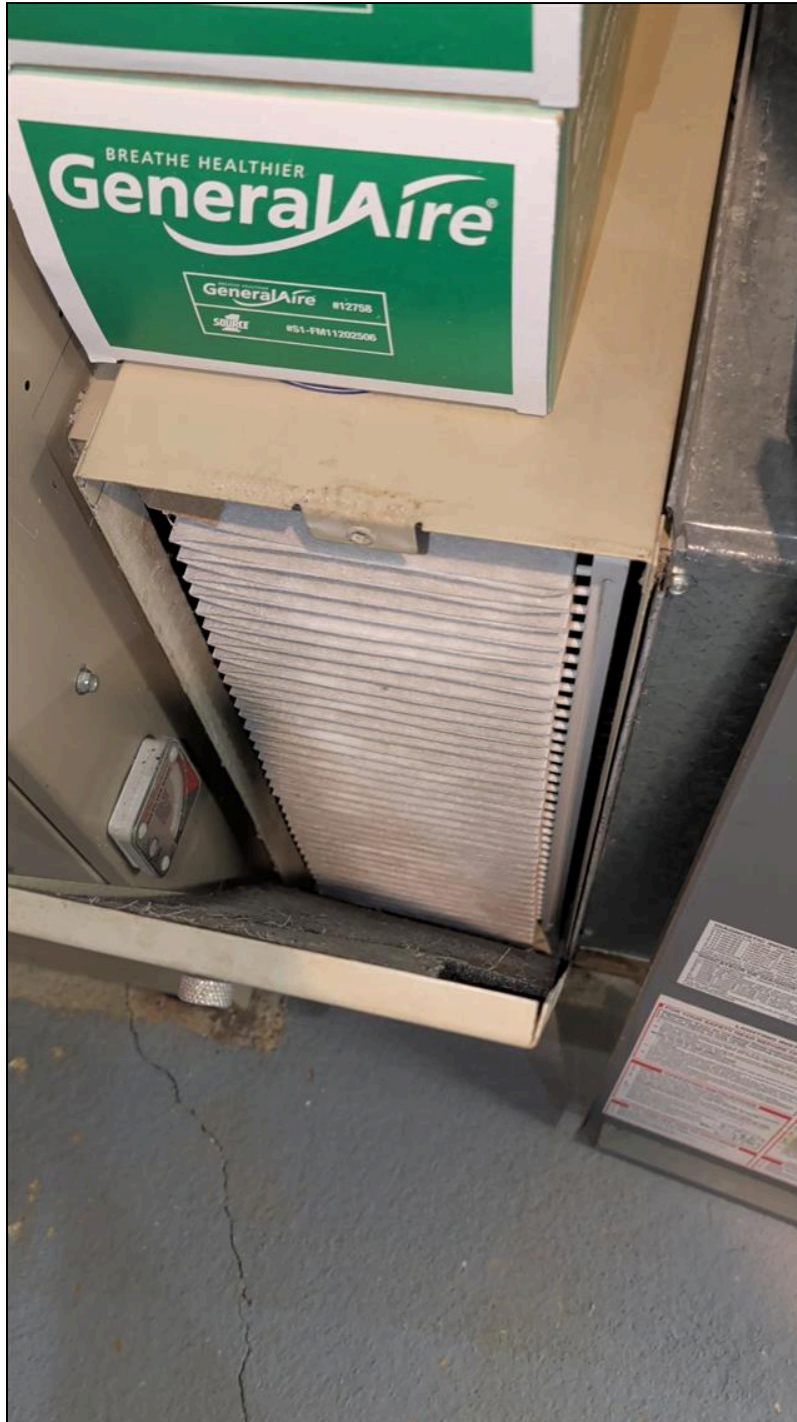
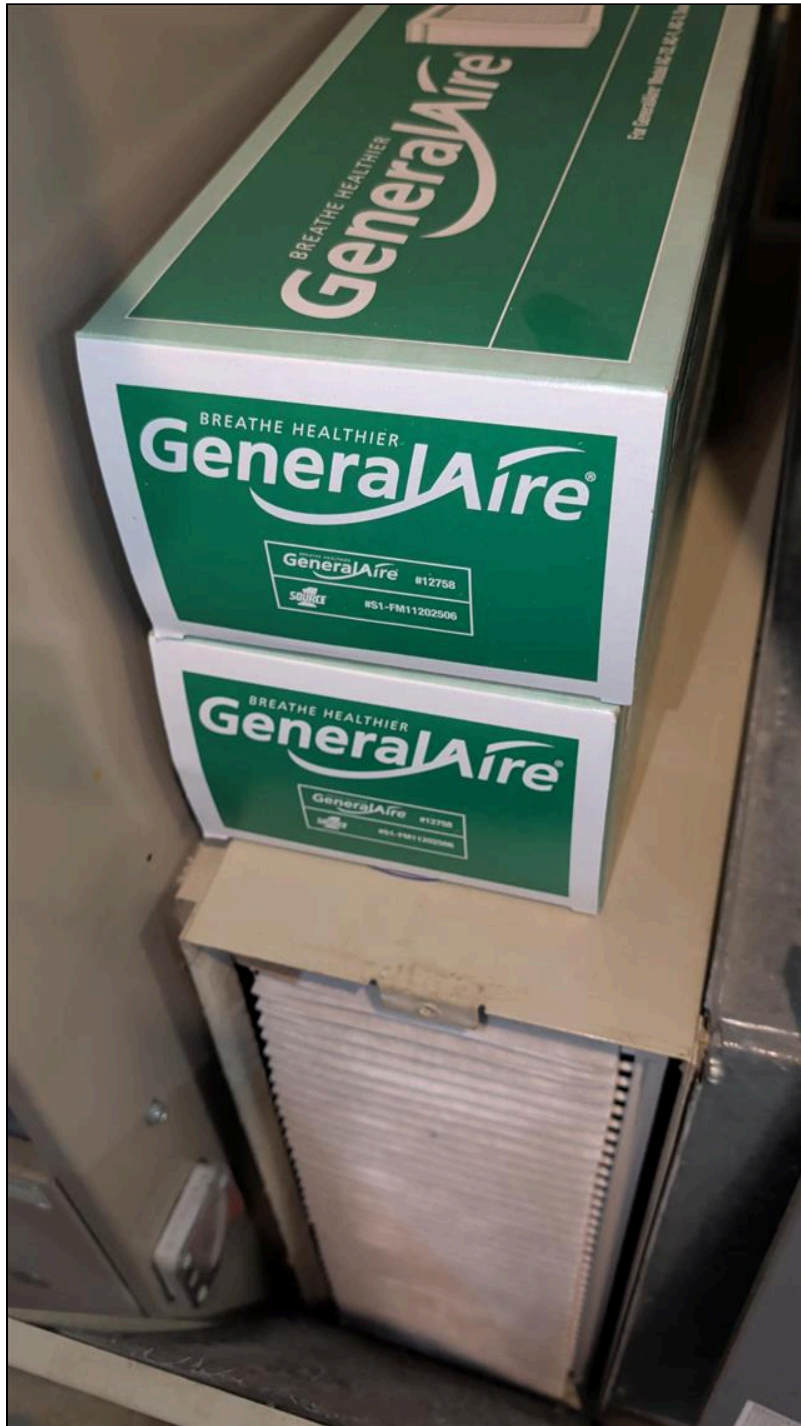
8.3 Item 1(Picture)

Filters should be checked every three months and replaced when they reach a condition in which accumulation of particles becomes so thick that particles may be blown loose from the filter and into indoor air. Homes in areas with high indoor levels of airborne pollen or dust may need to

have air filters checked and changed more frequently. Failure to change the filter when needed may result in the following problems: - Reduced blower life due to dirt build-up on vanes, which increasing operating costs. - Reduced effectiveness of air filtration resulting in deterioration of indoor air quality. - Increased resistance resulting in the filter being sucked into the blower. This condition can be a potential fire hazard. - Frost build-up on air-conditioner evaporator coils, resulting in reduced cooling efficiency and possible damage. - Reduced air flow through the home.

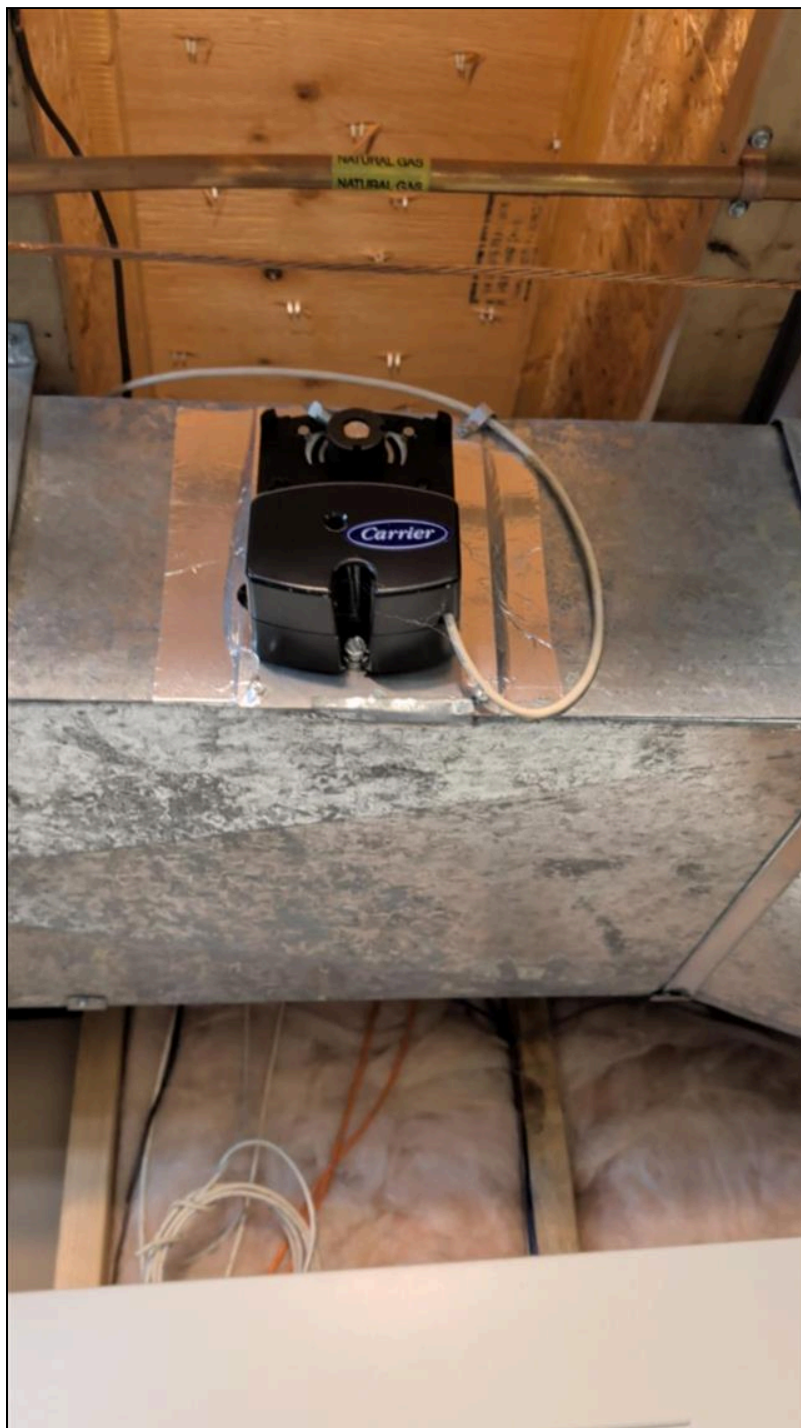
8.4 Item 1(Picture)

The home had a zoned system. This is done using mechanical dampers in the ducting that adjust more or less air flow to the different zones of the home. Ensuring these are working is beyond a home inspection and would require a hvac technician to further inspect.

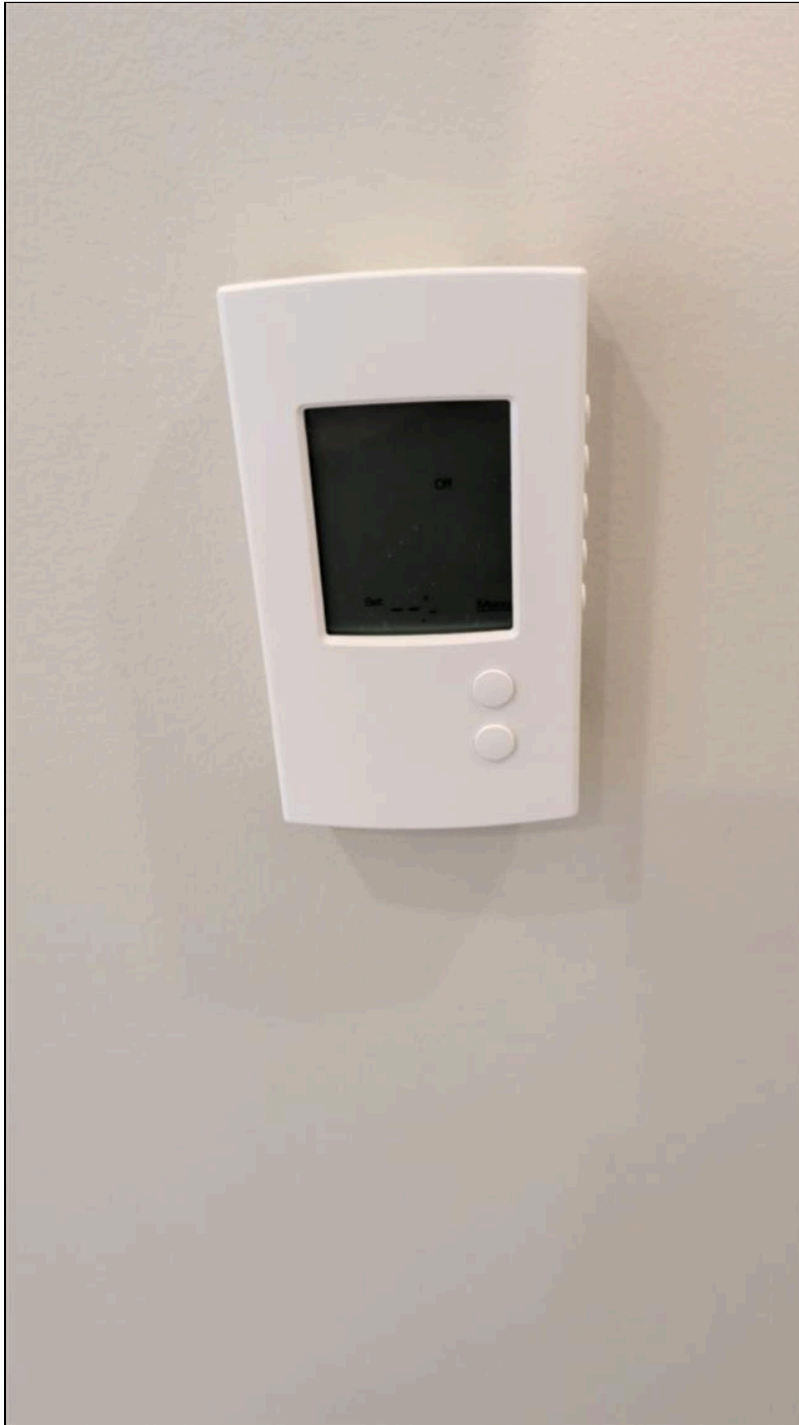
8.5 Item 1(Picture)

The master bathroom had electric radiant heating installed in the floor which responded to the thermostat at the time of inspection.

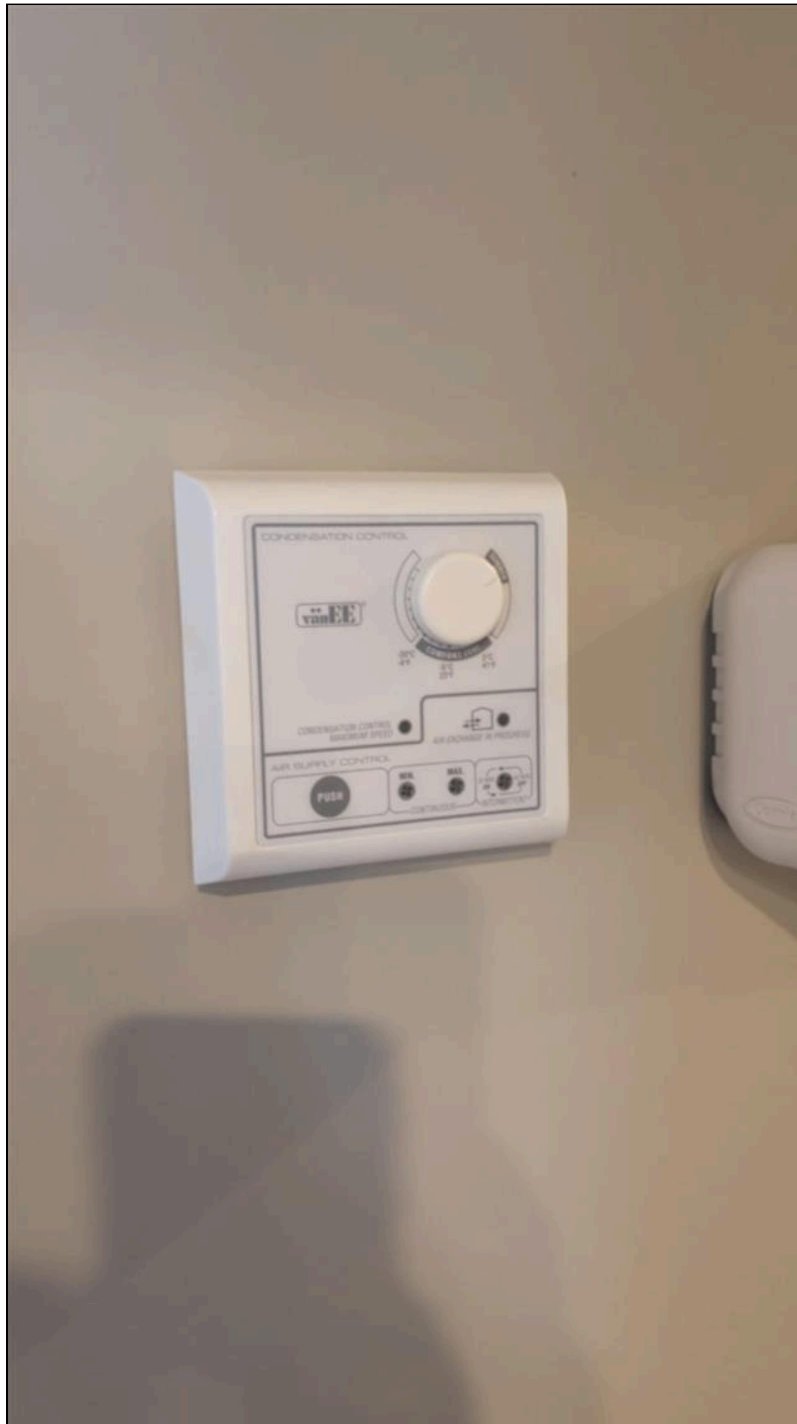
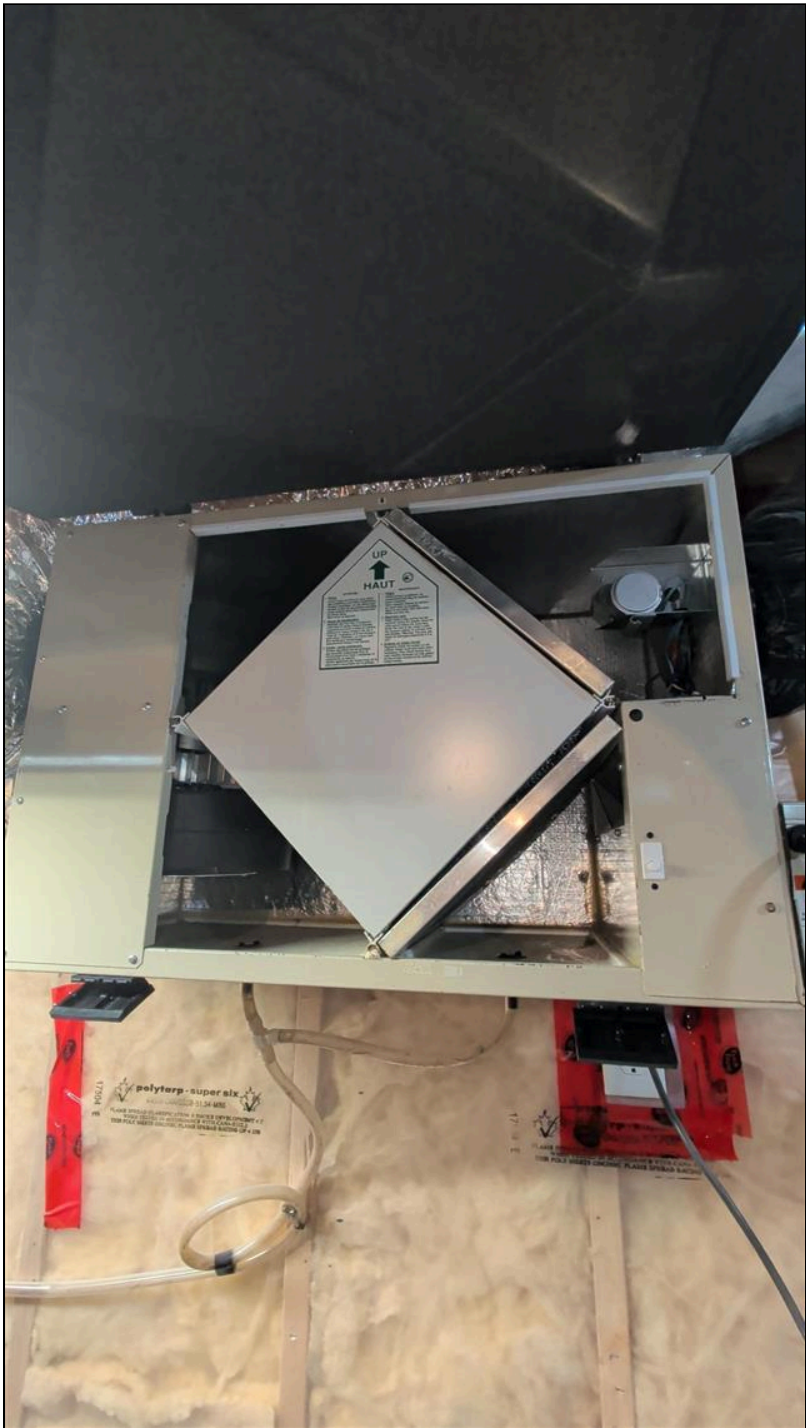
8.6 Item 1(Picture)

Newer homes are build so air tight that the don't "breath" like an older home would. Mechanical ventilation is now required. This system exhausts old air and intakes fresh air from outside. While the warm air is leaving the home, it exchanges the heat into the cold air coming in warming it up. This system also helps control the relative humidity in the home. There will be filters inside the unit that need regular cleaning.

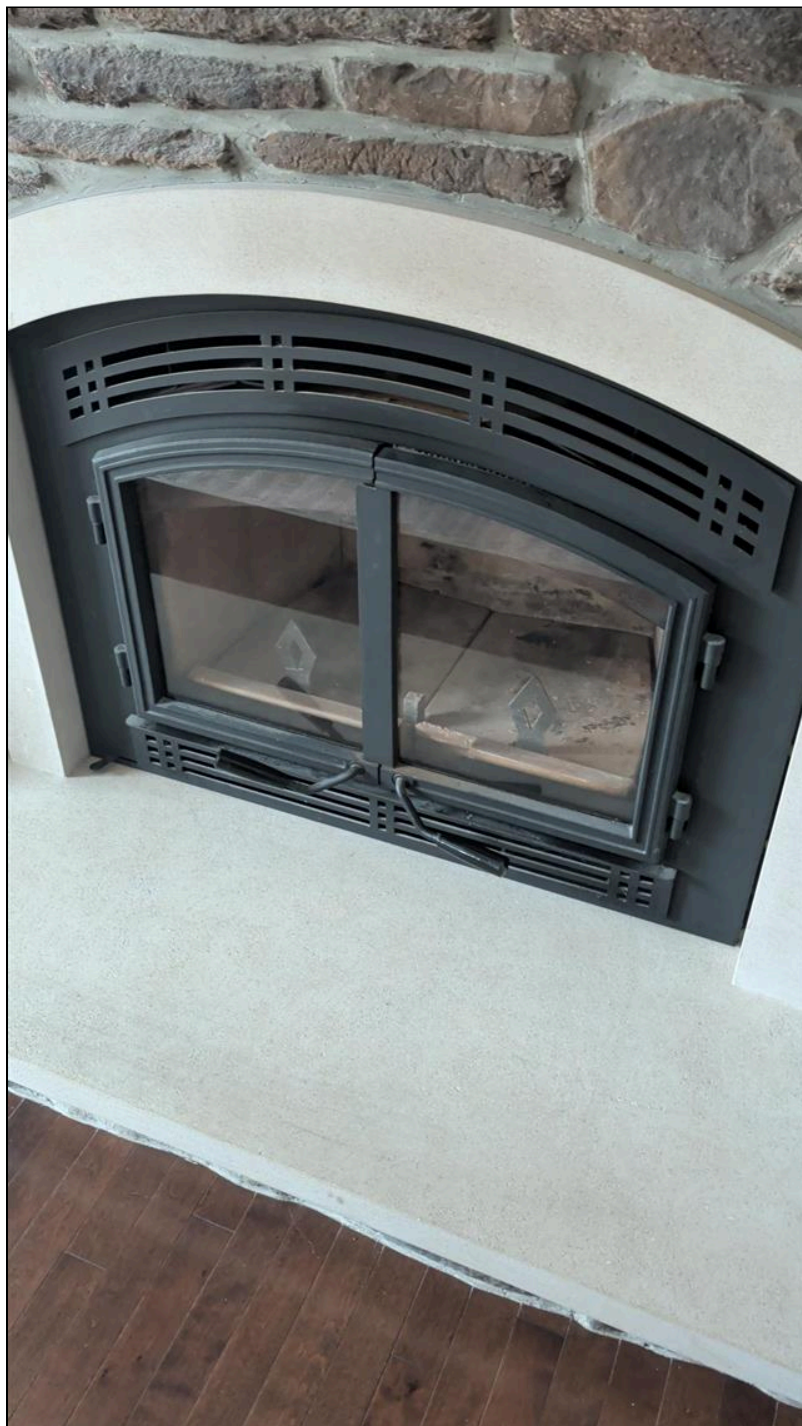
9.0 Item 1(Picture)

This wood burning fireplace will require a WETT inspection for insurance and to ensure its safe to use. I am certified to do this and can come back after getting possession to perform this inspection.

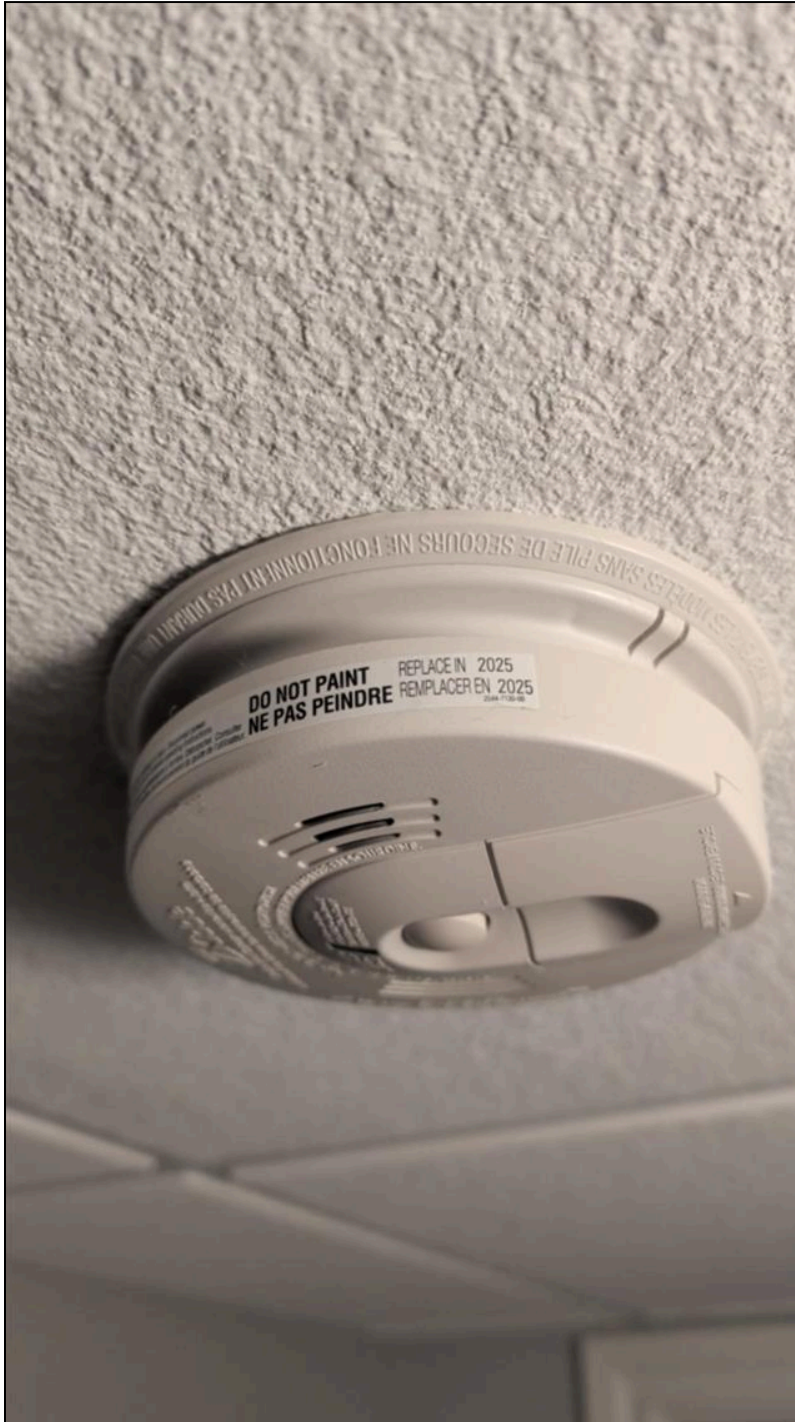
11.7 Item 1(Picture)

The smoke detectors in the home were older and need to be replaced. Replacement is required every 10 years. Hardwired smoke detectors should be replaced by a qualified electrical contractor.

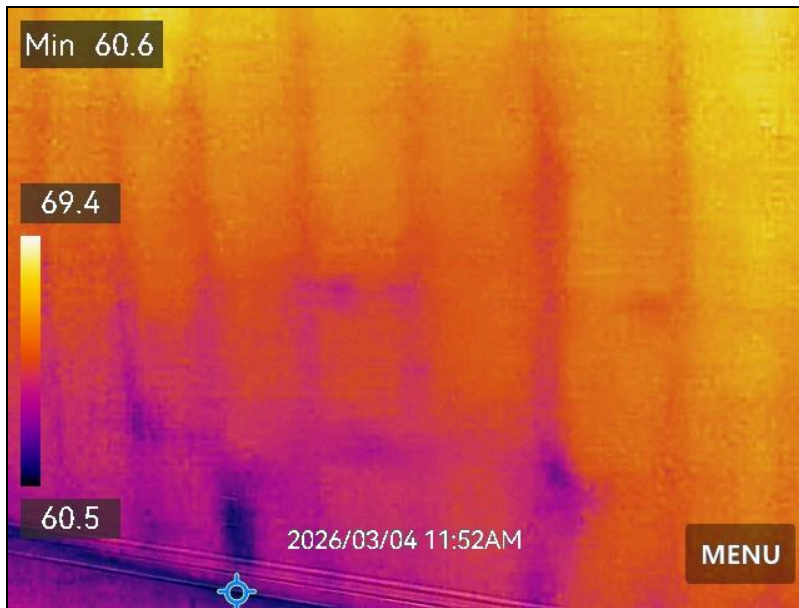
15.0 Item 1(Picture)

Thermal scanning of the finished basement walls showed no signs of moisture at the time of inspection.
