INSPECTION REPORT

3740 Oak Park Ct
Dubuque, IA 52002

04/09/2026

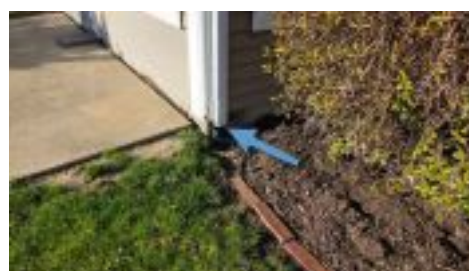
2.5.2 Roof Drainage System

DOWNSPOUT NOT CONNECTED TO TILING

Downspout pictured below not correctly aligned or connected with the underground tiling. This allows water to discharge directly against the foundation walls. This increases the ability for water to enter the basement level and cause damage. Recommend correctly attaching this to properly discharge water away from the home.

Recommendation

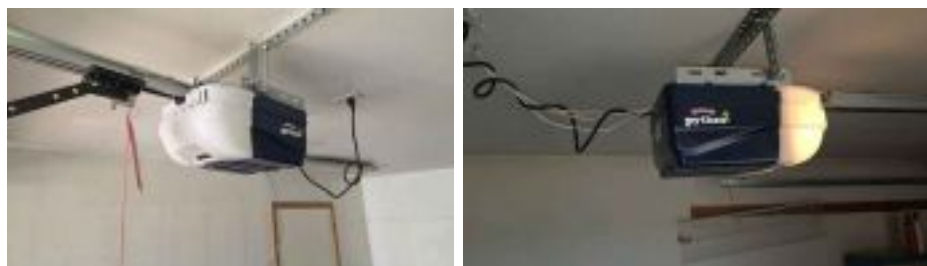
Garage Overhead Door: Photo Documentation

Garage Overhead Door: Panel(s), Cosmetic Damage

Panel(s) on the garage door had several areas that were dented or scratched. Currently this condition is considered cosmetic and does not affect their operation.

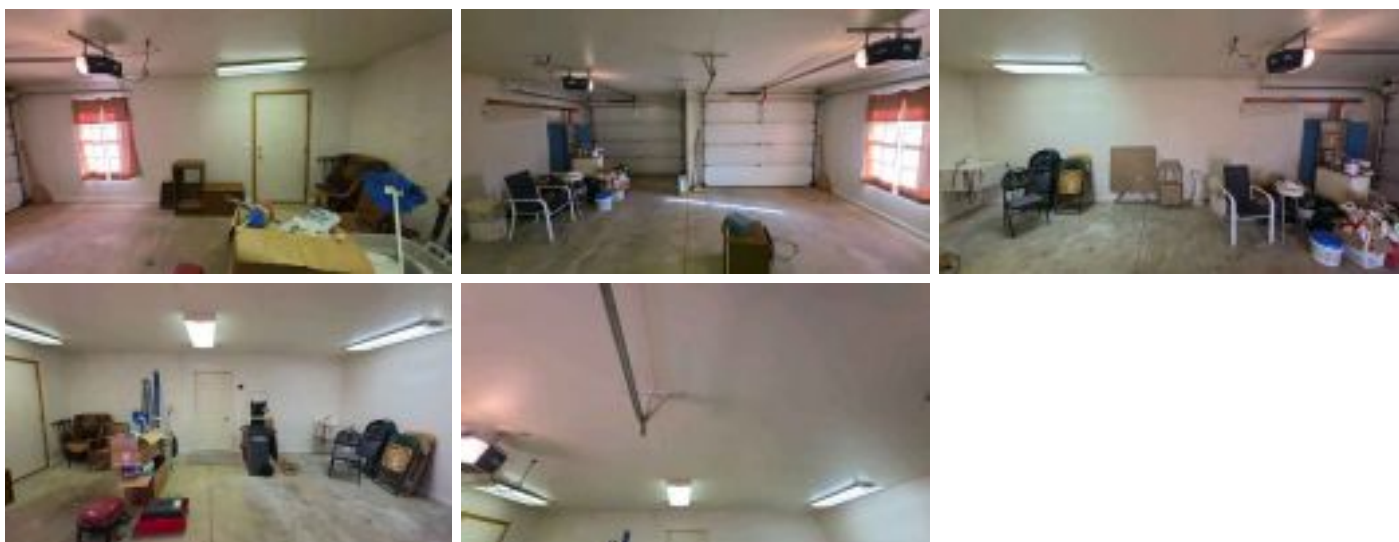
Garage Walls and Ceilings: Photo documentation

Garage Walls and Ceilings: Drywall, Common Joint Cracking

Common joint cracking was observed at the time of inspection. This is not a structural issue it is due to moving and settling of structure over time.

Garage walls and ceilings exhibited moderate damage to coverings and other surfaces. No significant damage was observed.

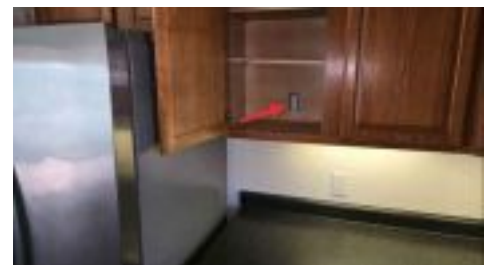
1st Floor Kitchen Cabinet Outlet

Several electrical outlets in the kitchen were found to be missing cover plates at the time of inspection. Exposed wiring at these locations poses a potential shock hazard, especially in a high-moisture environment like a kitchen where contact with water is more likely. Missing cover plates also leave wiring and connections vulnerable to physical damage and contamination from debris or cooking residue. Recommend installation of appropriate cover plates to restore safety and meet basic electrical safety standards.

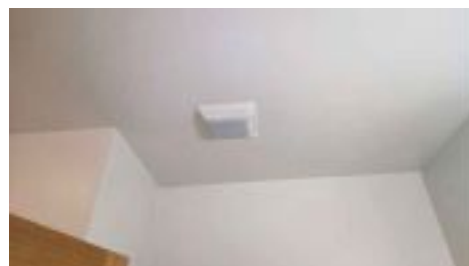
1st Floor Hall Bathroom Vent Light

The combination bathroom vent fan and light fixture was tested, and while the fan functioned as expected, the light did not operate. This may be due to a burned-out bulb; however, the possibility of a faulty switch, wiring issue, or problem within the fixture itself cannot be ruled out without further investigation. Recommend replacing the bulb first to determine if that resolves the issue. If the light remains non-functional, evaluation by a qualified electrician may be necessary to ensure safe operation and proper wiring.

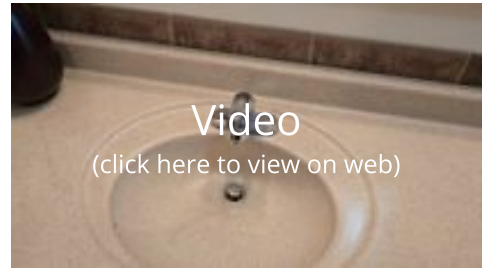
1ST FLOOR MASTER BATHROOM SINK

The bathroom sink faucet was observed to leak at the handle area when the valve is operated directly from the off position to either the hot or cold setting. When the handle is first moved to the middle position and then adjusted to hot or cold, the leaking does not occur. This behavior is commonly associated with internal valve or cartridge wear, deterioration of internal seals or O-rings, or improper alignment within the faucet assembly, which can allow water to escape during sudden pressure changes. While the faucet remains functional, this condition can worsen over time and may lead to continued water leakage, moisture damage within the cabinet, or increased water waste. Recommend repair or replacement of the faucet cartridge or internal components by a qualified plumber or handyman to prevent ongoing leakage and potential damage.

Recommendation

Contact a qualified professional.

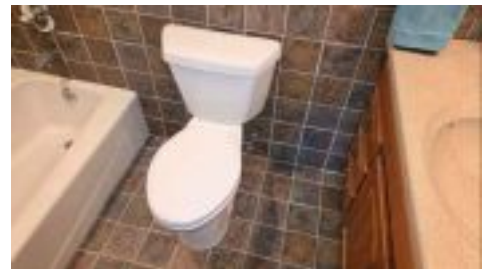
1st Floor Master Bathroom Toilet

BATHROOM TOILET, LOOSE CONNECTION TO FLOOR

The toilet was observed to be loose or wobbly when tested. A loose toilet can compromise the wax seal and lead to leaks. Recommend securing the toilet to the floor and inspecting the seal for damage.

Recommendation

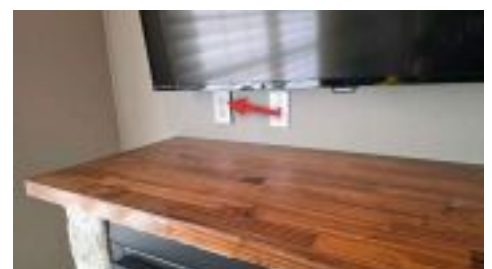
8.8.1 Interior Electrical

INTERIOR OUTLETS, LOOSE OR DAMAGED

Recommendation

Contact a qualified electrical contractor.

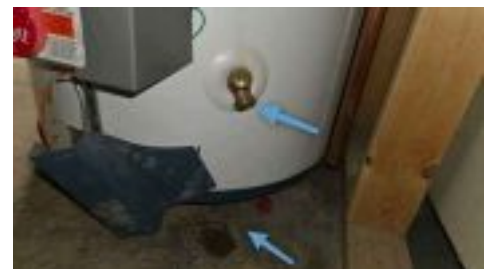
9.5.2 Water Heater

LEAKING OR MISSING DRAIN VALVE

Leaking

Recommendation

Contact a qualified plumbing contractor.

To Be corrected before close
