INSPECTION REPORT

2101 Wedgewood Drive
Dubuque IA 52002

04/30/2026

1: Inspection Details	5
2: Roof Systems	8
3: Exterior	12
4: Garage	16
5: Attic	20
6: Kitchen	21
7: Bathrooms	24
8: Interior	29
9: Plumbing	34
10: Structure	39
11: Electrical	41
12: HVAC	45
13: Radon In Iowa	50
14: Gold Shield Inspections Info	54
Standards of Practice	55

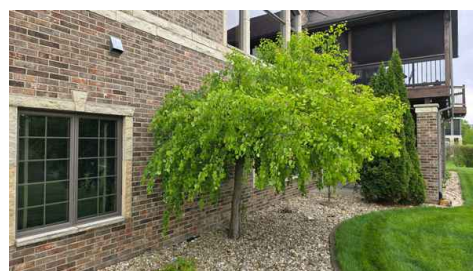
Bushes, plants, vegetation too close to home recommend at least 3 to 5 inches of clearance between home and vegetation as vegetation can promote moisture, and provide entry to wood destroying organisms to enter the home structure.

Contact a qualified professional.

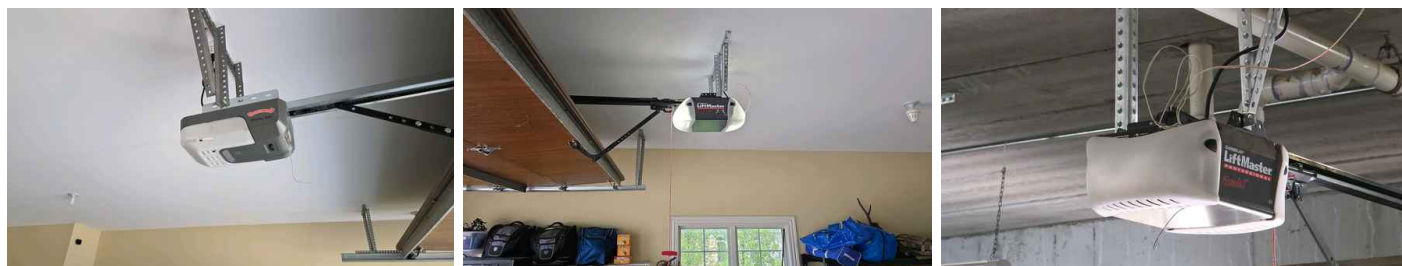
Garage Overhead Door: Photo Documentation

Garage Overhead Door: Panel(s), Cosmetic Damage

Panel(s) on the garage door had several areas that were dented or scratched. Currently this condition is considered cosmetic and does not affect their operation.

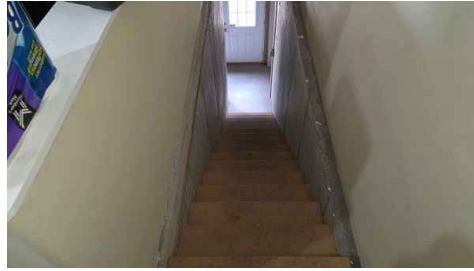
Handrail Height

4.10.1 Garage Stairs/Steps to Living Space

The steps leading to the door between the garage and the living space had no handrail installed. In order to comply with modern building practices which require a handrail at stairways with 4 or more risers, this stairway would need a handrail installed. The Inspector recommends that a handrail be installed by a qualified contractor that complies with modern building requirements.

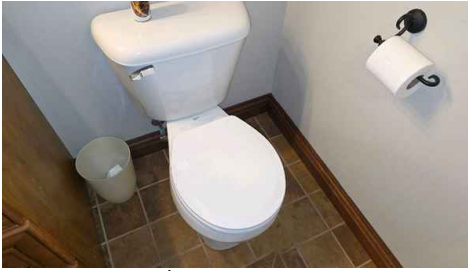
Basement Bathroom

7.5.1 Bathroom Toilet

Contact a qualified plumbing contractor.

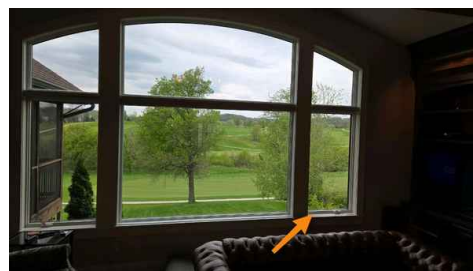
1st Floor Livingroom Right Window

INTERIOR WINDOW CASEMENT BINDING AT FRAME

The casement window was observed to bind at one corner during operation and required manual pressure to open initially. Once freed, the window operated more normally until closed, at which point the sticking condition repeated. This type of intermittent binding is commonly caused by minor frame misalignment, hardware wear, hinge distortion, or slight shifting of the window unit within the wall assembly. Continued operation in this condition can place additional stress on the window hardware and may lead to premature failure or further misalignment over time. Recommend adjustment and servicing of the window by a qualified professional to ensure smooth operation and prevent further wear on components.

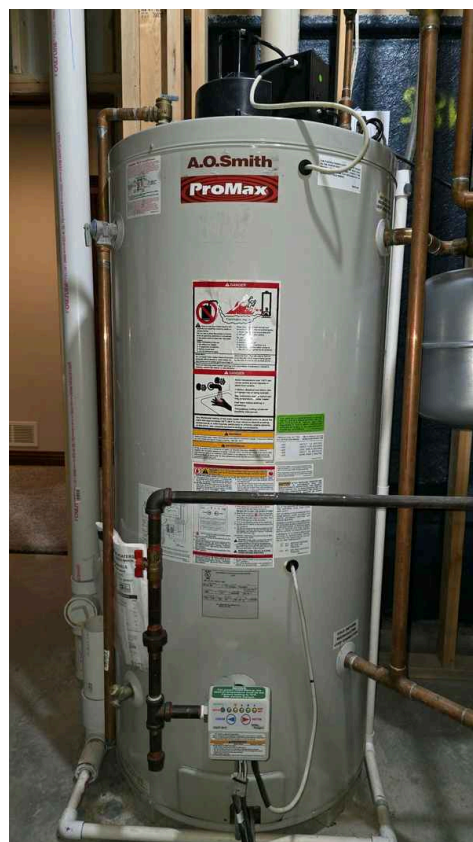
9.5.1 Water Heater

Contact a qualified plumbing contractor.

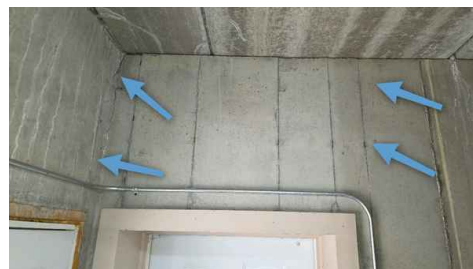
CONCRETE FOUNDATION, SMALL HAIRLINE CRACKS W/ NO WATER PENETRATION

Small hairline cracks are a common occurrence in concrete foundations and are typically caused by natural shrinkage during the curing process or minor settling over time. These cracks are generally superficial and do not pose a structural concern when there is no evidence of water penetration or widening over time. Regular monitoring of these cracks is recommended to ensure they do not grow larger or develop into a more significant issue. Sealing the cracks with an appropriate sealant can help prevent moisture intrusion and extend the life of the foundation.
