INSPECTION REPORT

2301 Helle Dr
Asbury, IA 52002

Dylan Hord
03/10/2026

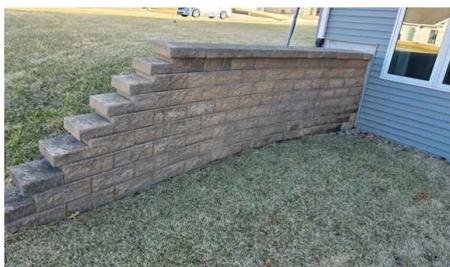
Retaining walls: Moderate retaining wall lean

Moderate retaining wall lean, this appears to have been caused by not using correct ties. These are designed to hold the wall back. Over time this will get worse and should be corrected.

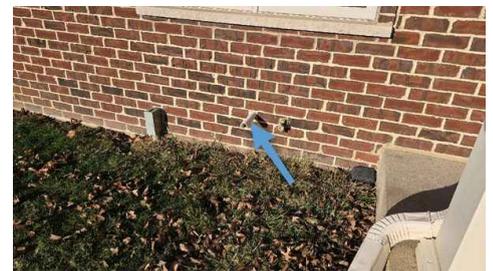
3.16.1 Sump pump

SUMP PUMP, DISCHARGE TO CLOSE TO FOUNDATION

Recommendation

Recommended DIY Project

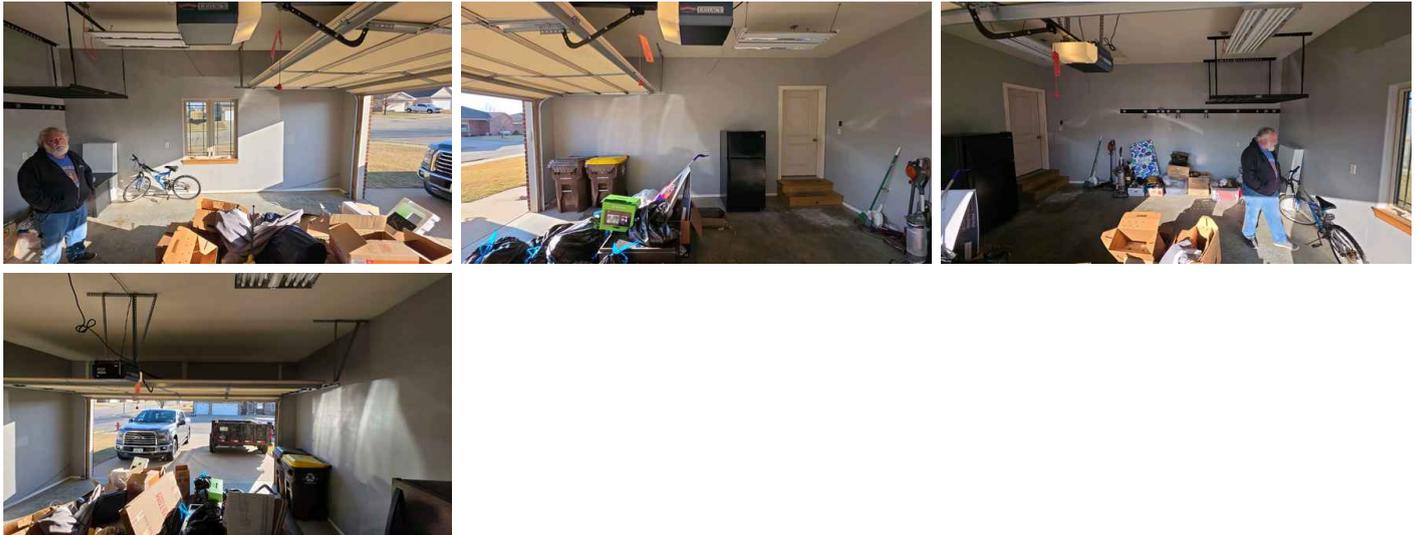
Garage Walls and Ceilings: Photo documentation

Garage Walls and Ceilings: Drywall, Common Joint Cracking

Common joint cracking was observed at the time of inspection. This is not a structural issue it is due to moving and settling of structure over time.

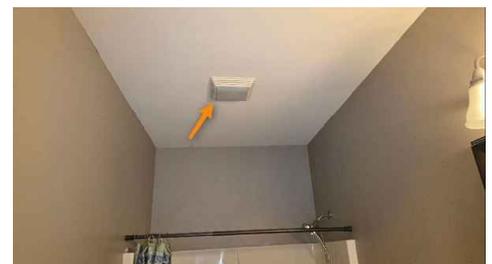
1st Floor Hall Bathroom Vent

BATHROOM VENTILATION, NON-FUNCTIONAL EXHAUST FAN

The exhaust fan was observed to be non-functional during the inspection. A non-operational fan cannot adequately remove moisture and odors from the bathroom. Recommend repair or replacement of the fan to restore proper ventilation.

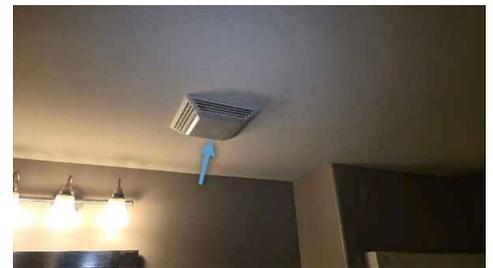
Basement Hall Bathroom Vent Light

**BATHROOM VENT FAN LIGHT
INOPERABLE**

The combination bathroom vent fan and light fixture was tested, and while the fan functioned as expected, the light did not operate. This may be due to a burned-out bulb; however, the possibility of a faulty switch, wiring issue, or problem within the fixture itself cannot be ruled out without further investigation. Recommend replacing the bulb first to determine if that resolves the issue. If the light remains non-functional, evaluation by a qualified electrician may be necessary to ensure safe operation and proper wiring.

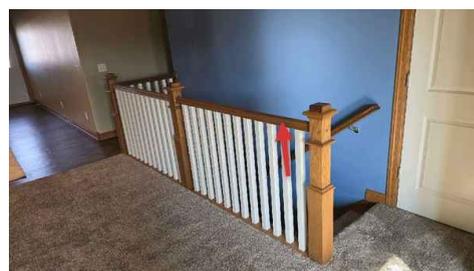
Loose

8.6.1 Interior Stairs

Recommendation

Contact a qualified general contractor.

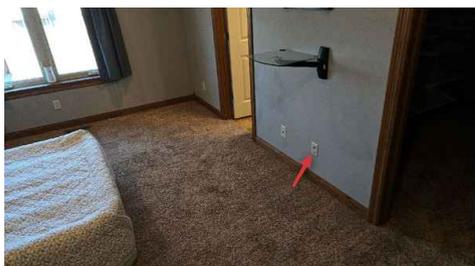
1st Floor Master Bedroom Outlet

**INTERIOR OUTLET SCORCHED**

An interior outlet was observed to have scorching or burn marks, indicating that it may have experienced overheating, arcing, or a short circuit. This condition presents a potential fire hazard and could compromise the safe operation of the outlet. Scorching is often caused by loose connections, overloaded circuits, or faulty wiring within or behind the outlet. It is strongly recommended that a licensed electrician evaluate the outlet and associated wiring promptly, and perform any necessary repairs or replacements to ensure safe operation and reduce the risk of electrical fire.

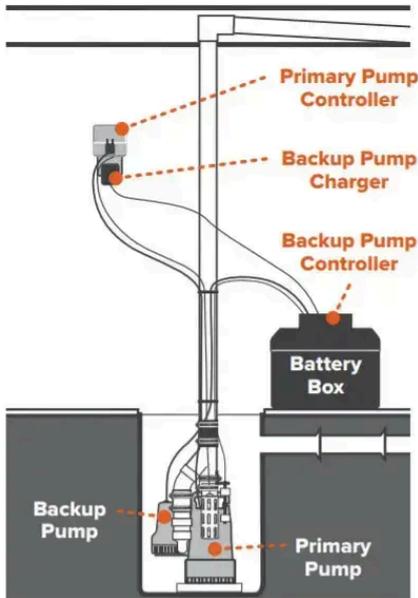
Sump Pump: Sump Pump System, No Battery or Backup System

The sump pump system lacked a battery or water-powered backup unit, leaving the property vulnerable to flooding during power outages or primary pump failure. Recommend installing a backup system to ensure continuous protection.

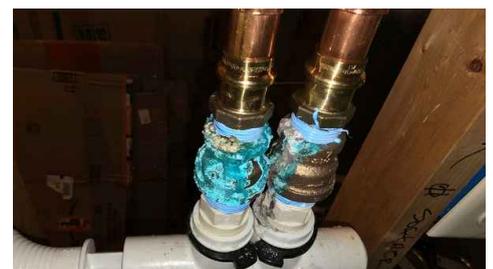
Back of water softener

9.2.1 Water Supply and Distribution

Contact a qualified plumbing contractor.

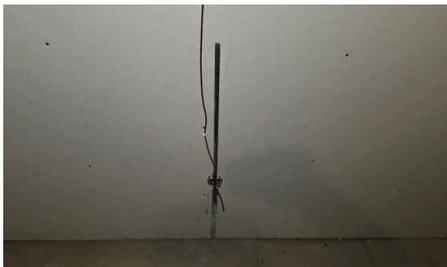
Service Grounding System : UFER electrode

The service was grounded to steel re-bar left protruding from the foundation for this purpose. This type of ground is called a "ufer" (YOO-fer) ground. This type of grounding electrode has length and continuity requirements which could not be confirmed at the time of the inspection due to the fact that the grounding electrode was encased in concrete. Evaluation of the effectiveness of the service ground would require the services of a qualified electrical contractor using special instruments.
