INSPECTION REPORT

1921 Avalon Rd
Dubuque, IA 52001

Roy Kosin
02/11/2026

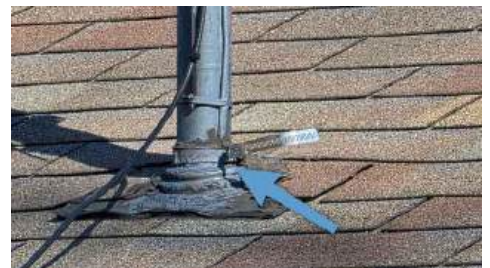
PENETRATION, RUBBER SEAL DETERIORATED

Contact a qualified roofing professional.

Seller to replace seal before closing.

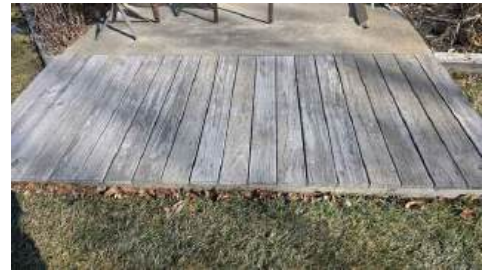
LIMITED INSPECTION, DUE TO BARRIER OR LOW CLEARANCE UNDER DECK

The deck inspection was limited due to a barrier or low clearance that restricted access to the attachment point to the home and the structure beneath the deck. As a result, the condition of the ledger board, support posts, beams, and other critical structural components could not be fully evaluated. Recommend removing obstructions or consulting a qualified contractor for a more thorough inspection to confirm the deck's stability and safety.

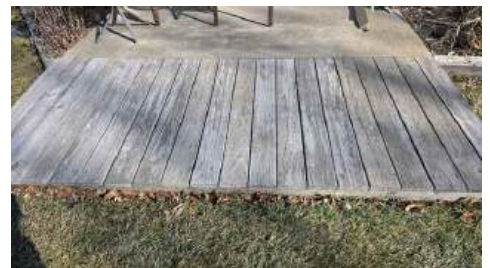
GENERAL, DECK WOODEN COMPONENTS NEEDING SEALANT

The wooden components of the deck, including the decking boards, railing, and structural supports, show signs of weathering, such as fading, discoloration, and minor surface cracking. These are indicative of the wood being exposed to the elements without adequate protection from a sealant.

Seller to seal wood on back deck before closing

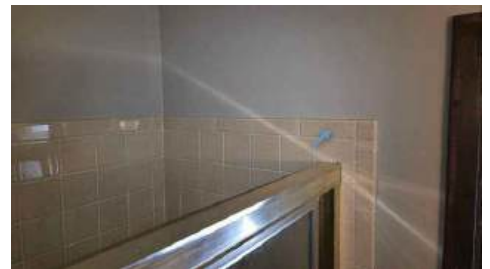
1st Floor Hall Bathroom Shower Enclosure Cracked

Recommendation

Contact a qualified professional.

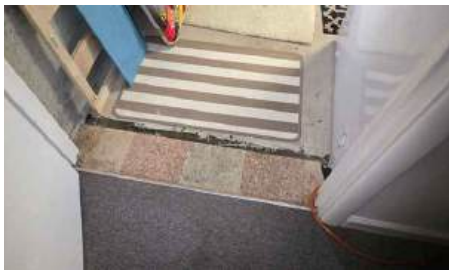
Interior Floors: Asbestos in pre-1980 tile flooring

The tile floor appeared to be older. 9x9 tile floors manufactured before 1980 may contain asbestos. Confirmation would require laboratory testing. Once the presence of asbestos was confirmed, you would be required to disclose its presence when you sell the home. Asbestos can be hazardous to human health if it is in a form in which asbestos fibers may be inhaled. Fibers may become airborne as a result of cutting, tearing, or abrading a material. Vinyl floors are best left in place. If another type of flooring is desired, it is often installed over the existing vinyl.

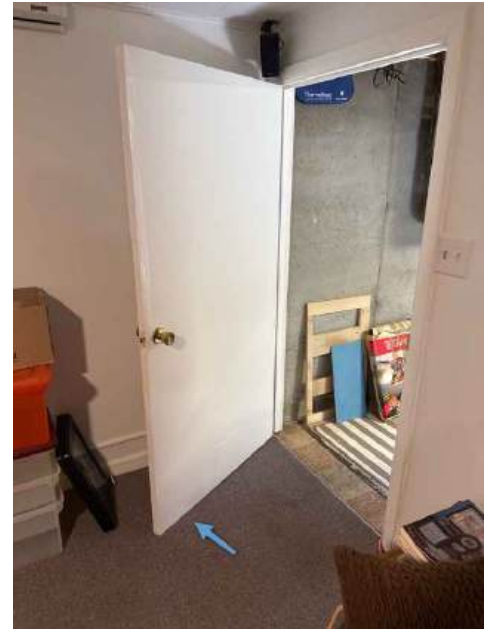
Basement Laundry Room Door Dragging On Carpet

Recommendation

Contact a qualified door repair/installation contractor.

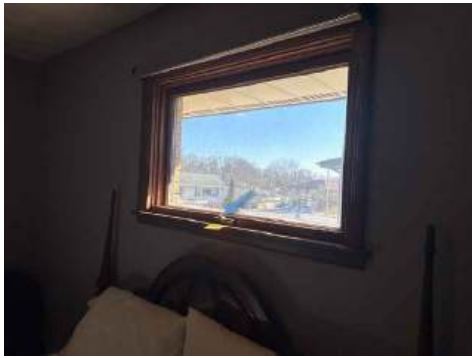
1st Floor Bedroom Window Unable To Test

Recommendation

Contact a qualified window repair/installation contractor.

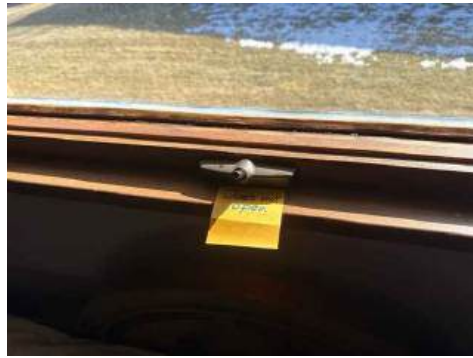
1st Floor Bedroom Window Unable To Test Close Up

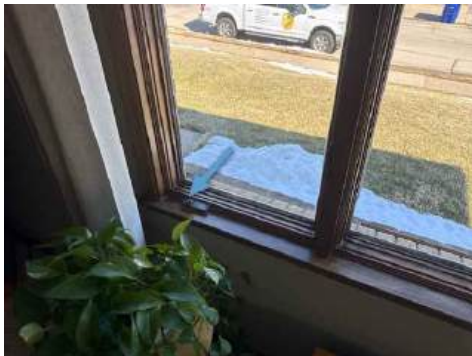
1st Floor Living Room Left Window Pane Missing Hand Crank

Recommendation

Contact a qualified window repair/installation contractor.

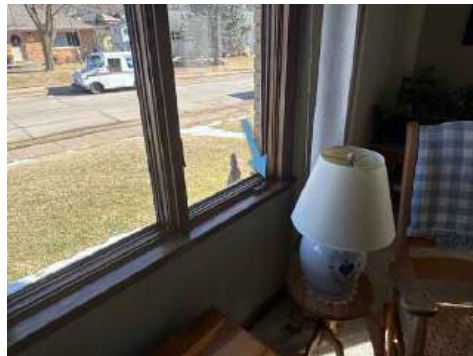
1st Floor Living Room Right Window Missing Hand Crank

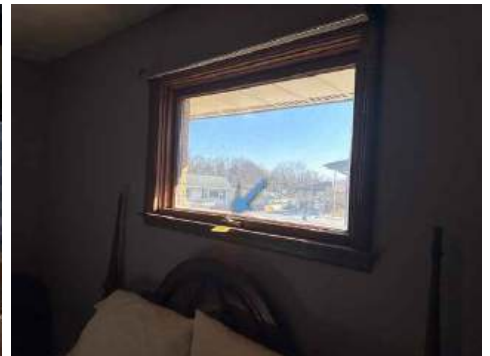
1st Floor Bedroom Window Missing Hand Crank

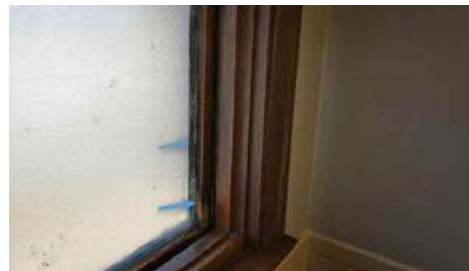
1st Floor Hall Bathroom Window

WOOD WINDOWS, ROTTING OR DETERIORATED WOOD FRAMES

Wood frames can rot due to prolonged exposure to moisture, often caused by poor drainage, leaks, or high humidity. Rot compromises structural integrity and can lead to pest infestations. Recommend repairing minor damage with wood epoxy or replacing the frame entirely for severe cases. Ensure proper sealing and painting to prevent future rot.

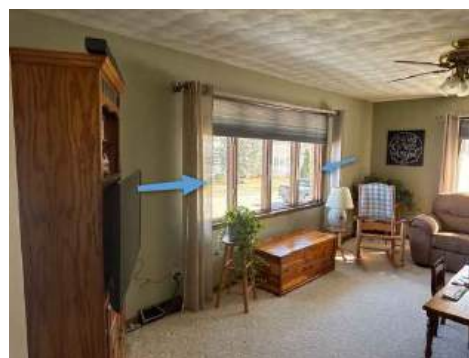
WOOD WINDOWS, PAINTED OR SEALED SHUT

Paint can unintentionally seal windows shut, limiting functionality and hindering emergency egress. This often occurs during renovations or maintenance. Recommend carefully removing excess paint with a utility knife or heat gun and restoring smooth operation.

1st Floor Living Room Window Painted Shut From Outside

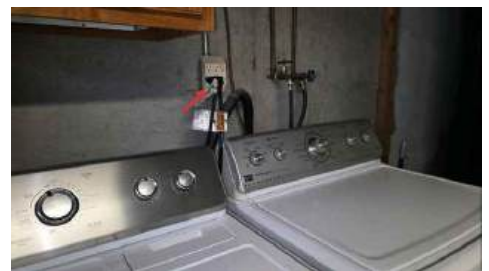
Basement Laundry Room

LAUNDRY ROOM, NO GFCI WASHER OUTLET

The laundry room outlets were not appropriate for the appliances. Missing GFCI protection for the washer. Recommend evaluation and correction by a licensed electrician.

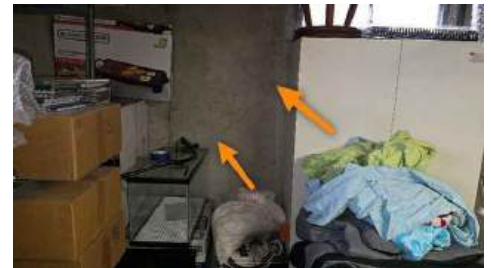
CONCRETE FOUNDATION, VERTICAL OR DIAGONAL CRACKING

Vertical or diagonal cracks were noted in the concrete foundation walls. These cracks may indicate settling, shifting, or soil movement under or around the foundation. While minor cracks may not pose immediate concerns, monitoring their progression is important. If cracks widen or show signs of active movement, evaluation by a foundation contractor is recommended. Repairs may involve sealing, reinforcement, or addressing underlying soil issues.

Recommendation

Contact a foundation contractor.

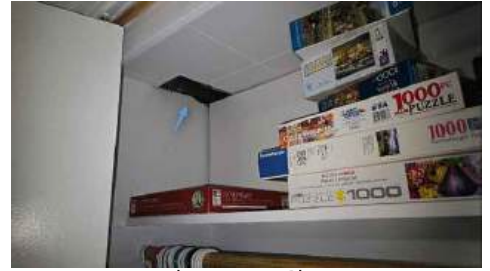
Basement Bedroom In Closet

An HVAC vent register is currently missing its cover, leaving the duct opening exposed. This condition can lead to debris and small objects falling into the ductwork, potentially impacting airflow efficiency and indoor air quality. It also presents a minor safety hazard, particularly in homes with children or pets, and can contribute to inconsistent temperature control in the space. Recommend installation of an appropriately sized vent cover to ensure proper airflow distribution, maintain cleanliness of the system, and improve overall occupant safety and comfort.
