INSPECTION REPORT

1440 Mt Pleasant St
Dubuque, IA 52001

Single Family (2 story)

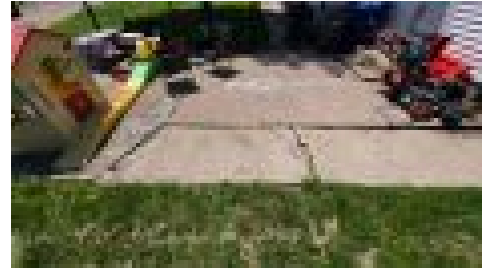
3.14.1 Patio

CONCRETE PATIO, SETTLING OR UNEVEN SURFACES

Contact a qualified concrete contractor.

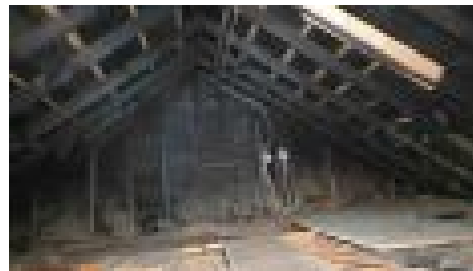
4.3.1 Roof Framing (from attic)

ROOF STRUCTURE, PREVIOUS FIRE DAMAGE

Evidence of previous fire damage was observed on wooden roof structural components. At the time of inspection, no significant structural movement, failure, or conditions requiring immediate repair were observed in the accessible areas inspected. The affected components appear to have been previously damaged and remain in generally serviceable condition. Recommend continued monitoring for any future movement, deterioration, or changes in the condition of the affected framing components over time.

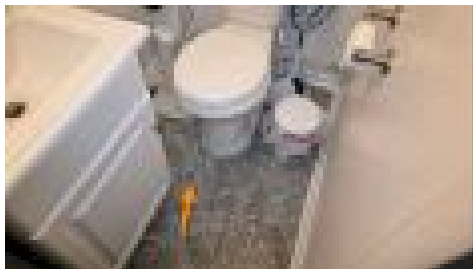
7.3.2 Interior Floors

1st Floor Hall Bathroom By Toilet The Floor Sinks In

Contact a qualified professional.

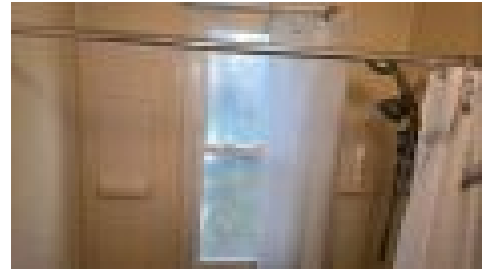
7.7.1 Interior Windows

GENERAL WINDOW, EXCESSIVE WEAR ON BALANCES OR SPRINGS

2nd Floor Hall Bathroom Window Will Just Drop

Contact a qualified window repair/installation contractor.

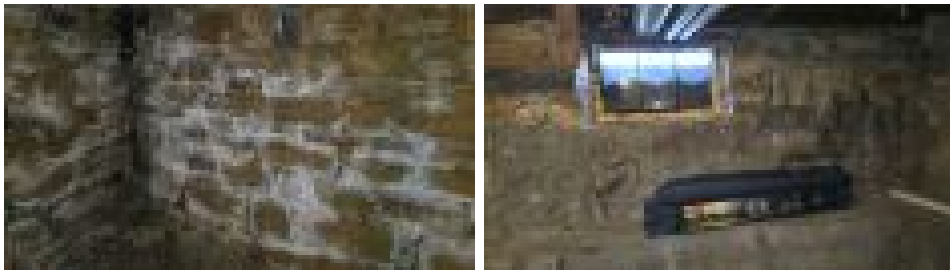
9.4.1 Foundation

HIGH MOISTURE BASEMENT, VENTILATION

Contact a qualified waterproofing contractor
