## INSPECTION REPORT

490 Alpine St  
Dubuque, IA 52001

05/28/2026

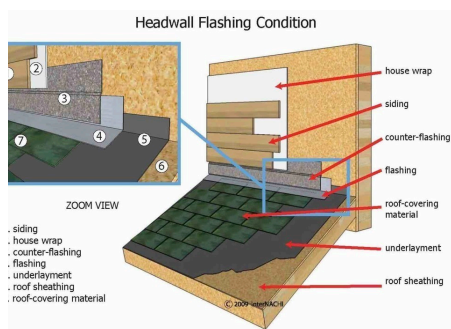
### Roof Flashing: Wall Intersections

I looked for flashing where the roof covering meets a wall or siding material. There should be step and counter flashing installed in these locations. This is not an exhaustive inspection of all flashing areas.

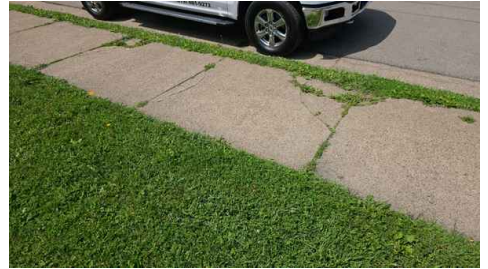
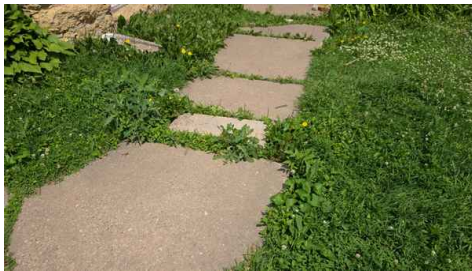
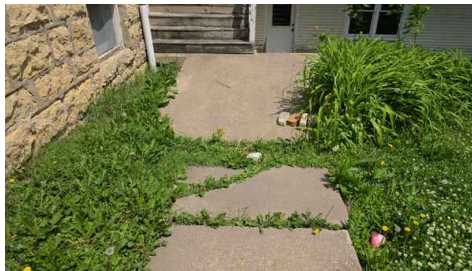
-   2.5.1 Roof Systems - Roof Drainage System: Drainage System Health
-   3.3.1 Exterior - Walkways: Sidewalk, Uneven or Sunken Sections
-   3.4.1 Exterior - Exterior Doors: Exterior, Exterior Door, Missing Landing and Safety Protection

Contact a qualified concrete contractor.

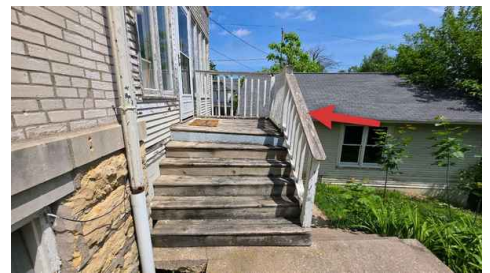
### 3.6.2 Exterior Stairs

#### **GENERAL STAIRS, POORLY ATTACHED HANDRAIL**

Contact a qualified general contractor.

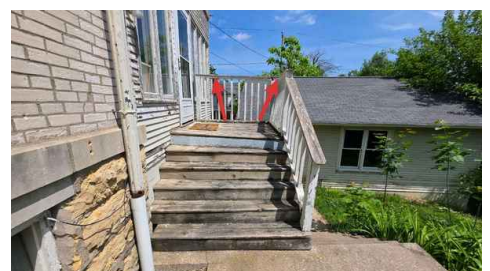
### 3.9.1 Deck, Balcony, Bridge and Porch

#### **GUARDRAIL, LOOSE OR WOBBLY**

Guardrails that shift or feel unstable when force is applied may not adequately prevent falls. This could be due to improperly secured posts, loose fasteners, or undersized hardware.

Contact a qualified deck contractor.

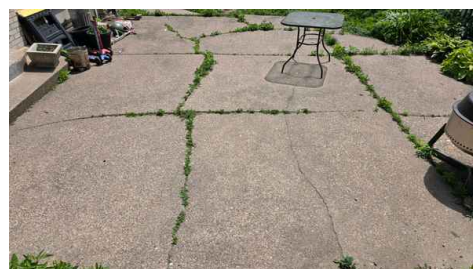
### CONCRETE PATIO, SETTLING OR UNEVEN SURFACES

Uneven or sunken areas of the patio are often caused by poor soil compaction or erosion beneath the slab. These surfaces create tripping hazards and can lead to drainage problems. Mudjacking, slab leveling, or replacement may be necessary to address the issue.

Contact a qualified concrete contractor.

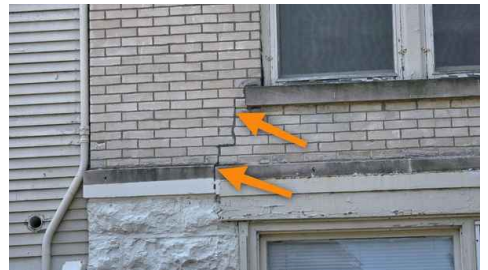
3.16.1 Brick exterior

**BRICK WALL, STEP CRACKING**

Contact a qualified masonry professional.

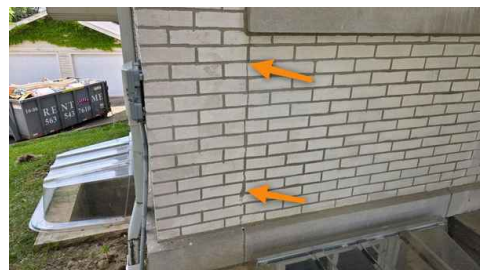
3.16.2 Brick exterior

**BRICK WALL, VERTICAL CRACKING**

Contact a qualified masonry professional.

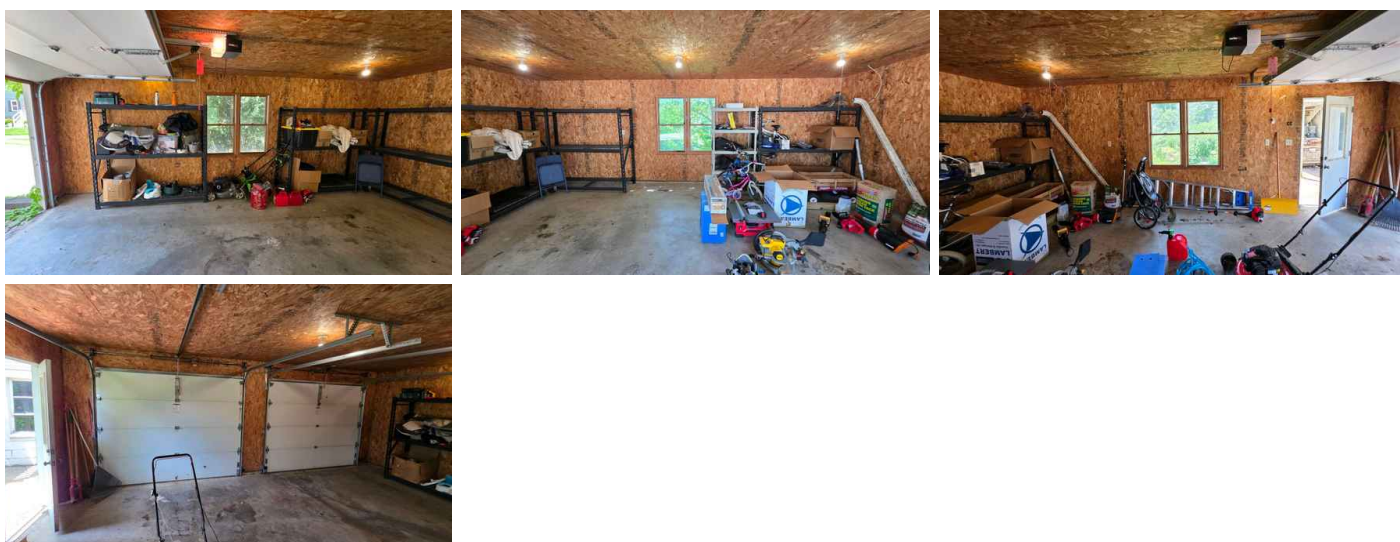
## Garage Walls and Ceilings: Walls and Ceilings, Moderate Damage

Garage walls and ceilings exhibited moderate damage to coverings and other surfaces. No significant damage was observed.

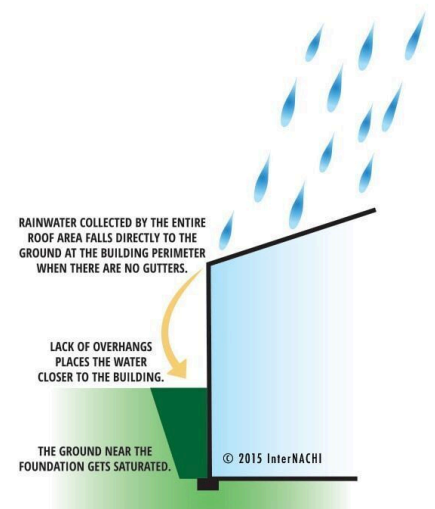
### 4.11.1 Garage Roof Drainage System

Downspout not installed

Contact a qualified gutter contractor

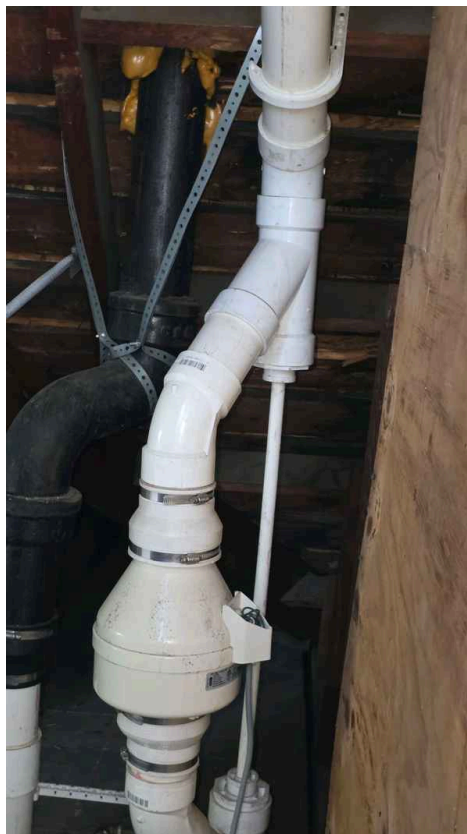
1. INSTALL THE VENT FAN IN THE VERTICAL RUN OF THE VENT PIPE. THE SIZE AND AIR-MOVEMENT CAPACITY OF THE VENT FAN SHALL BE SUFFICIENT TO CREATE AND MAINTAIN A PRESSURE FIELD BENEATH THE SLAB OR CRAWLSPACE MEMBRANE THAT IS LOWER THAN THE PRESSURE ABOVE THE SLAB OR MEMBRANE.
2. ALL POSITIVELY PRESSURED PORTIONS OF THE VENT PIPE AND FAN SHALL BE LOCATED OUTSIDE THE HABITABLE SPACE OF THE BUILDING.
3. PROVIDE A VISIBLE OR AUDIBLE WARNING SYSTEM TO ALERT BUILDING OCCUPANTS IF THERE IS A LOSS OF PRESSURE OR AIR FLOW IN THE VENT PIPE.

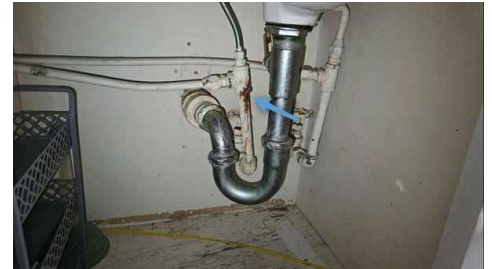
1st Floor Hall Bathroom Right Sink  
Corrosion On Supply

Contact a qualified plumbing contractor.

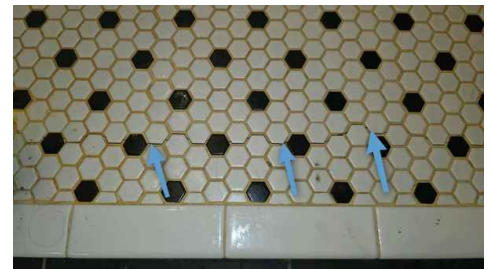
**BATHROOM TUB/SHOWER, MISSING OR DETERIORATED GROUT OR CAULKING**

Grout or caulking around tiles, tub edges, or shower joints was cracked, missing, or deteriorated. This can allow water to seep into surrounding materials, causing damage. Recommend removing old grout or caulking and applying fresh, waterproof material.

Recommended DIY Project

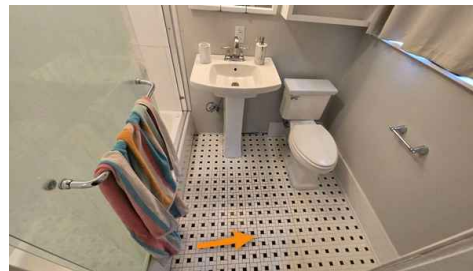
2nd Floor Master Bathroom Floor Dips Here

Contact a qualified professional.

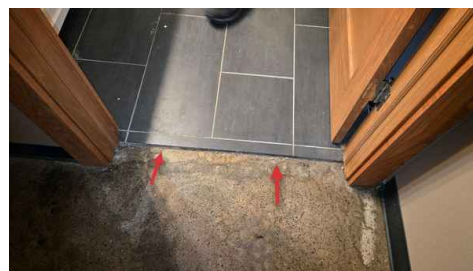
Basement Bathroom

**BATHROOM FLOOR, IMPROPER OR MISSING TRANSITION STRIPS**

The transition strip between the bathroom floor and adjacent rooms was missing or improperly installed. This creates a tripping hazard and may expose edges to damage. Recommend installing or replacing transition strips for a safer and finished appearance.

Contact a qualified flooring contractor

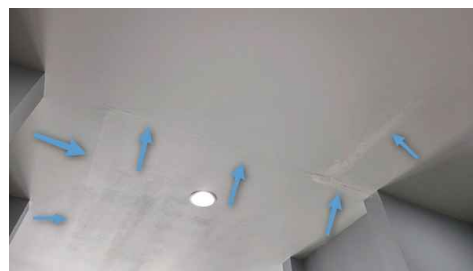
1st Floor Hall

**GYPSUM BOARD CEILING, CRACKS**

Cracks were observed in the drywall, potentially caused by settlement, structural movement, or temperature fluctuations. Recommend sealing minor cracks with appropriate materials.

Contact a qualified professional.

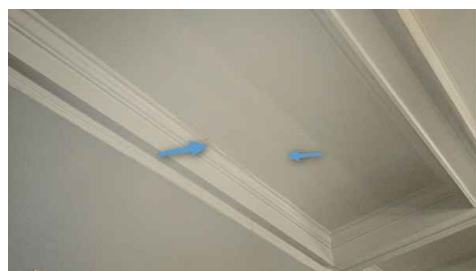
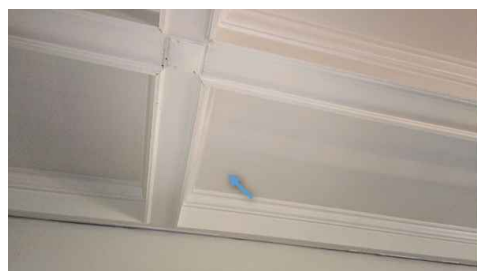
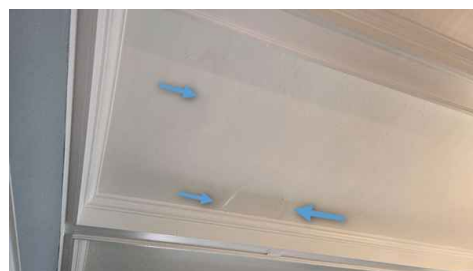
**PLASTER CEILING, WATER DAMAGE OR STAINING (PREVIOUS DAMAGE)**

Evidence of water damage or staining was noted on the plaster ceiling, indicating a possible leak or moisture intrusion. Moisture meter showed no elevated moisture at the time of the inspection. Recommend repairing or replacing the affected plaster to prevent further deterioration.

Contact a qualified general contractor.

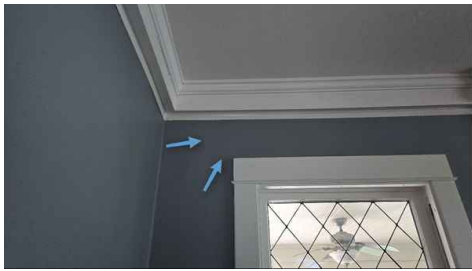
1st Floor Livingroom

**GYPSUM BOARD WALL, CRACKS**

Cracks were observed in the drywall, potentially caused by settlement, structural movement, or temperature fluctuations. Recommend sealing minor cracks with appropriate materials.

Contact a qualified professional.

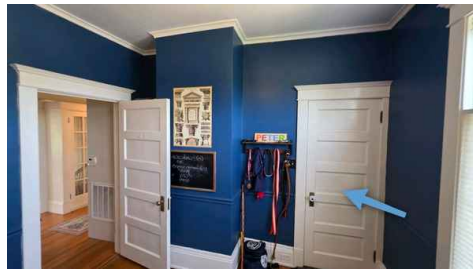
2nd Floor Bedroom

The door stuck or bound against the frame or floor when opened or closed, likely due to misalignment or swelling. Recommend planing or adjusting the door and inspecting the frame for issues.

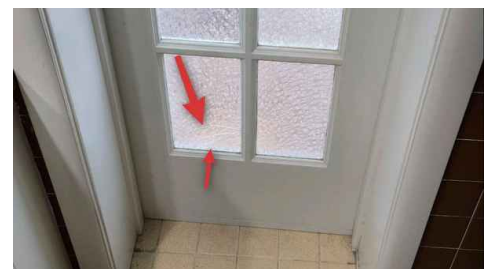
2nd Floor Hall Bathroom Door

## 8.5.2 Interior Doors

Contact a qualified professional.

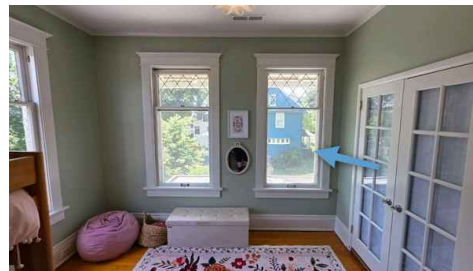
2nd Floor Bedroom

## 8.7.1 Interior Windows

Contact a qualified window repair/installation contractor.

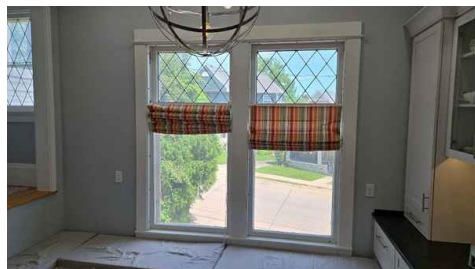
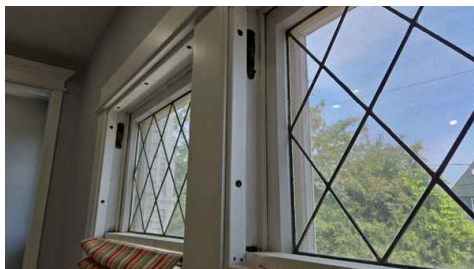
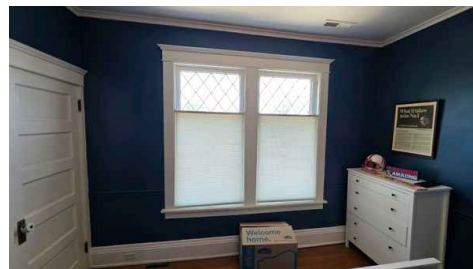
## 8.7.2 Interior Windows

1st Floor Hall Both Windows Missing Balances

Contact a qualified window repair/installation contractor.

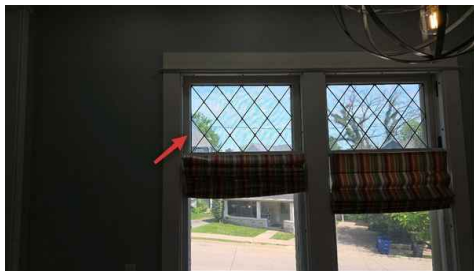
## 8.7.3 Interior Windows

1st Floor Hall Window

Contact a qualified window repair/installation contractor.

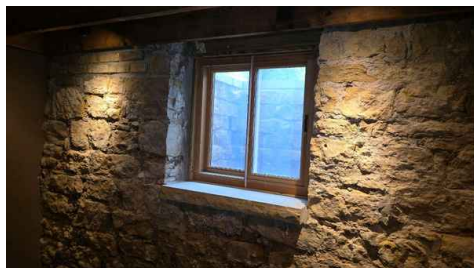
Basement Livingroom Back Right Window

8.7.4 Interior Windows

Contact a qualified professional.

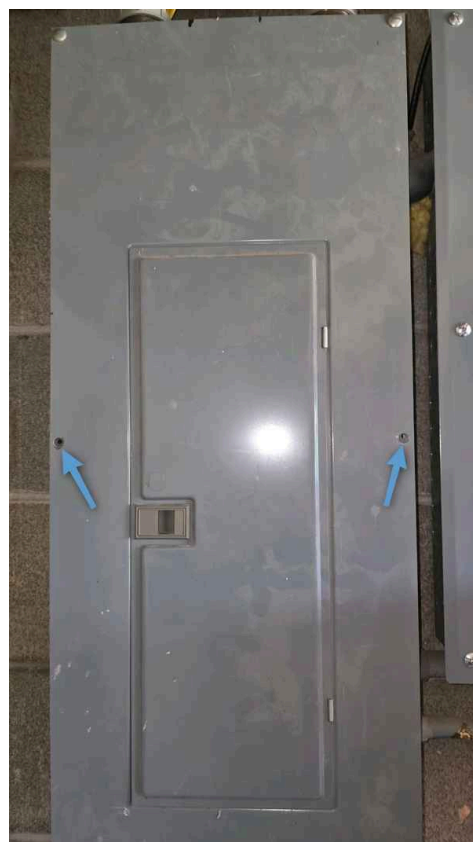
### ELECTRICAL PANEL, MISSING SCREWS

The electrical panel was found to be missing dead front cover screws. These attach the panel cover to ensure no direct contact with internal wiring.

Contact a qualified electrical contractor.
