INSPECTION REPORT

2301 Helle Dr
Asbury, IA 52002

Dylan Hord
03/10/2026

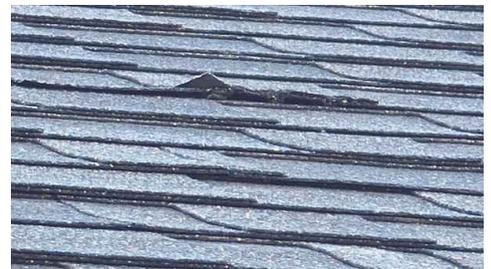
Multiple

ASPHALT SHINGLES, MISSING OR DAMAGED SHINGLES

Recommendation

Contact a qualified roofing professional.

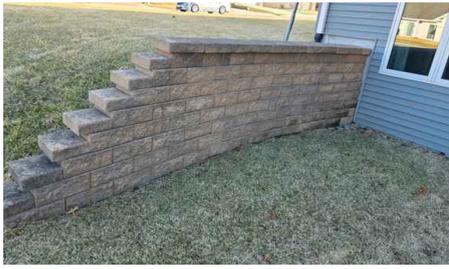
Retaining walls: Moderate retaining wall lean

Moderate retaining wall lean, this appears to have been caused by not using correct ties. These are designed to hold the wall back. Over time this will get worse and should be corrected.

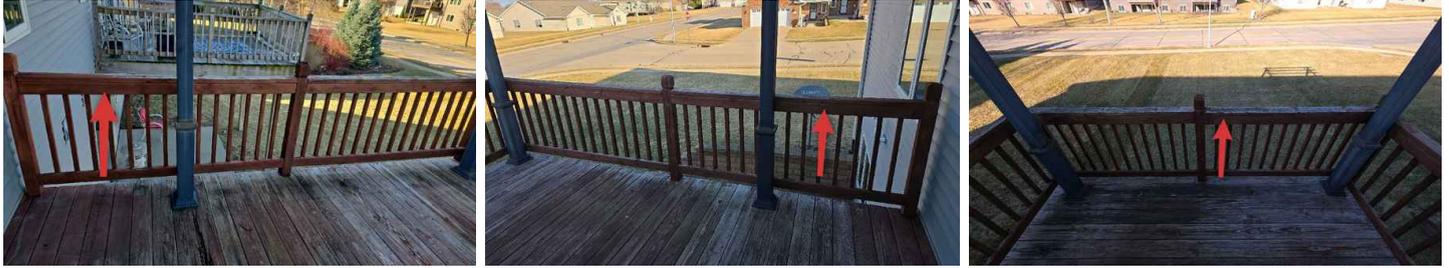
3.8.3 Deck, Balcony, Bridge and Porch,

DECKING, ROT OR DECAY

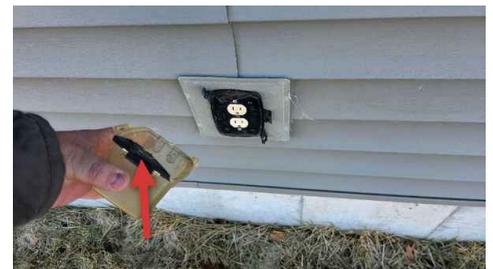
Broken attachment point

I observed exterior electrical receptacles that are not equipped with proper weather-resistant covers. Exterior outlets are exposed to rain, snow, and moisture, and without appropriate weather protection, water can enter the receptacle and electrical box. This condition can lead to corrosion, intermittent operation, increased risk of electrical shock, or potential damage to connected devices. This issue is commonly caused by missing, damaged, or outdated covers that are not designed for exterior use. Recommend installing proper weather-rated, in-use covers to protect the receptacles from moisture exposure and to improve overall safety and durability of the electrical system.

Recommendation

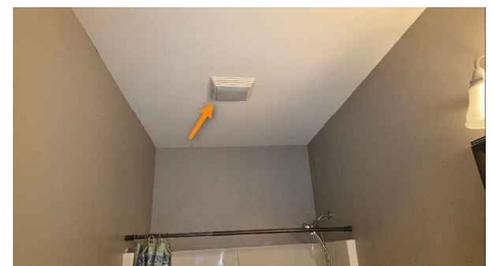
1st Floor Hall Bathroom Vent

The exhaust fan cover was dirty or clogged with dust, restricting airflow and reducing the fan's efficiency. Recommend cleaning the vent cover and inspecting the fan for further maintenance needs.

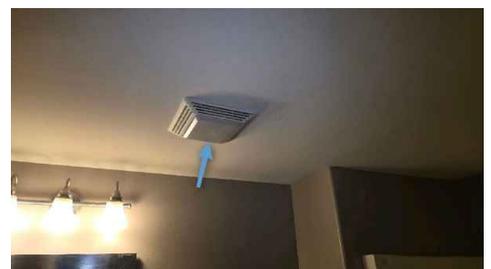
Basement Hall Bathroom Vent Light

**BATHROOM VENT FAN LIGHT
INOPERABLE**

The combination bathroom vent fan and light fixture was tested, and while the fan functioned as expected, the light did not operate. This may be due to a burned-out bulb; however, the possibility of a faulty switch, wiring issue, or problem within the fixture itself cannot be ruled out without further investigation. Recommend replacing the bulb first to determine if that resolves the issue. If the light remains non-functional, evaluation by a qualified electrician may be necessary to ensure safe operation and proper wiring.

**Seller will repair
prior to close.**

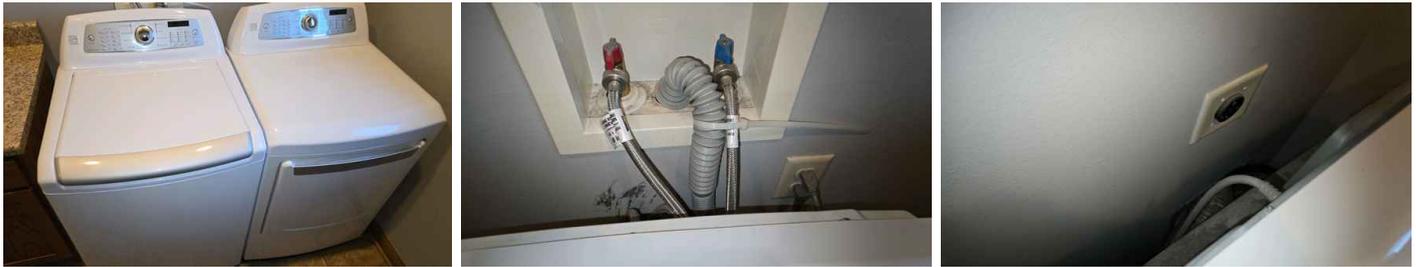
Laundry Room: Washer/Dryer Hook-up Photo

Washer and dryer hookups location.

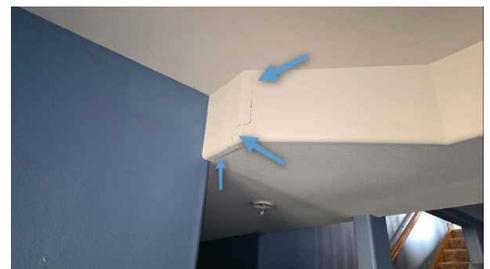
Basement Livingroom

8.4.2 Interior Ceilings and Walls

Recommendation

Contact a qualified drywall contractor.

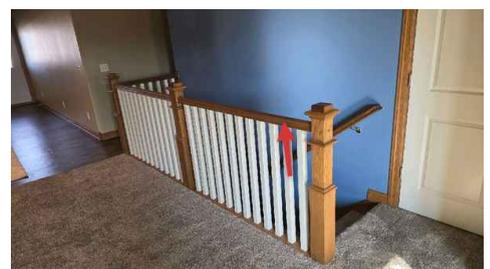
Loose

8.6.1 Interior Stairs

Recommendation

Contact a qualified general contractor.

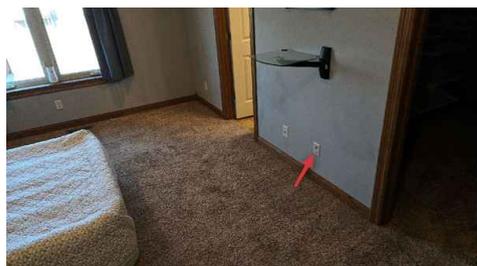
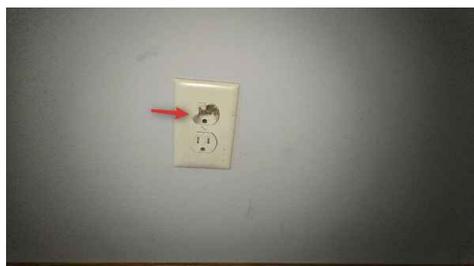
1st Floor Master Bedroom Outlet

INTERIOR OUTLET SCORCHED

An interior outlet was observed to have scorching or burn marks, indicating that it may have experienced overheating, arcing, or a short circuit. This condition presents a potential fire hazard and could compromise the safe operation of the outlet. Scorching is often caused by loose connections, overloaded circuits, or faulty wiring within or behind the outlet. It is strongly recommended that a licensed electrician evaluate the outlet and associated wiring promptly, and perform any necessary repairs or replacements to ensure safe operation and reduce the risk of electrical fire.

Seller will repair prior to close.

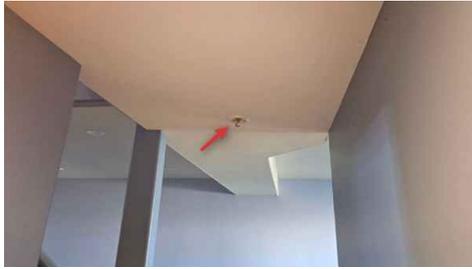
Basement Hall

The Inspector recommends installing a smoke detector to provide improved fire protection for common areas. Generally-accepted current safety standards recommend smoke detectors be installed in the following locations:

Seller will install prior to close.

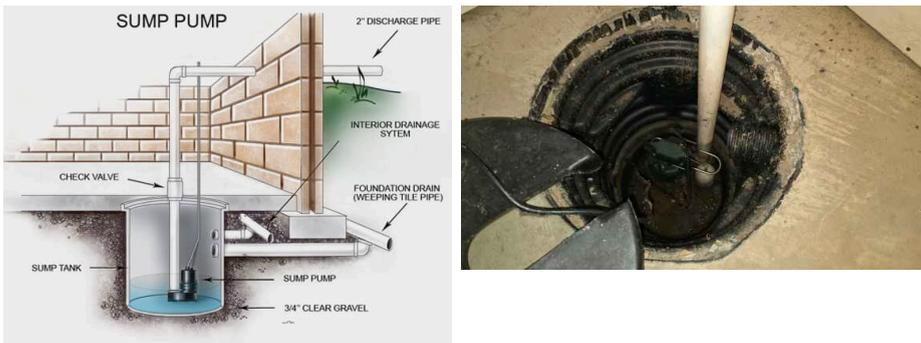
Sump Pump: Sump Pump System, No Battery or Backup System

The sump pump system lacked a battery or water-powered backup unit, leaving the property vulnerable to flooding during power outages or primary pump failure. Recommend installing a backup system to ensure continuous protection.

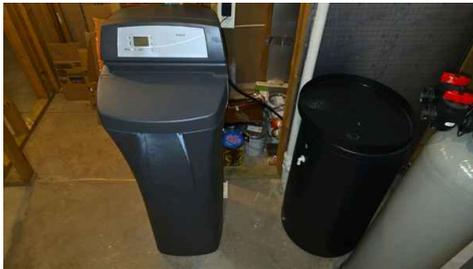
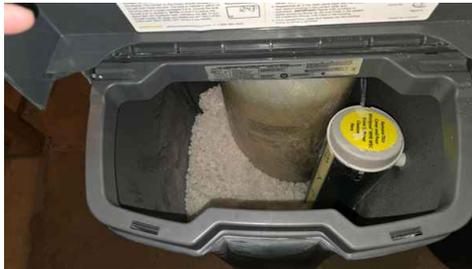
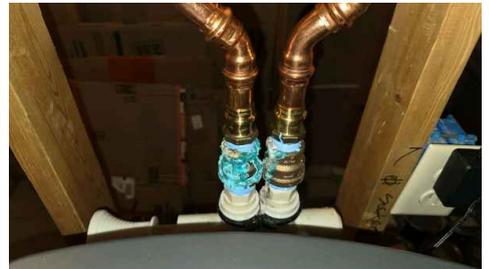
The water softener was not inspected as its evaluation falls outside the scope of our inspection and the InterNACHI Standards of Practice. Functionality, maintenance status, and overall condition of the unit were not assessed. Recommend consulting a qualified water treatment specialist for a full evaluation of the water softener system.

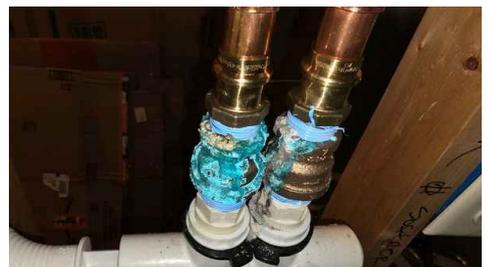
Back of water softener

9.2.1 Water Supply and Distribution

Recommendation

Contact a qualified plumbing contractor.

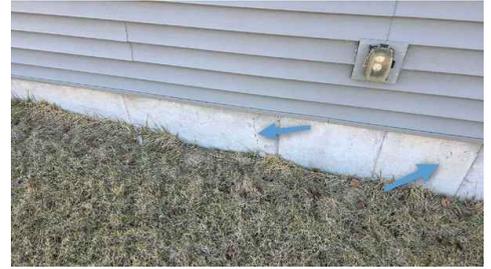
CONCRETE FOUNDATION, SMALL HAIRLINE CRACKS W/ NO WATER PENETRATION

Small hairline cracks are a common occurrence in concrete foundations and are typically caused by natural shrinkage during the curing process or minor settling over time. These cracks are generally superficial and do not pose a structural concern when there is no evidence of water penetration or widening over time. Regular monitoring of these cracks is recommended to ensure they do not grow larger or develop into a more significant issue. Sealing the cracks with an appropriate sealant can help prevent moisture intrusion and extend the life of the foundation.

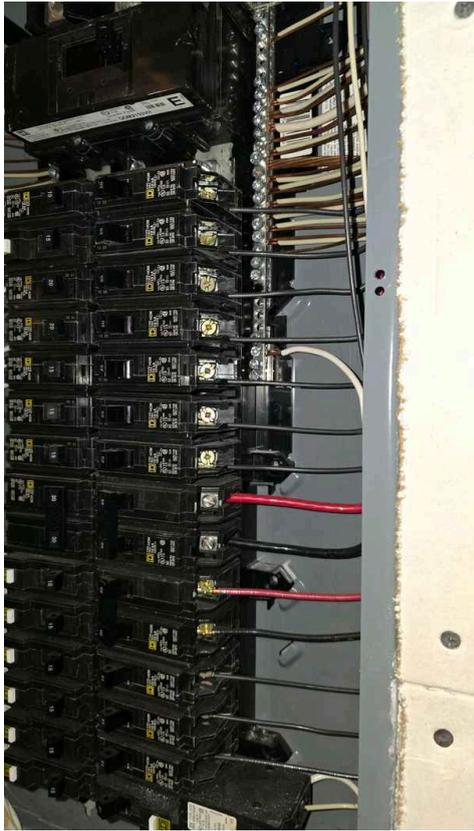
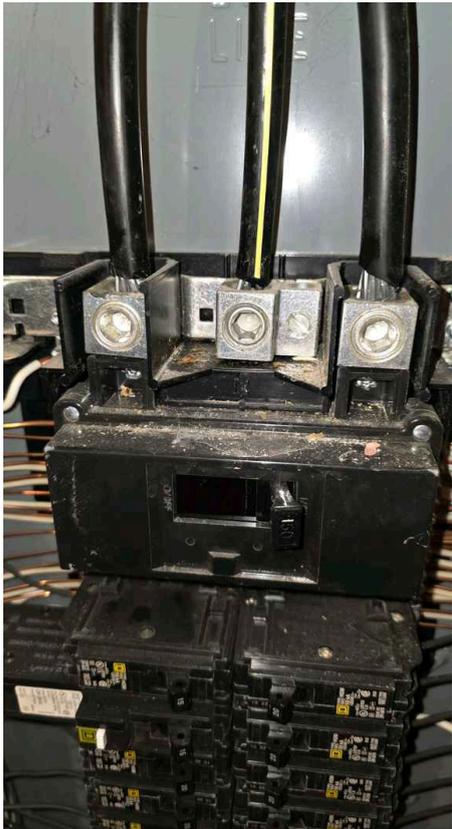
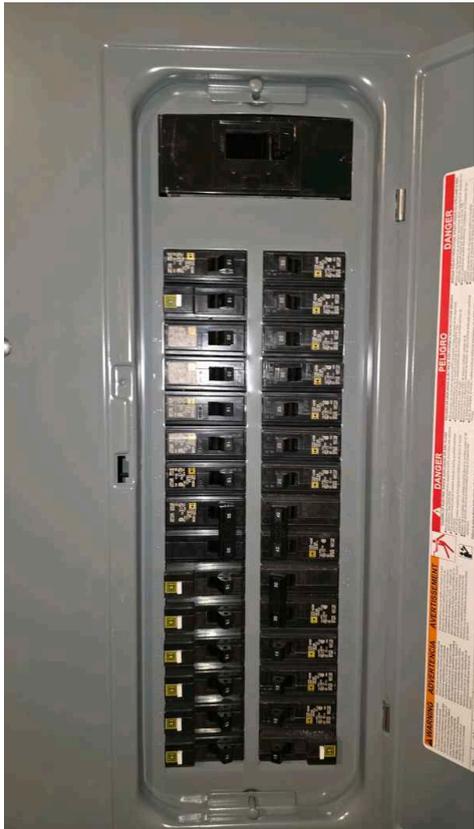
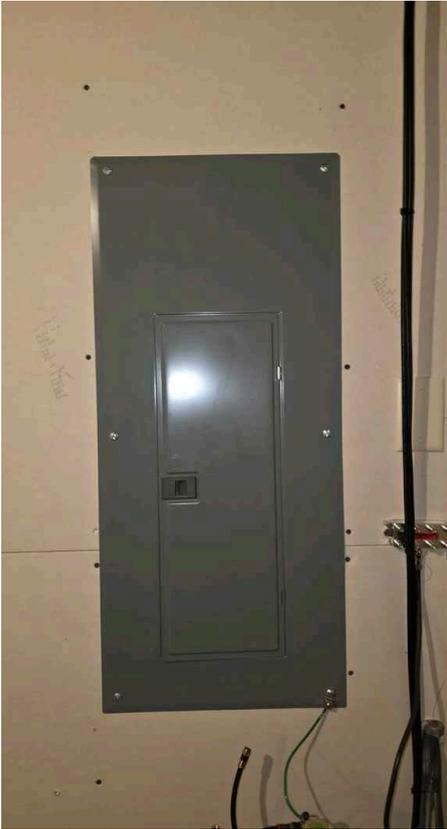
Service Panel Cabinet: Photo documentation

The service was grounded to steel re-bar left protruding from the foundation for this purpose. This type of ground is called a "ufer" (YOO-fer) ground. This type of grounding electrode has length and continuity requirements which could not be confirmed at the time of the inspection due to the fact that the grounding electrode was encased in concrete. Evaluation of the effectiveness of the service ground would require the services of a qualified electrical contractor using special instruments.

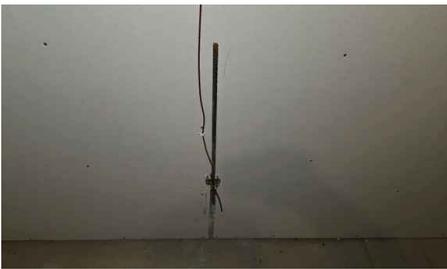
Service Grounding System : UFER electrode

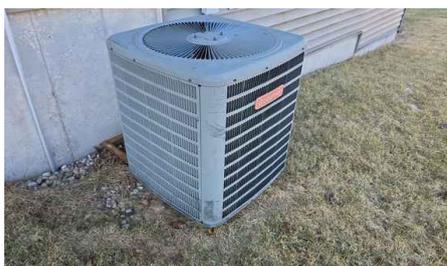
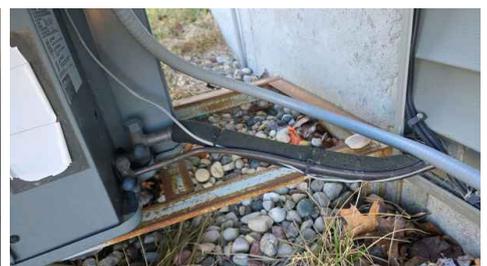
Central Air Conditioner: Photo documentation

A split air conditioning system is a common residential cooling setup consisting of two main units: an indoor unit and an outdoor unit. The outdoor unit contains the compressor, condenser coil, and fan, which work together to release heat from the home. The indoor unit houses the evaporator coil and air handler, which absorb heat from the indoor air and circulate cooled air through the home. Refrigerant lines connect the two units, transferring heat between them. A thermostat controls the system, regulating cooling cycles. Regular maintenance, such as changing filters and cleaning coils, helps keep the system efficient and prolongs its lifespan.

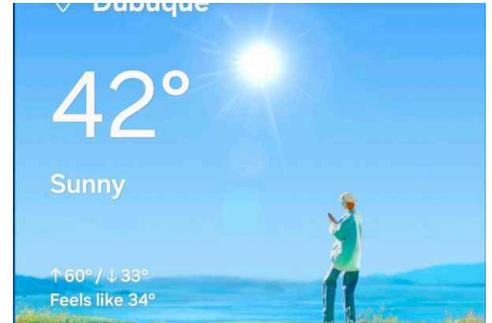
Limited Inspection on the central air conditioning system. The central air conditioning system was not tested during the inspection due to outdoor temperatures being below 65°F. Operating an air conditioning system in cooler weather can potentially cause damage to the compressor, as the system is designed to function optimally under warmer conditions. Running the system when it is too cold may result in improper lubrication of the compressor and can lead to system failure.

For accurate testing and evaluation of the air conditioning system, it is recommended to operate the system only when outdoor temperatures are consistently above 65°F for at least 24 hours. If further evaluation is needed, testing should be conducted under appropriate conditions by a qualified HVAC technician.
