GOLD SHIELD INSPECTIONS

## INSPECTION REPORT

6097 Apache Court  
Asbury, IA 52002

10/06/2025

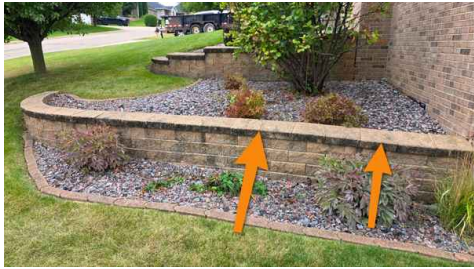
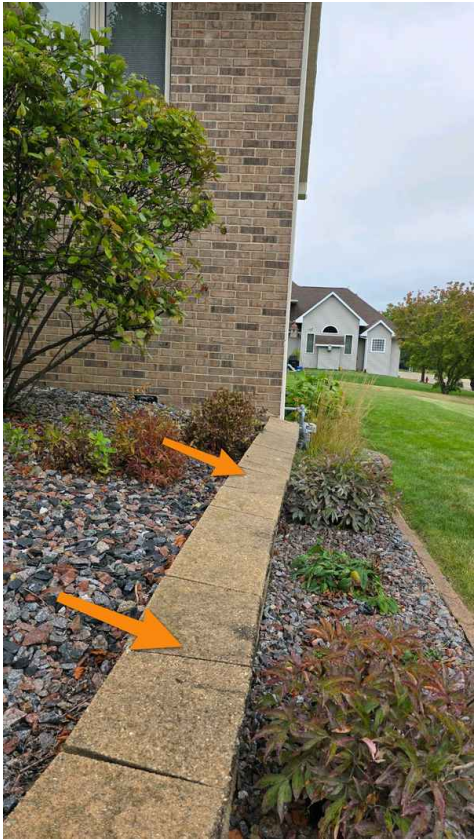
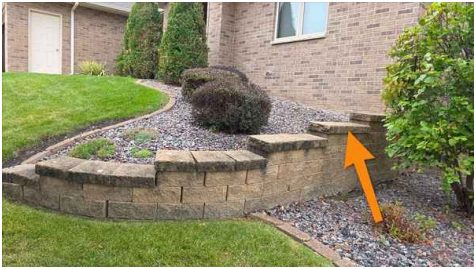
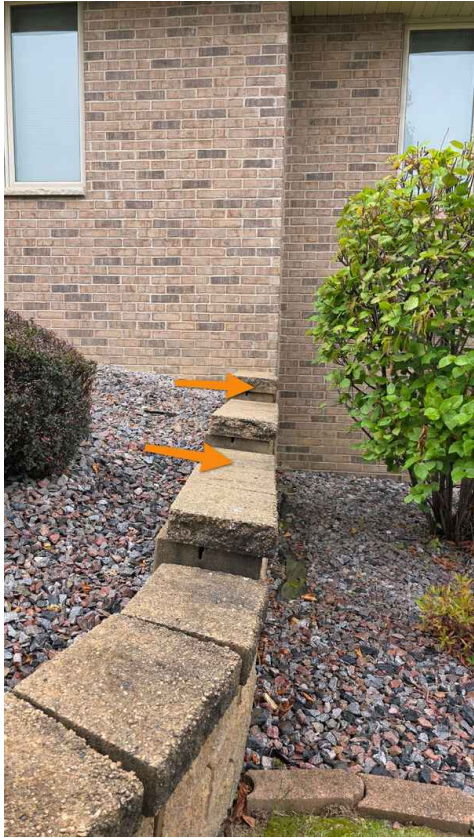
### 3.14.1 Retaining walls

Leaning in block retaining walls is often caused by improper base preparation, inadequate drainage, or excessive soil pressure. This condition requires attention, which may include rebuilding the wall with proper reinforcement and drainage systems.

Contact a qualified landscaping contractor

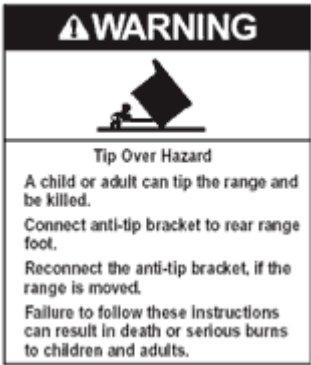
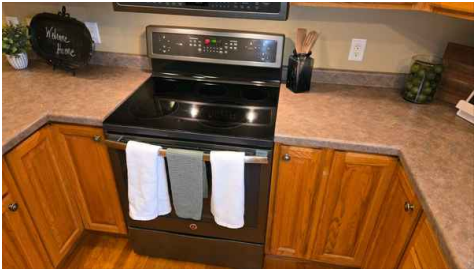
1st Floor Kitchen Range

6.10.1 Range

Contact a qualified appliance repair professional.

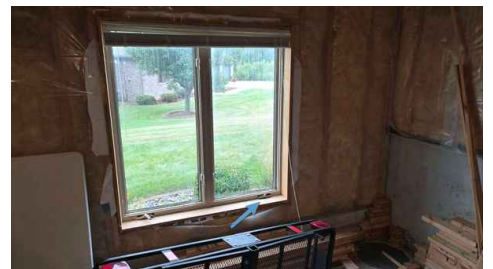
Basement Right Window

## 7.6.1 Windows throughout home

Contact a qualified professional.

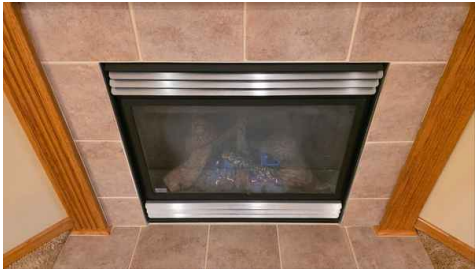
The glass front of the gas fireplace shows signs of fogging and buildup, which is typically caused by prolonged exposure to combustion byproducts such as moisture, carbon deposits, or residue from additives in the fuel. This condition may indicate that the fireplace is not burning cleanly or that ventilation within the sealed unit is compromised. While this does not always pose an immediate safety risk, it can obscure visibility of the flame, affect appliance efficiency, and point to the need for service. Recommend cleaning the glass per the manufacturer's specifications and having the fireplace evaluated by a qualified technician to ensure safe and proper operation.

Contact a qualified fireplace contractor.

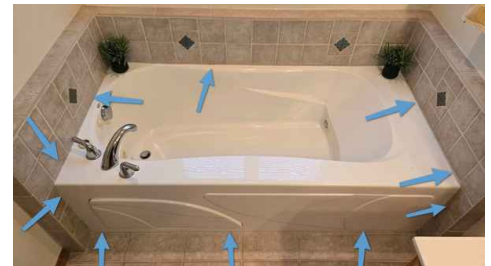
1st Floor Master Bathroom Tub  
Deteriorated Grout

### 8.7.1 Bathroom Tub/Shower

Recommended DIY Project

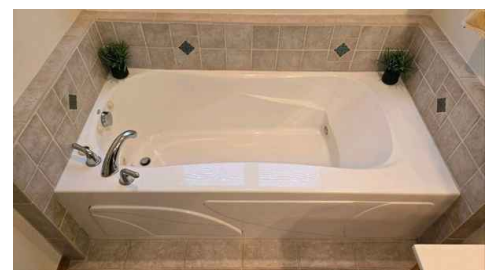
1st Floor Master Bathroom Tub

The bathroom whirlpool tub was found to be nonfunctional at the time of inspection. When operated using the control switch, the jets did not engage, indicating a possible issue with the motor, electrical connection, or internal components. Inoperable whirlpool tubs can result from lack of use, mechanical failure, or disconnected power sources. It is recommended that a qualified plumber or appliance technician evaluate the unit to determine the cause of inoperation and perform any necessary repairs to restore proper functionality and ensure safe use.

Recommendation

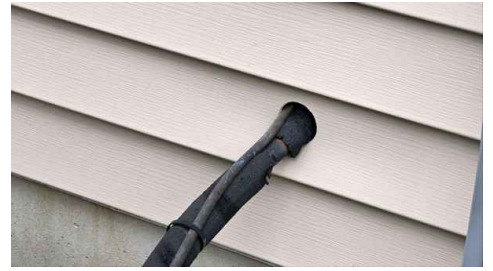
##### **A/C, SEAL WALL PENETRATION**

The hole in the exterior wall-covering cut to allow penetration of air-conditioning lines should be sealed with an appropriate sealant to prevent moisture and insect/pest entry.
