PROPERTY INSPECTION REPORT

89410 Ryan Gulch Rd DD-104
Silverthorne, CO 80497

11/26/2025

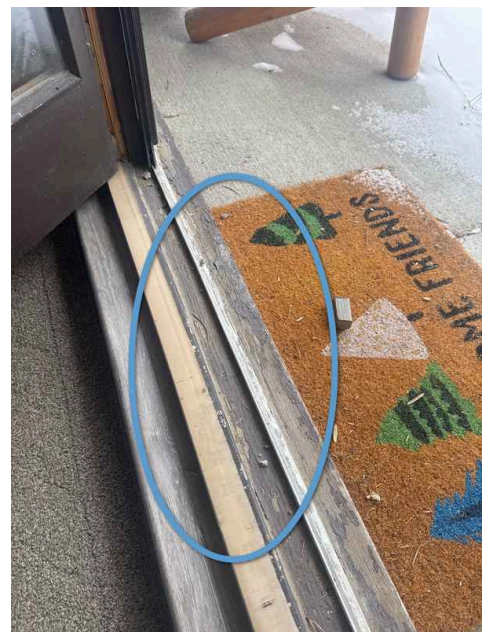
3.2.1 Siding / Trim

FAILING PAINT OR STAIN - SOME AREAS

The paint or stain finish exhibited signs of deterioration, such as peeling, fading, wearing, thinning, and drying out, in certain areas. Siding and trim with compromised finishes are susceptible to damage from moisture and sunlight exposure. It is advised that a qualified professional undertake preparatory steps, including cleaning, scraping, sanding, priming, and caulking as necessary, before repainting or restaining the building exterior according to standard procedures. Any required repairs to the siding or trim should be addressed prior to refinishing.

Contact a qualified painting contractor.

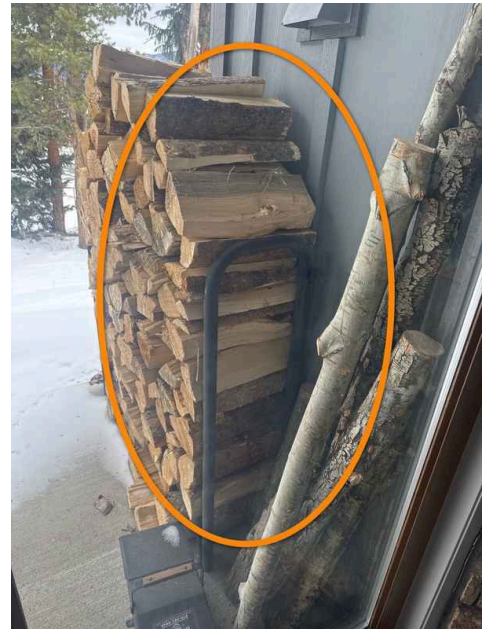
3.2.2 Siding / Trim

FIREWOOD

Firewood was stored so that it was in contact with or close to the building exterior. Recommend storing firewood outdoors in an open area, and as far away from buildings as practical to keep insects away from buildings.

Recommendation
Recommended DIY Project

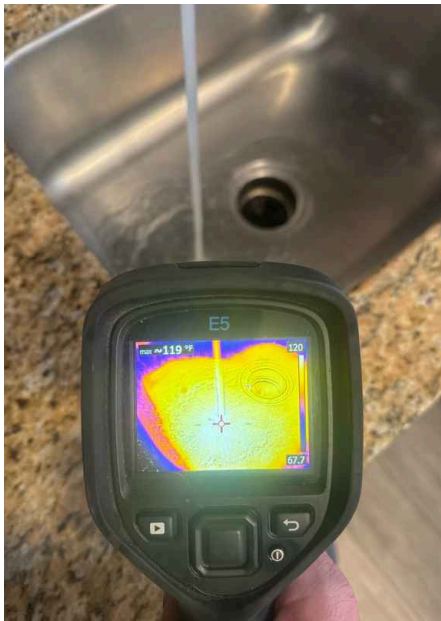
Temperature: Condition

Good - Within the recommended range of 115-120 degrees

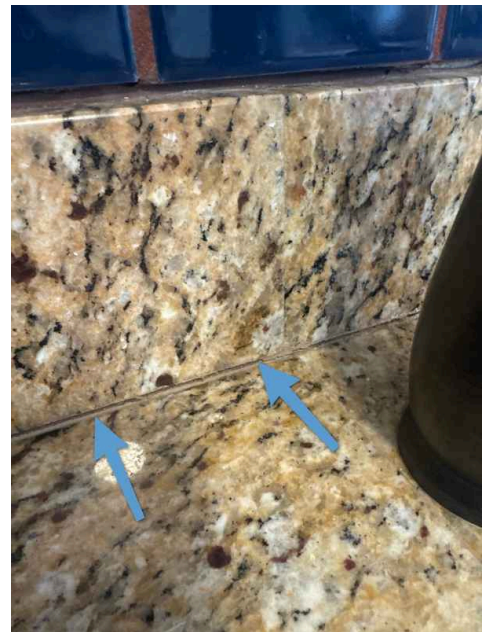
9.2.1 Counters

NEED CAULK AT GAPS

Caulking was either missing or substandard around the sink area. Repair as needed.

Contact a handyman or DIY project

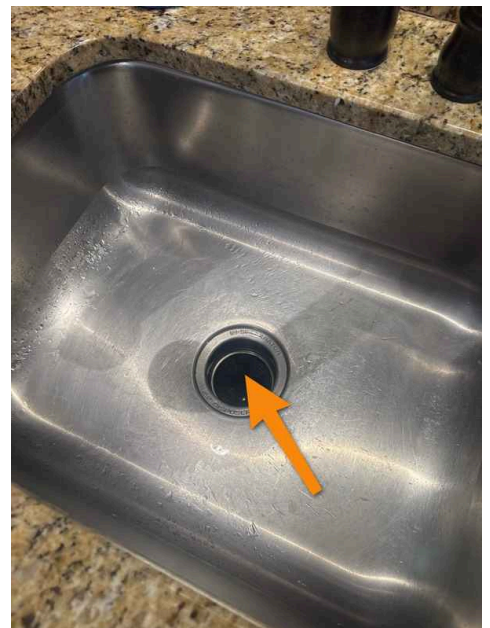
9.10.1 Under-Sink Food Disposals

NOT WORKING PROPERLY

The under-sink food disposal was either jammed, noisy or vibrated excessively, significantly corroded. Recommend a professional to repair or replace as needed.

Noisy/debris

Contact a qualified professional.

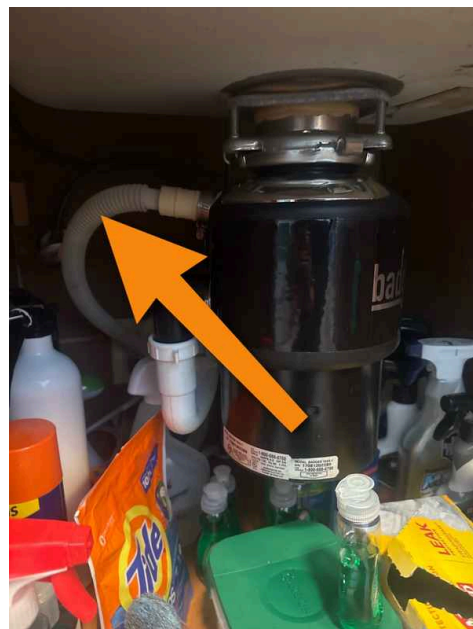
9.11.1 Dishwashers

Deficiency/Further Evaluation**NO HIGH LOOP OR AIR GAP**

There is no high loop on the dishwasher drain line. A high loop is created by routing the drain line up to the bottom surface of the countertop above and securely fastening it to that surface. An air gap is a device that makes the drain line non-continuous. Both of these prevent waste-water backflow from entering the dishwasher, and possibly flooding out of the dishwasher if/when a siphon occurs. Some newer dishwashers have these devices built in. Recommend reviewing the dishwasher's installation instructions and/or having a qualified professional evaluate further to determine if a high loop and air gap are installed or needed. If not installed, and none is built into the dishwasher, then recommend that a qualified professional install a high loop and air gap per standard building practices.

Contact a qualified professional.

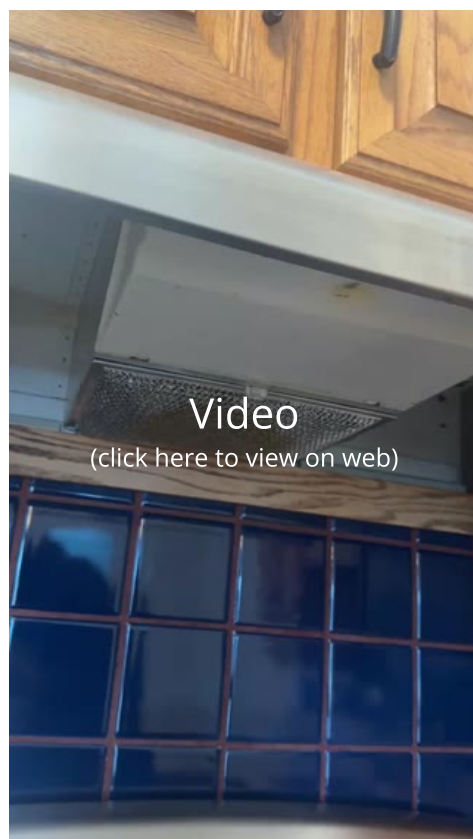
9.13.1 Ventilation

Deficiency/Further Evaluation**FAN**

The cooktop exhaust fan was *inoperable / noisy or vibrated excessively / slow*. Recommend that a qualified person repair or replace as necessary.

Contact a qualified appliance repair professional.

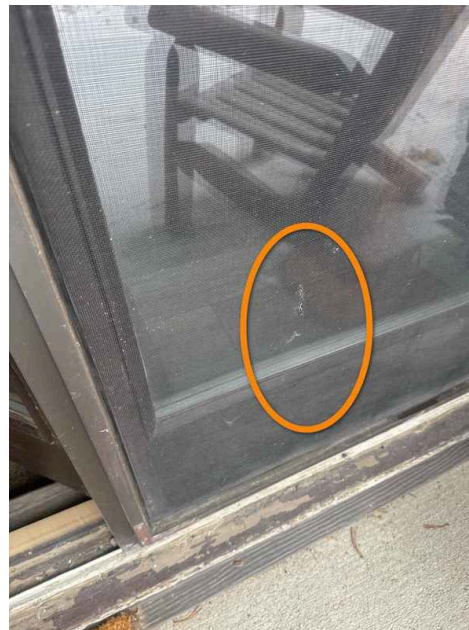
11.4.1 Doors

SCREEN / STORM DOOR

The screen or storm door was *damaged / deteriorated / missing*. Recommend repairs as needed.

Contact a qualified door repair/installation contractor.
