INSPECTION REPORT

925 Hawkeye Dr
Dubuque, IA 52001

03/19/2026

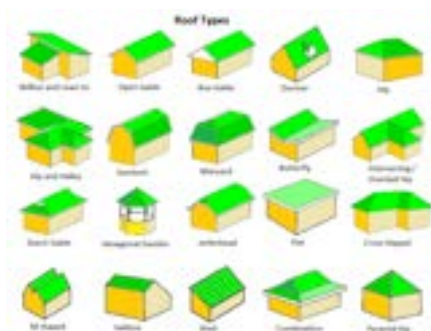
General Overview and Limitations of Roof Inspection: Roof Style

Open Gable

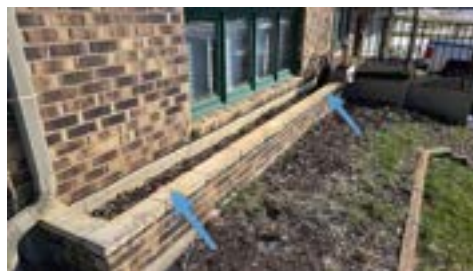
Potential Problems with Gardens or Planters Against Exterior Walls

Problems with Gardens and Planters Against Exterior Walls

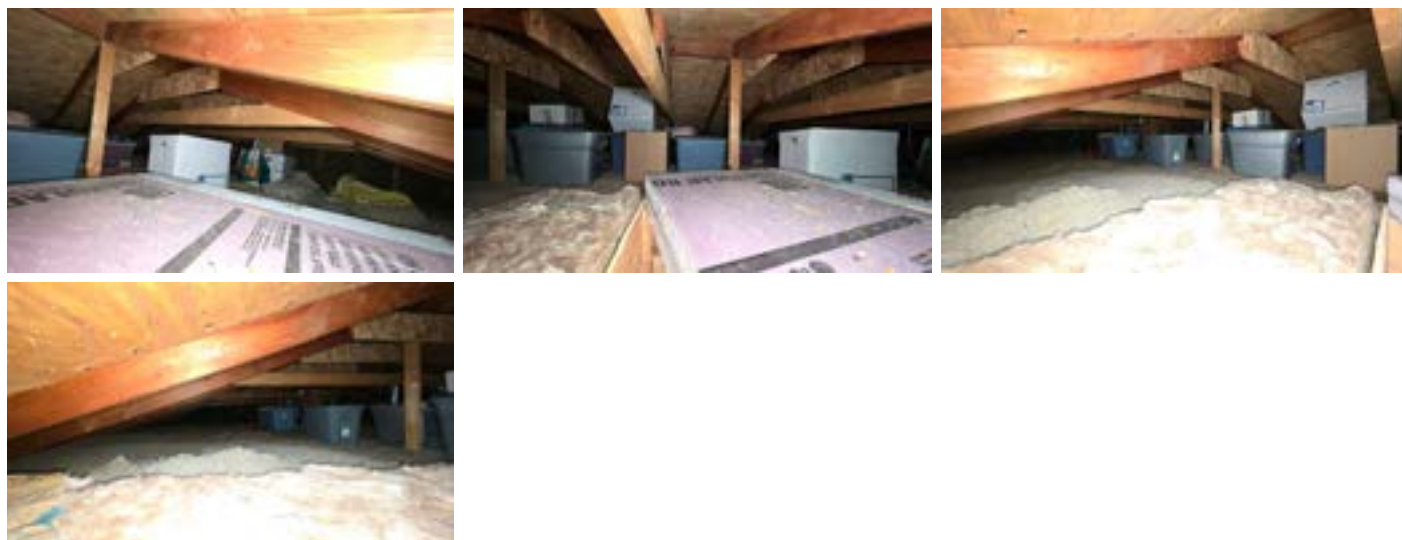
General Overview: Photo Documentation

General Overview and Limitations of Attic Inspection:
Roof Ventilation Type:
 Continuous ridge vent, Soffit vents

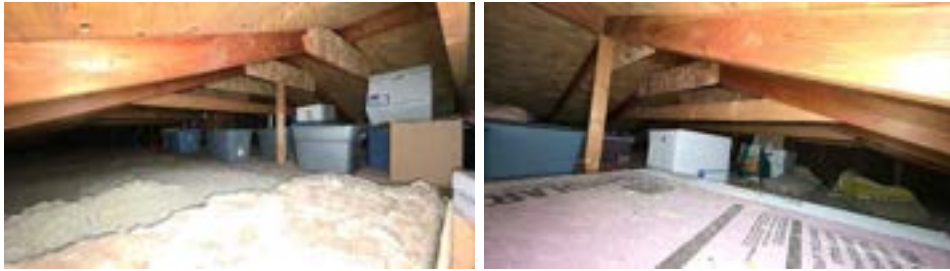
Access to the attic was blocked by the occupants' personal belongings, such as stored items or furniture, placed in or around the attic access hatch. This prevented a thorough inspection of the attic space, including insulation, framing, and ventilation. Clearing the area to allow safe access and scheduling a re-inspection is recommended to evaluate the attic's condition fully.

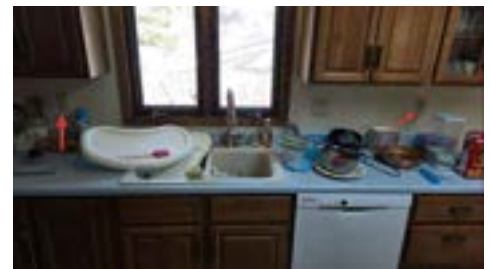
1st Floor Kitchen Outlets No GFCI Protections

Outlets near the sink, countertops, or other wet areas lacked Ground Fault Circuit Interrupter (GFCI) protection, or the GFCI outlets were not functioning correctly when tested. GFCI protection is required for safety in areas with water exposure. Recommend upgrading or repairing the outlets by a licensed electrician to ensure compliance with safety standards.

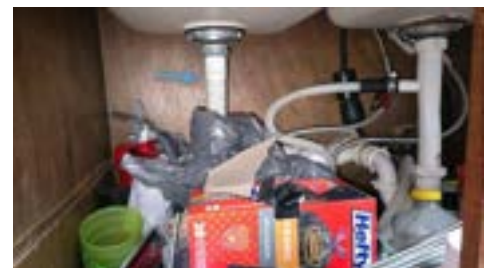
1st Floor Kitchen Sink

Flex pipe installed under kitchen sink at time of inspection. Drainage fittings should have a smooth interior waterway of the same diameter as the piping served. All fittings should conform to the type of pipe used. Drainage fittings should have no ledges, shoulders or reductions which can retard or obstruct drainage flow in the piping. Recommend replacement of flex pipe

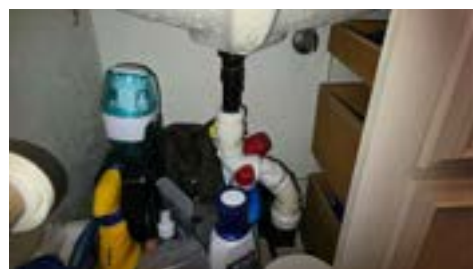
Basement Hall Bathroom Sink

The bathroom sink was observed to be missing a plumbing trap beneath it. A trap is a necessary component of the drainage system designed to hold water and prevent sewer gases from entering the living space. Without a trap, unpleasant odors and potentially harmful gases can migrate into the home, creating both a health and comfort concern. This condition is typically the result of improper installation or past modifications. It is recommended that a licensed plumber install an appropriate plumbing trap to restore proper function and ensure occupant safety.

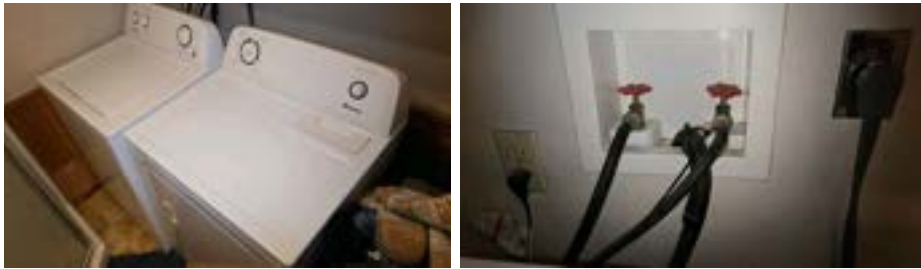
Laundry Room: Washer/Dryer Hook-up Photo

Washer and dryer hookups location.

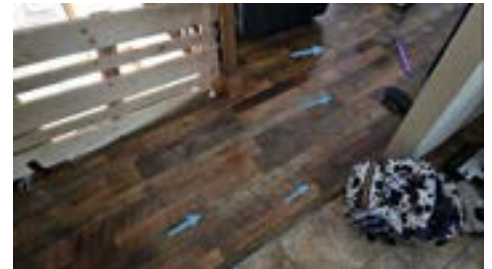
1st Floor Livingroom

Gaps were observed between sections of the wooden flooring. This condition is commonly caused by seasonal expansion and contraction of the wood due to changes in temperature and humidity, or it may result from age, installation practices, or settling of the subfloor. While minor gapping is often cosmetic, larger or uneven gaps can collect debris, create tripping points, and contribute to further wear of the flooring edges. Recommend monitoring the gaps and consulting a flooring specialist for repair or refinishing if the condition worsens or becomes a safety or maintenance concern.

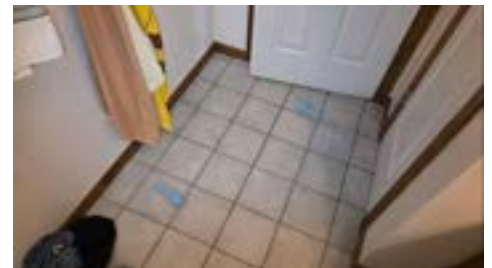
1st Floor Hall Bathroom Cracked Tile

The floor tiles were observed to be cracked, chipped, or loose allowing water to seep through to the subfloor. This can lead to water damage or mold growth. Recommend replacing damaged tiles and securing loose tiles to restore safety and functionality.

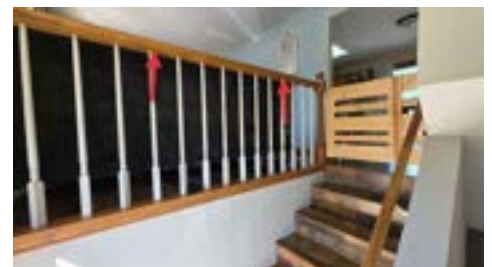
Loose

The handrail was observed to be loose or damaged, which may reduce its effectiveness in preventing falls. Recommend securing or repairing the handrail to ensure it provides adequate support.

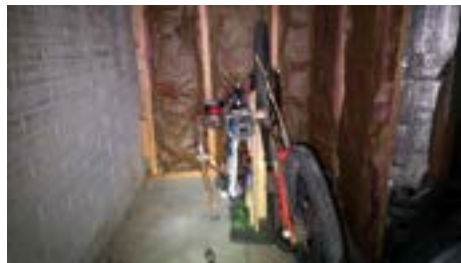
Inspection: Water main shut off

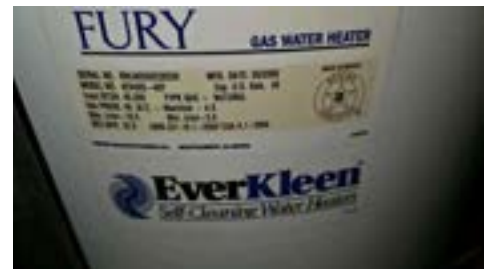
The water heater appeared to be nearing or exceeding its typical lifespan of 10–15 years. Aging units are more prone to leaks, inefficiency, and failure. Recommend monitoring performance and planning for replacement.

Recommendation

Contact a qualified plumbing contractor.

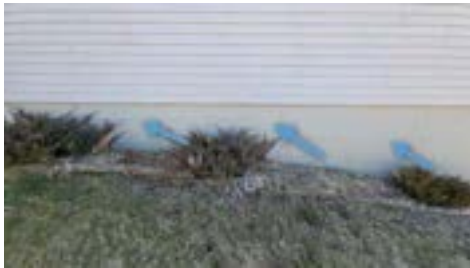
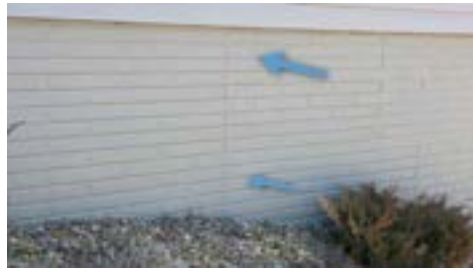
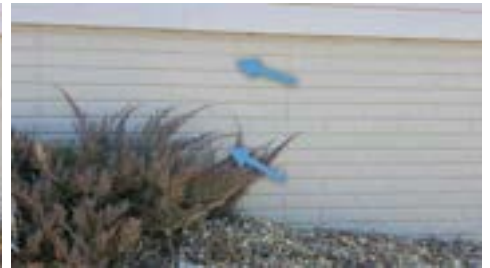
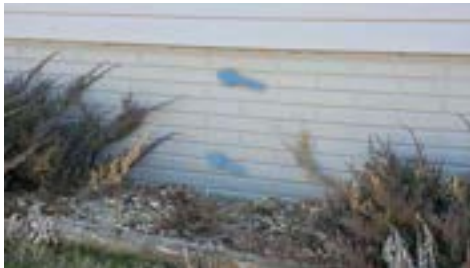
Small hairline cracks are a common occurrence in concrete foundations and are typically caused by natural shrinkage during the curing process or minor settling over time. These cracks are generally superficial and do not pose a structural concern when there is no evidence of water penetration or widening over time. Regular monitoring of these cracks is recommended to ensure they do not grow larger or develop into a more significant issue. Sealing the cracks with an appropriate sealant can help prevent moisture intrusion and extend the life of the foundation.

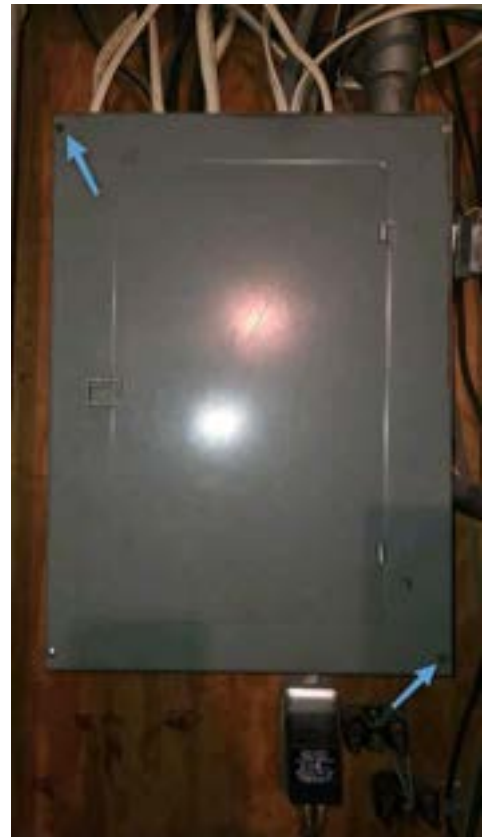
ELECTRICAL PANEL, MISSING SCREWS

The electrical panel was found to be missing dead front cover screws. These attach the panel cover to ensure no direct contact with internal wiring.

Recommendation

Contact a qualified electrical contractor.

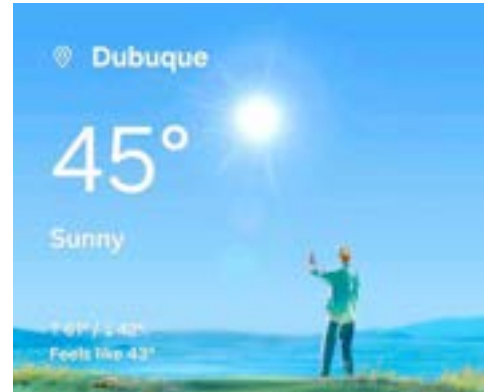
Limited Inspection on the central air conditioning system. The central air conditioning system was not tested during the inspection due to outdoor temperatures being below 65°F. Operating an air conditioning system in cooler weather can potentially cause damage to the compressor, as the system is designed to function optimally under warmer conditions. Running the system when it is too cold may result in improper lubrication of the compressor and can lead to system failure.

For accurate testing and evaluation of the air conditioning system, it is recommended to operate the system only when outdoor temperatures are consistently above 65°F for at least 24 hours. If further evaluation is needed, testing should be conducted under appropriate conditions by a qualified HVAC technician.
