INSPECTION REPORT

757 Roberts St
Dubuque, IA 52001

Steven Jabini
01/21/2026

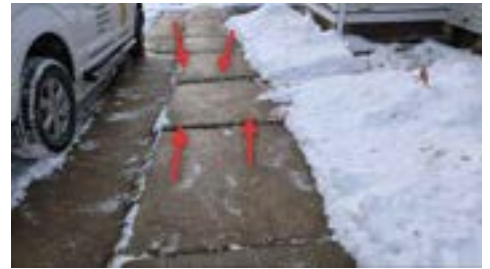
Uneven or sunken sections of the driveway were observed, which may pose tripping hazards and allow water pooling. Settlement or poor subgrade preparation are common causes. Recommend leveling the affected areas, such as through mudjacking or slab replacement.

Contact a qualified concrete contractor.

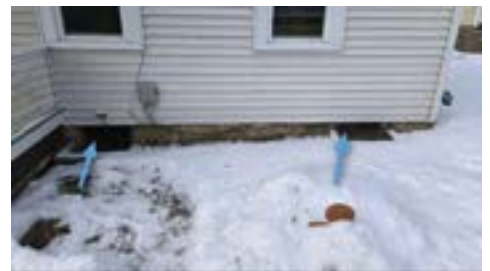
Front Of House Windows

Recommend installation of window well covers to keep moisture and debris out of window wells.

Recommended DIY Project

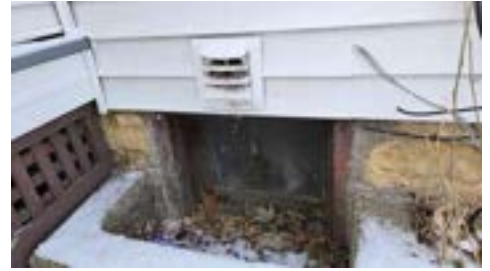
3.12.1 Dryer vent.

-   3.8.2 Exterior - Deck, Balcony, Bridge and Porch,: Exterior, Deck Support Piers, Concrete Surface Deterioration and Scaling
-   3.12.1 Exterior - Dryer vent. : Dryer Vent, Obstructed With Lint

Recommendation

Recommended DIY Project

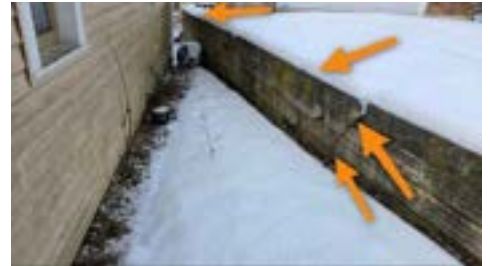
3.13.1 Retaining walls

-   3.13.1 Exterior - Retaining walls: Retaining Wall, Structural Displacement and Forward Leaning
-   4.9.1 Garage - Garage Structural: Garage, Concrete Footing, Cracked With Displacement

Recommendation

Contact a qualified landscaping contractor

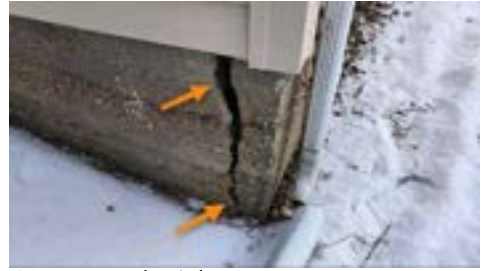
Garage Back Right Corner

GARAGE, CONCRETE FOOTING, CRACKED WITH DISPLACEMENT

The concrete footing in the garage was observed to have cracking with visible displacement, indicating movement of the concrete rather than a superficial surface crack. This type of cracking is commonly associated with soil movement, settlement, frost-related heaving, or inadequate support beneath the footing. Displacement suggests the footing may no longer be performing as intended, which can affect the stability and load support of the garage structure above. While the full extent and progression of movement could not be determined at the time of inspection, this condition is more significant than typical shrinkage cracking and warrants attention. Recommend further evaluation by a qualified foundation contractor or structural professional to determine the cause of movement and to advise on appropriate repairs to prevent further deterioration or structural concerns.

Recommendation

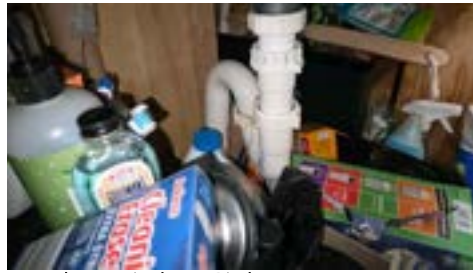
1st Floor Kitchen Sink

S-Trap vs. P-Trap

Contact a qualified plumbing contractor.

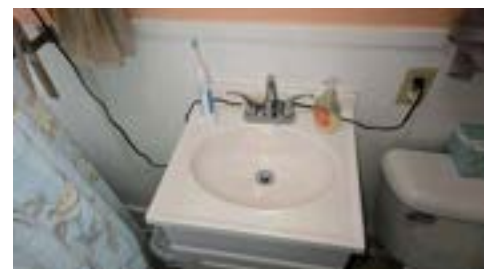
1st Floor Hall Bathroom Sink Cold Water Significantly Lower Water Pressure Compared To Hot Water

Contact a qualified plumbing contractor.

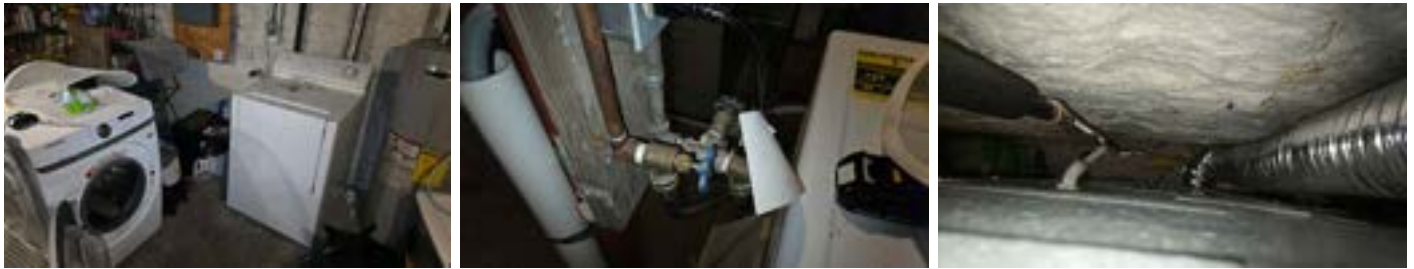
Laundry Room: Washer/Dryer Hook-up Photo

Washer and dryer hookups location.

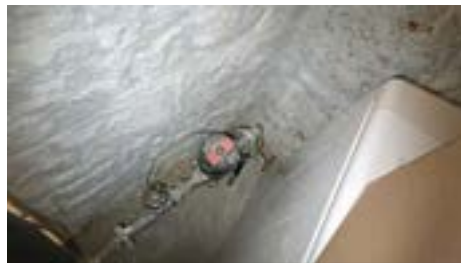
Inspection: Water Distribution Pipes:

1/2 and 3/4-inch galvanized steel,
1/2-inch and 3/4-inch copper,
Cross-linked Polyethylene (PEX)

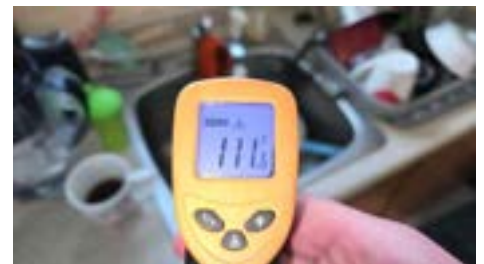
Inspection: Water Temperature At Faucet

111.6

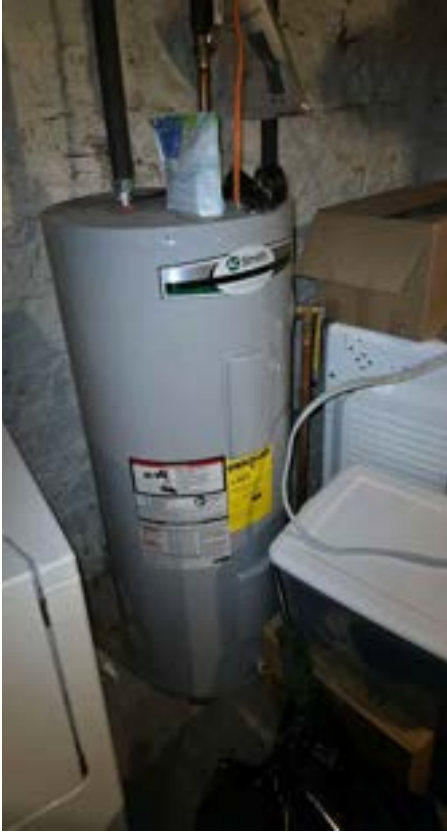
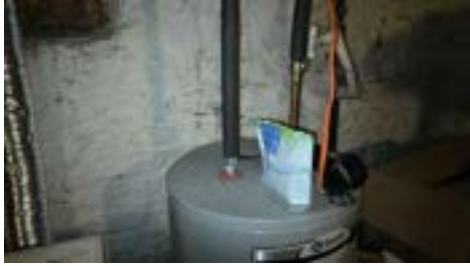
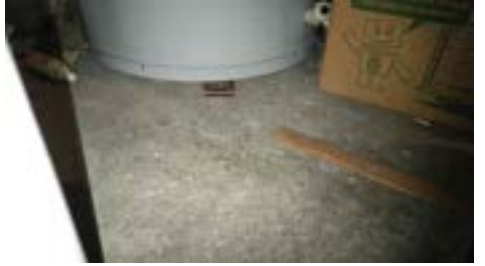
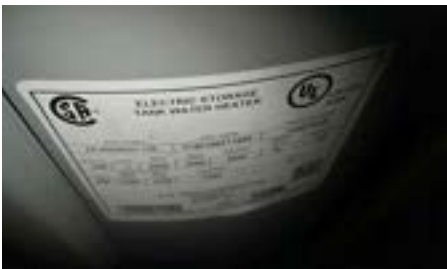
Water Heater: Photo documentation

40 gallons

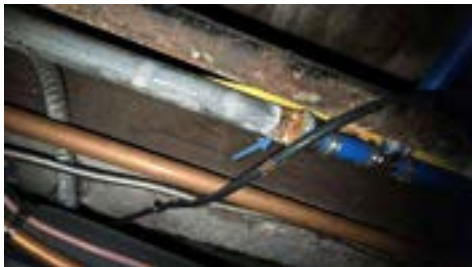
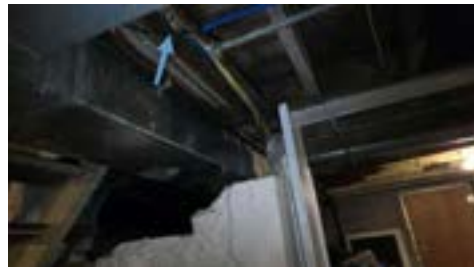
Basement

CORRODED PIPES

Signs of corrosion were noted on the supply lines, particularly at joints or fittings. Corrosion weakens the pipes and increases the risk of leaks or bursts. Recommend replacing corroded sections with durable materials, such as copper or PEX.

Recommendation

Contact a qualified plumbing contractor.

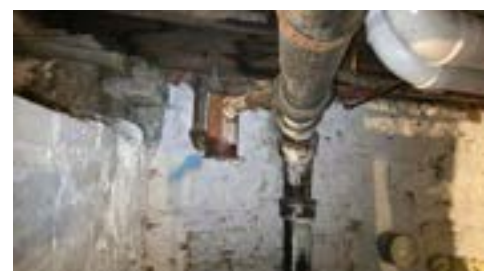
D-traps were observed at one or more plumbing fixtures. D-traps are considered an outdated plumbing configuration and are more prone to siphoning, which can allow sewer gases to enter the living space if the water seal is lost. This condition is commonly found in older homes or where plumbing modifications were made without updating the trap configuration. While the plumbing may appear functional at the time of inspection, D-traps do not provide the same level of protection as modern P-traps and can contribute to odor issues or potential health concerns. Recommend correction by a qualified plumber, typically by replacing D-traps with properly configured P-traps to improve performance and reduce the risk of sewer gas intrusion.

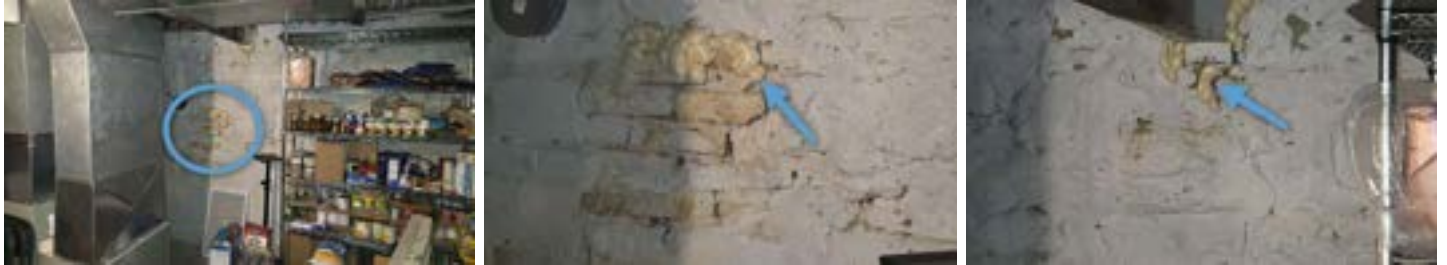
FOUNDATION MORTAR IMPROPER REPAIR MATERIALS

Observed areas of missing or deteriorated mortar joints had been improperly filled using materials such as caulking and spray foam. These materials are not suitable substitutes for mortar and fail to provide the necessary strength, bond, and durability to maintain the structural integrity and weather resistance of the masonry. Caulking and foam can degrade quickly when exposed to the elements, allow moisture intrusion, and compromise the load distribution between masonry units. Proper tuck-pointing should be performed using a compatible mortar mix designed for the masonry type. Recommend evaluation and repair by a qualified mason to ensure the longevity and stability of the affected areas.

Recommendation

Contact a qualified masonry professional.

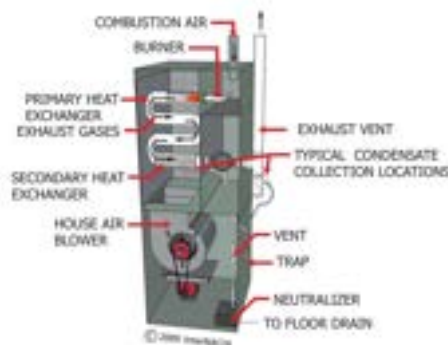
High efficiency furnace

CONDENSATION IN A HIGH-EFFICIENCY FURNACE
