## INSPECTION REPORT

212 S Chestnut St  
Monticello, IA 52310

Tom May  
01/19/2026

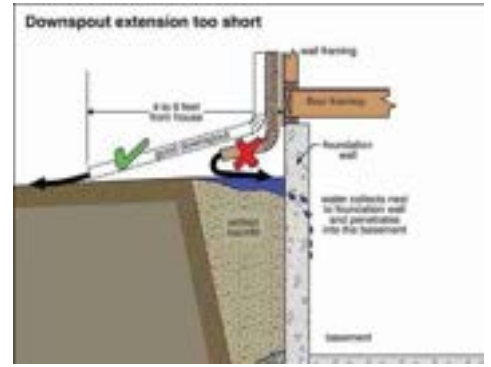
2.5.1 Roof Drainage System

**DRAINAGE SYSTEM HEALTH**

All downspouts should extend a minimum of 4-6' from the foundation or slab. Discharging near the foundation can affect the ability of the soil to support the weight of the structure above and can cause damage related to soil/foundation movement. Adding extensions can be a cheap way to avoid moisture issues in the future.

Also watch for downspouts that discharge along walkways or driveways. These areas can cause extra moisture to be pushed below the surface which can cause cracking and displacement. In Iowa our winters can also cause these discharge locations to freeze over and be a fall hazard.

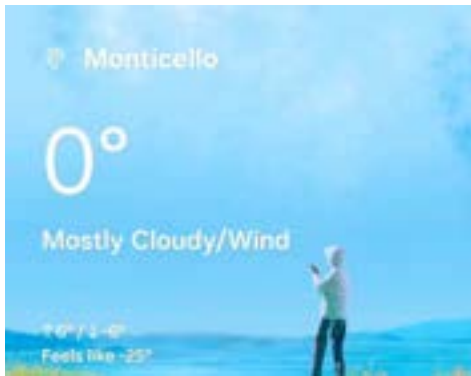
### LIMITED INSPECTION, TEMPERATURE RESTRICTION

Limited inspection on house bibs due to freezing temperatures at any point during the day. This could cause damage if ran when evening temperatures reach below freezing.

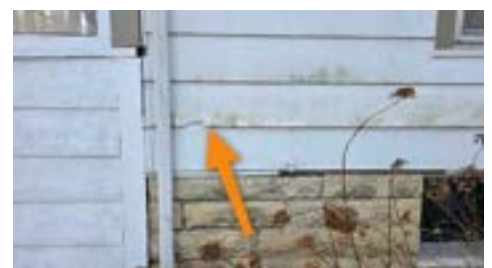
## 3.16.1 Composite Siding

Maintenance or Low Priority

Composite siding can delaminate over time due to moisture intrusion or manufacturing defects. This results in the layers of the siding separating, reducing its structural integrity and exposing the interior to water damage. Delaminated siding should be replaced to prevent further deterioration.

**3.16.1 repaired**

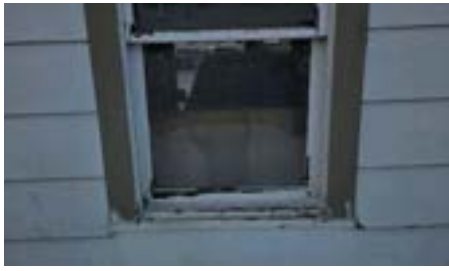
## Garage Windows: Wooden Windows, Chipping/ Peeling Paint

Wooden windows on the garage have areas of paint that requires maintenance to ensure proper moisture deterioration.

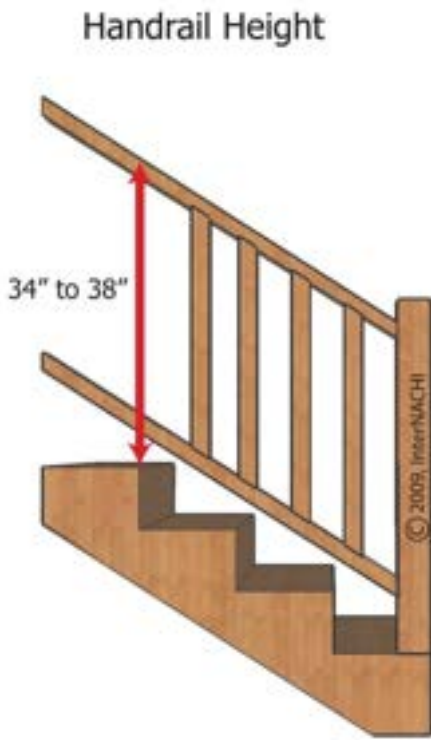
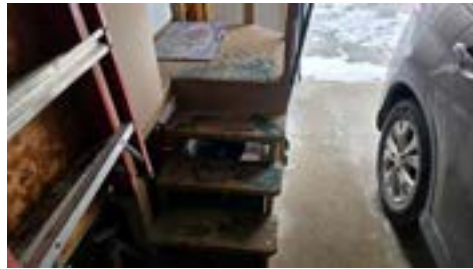
### 4.10.1 Garage, Stairs/Steps to Living Space

#### HANDRAIL, NOT INSTALLED

The steps leading to the door between the garage and the living space had no handrail installed. In order to comply with modern building practices which require a handrail at stairways with 4 or more risers, this stairway would need a handrail installed. The Inspector recommends that a handrail be installed by a qualified contractor that complies with modern building requirements.

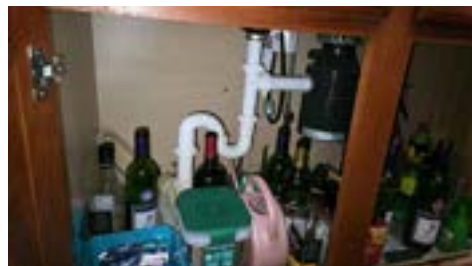
1st Floor Kitchen Sink

#### S-Trap vs. P-Trap

Contact a qualified plumbing contractor.

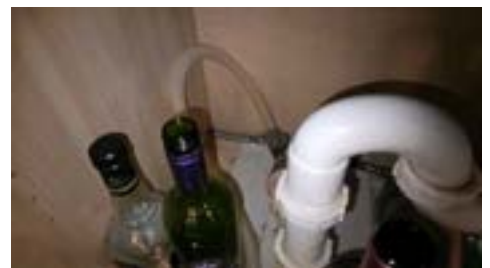
1st Floor Kitchen

#### 6.4.2 Kitchen Plumbing / Sink

Recommendation

Contact a qualified plumbing contractor.

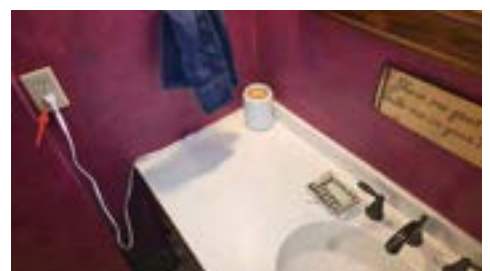
1st Floor Bathroom Outlet No GFCI Protection

#### BATHROOM RECEPTACLE, MISSING OR NON-FUNCTIONING GFCI PROTECTION

Outlets near the sink, countertops, or other wet areas lacked Ground Fault Circuit Interrupter (GFCI) protection, or the GFCI outlets were not functioning correctly when tested. GFCI protection is required for safety in areas with water exposure. Recommend upgrading or repairing the outlets by a licensed electrician to ensure compliance with safety standards.

7.3.1 ? to be repaired before close.

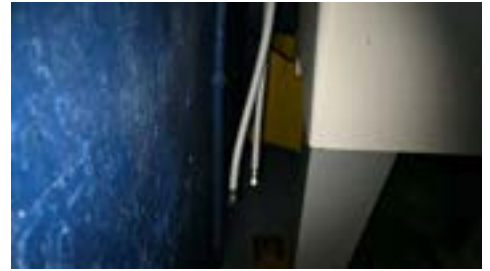
Basement Bathroom Sink

### BATHROOM, SINK WATER SUPPLY, NOT CONNECTED

The bathroom sink water supply lines were observed to be disconnected and not supplying water to the fixture at the time of inspection. This condition may be the result of prior repairs, incomplete installation, or intentional shutoff; however, it prevents the sink from functioning as intended and limits the ability to fully evaluate the fixture and related plumbing components. An unconnected water supply can also lead to leaks or water damage if the lines are inadvertently turned on or improperly capped. Recommend connection and verification of the water supply by a qualified plumber, followed by proper testing to ensure normal operation and to confirm there are no leaks present.

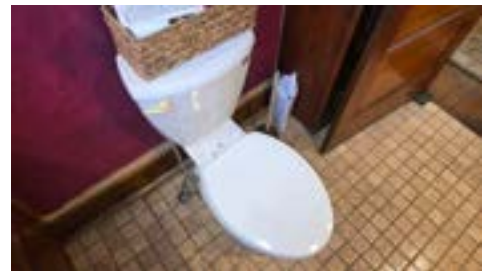
1st Floor Bathroom Toilet

### BATHROOM TOILET, LOOSE CONNECTION TO FLOOR

The toilet was observed to be loose or wobbly when tested. A loose toilet can compromise the wax seal and lead to leaks. Recommend securing the toilet to the floor and inspecting the seal for damage.

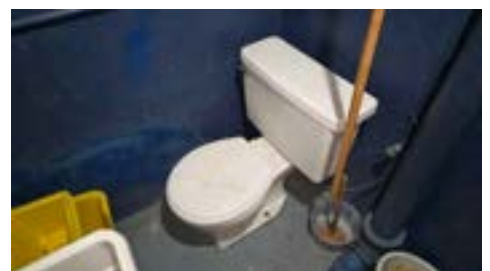
Basement Bathroom Toilet

### BATHROOM TOILET WATER SUPPLY SHUT OFF

The water supply to the bathroom toilet was shut off at the time of inspection, preventing verification of proper operation and functionality. This condition may indicate a leak, a defective fill valve, or another unresolved plumbing issue that required the water to be turned off. A nonfunctional toilet is considered a critical concern, as it limits the use of essential plumbing facilities. I recommend further evaluation by a licensed plumbing contractor to determine the cause of the shut-off, restore the water supply, and make any necessary repairs to ensure the toilet operates safely and reliably.

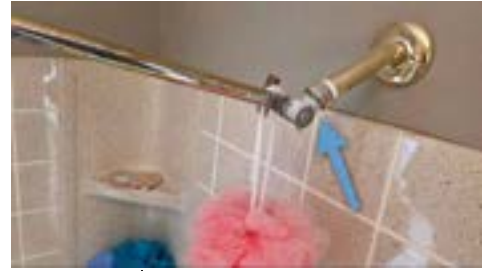
Master Bathroom

### BATHROOM TUB/SHOWER, LEAKING FAUCETS OR SHOWERHEADS

Water was observed dripping from the faucet or showerhead after being turned off, indicating worn seals, washers, or cartridges. Leaks waste water and may increase utility costs. Recommend repairing or replacing the affected components to prevent further water waste.

Recommendation

Contact a qualified plumbing contractor.

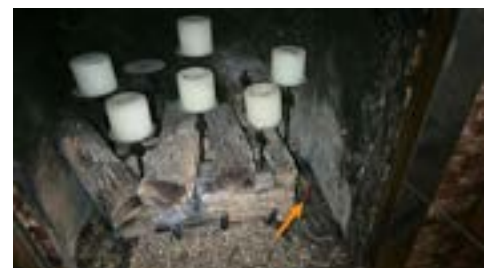
1st Floor Livingroom FirePlace

### LIMITED INSPECTION, GAS SHUT-OFF TO FIREPLACE

The fireplace inspection was limited because the gas supply to the unit was turned off at the time of the inspection. As a result, the operation and performance of the gas fireplace could not be evaluated. Recommend confirming the functionality of the unit once the gas supply is restored and consulting a qualified fireplace technician if issues arise.

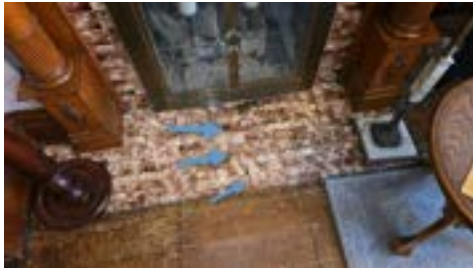
1st Floor Livingroom Around FirePlace

**INTERIOR FLOORING TILE CRACKED OR DAMAGED**

Interior floor tiles were observed to be cracked or damaged. This type of deterioration is often caused by normal wear and tear, impact damage, or movement in the underlying subfloor or slab. Damaged tiles can create tripping hazards, allow moisture to penetrate beneath the flooring, and may lead to further loosening or breakage over time. Recommend replacement of the affected tiles and evaluation of the underlying surface to ensure it is stable and properly supported before repairs are completed.

Recommendation

Contact a qualified professional.

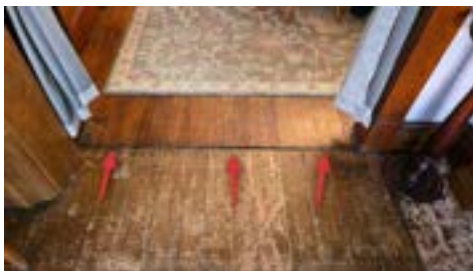
1st Floor Livingroom To Dining Room Floor

**INTERIOR FLOOR, IMPROPERLY INSTALLED FLOORING TRANSITIONS**

The transition between different flooring materials is not securely attached, damaged, creating a potential tripping hazard and/or an uneven surface. This issue can arise due to improper installation techniques, the use of inadequate adhesives, or movement in the subfloor over time. Loose or misaligned transitions not only detract from the aesthetic appeal but can also lead to premature wear on flooring edges. It is recommended to secure the transition properly with appropriate fasteners or adhesives and ensure it provides a smooth and stable connection between the different flooring materials.

Recommendation

Contact a qualified flooring contractor

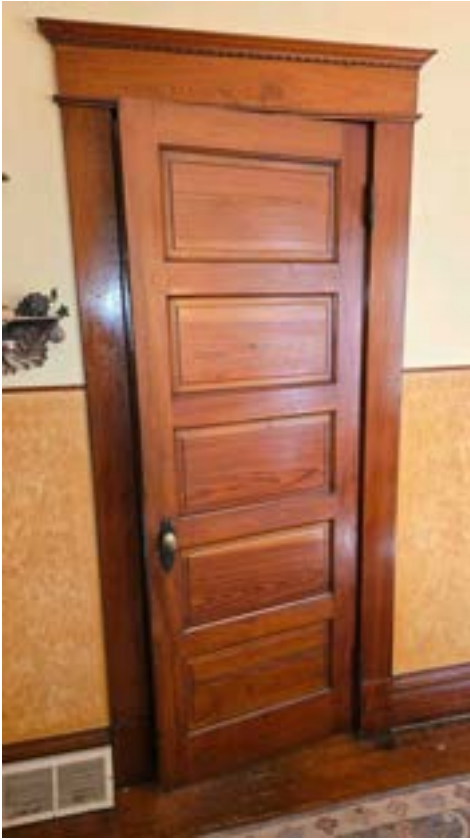
1st Floor Dining Room To Hall Door Can't Latch

Repaired; now latches

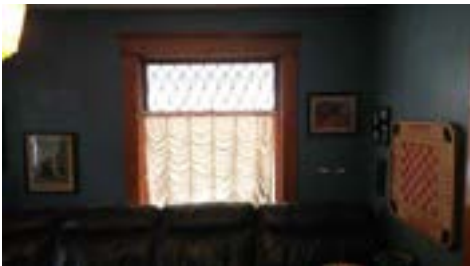
1st Floor Livingroom Window Damaged and Missing Balances

Contact a qualified window repair/installation contractor.

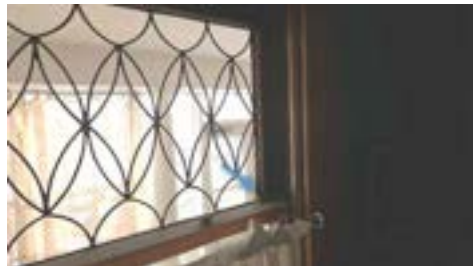
1st Floor Livingroom Window Damaged Balances

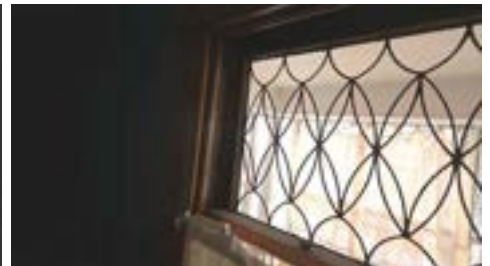
1st Floor Livingroom Window Missing Balances

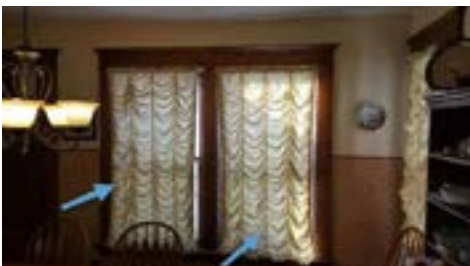
1st Floor Dining Room Windows Lower Sash Wont Stay Up When Opened

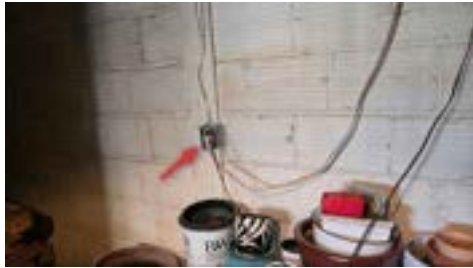
Basement Room Outlet

**INTERIOR SWITCHES OR OUTLETS, MISSING OR DAMAGED COVER PLATES**

Cover plates protect users from accidental contact with live wires and prevent debris from entering electrical boxes. Missing plates increase the risk of shocks or short circuits. Recommend installing cover plates over all exposed switches to ensure safety.

Recommendation

Contact a qualified professional.

8.8.1 ? will be repaired before close.

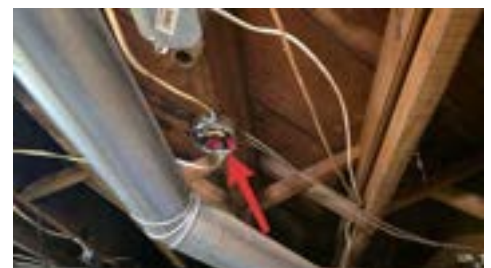
Basement back shop

An outlet with an open ground lacks a proper ground connection, which is critical for safely redirecting excess current in case of a fault. This issue can increase the risk of electrical shock and is common in older homes. Recommend upgrading or repairing the outlet to include a proper ground wire.

Recommendation

Contact a qualified electrical contractor.

8.8.3 ? to be repaired before close

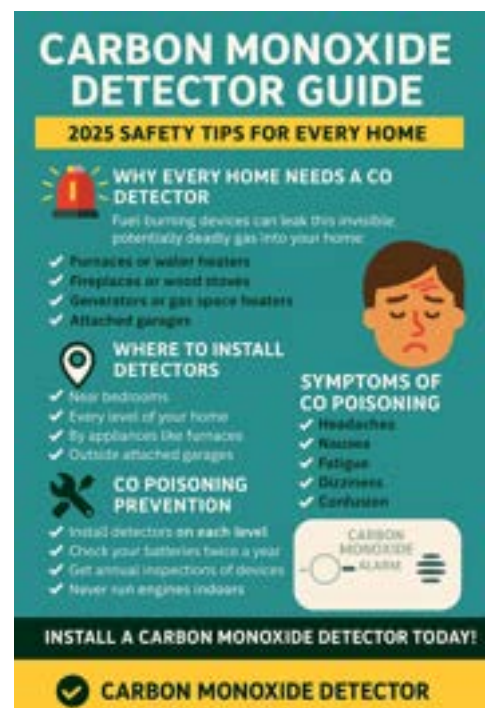
#### CO DETECTOR NEEDED

Recommended DIY Project

CO detectors on all levels

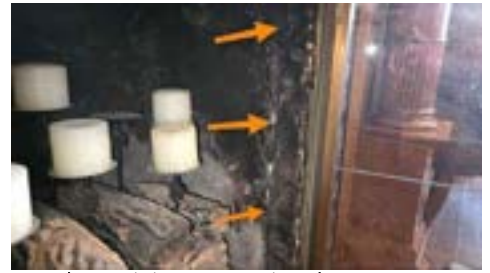
1st Floor Livingroom FirePlace

**GENERAL FIREPLACE, CRACKED OR DAMAGED FIREBOX**

Cracks or damage were observed in the firebox, which may allow heat, flames, or smoke to escape into surrounding areas, increasing the risk of fire. This condition may also indicate underlying structural issues or excessive wear. Recommend repair by a qualified fireplace technician to ensure the firebox is safe and functional.

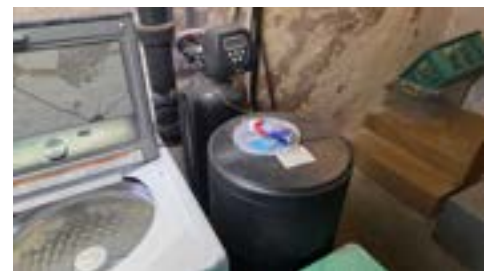
### LIMITED INSPECTION DUE TO WATER SOFTENER OUTSIDE SOP

The water softener was not inspected as its evaluation falls outside the scope of our inspection and the InterNACHI Standards of Practice. Functionality, maintenance status, and overall condition of the unit were not assessed. Recommend consulting a qualified water treatment specialist for a full evaluation of the water softener system.

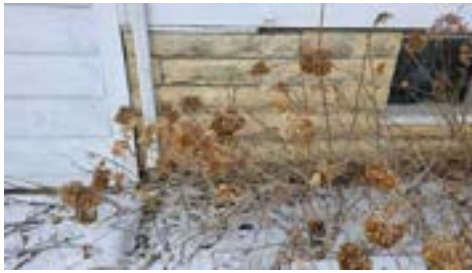
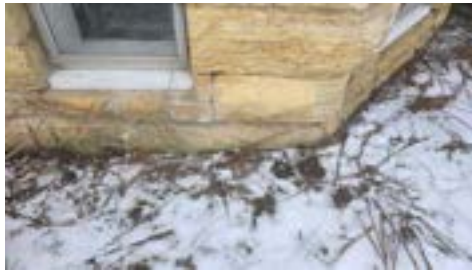
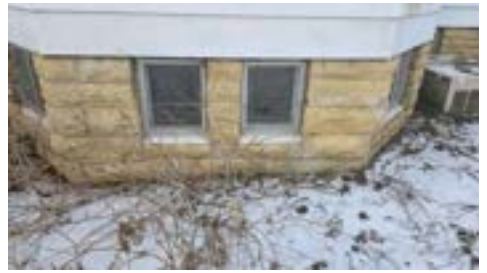
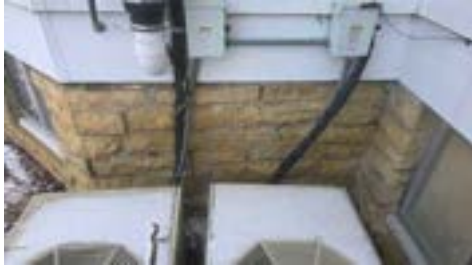
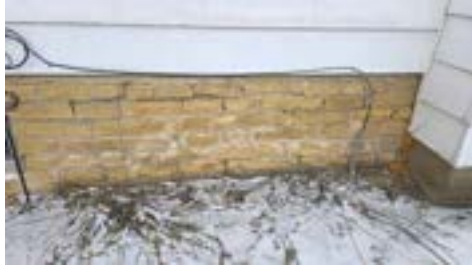
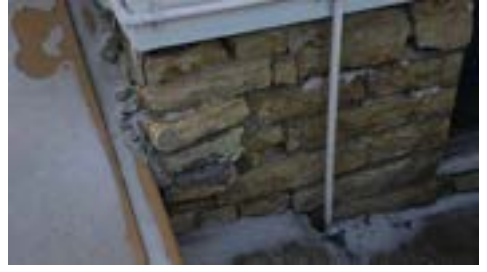
### 10.4.2 Foundation

Stone foundation mortar decay was observed at the time of inspection. Recommend tuck point mortar repair to ensure ongoing stability of Foundation.

repaired ^

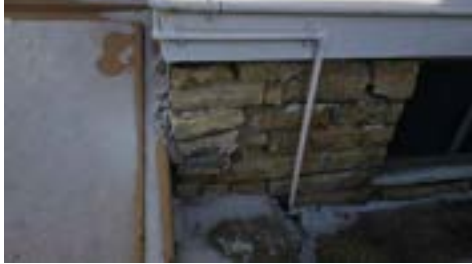
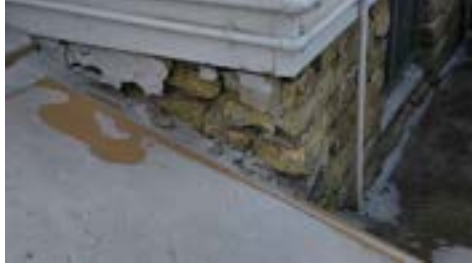
### STONE FOUNDATION, TUCK POINTING

Repaired ^

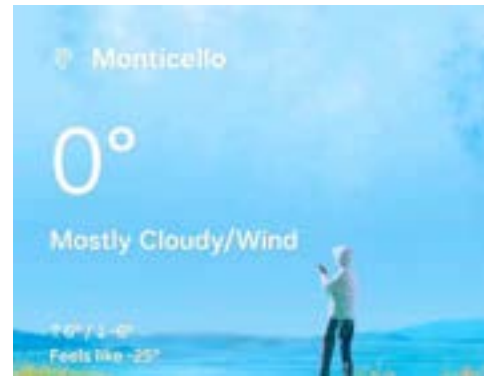
Limited inspection on the central air conditioning system. The central air conditioning system was not tested during the inspection due to outdoor temperatures being below 65°F. Operating an air conditioning system in cooler weather can potentially cause damage to the compressor, as the system is designed to function optimally under warmer conditions. Running the system when it is too cold may result in improper lubrication of the compressor and can lead to system failure.

For accurate testing and evaluation of the air conditioning system, it is recommended to operate the system only when outdoor temperatures are consistently above 65°F for at least 24 hours. If further evaluation is needed, testing should be conducted under appropriate conditions by a qualified HVAC technician.

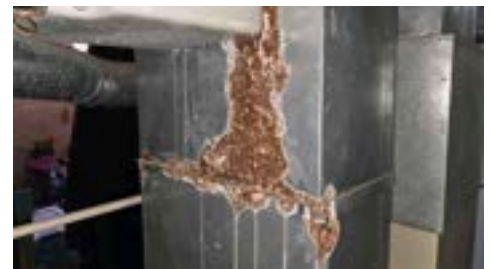
Heavy corrosion was observed along the low point of the HVAC ductwork. This type of deterioration is commonly caused by prolonged moisture exposure, which may result from condensation forming on cooler duct surfaces, inadequate insulation, high indoor humidity levels, or previous water intrusion in the surrounding area. Over time, corrosion can weaken the metal, create air leaks, and reduce system efficiency. Recommend having a qualified HVAC contractor evaluate the affected duct sections, identify the source of moisture, and complete any necessary repairs or replacement to prevent further deterioration and maintain proper system performance.

Contact a qualified professional.

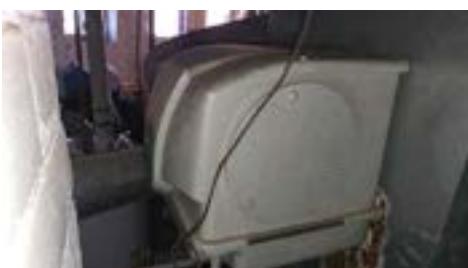
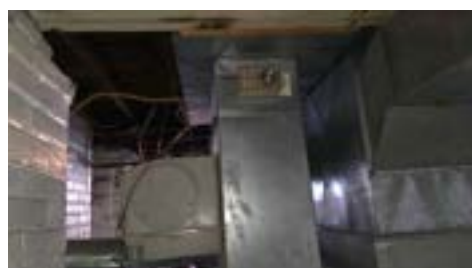
### **HVAC HUMIDIFIER INOPERABLE AND ABANDONED**

During the inspection, a duct-mounted whole-house humidifier was observed to be no longer operable and appears to have been out of service for an extended period of time. The unit shows signs of disuse and no longer provides any functional benefit to the HVAC system. Abandoned humidifiers can allow unsealed openings in the ductwork, which may contribute to air leakage, reduced system efficiency, and potential moisture or debris entry. Recommend removal of the inoperable humidifier and proper patching and sealing of the ductwork opening by a qualified HVAC professional to restore the integrity of the system and prevent future issues.

Contact a qualified HVAC professional.
