GOLD SHIELD INSPECTIONS

## INSPECTION REPORT

17408 Emerald Dr  
Dubuque, IA 52002

03/24/2026

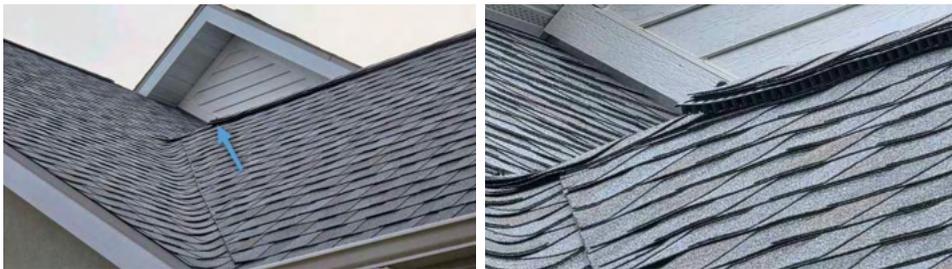
#### EXTERIOR ROOF RIDGE VENT IMPROPERLY SECURED

The ridge vent at the end of the roof was observed to be loose and not fully secured to the roof structure. This condition is typically caused by improper installation, inadequate fastening, or fasteners loosening over time due to weather exposure and thermal movement. A loose ridge vent can allow wind-driven rain, snow, and debris to enter the roof system, which may lead to moisture intrusion, deterioration of roof sheathing, and reduced attic ventilation performance. Properly installed ridge vents are critical for allowing consistent airflow through the attic space, helping to regulate temperature and moisture levels. Recommend securing or reinstalling the ridge vent to ensure it is properly fastened and sealed to prevent water intrusion and maintain proper attic ventilation.

Contact a qualified roofing professional.

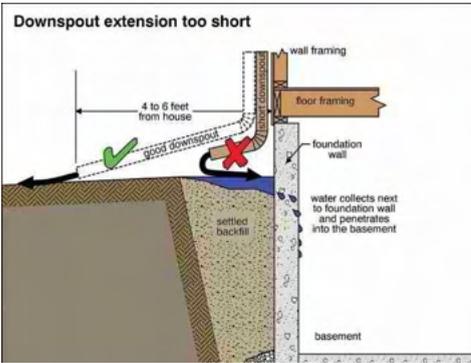
### 2.5.1 Roof Drainage System

All downspouts should extend a minimum of 4-6' from the foundation or slab. Discharging near the foundation can affect the ability of the soil to support the weight of the structure above and can cause damage related to soil/foundation movement. Adding extensions can be a cheap way to avoid moisture issues in the future.

Also watch for downspouts that discharge along walkways or driveways. These areas can cause extra moisture to be pushed below the surface which can cause cracking and displacement. In Iowa our winters can also cause these discharge locations to freeze over and be a fall hazard.

Recommended DIY Project

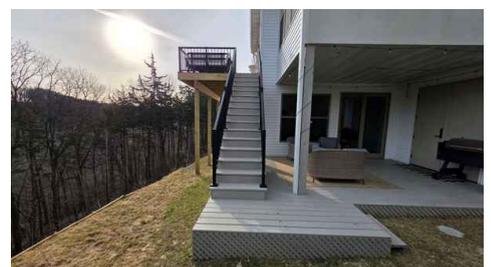
### LIMITED INSPECTION, DUE TO BARRIER OR LOW CLEARANCE UNDER DECK

The deck inspection was limited due to a barrier or low clearance that restricted access to the attachment point to the home and the structure beneath the deck. As a result, the condition of the ledger board, support posts, beams, and other critical structural components could not be fully evaluated. Recommend removing obstructions or consulting a qualified contractor for a more thorough inspection to confirm the deck's stability and safety.

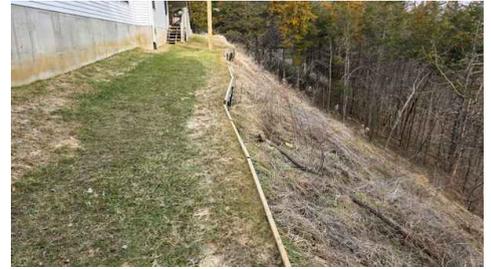
## 3.14.1 Retaining walls

**EXTERIOR RETAINING WALL  
SIGNIFICANT LEAN**

Contact a qualified landscaping contractor

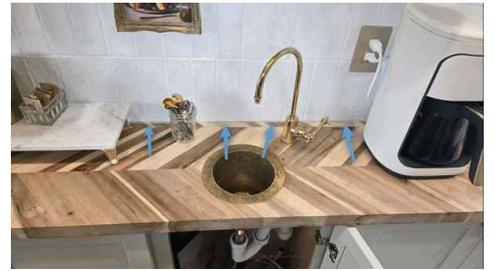
1st Floor Kitchen

The sealant where the counter and sink, faucet, counter and/or wall meets had sections of sealant that were cracking, missing and/or damaged. This may allow damage from moisture intrusion. Recommend correction by qualified contractor.

Recommendation  
Contact a qualified professional.

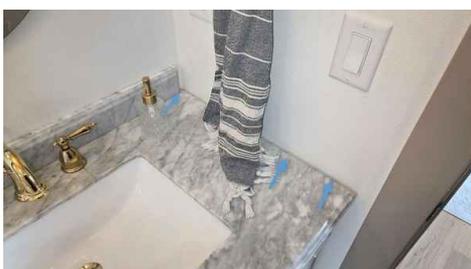
1st Floor Master Bathroom Right Sink Missing Caulking

Recommended DIY Project

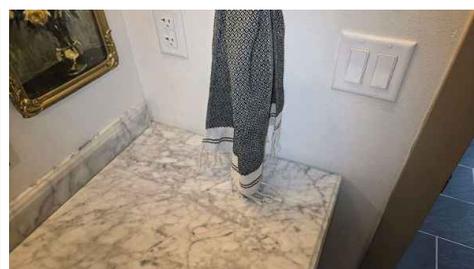
Basement Hall Bathroom Sink Missing Caulking

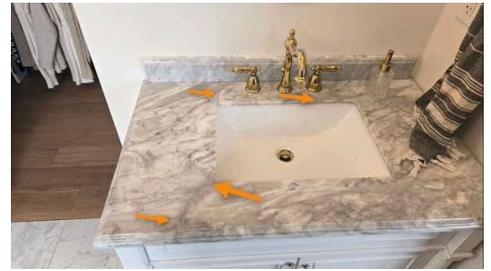
## 7.4.2 Bathroom Sink

1st Floor Master Bathroom Right Sink Counter Top

Contact a qualified professional.

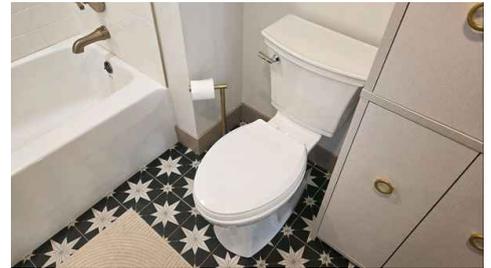
## 7.5.1 Bathroom Toilet

Basement Hall Bathroom Toilet

Contact a qualified plumbing contractor.

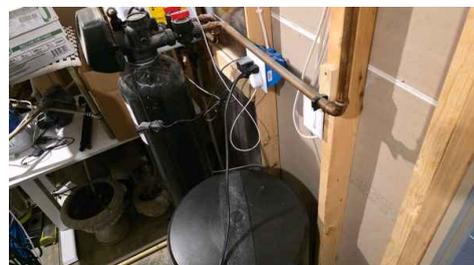
### **LIMITED INSPECTION DUE TO WATER SOFTENER OUTSIDE SOP**

The water softener was not inspected as its evaluation falls outside the scope of our inspection and the InterNACHI Standards of Practice. Functionality, maintenance status, and overall condition of the unit were not assessed. Recommend consulting a qualified water treatment specialist for a full evaluation of the water softener system.

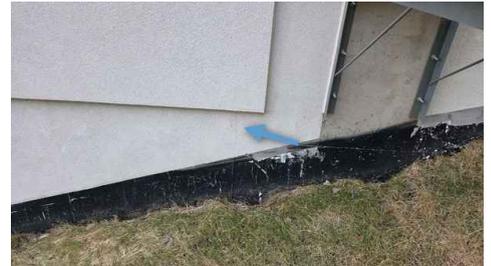
### CONCRETE FOUNDATION, SMALL HAIRLINE CRACKS W/ NO WATER PENETRATION

Small hairline cracks are a common occurrence in concrete foundations and are typically caused by natural shrinkage during the curing process or minor settling over time. These cracks are generally superficial and do not pose a structural concern when there is no evidence of water penetration or widening over time. Regular monitoring of these cracks is recommended to ensure they do not grow larger or develop into a more significant issue. Sealing the cracks with an appropriate sealant can help prevent moisture intrusion and extend the life of the foundation.
