GOLD SHIELD INSPECTIONS

## INSPECTION REPORT

9935 Ginger Ridge  
Dubuque , IA 52001

10/17/2025

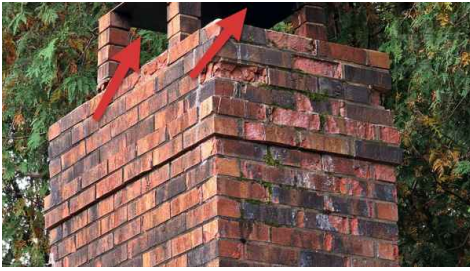
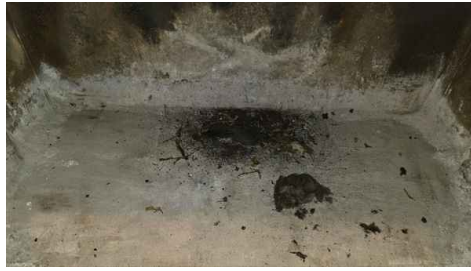
The chimney(s) had no spark arrestor. The Inspector recommends that all chimneys have an approved spark arrestor installed by a qualified contractor to prevent pest entry and to help protect the roof-covering materials from potential chimney-source ignition.

Contact a qualified roofing professional.

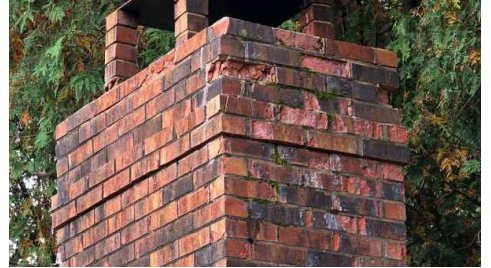
### 2.5.2 Chimney at Roof

## CHIMNEY BRICK SPALLING AND DETERIORATION

The exterior chimney structure shows significant brick spalling and mortar deterioration, particularly near the upper courses. Spalling occurs when moisture penetrates the masonry surface and freezes, causing the outer layers of brick to crack and flake off. This process can be accelerated by poor cap flashing, inadequate crown protection, or prolonged exposure to moisture. Over time, spalling can compromise the structural integrity of the chimney, allowing water intrusion into the masonry and interior spaces. It is recommended that the chimney be evaluated and repaired by a qualified masonry contractor. Repairs may include replacing damaged bricks, repointing deteriorated mortar joints, and ensuring that proper flashing and crown protection are in place to prevent future moisture damage.

Contact a qualified masonry professional.

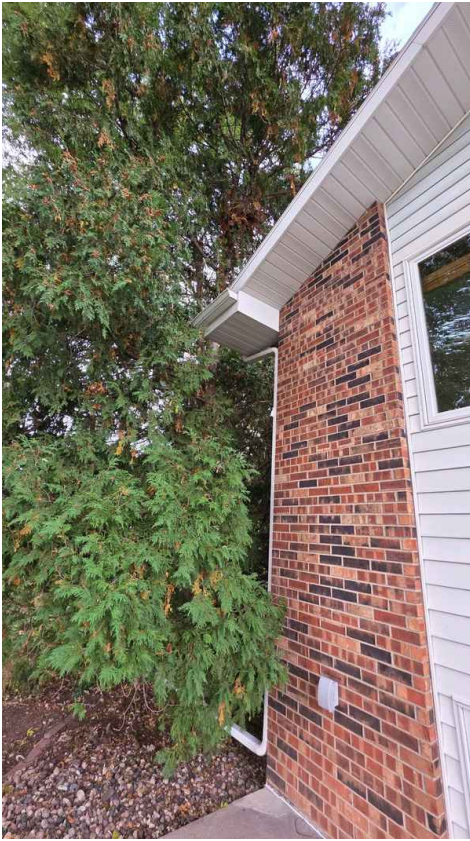
Bushes, plants, vegetation too close to home recommend at least 3 to 5 inches of clearance between home and vegetation as vegetation can promote moisture, and provide entry to wood destroying organisms to enter the home structure.

Maintenance or Low Priority

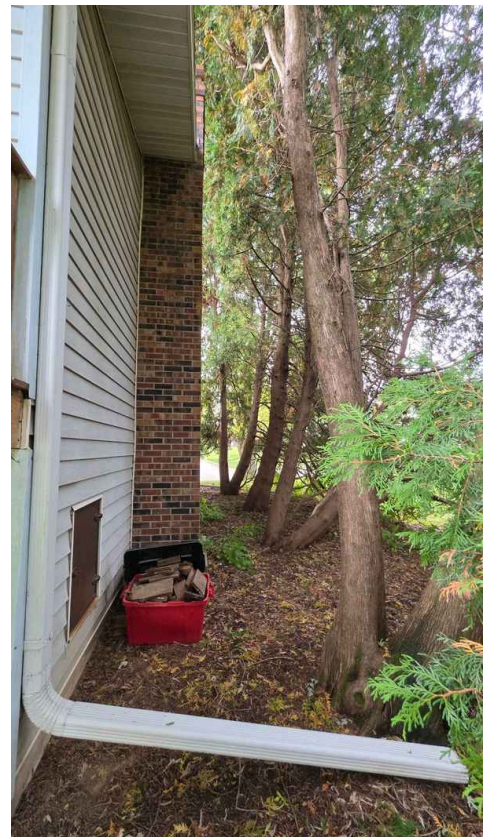
### 3.5.2 General Grounds

#### **EXTERIOR VEGETATION TREE PROXIMITY TO FOUNDATION WALLS**

Multiple mature trees were observed in close proximity to the home's foundation walls. Root systems from nearby trees can exert significant lateral pressure on foundation structures, leading to cracking, displacement, or uneven settlement over time. Additionally, these roots can damage underground drainage systems and contribute to moisture intrusion by retaining water near the foundation. It is recommended that trees and large vegetation be removed or relocated to a safe distance from the structure to prevent potential root-related foundation damage and to maintain proper drainage away from the home.

Contact a qualified tree service company.

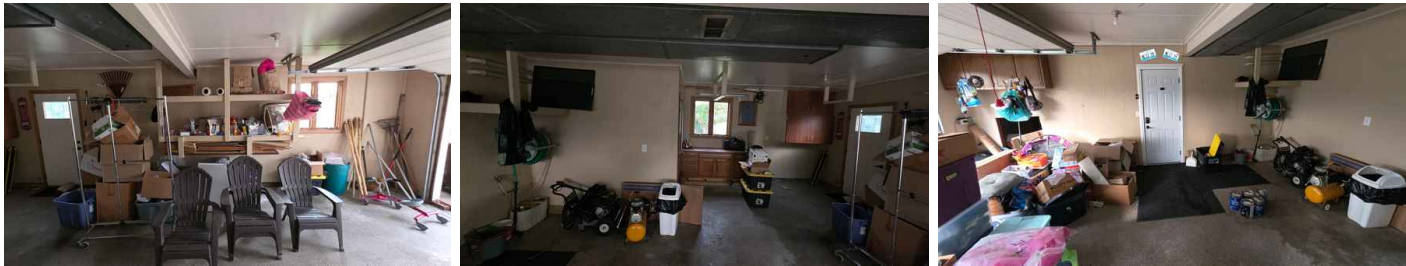
Garage Walls and Ceilings: Photo documentation

Garage Walls and Ceilings: Walls and Ceilings, Moderate Damage

Garage walls and ceilings exhibited moderate damage to coverings and other surfaces. No significant damage was observed.

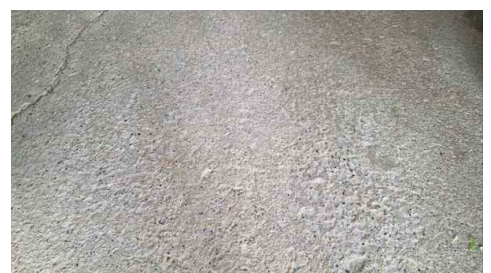
### 4.3.3 Garage Floors

#### **GARAGE FLOOR, SPALLING OR SURFACE DETERIORATION**

Contact a qualified concrete contractor.

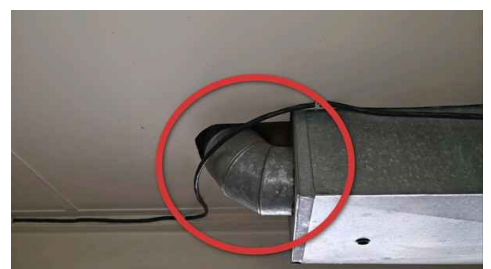
### 4.4.1 Garage Walls and Ceilings

#### **AIR BARRIER BETWEEN GARAGE CEILING AND FLOOR ABOVE (DRIVE UNDER GARAGE)**

Recommend installation of an air barrier or sealing drywall to ensure no carbon monoxide seeping into living space above. This is important if you plan on parking in your garage as your vehicle will put off carbon monoxide while running.

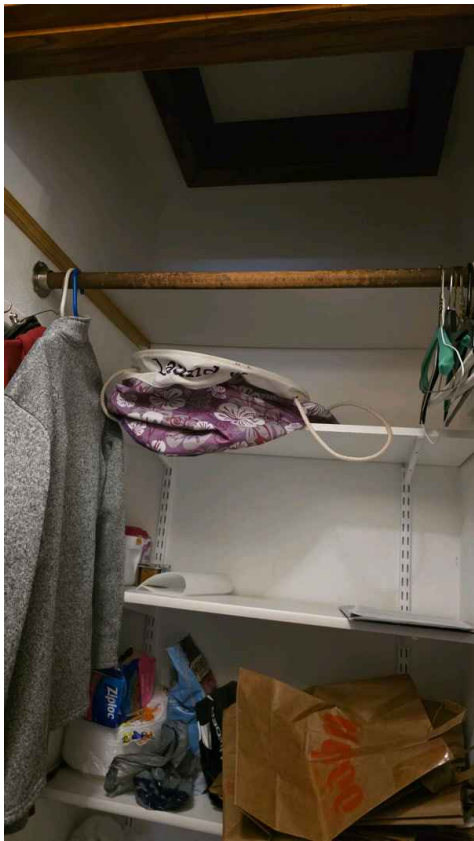
### **LIMITED INSPECTION, RESTRICTED ACCESS - INSPECTION POLE USED**

Access to the attic space was restricted, preventing full entry and thorough evaluation. To compensate, an inspection pole and camera were used to view the areas immediately surrounding the attic access hatch. The inspection was limited to the portions of the attic visible in the captured images, and other areas of the attic may not have been assessed. It is recommended to address the access restrictions and, if necessary, schedule a follow-up inspection to evaluate the attic space more comprehensively.

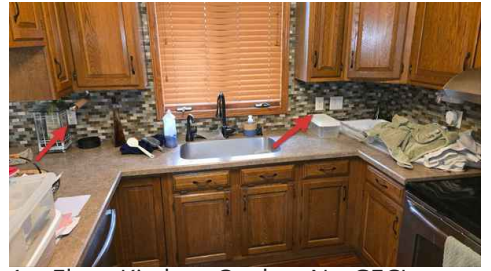
1st Floor Kitchen Outlets No GFCI Protections

Contact a qualified electrical contractor.

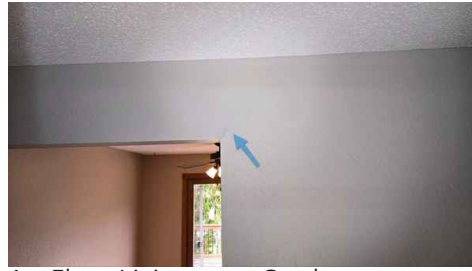
1st Floor Livingroom Crack

Contact a qualified professional.

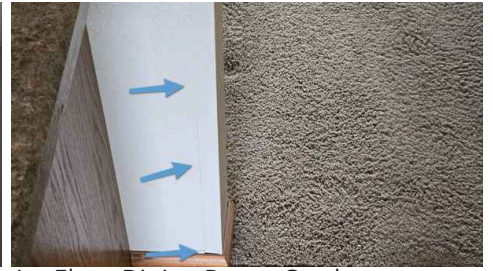
1st Floor Dining Room Crack

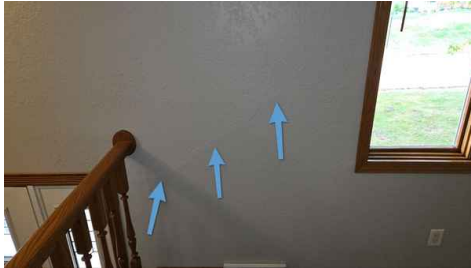
1st Floor Livingroom Wall Starts From Front Door Goes To Livingroom Window

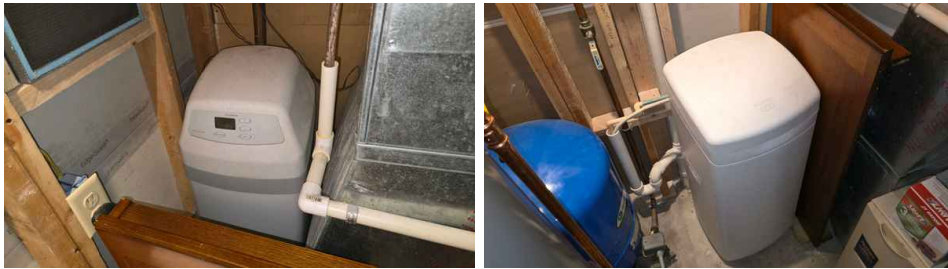
### **LIMITED INSPECTION DUE TO WATER SOFTENER OUTSIDE SOP**

The water softener was not inspected as its evaluation falls outside the scope of our inspection and the InterNACHI Standards of Practice. Functionality, maintenance status, and overall condition of the unit were not assessed. Recommend consulting a qualified water treatment specialist for a full evaluation of the water softener system.
