## INSPECTION REPORT

2305 Buckskin Cir  
Dubuque, IA 52001

09/29/2026

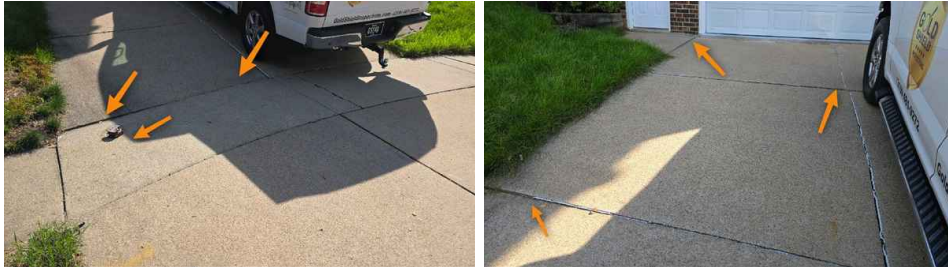
## 3.2.1 Driveway

One section has settled enough to have an exposed main water shut off terminal above the concrete level in the driveway

Contact a qualified concrete contractor.

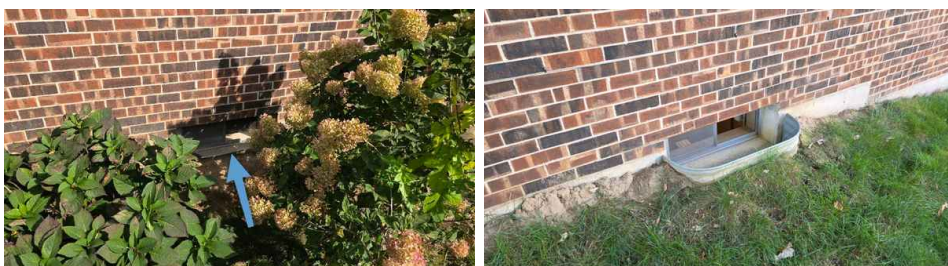
## 3.5.1 Exterior of Windows

**WINDOW WELL COVERS**

Recommended DIY Project

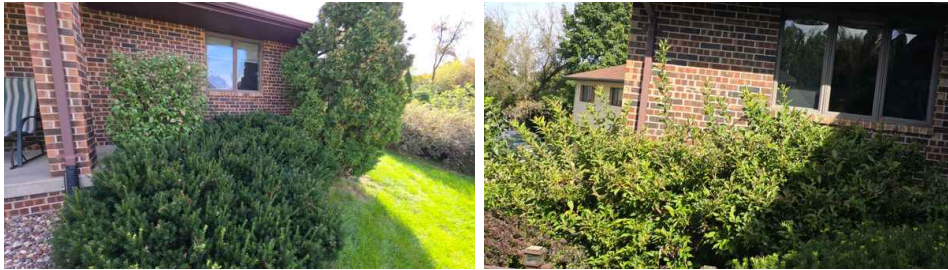
## 3.11.1 General Grounds

**VEGETATION TO CLOSE TO STRUCTURE**

Contact a qualified professional.

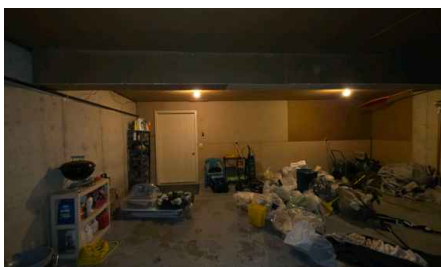
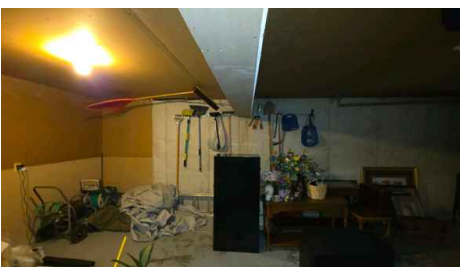
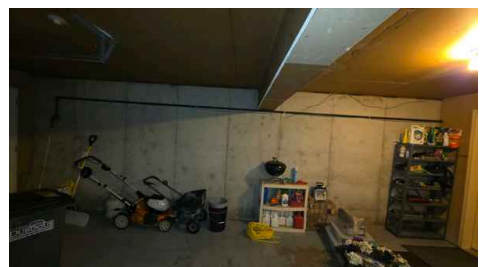
## Garage Walls and Ceilings: Walls and Ceilings, Moderate Damage

Garage walls and ceilings exhibited moderate damage to coverings and other surfaces. No significant damage was observed.

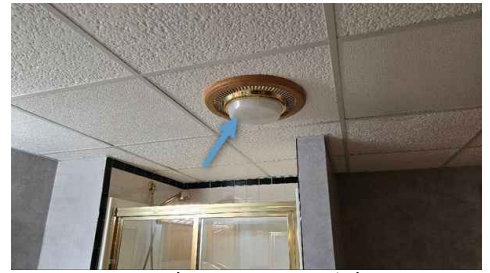
Basement Bathroom Vent Light

**BATHROOM VENT FAN LIGHT INOPERABLE**

The combination bathroom vent fan and light fixture was tested, and while the fan functioned as expected, the light did not operate. This may be due to a burned-out bulb; however, the possibility of a faulty switch, wiring issue, or problem within the fixture itself cannot be ruled out without further investigation. Recommend replacing the bulb first to determine if that resolves the issue. If the light remains non-functional, evaluation by a qualified electrician may be necessary to ensure safe operation and proper wiring.

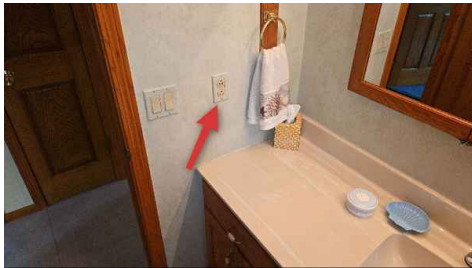
1st Floor Hall Bathroom Bathroom Outlet Improperly Wired and Loose

Contact a qualified electrical contractor.

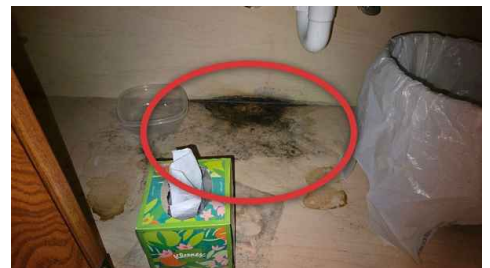
1st Floor Hall Bathroom Sink Inside Cabinet

**BATHROOM CABINET POTENTIAL BIOLOGICAL GROWTH UNDER SINK**

Potential biological growth was observed on the surfaces beneath the bathroom sink. This growth is typically associated with conditions of elevated moisture, often resulting from plumbing leaks, condensation, or past water intrusion events. The affected area may pose health concerns for sensitive individuals and could indicate ongoing or prior moisture issues that warrant further attention. It is recommended that a qualified professional evaluate the plumbing for leaks, and that remediation of the affected materials be performed by a contractor experienced in the proper handling and removal of biological growth.

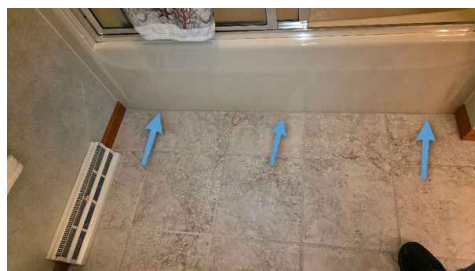
1st Floor Hall Bathroom Tub Missing Caulking

Recommended DIY Project

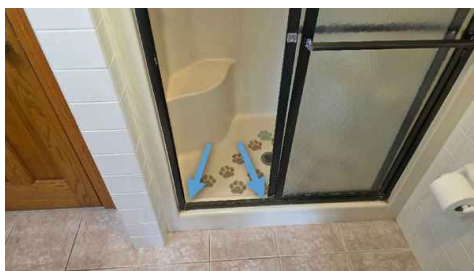
1st Floor Master Bathroom

#### **BATHROOM TUB/SHOWER, MISSING OR DETERIORATED GROUT OR CAULKING**

Grout or caulking around tiles, tub edges, or shower joints was cracked, missing, or deteriorated. This can allow water to seep into surrounding materials, causing damage. Recommend removing old grout or caulking and applying fresh, waterproof material.

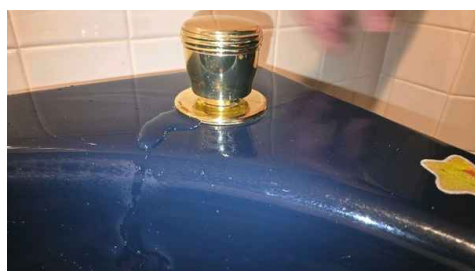
Basement Bathroom Tub Handle Leak

Contact a qualified professional.

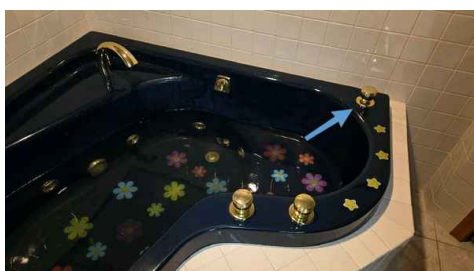
#### **BATHROOM, SHOWER OR TUB HANDLES, LEAKING WHEN OPERATED**

The shower or tub handle assembly was observed leaking when the water was turned on, indicating that the internal cartridge, stem, or associated seals are no longer providing a proper watertight seal. This type of leakage is commonly caused by worn O-rings, deteriorated cartridges, or mineral buildup within the valve body. While currently limited to the handle area, ongoing leakage can lead to moisture damage inside the wall cavity and accelerate deterioration of the shower valve components. Recommend evaluation and repair by a qualified plumbing contractor to restore proper function and prevent further moisture-related issues.

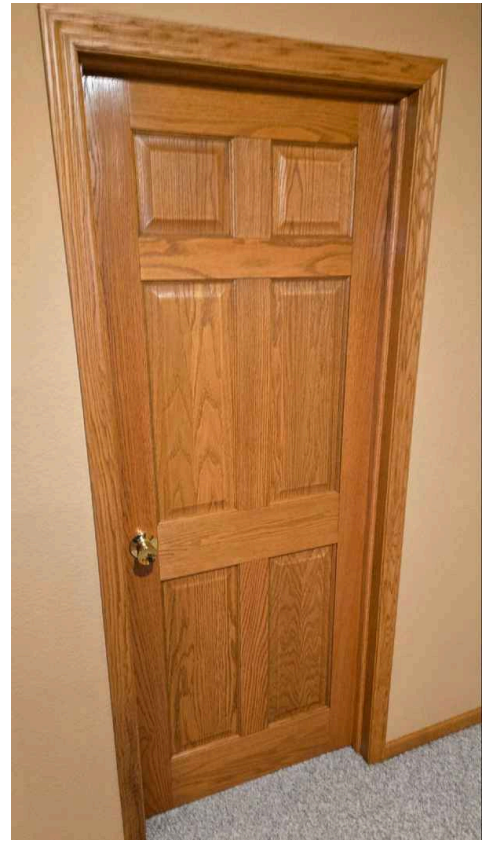
Basement Bedroom's Door Wont Latch and Drags on Carpet

Contact a qualified door repair/installation contractor.

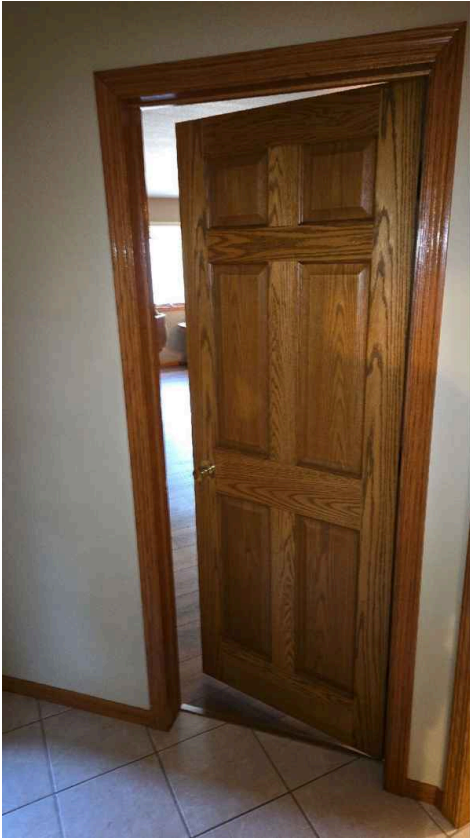
1st Floor Livingroom Door Missing Striker Plate and Wont Latch

Contact a qualified door repair/installation contractor.

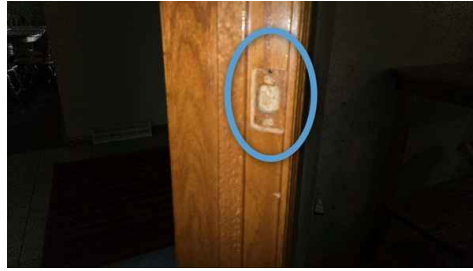
Door hardware such as knobs, handles, or locks was loose, missing, or malfunctioning. Recommend replacing or repairing the hardware for proper operation and security.

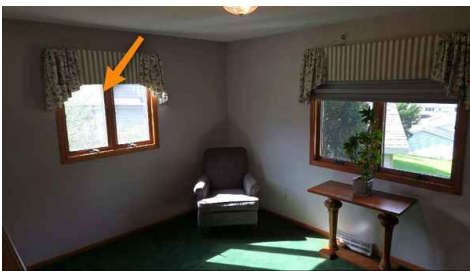
1st Floor South West Bedroom's Far Left Window

### GENERAL WINDOW, FOGGED OR FAILED SEALS (BLOWN SEAL)

Contact a qualified professional.

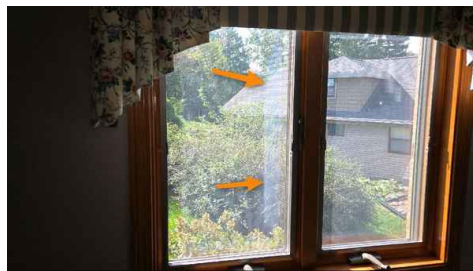
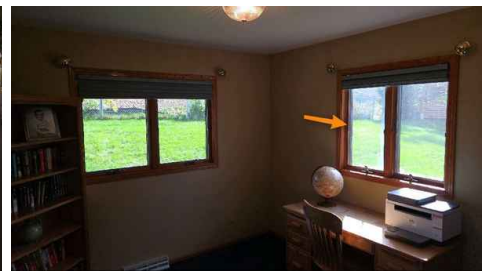
Seal failure in insulated glass units (IGUs) allows moisture and air between panes, leading to fogging. This reduces insulation and visibility. Seal failure is often caused by aging, poor manufacturing, or extreme weather. Recommend replacing the IGU to restore clarity and energy efficiency.

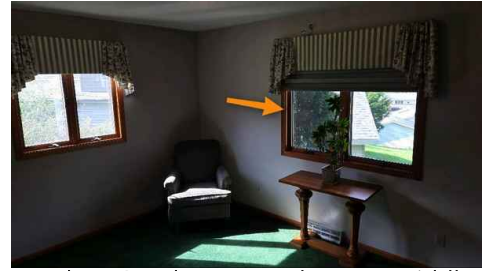
1st Floor South West Bedroom's Middle Right Window (When Trying To Open Gets Sticking On Top)

Contact a qualified window repair/installation contractor.

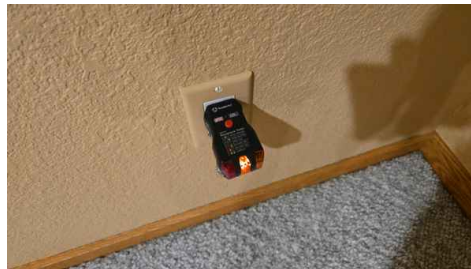
Basement Livingroom Outlet

An outlet with an open ground lacks a proper ground connection, which is critical for safely redirecting excess current in case of a fault. This issue can increase the risk of electrical shock and is common in older homes. Recommend upgrading or repairing the outlet to include a proper ground wire.

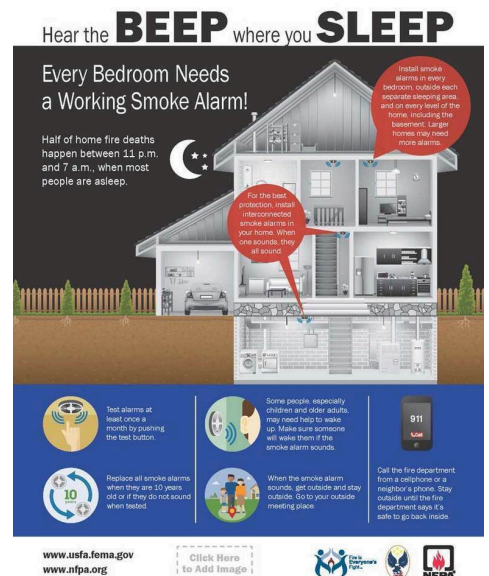
**SMOKE DETECTOR INSTALL MORE**

The Inspector recommends installing a smoke detector to provide improved fire protection for common areas. Generally-accepted current safety standards recommend smoke detectors be installed in the following locations:

Recommended DIY Project

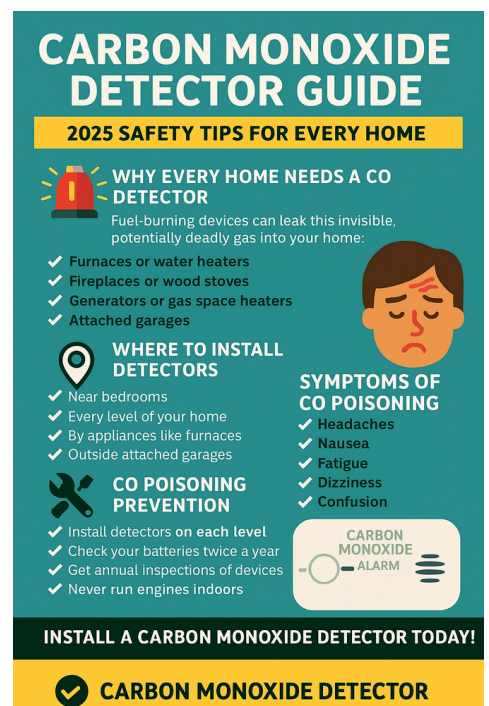
### CO DETECTOR NEEDED

The Inspector recommends installing a carbon monoxide detector. Carbon monoxide is an odorless, colorless, tasteless, toxic gas that is a product of the combustion process. Combustion appliances such as gas furnaces and heaters can introduce dangerously high levels of carbon monoxide onto the indoor air if combustion components need adjustment. Carbon monoxide detectors monitor indoor air and sound an alarm if dangerously high levels of carbon monoxide are detected. They are inexpensive and available at most hardware and home improvement stores. The Inspector recommends installation by a qualified contractor.

Safety Concern

Recommended DIY Project

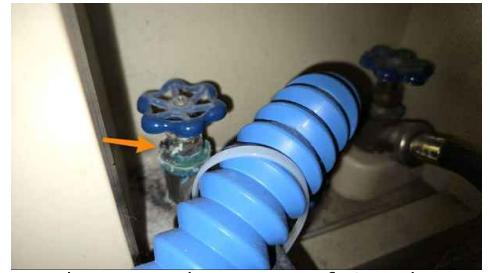
1st Floor Laundry Room Left Supply

**LAUNDRY ROOM WASHER WATER SUPPLY CORRODED AND RUSTED**

Contact a qualified professional.
