## INSPECTION REPORT

317 W Grand St  
Monticello, IA 52310

05/13/2026

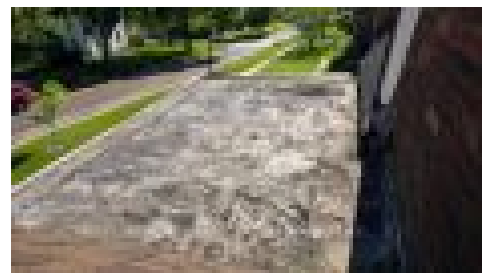
The flat roof surface showed significant deterioration and areas where the protective roof coating is worn, deteriorated, or missing. Protective coatings on this style of roof help shield the roofing materials from ultraviolet exposure, moisture intrusion, and premature surface deterioration. As coatings deteriorate over time, the roof membrane becomes more susceptible to cracking, accelerated wear, ponding-related damage, and active leaks. The roof surface also showed general weathering and aging consistent with prolonged exposure. Recommend evaluation and repair by a qualified roofing contractor, including recoating or replacement of damaged roofing materials as needed to help extend the service life of the roof and reduce the potential for moisture intrusion.

Recommendation

Contact a qualified roofing professional.

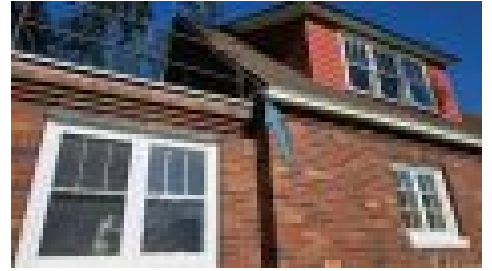
#### **DOWNSPOUT, NOT INSTALLED**

No downspout was installed at the time of the Inspection. This allows water to flow directly along the siding from the discharge of the gutter. Overtime this can force water behind the siding into the wall structure causing damage as well as possible biological growth. Recommend installation of downspout so water is routed off and away from the home.

Recommendation

Contact a qualified gutter contractor

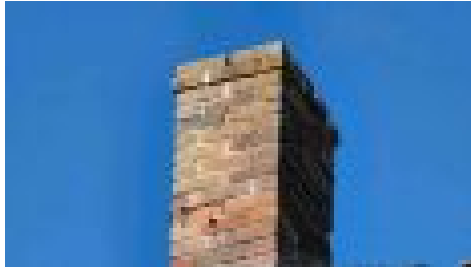
The brick chimney had severely deteriorated brick and mortar. This can result in a reduction of structural integrity. Recommend tuck point repairs on mortar to ensure stability.

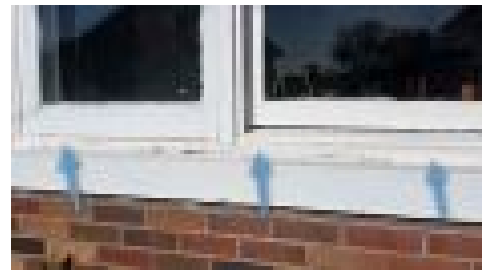
### EXTERIOR, WINDOW SILL, MOISTURE DAMAGE

The exterior wooden window sill showed signs of moisture damage and deterioration. Visible deterioration, peeling materials, softening wood, and weather-related wear were noted at the sill area. This condition is commonly caused by prolonged exposure to moisture, inadequate sealing or painting, improper drainage, or age-related deterioration of the exterior wood components. If not corrected, continued moisture intrusion can lead to additional wood rot, damage to surrounding exterior materials, and potential pest intrusion. Recommend repair or replacement of the damaged window sill materials and sealing or painting of exposed wood surfaces to help prevent further deterioration.

## Recommendation

Contact a qualified professional.

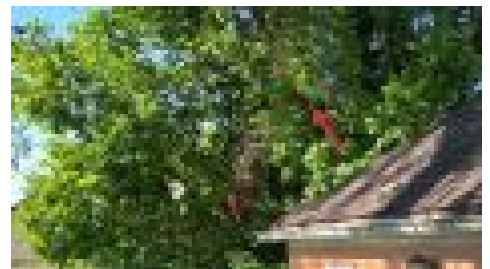
Tree limbs in direct contact with the service entrance lines pose a significant safety hazard. Movement from wind or storms can cause the branches to abrade the insulation on the wires, potentially leading to exposed conductors, electrical arcing, or power outages. Additionally, heavy limbs may place stress on the service drop, causing damage to the connection points at the home. It is recommended to have the tree limbs professionally trimmed to maintain a safe clearance around the service entrance lines and prevent potential electrical hazards.

## Recommendation

Contact your local utility company

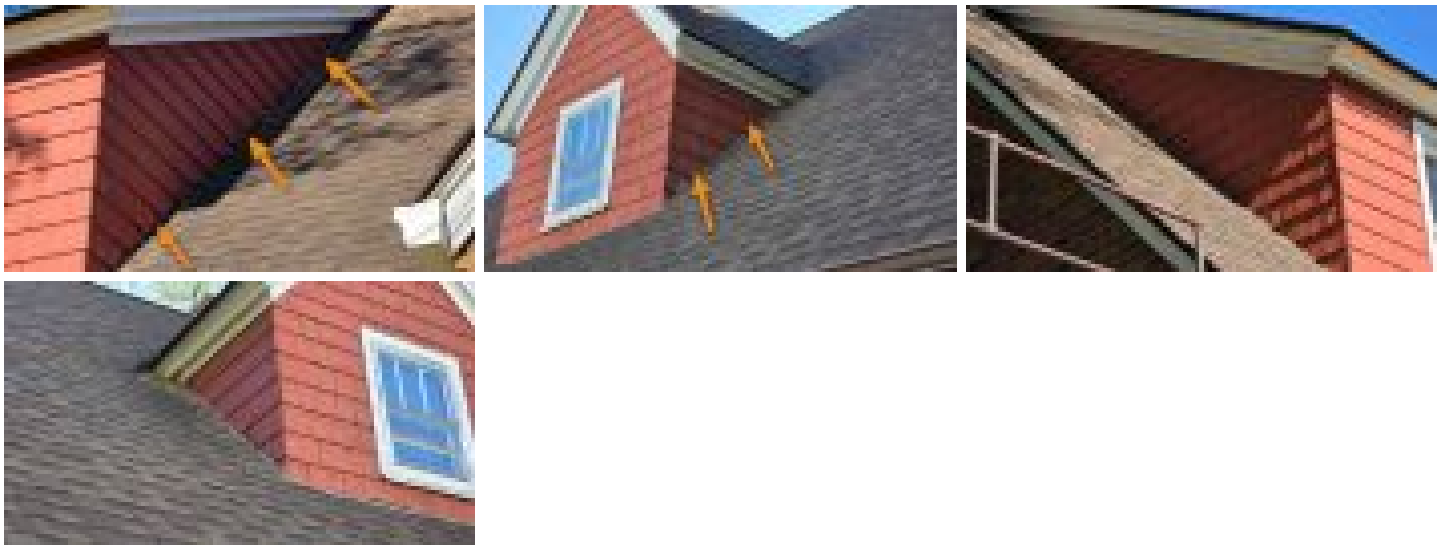
## 3.13.1 Wood Siding

The wood siding is in direct contact with the asphalt roofing shingles, a condition that can lead to accelerated material deterioration and moisture intrusion. Wood materials should be kept properly elevated above roof surfaces to prevent water wicking, saturation, and decay. When siding materials terminate directly on the roof covering without an adequate clearance or flashing detail, they are subjected to constant moisture exposure from runoff and debris accumulation, which can result in rot, mold, or structural compromise of the siding and sheathing underneath. This installation practice also limits the ability of the roof surface to shed water properly. Recommend evaluation and correction by a qualified contractor to establish the necessary clearance and install proper flashing if needed, helping to ensure the longevity and effectiveness of both the siding and roofing system.

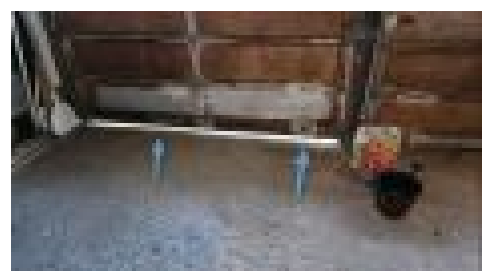
Garage Left Door From Inside

The garage overhead door does not fully seal along the bottom when in the closed position. Visible gaps were observed between the bottom weather seal and the floor surface, which can allow air infiltration, moisture intrusion, debris, and pests to enter the garage. This condition is commonly caused by a worn or deteriorated bottom seal, uneven or settled concrete floor slab, misalignment of the door tracks, or improper door adjustment.

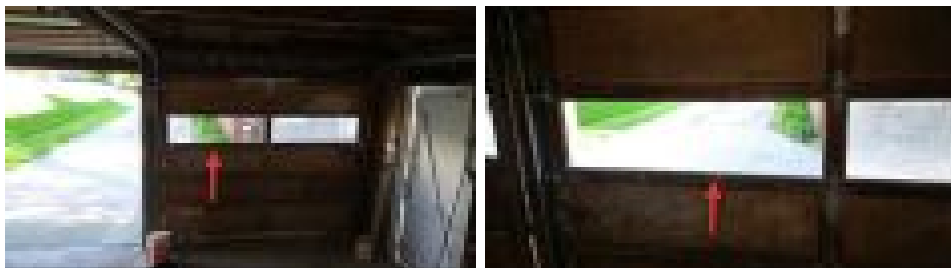
Garage Right Door Missing Glass Panel

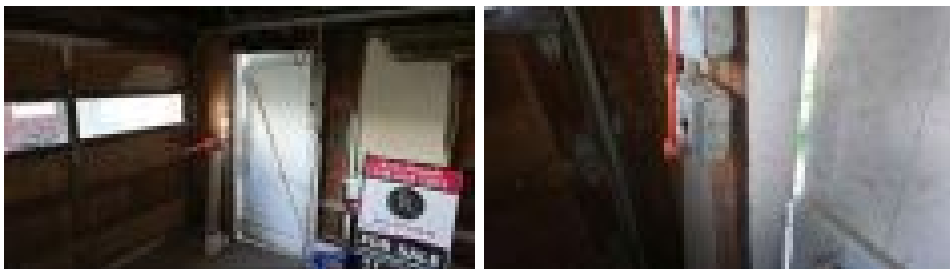
Garage Outlet Loose

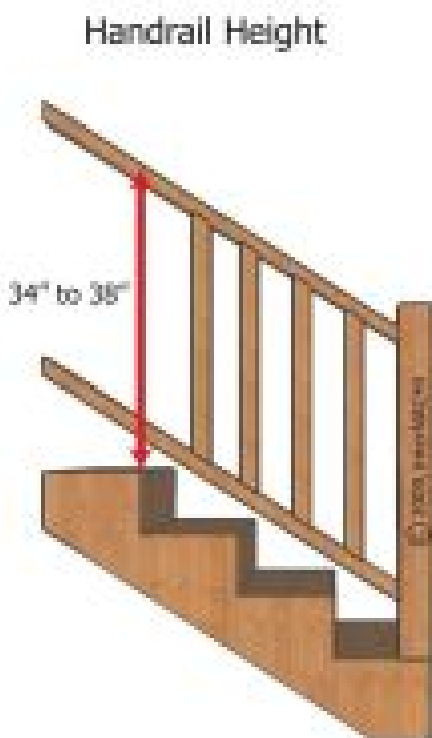
4.9.1 Garage Stairs/Steps to Living Space

The steps leading to the door between the garage and the living space had no handrail installed. In order to comply with modern building practices which require a handrail at stairways with 4 or more risers, this stairway would need a handrail installed. The Inspector recommends that a handrail be installed by a qualified contractor that complies with modern building requirements.

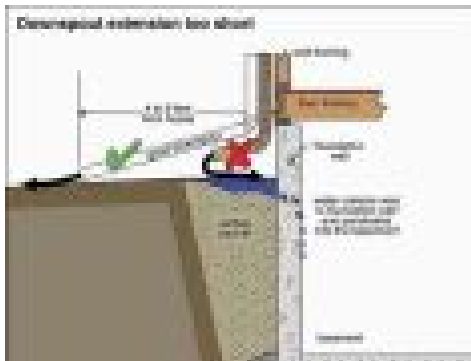
Back Of Garage

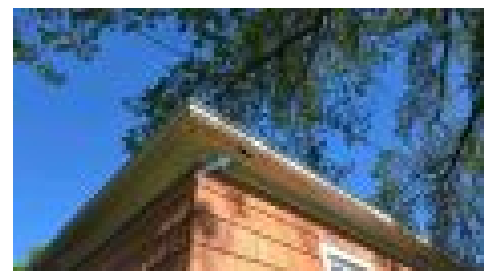
Garage Left Side Of Garage

No downspout was installed at the time of the Inspection. This allows water to flow directly along the siding from the discharge of the gutter. Overtime this can force water behind the siding into the wall structure causing damage as well as possible biological growth. Recommend installation of downspout so water is routed off and away from the home.

Recommendation

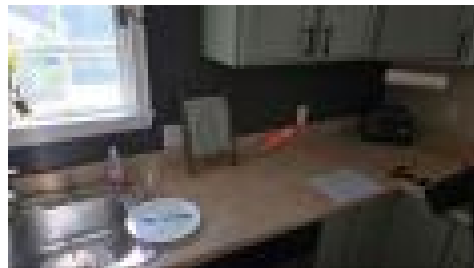
1st Floor Kitchen Outlet No GFCI Protection

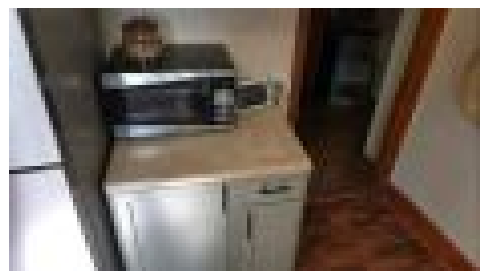
**Defect:** Cabinets were observed to be inadequately secured to the wall or floor, posing a potential safety hazard.

1st Floor Kitchen Cabinet Countertop

**Recommendation:** Reinforce cabinet fastenings to ensure they are securely attached and capable of supporting their intended loads.

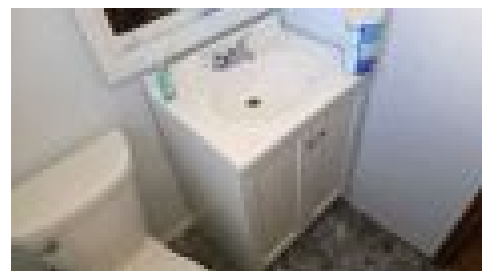
2nd Floor

The sink was loose or improperly secured to the countertop, wall, or vanity. This condition can worsen over time and lead to water leaks or damage. Recommend securing the sink properly to ensure stability.

#### Recommendation

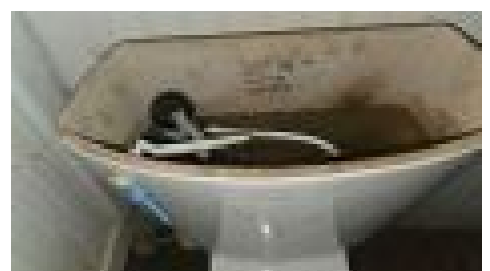
The toilet handle is broken and non-functional. This was observed during inspection of the toilet. A broken handle prevents normal operation of the toilet flush mechanism, requiring repair or replacement to restore proper function.

Recommendation

Contact a qualified plumbing contractor.

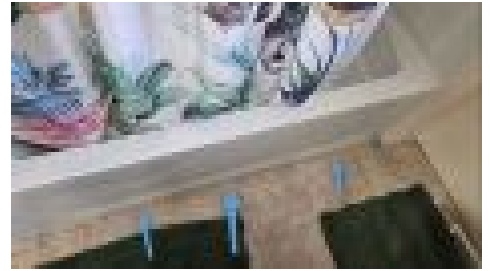
Grout or caulking around tiles, tub edges, or shower joints was cracked, missing, or deteriorated. This can allow water to seep into surrounding materials, causing damage. Recommend removing old grout or caulking and applying fresh, waterproof material.

1st Floor Hall Bathroom Tub Missing Caulking

Recommendation

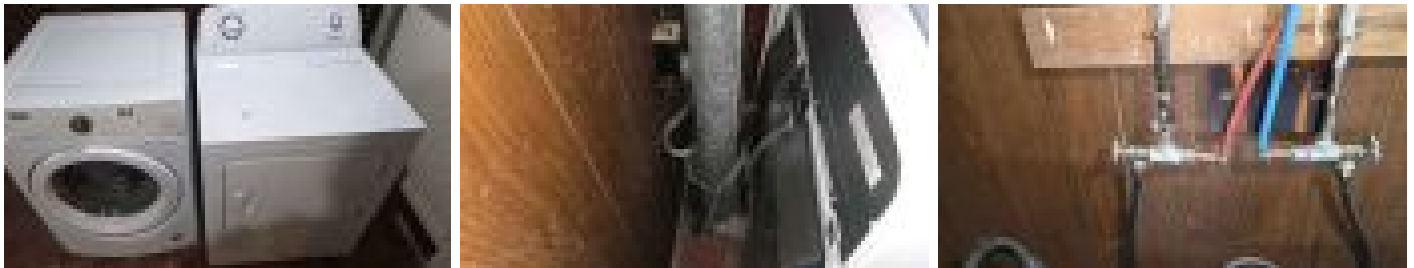
Washer and dryer hookups location.

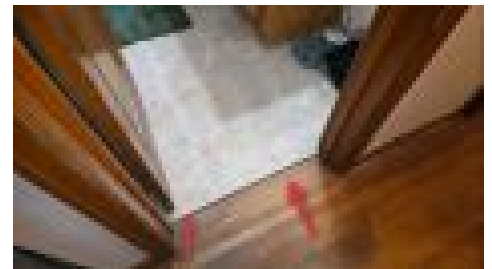
1st Floor Hall Bathroom

The transition strip between the bathroom floor and adjacent rooms was missing or improperly installed. This creates a tripping hazard and may expose edges to damage. Recommend installing or replacing transition strips for a safer and finished appearance.

Contact a qualified flooring contractor

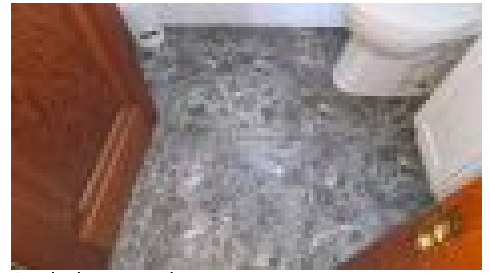
2nd Floor Bathroom

Peel-and-stick vinyl tiles in the bathroom are loose with visible gaps between tiles. This indicates poor adhesion and incomplete installation. Loose tiles can create trip hazards and allow moisture to penetrate underneath, potentially causing water damage and mold growth. The tiles should be firmly re-adhered or replaced by a flooring professional to ensure proper installation and moisture protection.

Contact a qualified flooring contractor

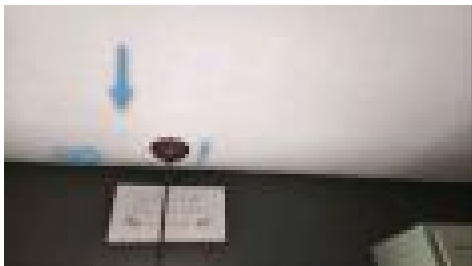
1st Floor Kitchen Above Window

Cracks were observed in the drywall, potentially caused by settlement, structural movement, or temperature fluctuations. Recommend sealing minor cracks with appropriate materials.

Contact a qualified professional.

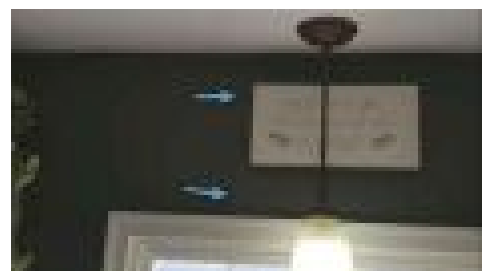
1st Floor Kitchen Above Window

Cracks were observed in the drywall, potentially caused by settlement, structural movement, or temperature fluctuations. Recommend sealing minor cracks with appropriate materials.

Contact a qualified professional.

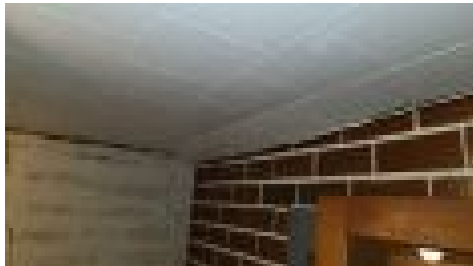
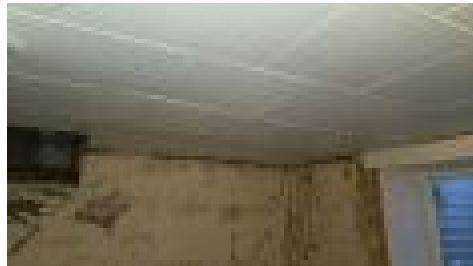
Basement

Sections of the suspended ceiling were observed to be sagging and partially loose from the supporting wood framing system. This condition is commonly caused by improper fastening, moisture intrusion, age-related deterioration, movement of the framing structure, or previous repairs that were not properly secured. Loose or drooping ceiling materials may continue to separate over time and can potentially fall, especially in areas exposed to vibration or elevated humidity levels. Recommend further evaluation and repair of the affected ceiling areas, including correction of any underlying

Contact a qualified professional.

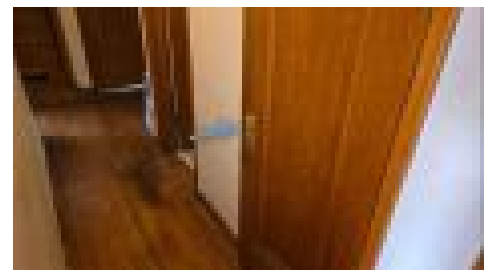
1st Floor Hall Closet Door Missing Handle

Contact a qualified door repair/installation contractor.

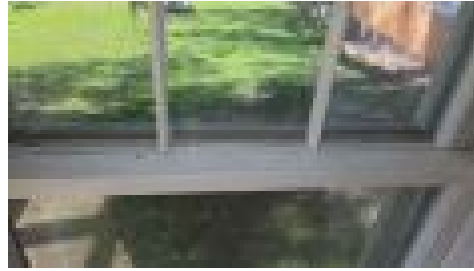
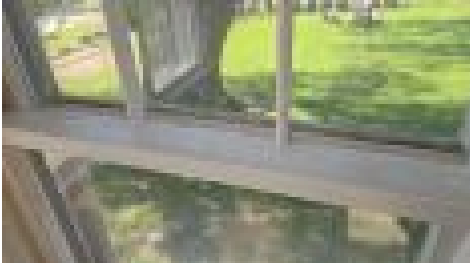
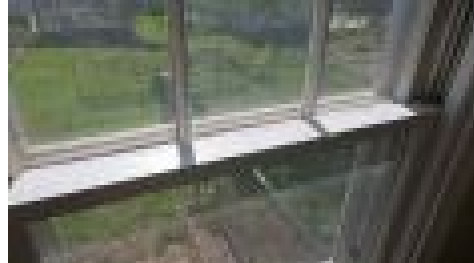
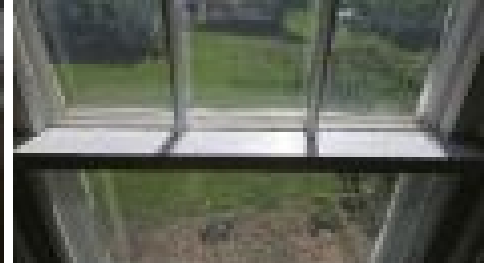
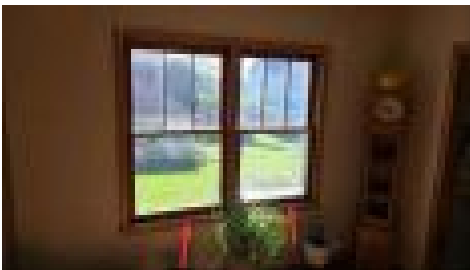
1st Floor Dining Room Windows

Broken or missing locks compromise home security and child safety. Locks often fail due to wear, misuse, or poor-quality materials. Recommend replacing with durable, properly fitting locks to enhance security.

Contact a qualified window repair/installation contractor.

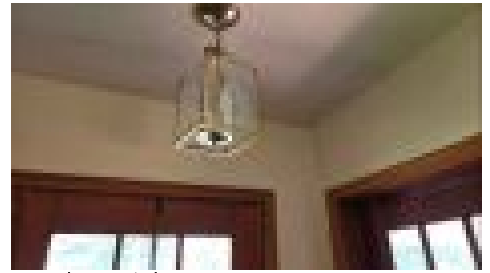
1st Floor Light By Front Door

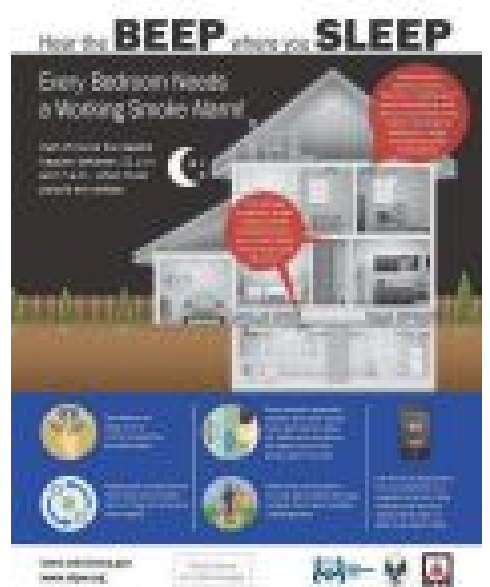
**SMOKE DETECTOR INSTALL MORE**

The Inspector recommends installing a smoke detector to provide improved fire protection for common areas. Generally-accepted current safety standards recommend smoke detectors be installed in the following locations:

Recommended DIY Project

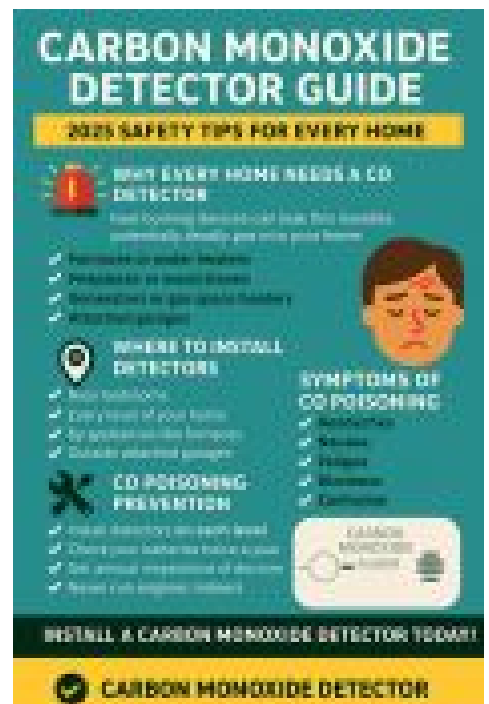
The Inspector recommends installing a carbon monoxide detector. Carbon monoxide is an odorless, colorless, tasteless, toxic gas that is a product of the combustion process. Combustion appliances such as gas furnaces and heaters can introduce dangerously high levels of carbon monoxide onto the indoor air if combustion components need adjustment. Carbon monoxide detectors monitor indoor air and sound an alarm if dangerously high levels of carbon monoxide are detected. They are inexpensive and available at most hardware and home improvement stores. The Inspector recommends installation by a qualified contractor.

Recommended DIY Project

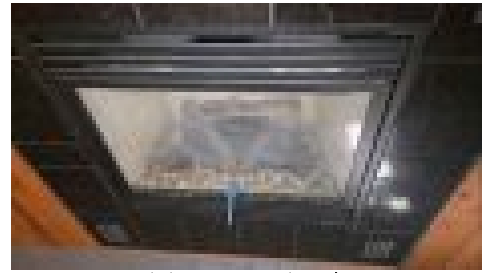
Basement Livingroom FirePlace

The gas fireplace has visible fogging and etching on the interior surface of the glass panel. This condition is often caused by the buildup of mineral deposits or combustion byproducts from prolonged use without regular cleaning or maintenance. Over time, these residues can permanently etch the glass, reducing visibility and detracting from the unit's appearance. While this may not affect the functionality of the fireplace, it is an indication that the unit could benefit from a professional cleaning and inspection to ensure safe and efficient operation. Recommend evaluation and maintenance by a qualified fireplace technician.

Recommended DIY Project

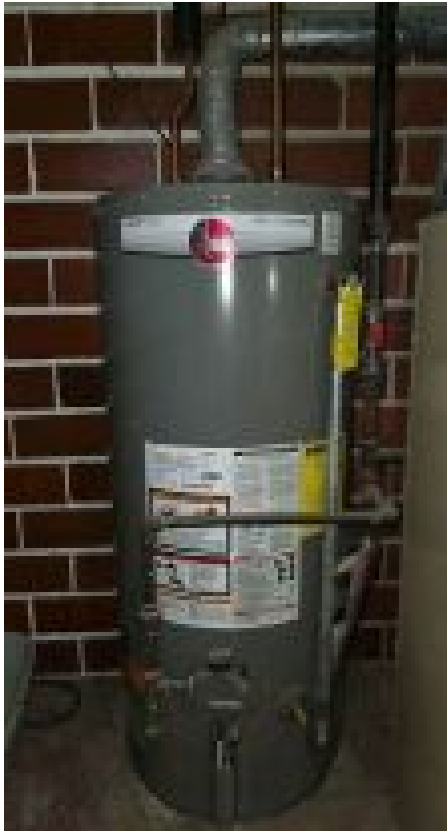
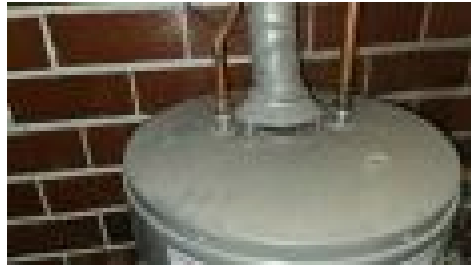
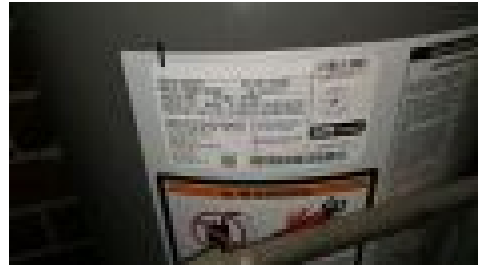
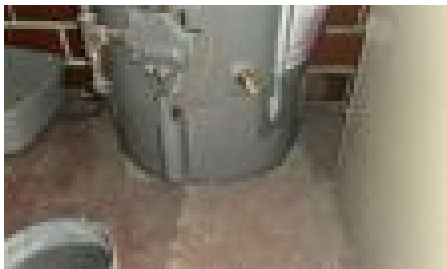
### Water Heater: Photo documentation

40 gallons

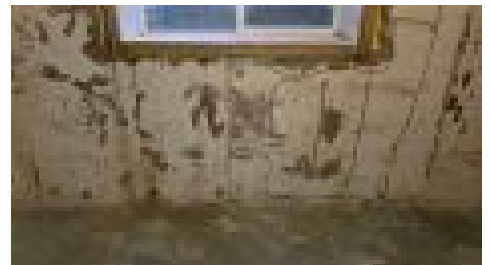
#### BASEMENT WINDOW MOISTURE SEEPAGE AT FOUNDATION WALL

Moisture staining and visible streaking were observed along the foundation wall beneath a basement window, indicating water intrusion around the lower section of the window assembly. This condition is often caused by inadequate exterior drainage, missing or compromised window well covers, failed or absent flashing, or sealant breakdown at the window perimeter. If not addressed, continued seepage can lead to interior damage, elevated humidity, and possible biological growth along concealed or finished wall areas. Recommend evaluation and corrective measures by a qualified contractor, which may include improving exterior drainage, resealing the window assembly, or adding a properly sized window well and cover.

Contact a qualified waterproofing contractor

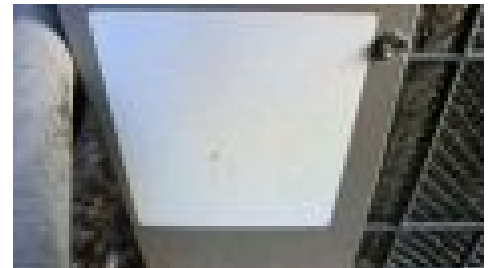
12.3.1 Central Air Conditioner

This A/C unit was beyond its average design life of 15 years. The Inspector recommends yearly service by a qualified HVAC technician to ensure that it is in the best possible working condition. Yearly maintenance can extend the life of the components. Unless otherwise noted the unit was operating and in good condition at the time of the inspection.

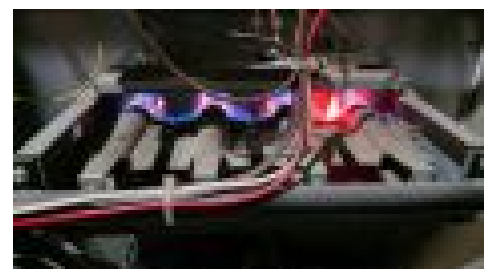
#### 12.4.2 Furnace

The furnace was observed to have an orange flame, which may indicate improper combustion. A properly functioning furnace typically has a steady, blue flame, which signifies clean and efficient burning of fuel. An orange or yellow flame can suggest incomplete combustion, which may result in the production of carbon monoxide, a dangerous and potentially life-threatening gas.
