**ALPINE MEADOWS CAMP**  
**Review of Selected Civil Engineering**  
**Aspects of the Camp**

December 2004

## **ALPINE MEADOWS CAMP SUMMARY OF FINDINGS AND RECOMMENDATIONS**

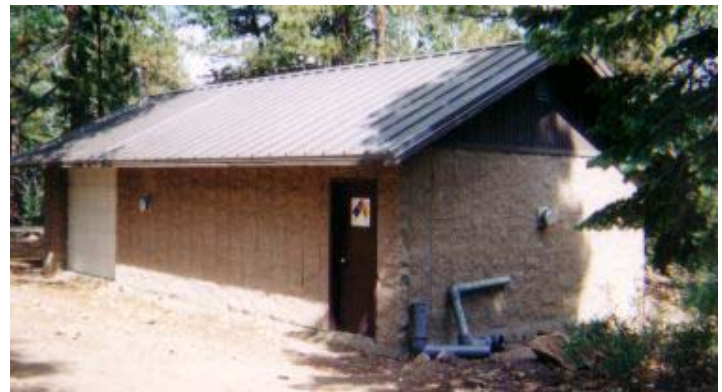
**Water Treatment Plant for the Barton Flats Camping Association**

The potable water for Alpine Meadows Camp comes from the South Fork of the Santa Ana River. The USFS owns the intake system and the treatment plant. The Barton Flats Camp Association, which is made up of eight separate camps including Alpine Meadows, is responsible for the operation of the water system. Summary information regarding the water system is included in Appendix A (To be included in final report)

The water treatment plant is licensed by the California Department of Health Services and is operated by a contract operator. The treatment plant was designed and built by the USFS and is of sophisticated design using membrane treatment technology, which is capable of providing high quality finished water. The camping association has had occasional issues with the operation of the treatment plant. One of the main issues has been that the treatment plant has not been operated consistently to provide the design output. The low water temperature has been cited as a reason for the periodic lower output, but there are likely operational issues as well. The camping association has been addressing the operational issues and has considered installing a sand filter as well to provide additional capacity and reliability. The treatment plant is relatively new and should be capable of providing sufficient water for existing needs given appropriate operation and maintenance. In the future, the plant may need to be upgraded to meet future needs.

1. Continue working with the Barton Flats Camping Association on the operation and maintenance of the water treatment plant. Work with the operator on improving treatment output and reliability. Continue to investigate the possible need for expanding treatment capacity based on the projected future demands of all members
2. Size a new water tank based on future development of Alpine Meadows
3. Relocate the water tank up the hill to provide sufficient pressure by gravity, eliminating the need for booster pumps, hydropneumatic tanks, and fire pumps
4. Construct the new water tank of glass fused steel to provide longer life with lower maintenance.
5. Evaluate and upgrade distribution system to provide adequate fire flow to fire hoses and to buildings with sprinklers based on future development plans

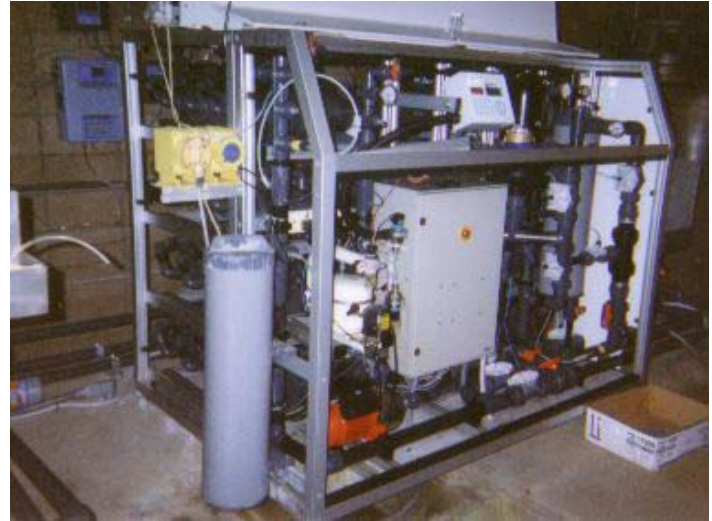
**Water Treatment Plant Filtration Equipment**

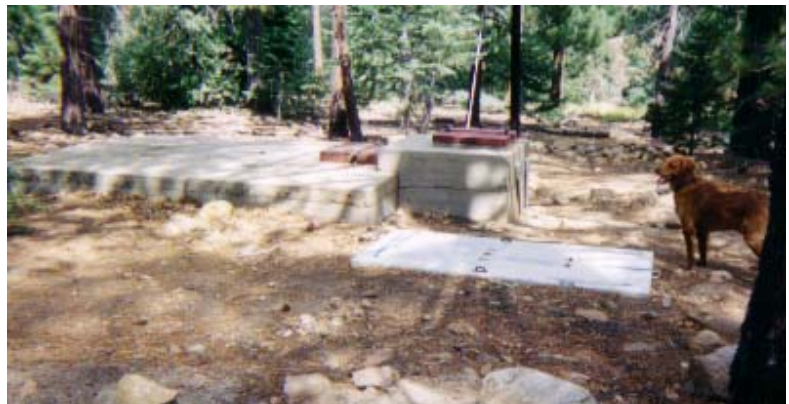
One issue with the management of the overall drinking water supply for the Barton Flats Camping Association has to do with the timing of the use of water. There is a relatively small amount of storage at the treatment plant and most of the storage is in tanks at individual camps. There is a small below ground concrete storage tank at the treatment plant that provides interim storage as the water is conveyed to each of the camps. Alpine Meadows is the closest camp to the treatment plant and hence, receives water first. There is the need for the camps to coordinate filling of swimming pools at the beginning of the season, otherwise the small tank at the treatment plant can be drained and there can be a shortage of drinking water at some camps. According to camp

**Below Ground Storage Tank at the Water Treatment Plant**

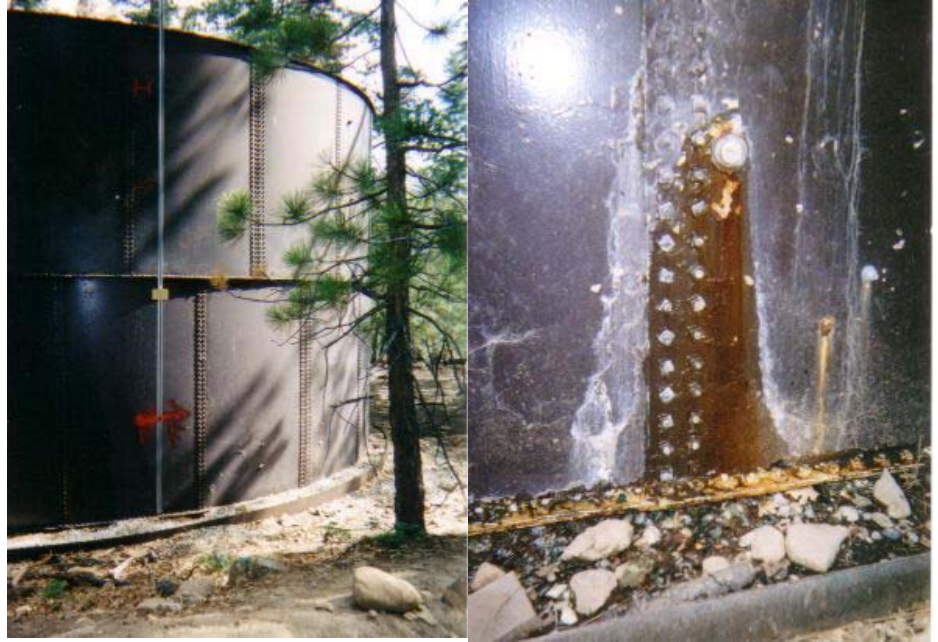
The storage tank for Alpine Meadows is located down the hill from the treatment plant. It is 88,000 gallons in size and is a painted bolted steel tank. The tank has various leaks and has been patched numerous times. It is not seismically restrained. The tank will need to be replaced in the near future. It is recommended that the new tank be constructed of bolted glass fused steel which provides a long life and does not require recoating.

**88,000 Gallon Painted Bolted Steel Water Tank Showing Leaking Plug**

It is recommended that the new tank be located at an appropriate location up the hill on USFS property at the proper elevation, which would be outside the boundaries of the existing camp.

The main reason for moving the tank is that the existing tank is at an elevation where it is too low relative to the buildings to provide adequate pressure by gravity and a booster pump system is needed. The booster pump system requires an electric pump and hydropneumatic tank to operate. If there is a power outage then a generator would be needed to provide water. As discussed below, the network of fire hoses throughout the camp are fed off of the potable water booster pump, which will not provide a high flow for fighting a fire and is dependent on electricity. Also, as discussed below, the fire sprinkler system feeds off of a separate pipeline from the 88,000 gallon tank and has a rated fire pumping system. If there was adequate flow from a storage tank up the hill, then a separate fire pumping system would not be needed. This could save money in the future if the camp were to be expanded with additional buildings that require sprinkling.

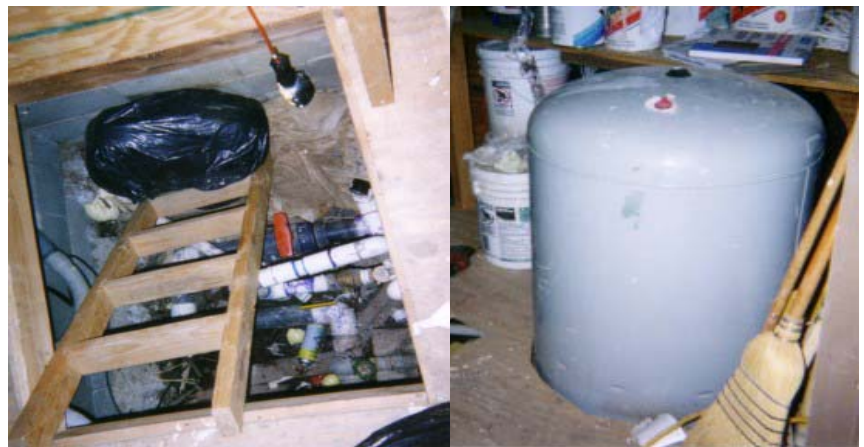
**Electric Booster Pump in Vault and Hydropneumatic Tank For Potable Water System**

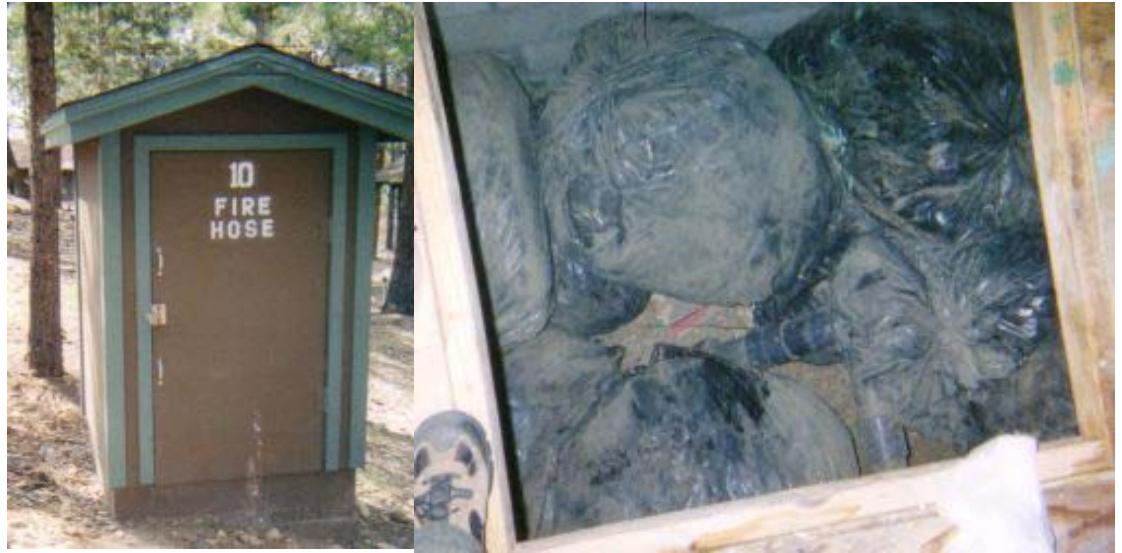
The Alpine Meadows Camp is equipped with 14 exterior fire hoses in exterior storage sheds. The fire hoses are connected to the 2 inch water distribution

**Typical Fire Hose Storage Shed and View of Below Ground Piping With Bags of Insulation**

water. The sheds provide both storage of the hoses and access to the below ground piping in vaults. The vaults are filled with plastic bags of insulation. This helps protect the piping from freezing.

The fire hoses are connected to the potable water system that are fed from the hydropneumatic tank and booster pump from the 88,000 gallon storage tank. It is recommended that the water distribution system be reevaluated based on required fire flow rates and upgrades be made to the water distribution system. As stated above, this would include building a new storage tank higher up the hill to provide gravity flow, which eliminates the need for booster pumps.

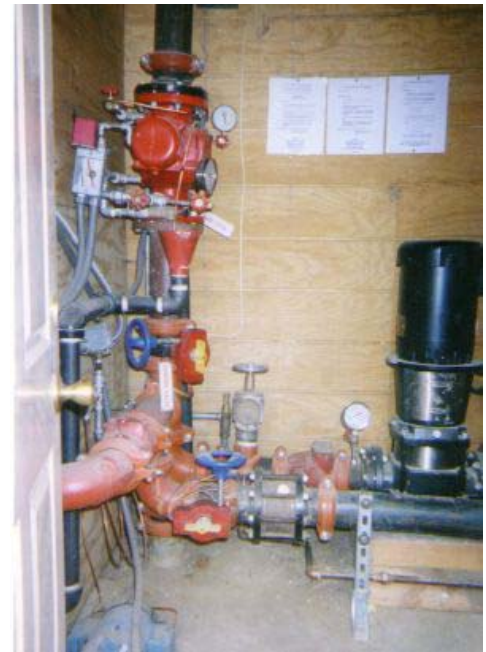
Currently Eagle Lodge and Coyote Lodge are the only buildings with fire sprinkler systems. There are some old sprinklers in Wolf Lodge, but they are not connected to a water system. The fire pump is in a closet in Eagle lodge and it was recently installed along with the

**Fire Pump and Riser in Eagle Lodge**

The fire pumping system is fed from a separate 4 inch pipe from the storage tank. If the water storage tank were moved up with hill to an appropriate location to provide adequate pressure, and an adequately sized distribution pipe were installed, then the fire pumping system could be eliminated. The fire risers and other fire sprinkling mechanical equipment would still be required for to meet the building codes required for the planned structures.

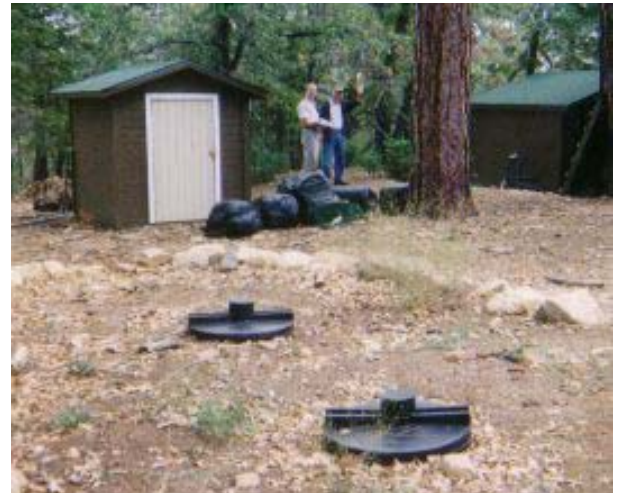
**Below Ground Irrigation Storage and Shed with Booster Pump and Hydropneumatic Tank**

Alpine Meadows Camp has an irrigation system separate from the potable and fire systems. The irrigation system captures backwash water from the water treatment plant and stores it in two 1500 gallon below ground tanks. There is a separate booster pump and hydropneumatic tank that conveys the water to various irrigation systems around the camp. There were no maps available showing irrigation piping and camp staff only had a general idea where pipes were likely located and no coherent map could be created from this information, although irrigation valving and sprinklers is generally apparent in the field.

The irrigation system meets the current needs of the camp. If the camp is expanded, the irrigation system should be reevaluated to determine what will be required to meet the new irrigation requirements.

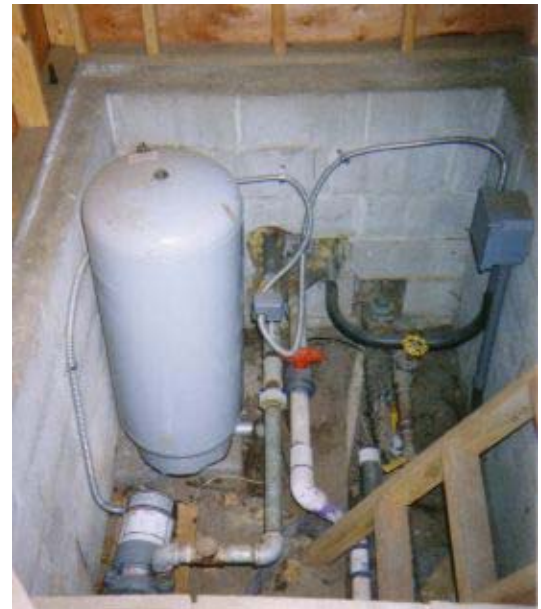
**Hydropneumatic Tank and Electric Booster Pump for Irrigation Water System**

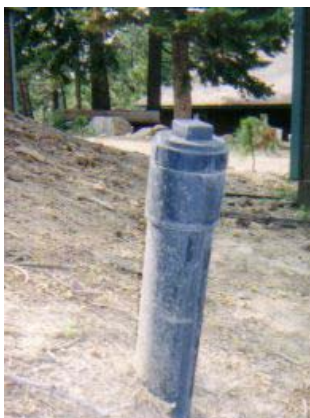
**Typical Wastewater Cleanout Riser**

The site was inspected and existing maps were reviewed. Systems served one or more buildings. Each system was of similar configuration with a septic tank and associated leach fields. Cleanout risers were common. The access ports for both distribution boxes and for the septic tanks were constructed of concrete riser rings and cast iron lids. This is a level of quality not commonly used in areas of low or

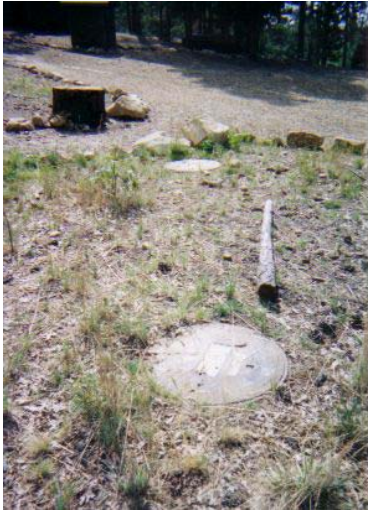
**Typical Septic Tank  
Access Manholes**

operation. Septic tanks have air volume that is above the wastewater in the tank. As the water flows in and out of the tank, the air volume varies because the water surface can change. This requires that some air volume exchanges in and out of the tank. It either exchanges through spaces around access covers or potentially through the soil if the air can move through the leach pipes and through perforations into the leach field soils. If desired, the access covers can be sealed with a product called Ram Nek or similar to reduce air exchange around the covers.

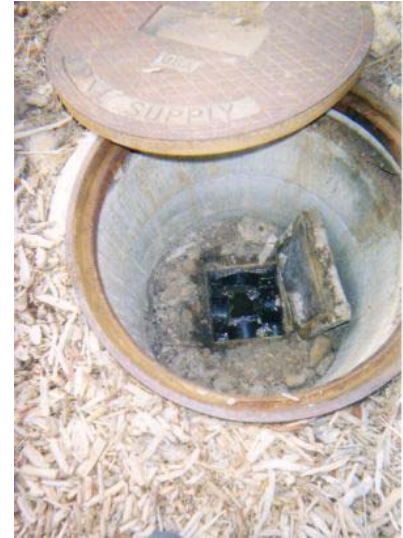
**Typical Septic System  
Distribution Manhole**

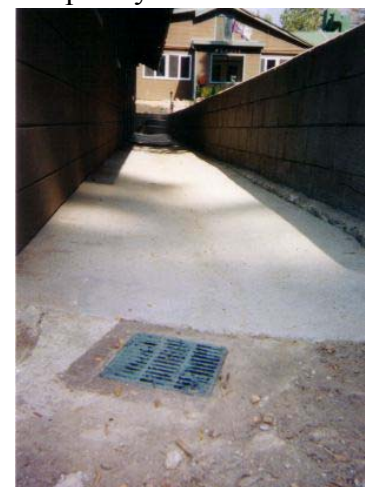
**Storm Drain at Wolf  
Lodge**

developed drainage ditches or piping. The one exception is that a small drain was installed in a sidewalk area behind a retaining wall at Wolf Lodge that was a low spot that puddle. Other than that, there is little need for formal drainage facilities. As the camp is expanded in the future, the potential for additional building and site drainage should be evaluated on a case by case basis.

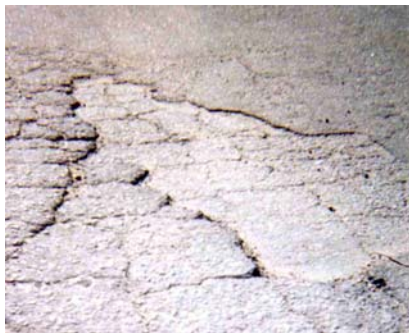
The main road in camp is approximately 4,000 feet long and an average of 10 feet wide. It is unknown when the road was originally paved. Based on its condition, the road has not had a significant paving improvement for many years. There is evidence of a series of thin paving patches along the road, some of which are peeling. Although there is severe alligator cracking on much of the road, large potholes and damage

**Peeling Thin Pavement Patch**

to the road subgrade have yet to develop. However, without additional maintenance, more severe degradation of the roadway will occur. There is also no crown on the road and the shoulders of the road have not been graded for some time, which is needed to facilitate proper draining. Without significant work to the road, the existing paving will break up and pothole severely over time.

It is recommended that the entrance road be repaved. This should include petromat fabric to bridge the alligator cracking, a leveling course of asphalt to reestablish the proper road grade, and a two tenths of a foot minimum asphalt overlay course. The shoulders of the road should also be graded to create proper drainage. Backing (a type of base rock) should also be compacted on the shoulders to make an even transition from the asphalt to the shoulder, which helps protect the edge of the paving and provides a smooth transition.

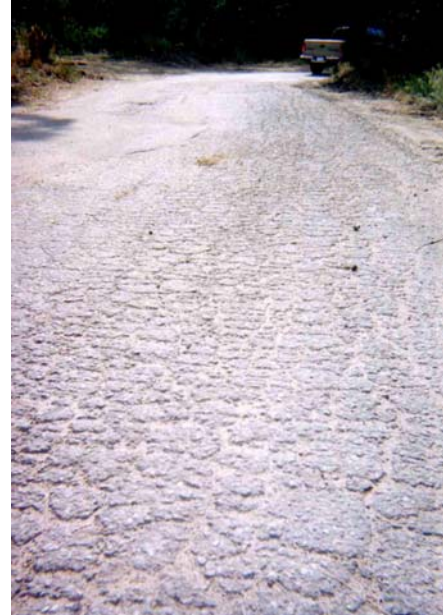
**Typical Condition of Access Road Showing Alligator Cracking**

An alternative to improving the road would be to wait until it deteriorates further, then bring in a pavement grinder and grind and recompact the surface and apply an oil sealant. This would provide an improvement over dirt, but with regular traffic and a variety of weather conditions, overall performance would be poor.

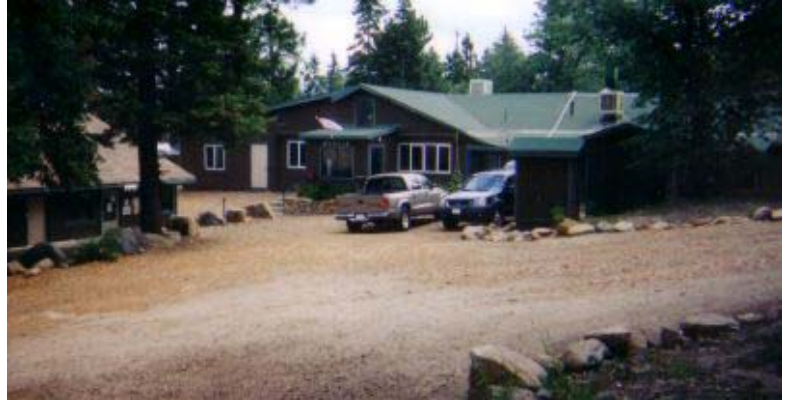
The gravel roads within the camp are in relatively good condition, although they are uneven in places. Since traffic is low, and the condition is relatively good, paving is not warranted. Occasional light grading is likely all that will be needed to keep the camp roads in acceptable condition.

**Eagle Lodge and Typical Gravel Roads  
Around the Camp**
