PROPERTY INSPECTION REPORT FORM

Home Inspection Report

PROPERTY INSPECTED:
1600 Barton Springs Road
4406
Austin, TX 78704

DATE OF INSPECTION: 07/13/2022
Inspection No. 521255-2333

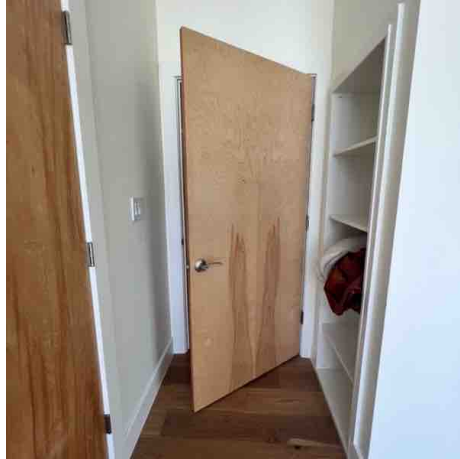
- The entry door and closet door handles are loose. Refasten for improved function. (Guest Room)

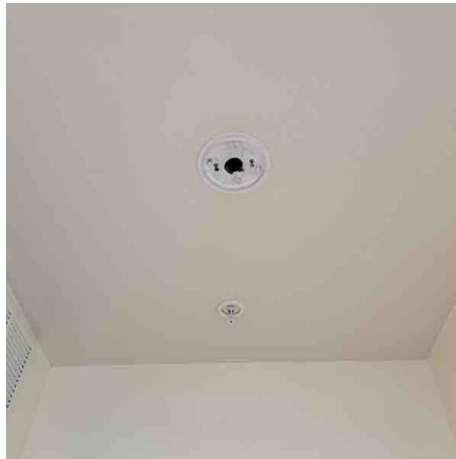
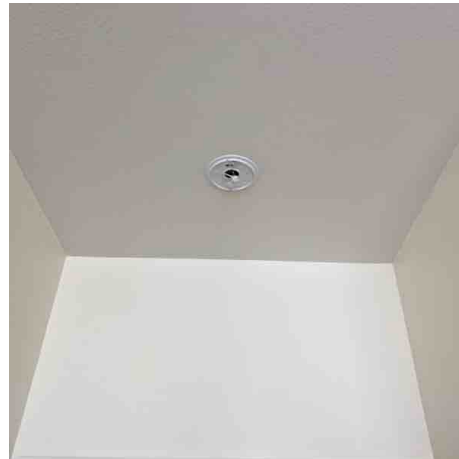
- The smoke detectors are missing. These should be replaced for safety.

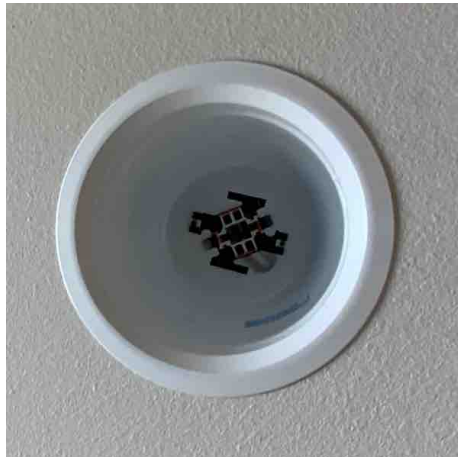
- Shower light fixture is missing its bulb.

Replace bulb and otherwise consult with a qualified contractor to further evaluate and repair. **(Primary Bathroom)**

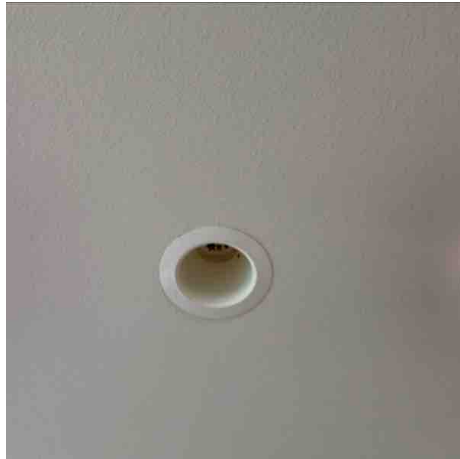
- **Island light fixture is missing its bulb.**

Replace bulb and otherwise consult with a qualified contractor to further evaluate and repair. (Kitchen)

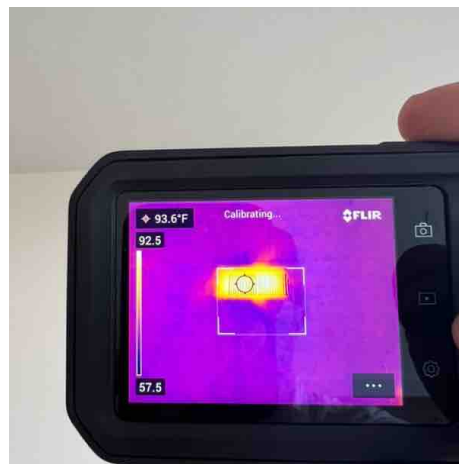
- Unit functional test of heating equipment:
The heating system was tested for function and temperature differential and was functioning within the expected range.

Unable to inspect heat exchanger as it is a sealed unit. Dismantling of the furnace is required to thoroughly inspect the heat exchanger for cracks and is outside the scope of this inspection.

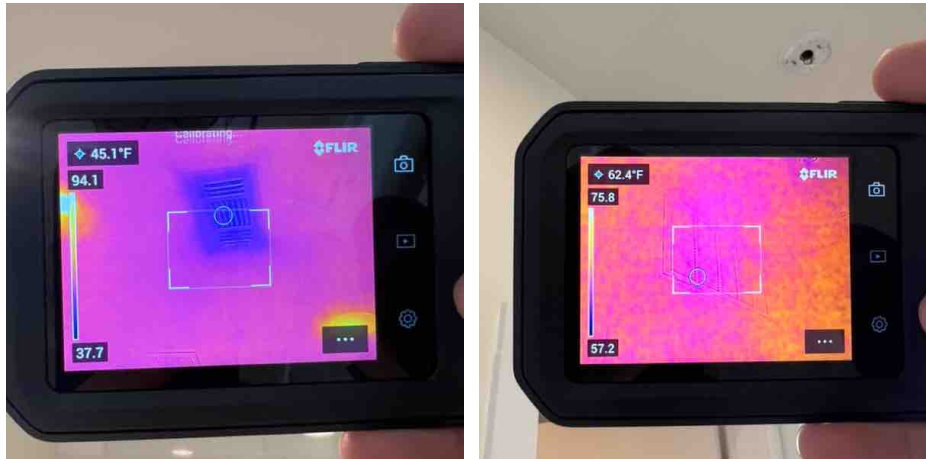
The system was tested for function based on temperature differential and was functioning within the expected range.

15 to 22 Degrees F is considered normal differential.

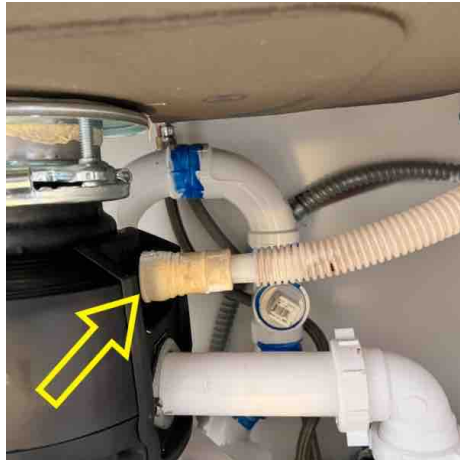
- The dishwasher drain line is missing a hose clamp where it connects to the garbage disposal. Add a hose clamp to secure the line.

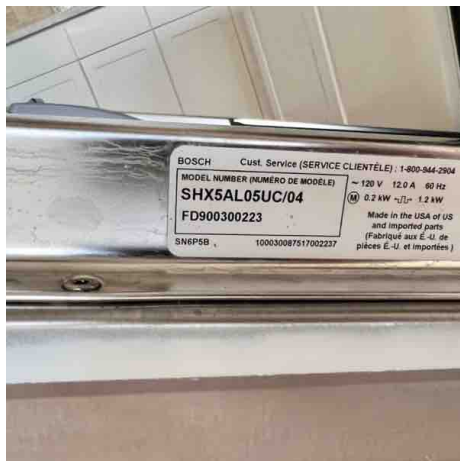
- Dishwasher is a Bosch.

Dishwasher completed a full cycle and is working within normal parameters at the time of the inspection. Overall cleaning efficiency of the unit cannot be determined by the visual inspection and is beyond the scope of the review.

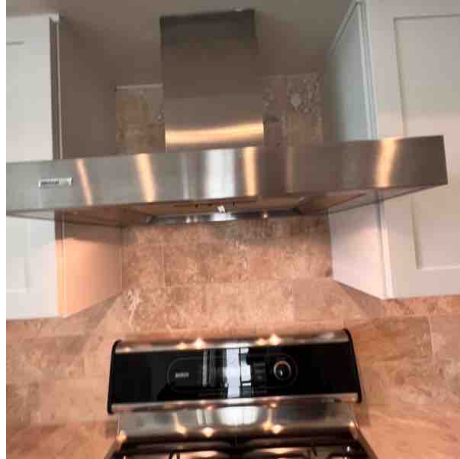
- The range hood fan and light functioned within normal parameters at the time of the inspection.

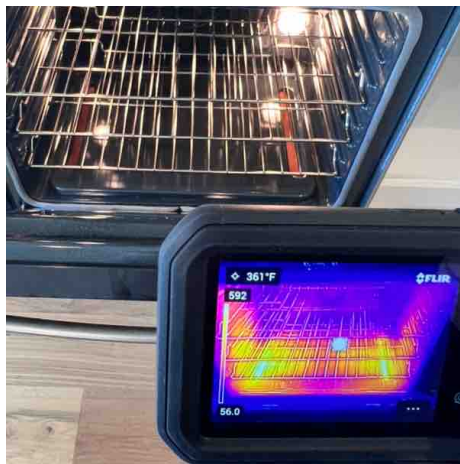
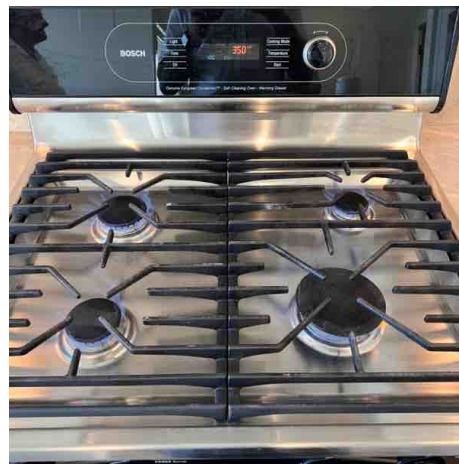
- The freestanding range is a Bosch unit.

The oven heated to 361 F when set to 350 F.
A difference of 25 degrees is considered normal.

All cooktop burners functioned normally.
