# PROPERTY INSPECTION REPORT FORM

12318 Furrow Cove #A, Austin, TX 78753

09/06/2023 12:30 pm

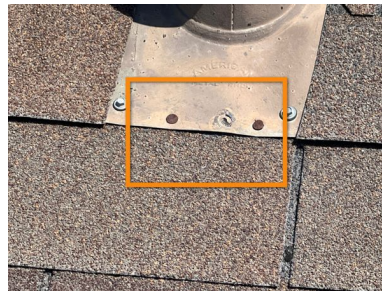
Exposed nail heads at multiple locations throughout rooftop

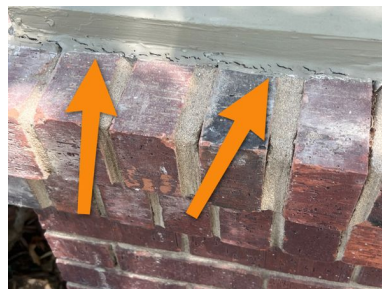
Routine Maintenance - The deteriorated caulk joints between the exterior cladding/veneer and ALL wall penetrations need to be properly sealed such as utility connections, downspouts, hose bibs, lighting fixtures, receptacles, etc with an exterior grade elastomeric sealant (caulking) to prevent wind driven rain/moisture from entering behind the exterior veneers, doors, windows and other wall penetrations.

Caulk and seal needed - multiple locations

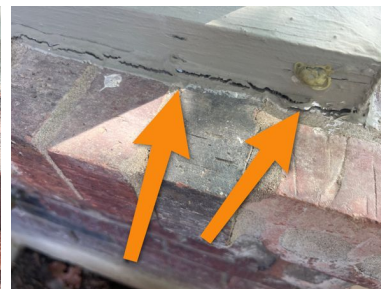
Caulk and seal needed - multiple locations

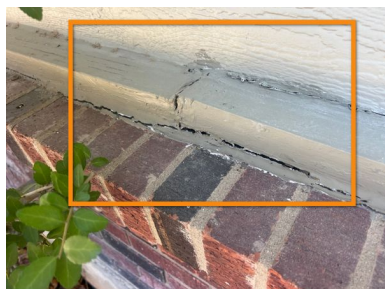
Caulk and seal needed - multiple locations

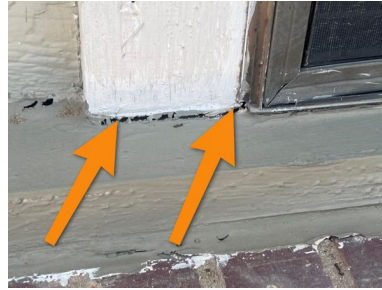
Caulk and seal needed - multiple exterior windows

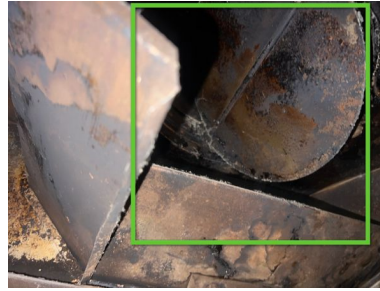
Fireplace dampner - Working as Intended

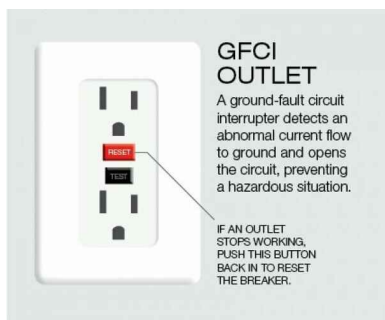
Section 210.8(B)(A) GFCI protection requirements. GFCI plugs are missing in one or more locations. GFCI protection is required on 15A/20A circuits providing power to kitchens, bathrooms, garages, laundry rooms, exterior receptacles, pools, spas and whirlpool tubs. GFCI receptacles are required in the kitchen and within 6' of water basins. All 125-volt through 250-volt receptacles (IE.cloths dryer) installed in the locations specified in 210.8(A)(1) through (A)(11) and supplied by single-phase branch circuits rated 150 volts or less to ground shall have ground-fault circuit-interrupter protection for personnel.

GFCI plug receptical

**Repaired  
Oct 2023**

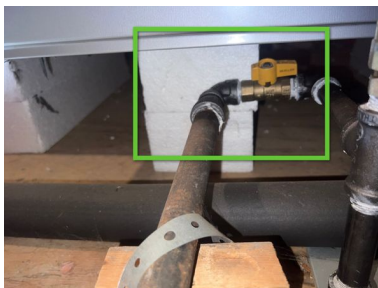
Gas shut off valve - attic furnace unit

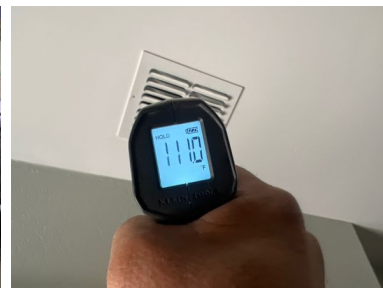
111° average heat at interior registers

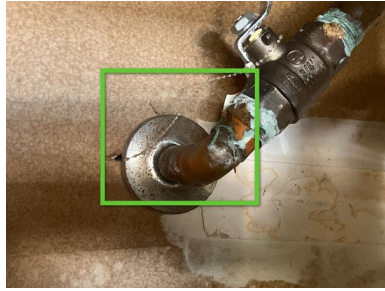
Copper water lines visible - garage

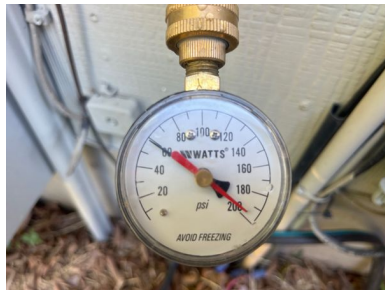
Static water pressure approximately 58 psi

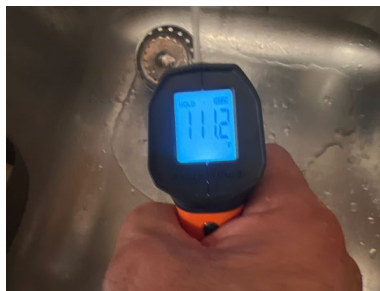
111° average hot water at all faucets

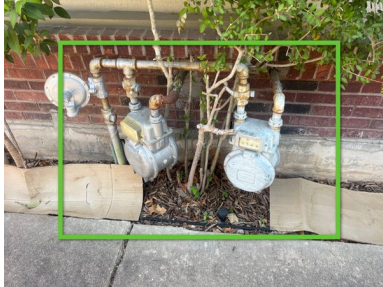
Gas meter - left exterior wall
