Inspection Report

G2 Home Inspections

Property Address 5207 Crane Dr West Richland Wa

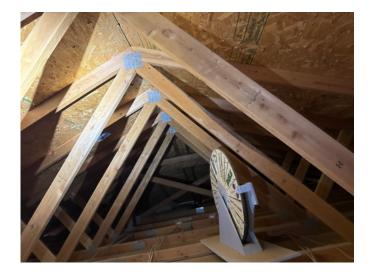
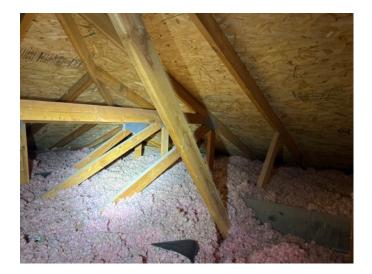
The visible and accessible portions of the attic appeared to be in serviceable condition at the time of the inspection.

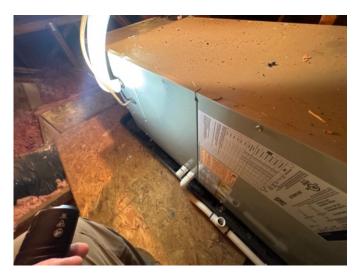
The heating system was operational at time of inspection. This is not an indication of future operation or condition.

There were no service records visible for the HVAC system at the time of inspection. Recommend having this system serviced by a qualified technician.

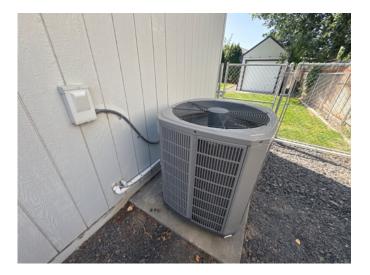
The heat pump was operational at the time of inspection. This is not an indication of future operation or condition.

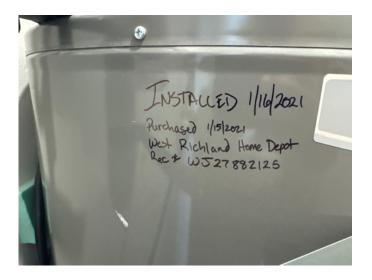
The water heater was operable at the time of inspection. This does not however guarantee future performance, operation, or condition.

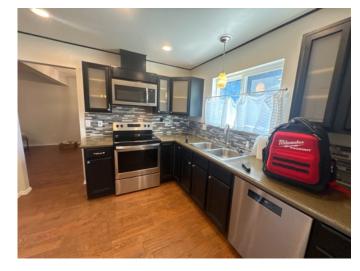
The kitchen cabinets appeared to be in serviceable condition at the time of inspection. The kitchen cabinets showed evidence of minor wear.

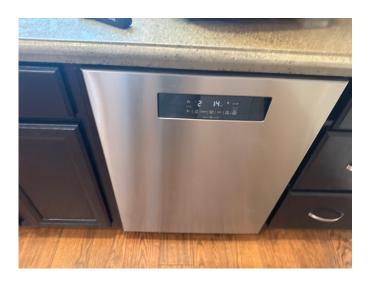
The dishwasher appeared to be in serviceable condition at the time of the inspection. This does not however guarantee future performance or conditions.
