Hanna Home Inspection

Home Inspection Report

1248 Enfield, Forest Glade, ON

Inspection prepared for: Al Teshuba
Date of Inspection: 9/7/2024

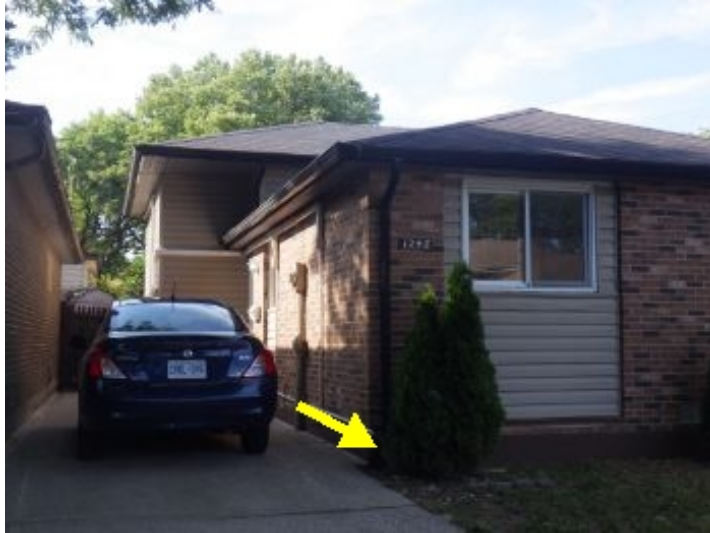
Observations:

- An effective water management program is required for all homes. This includes maintenance of all wooden components, caulking of all openings and ongoing vigilance of water handling systems, roof and flashing. Buyer is advised that while there may not be evidence of water intrusion into structure at time of inspection, NO STATEMENT referring to future performance can be made due to changing weather and structure conditions.
