# Inspection Report

**Al Teshuba**

3404 Victoria  
Windsor ON

<b>Date:</b> 2025-03-20	<b>Time:</b> 10:00	<b>Report ID:</b> 032001
<b>Property:</b> 3404 Victoria Windsor ON	<b>Customer:</b> Al Teshuba	<b>Real Estate Professional:</b>

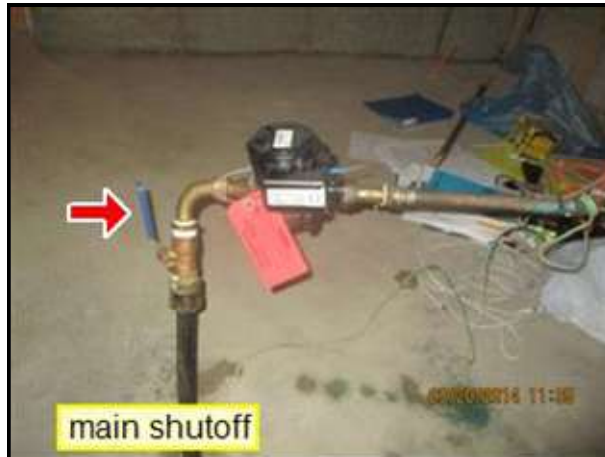
14.0 Picture 1

It would be wise to consult a plumber and/or do your own research on the internet to find out as many facts as possible while making your decisions.
