HOME INSPECTION & PEST CONTROL

This Professional Inspection Report Has Been Prepared Exclusively For:

**Danielle Gumapac
6 Parkway Plaza
Lufkin, TX 75904
November 3, 2022**

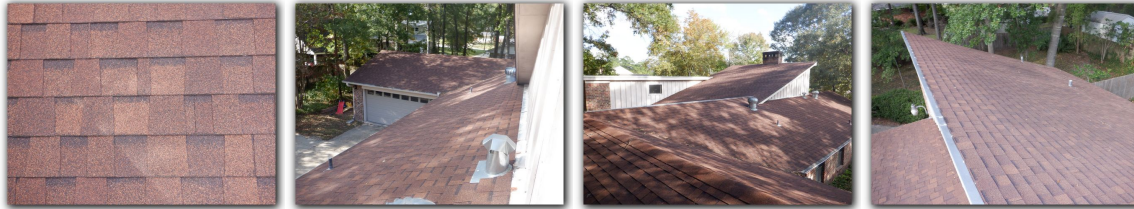
This structure has a 25-30 year composition type roof covering and is estimated to be in the top third of its life. The roof was inspected by walking the roof. Portions of the roof being inspected from inside the attic space. The roof fasteners appear to be installed and fastened properly.

The roof covering materials appeared to be in good condition on the day of the inspection.

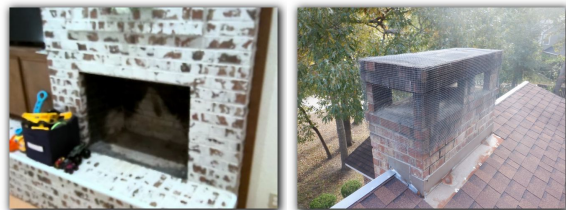
The fireplace and chimney appeared to be in fair condition on the day of the inspection.
