# **Inspection Report**

# **G2** Home Inspections

Property Address 1824 W 28th Ave Kennewick Wa

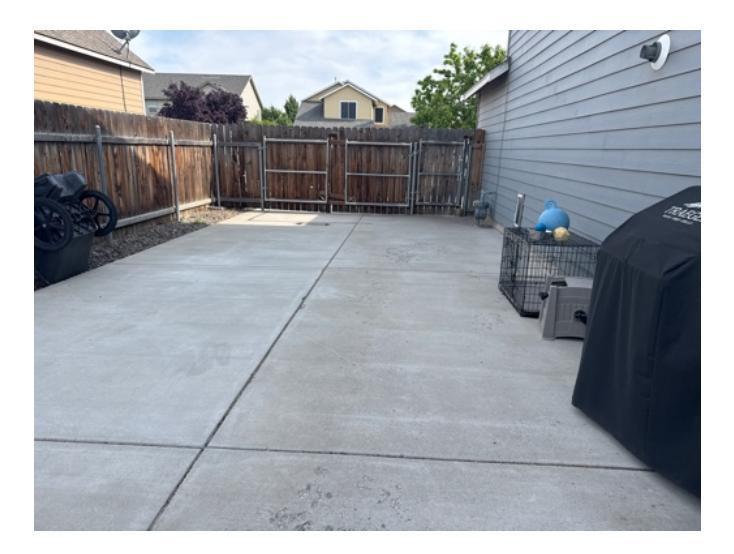
The driveway appeared to be in serviceable condition at the time of the inspection.

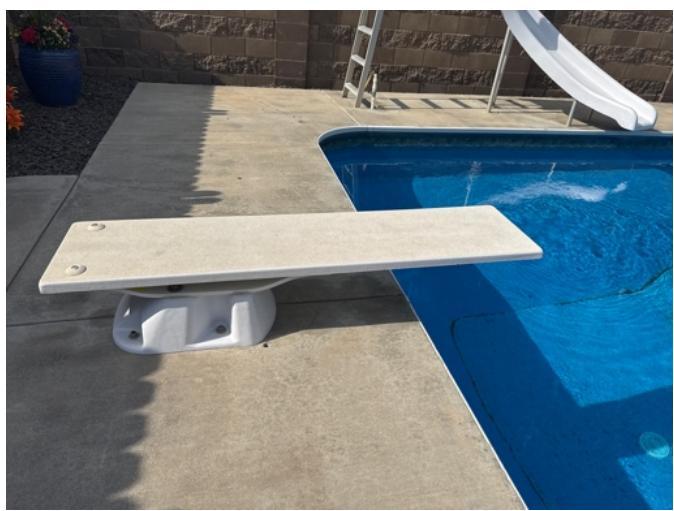
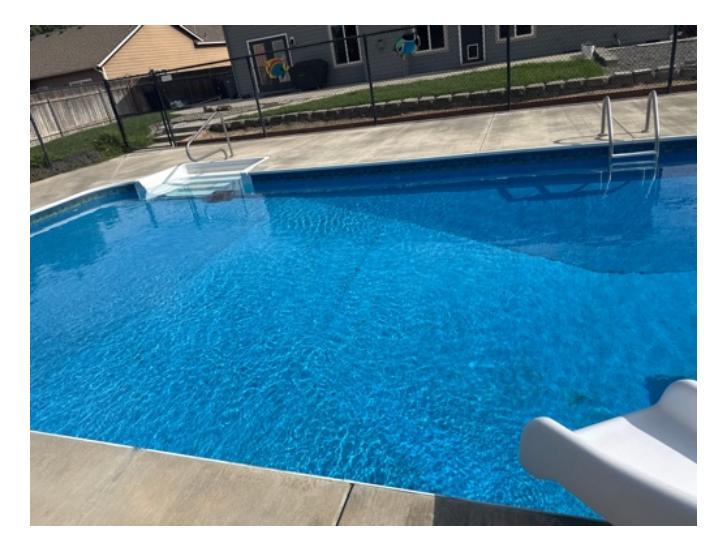
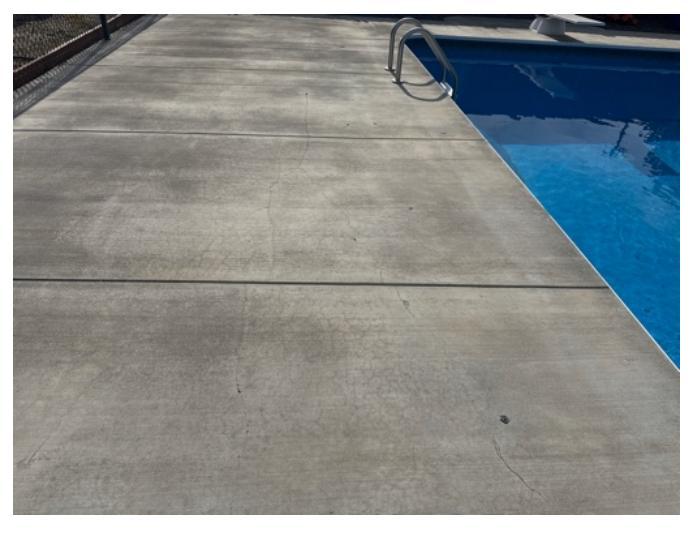
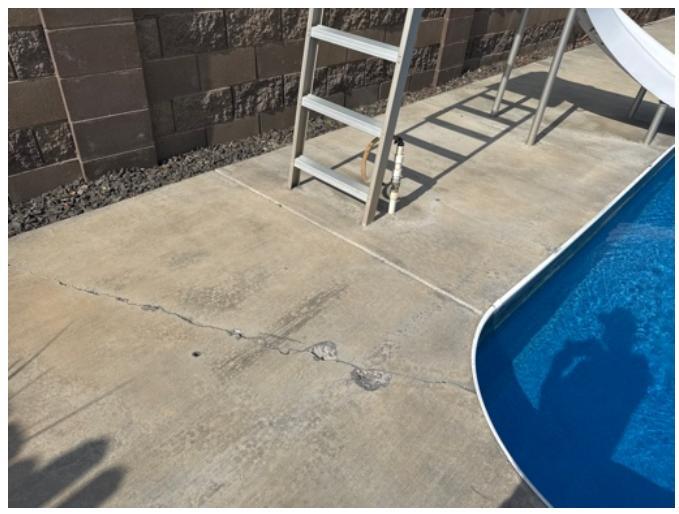
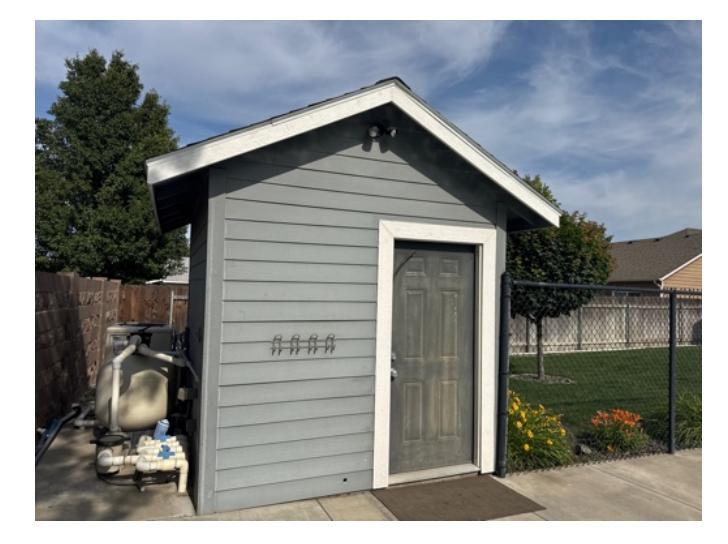
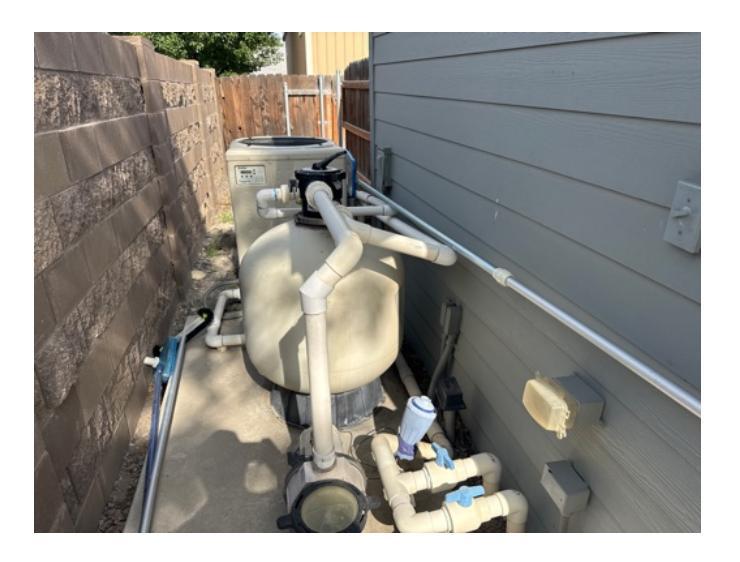
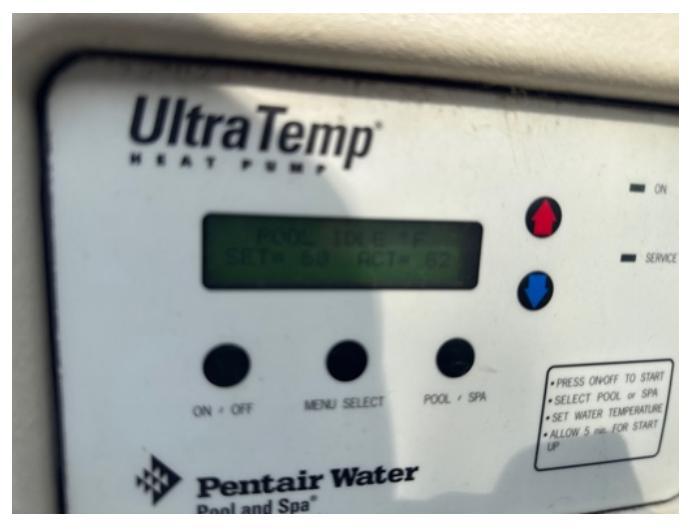
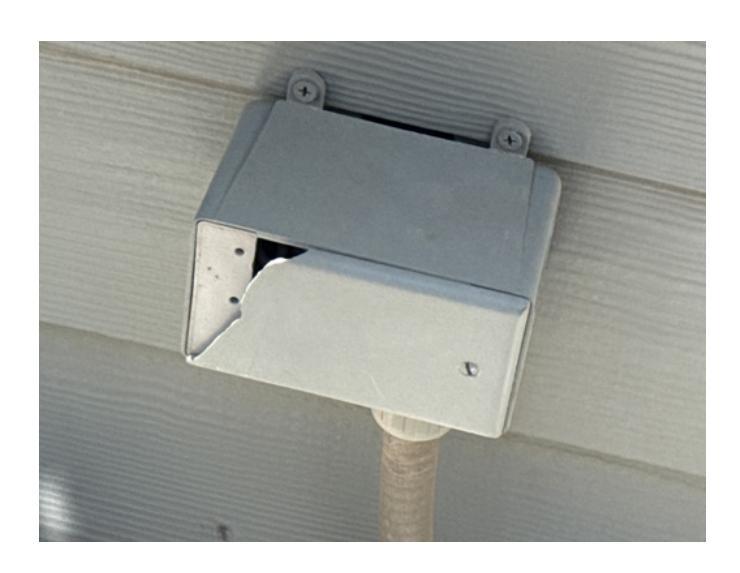
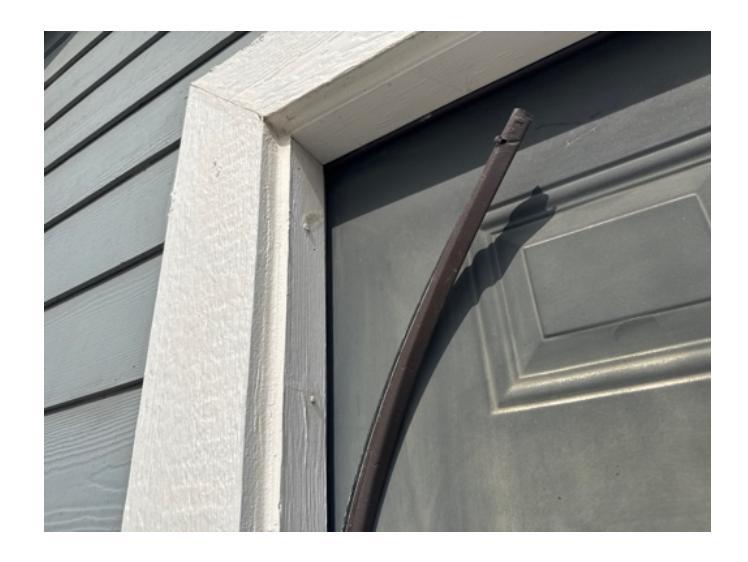
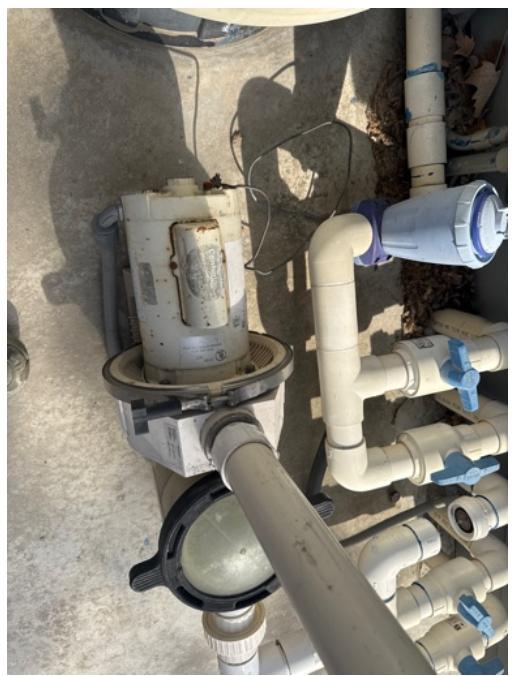
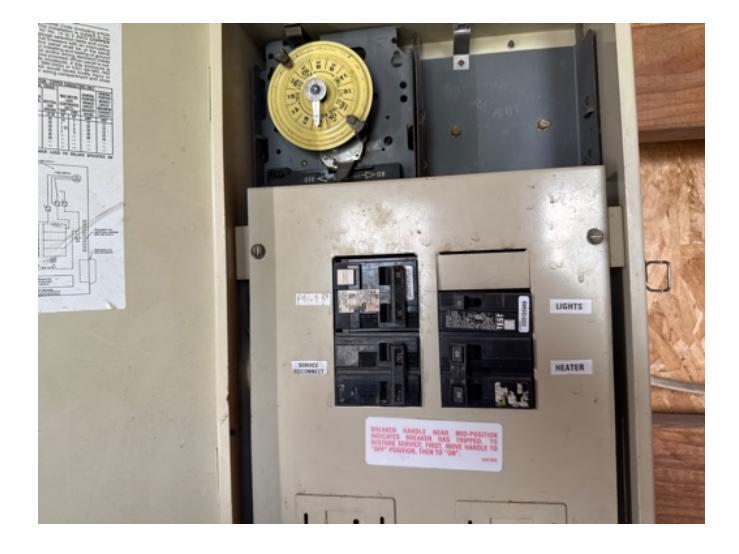
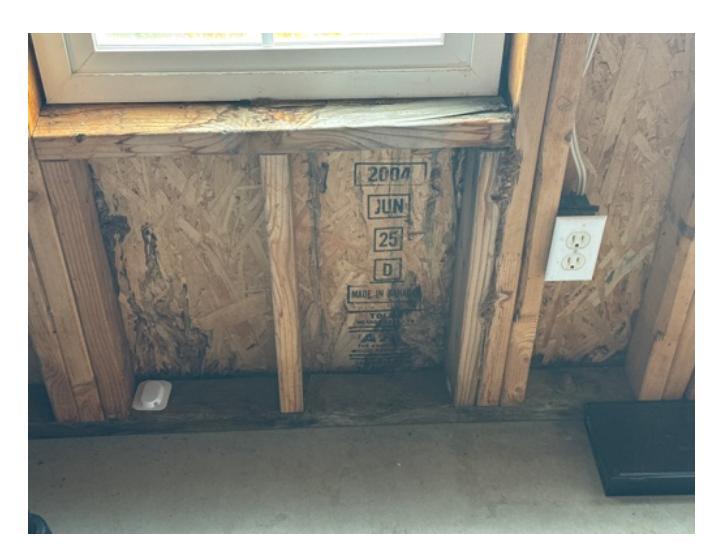
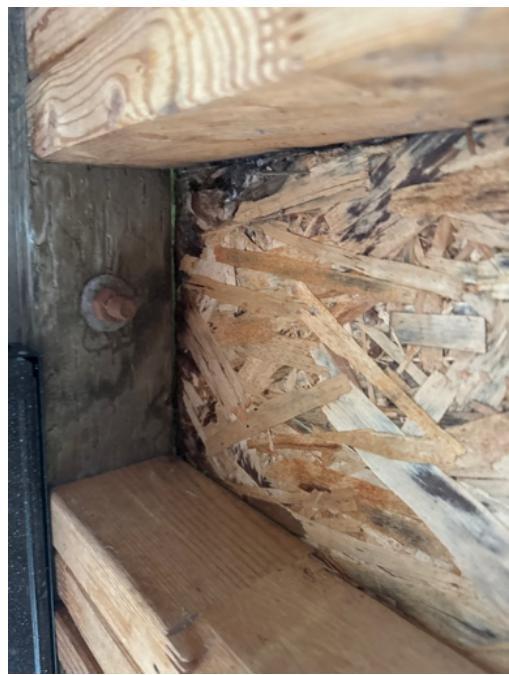
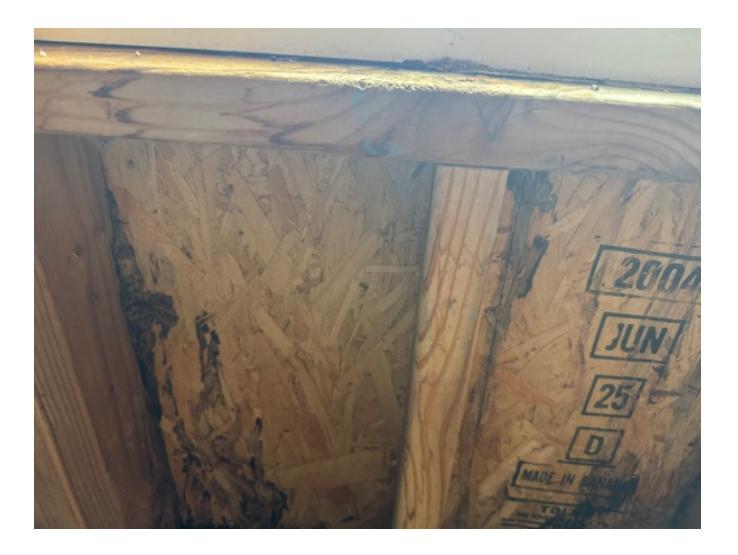
There was evidence of moisture exposure and damage observed at the wall, sheathing and framing components below the window windows at the south wall of the pool house. Recommend further evaluation and repair by a qualified contractor.

The weatherstripping at the exterior door to the pool house was damaged. Recommend repair.

There were cracks and minor surface deterioration observed at the concrete pool deck. Recommend monitoring condition and repair as needed.

There was a damaged blank cover at an exterior junction box at the pool house. Recommend replacing cover.

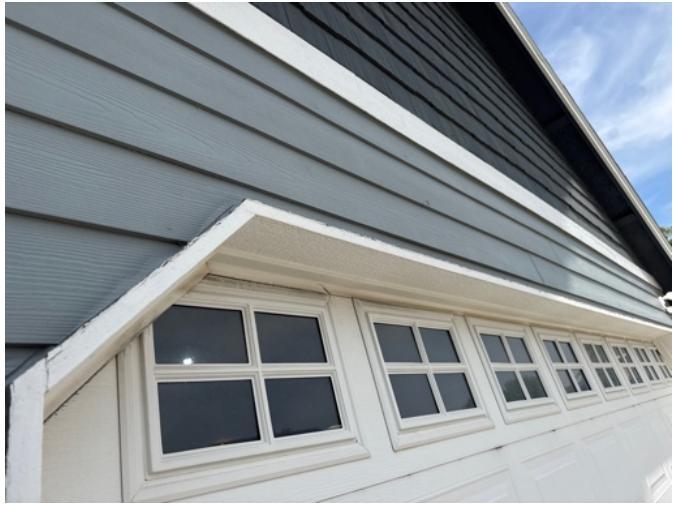
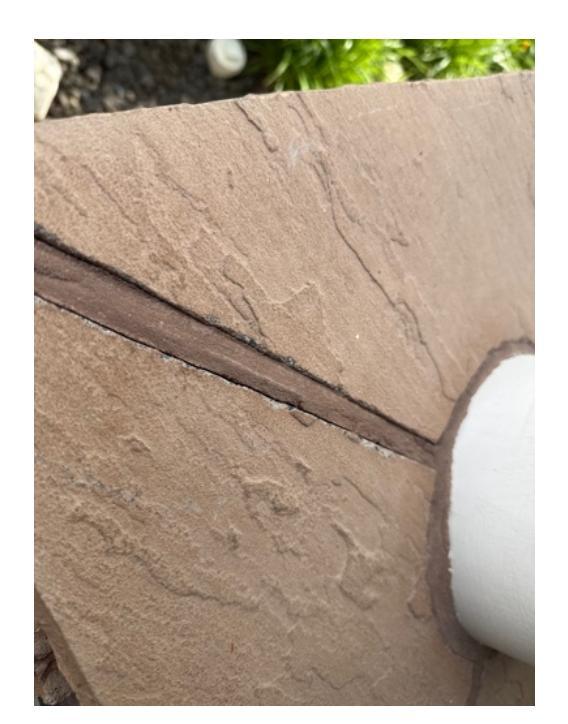
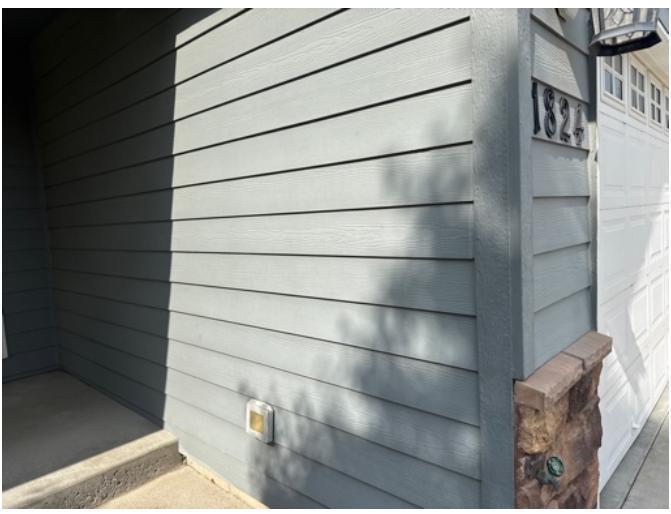
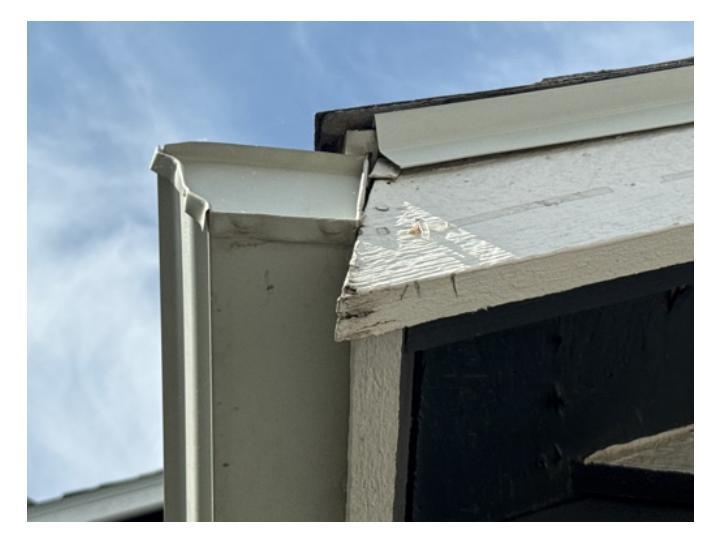
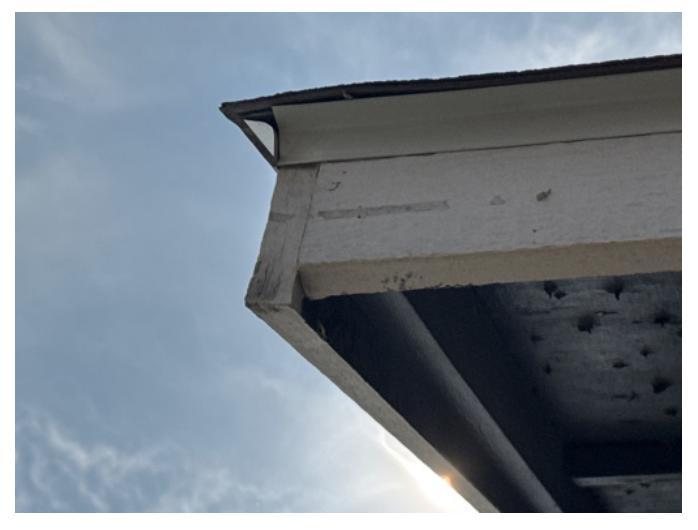
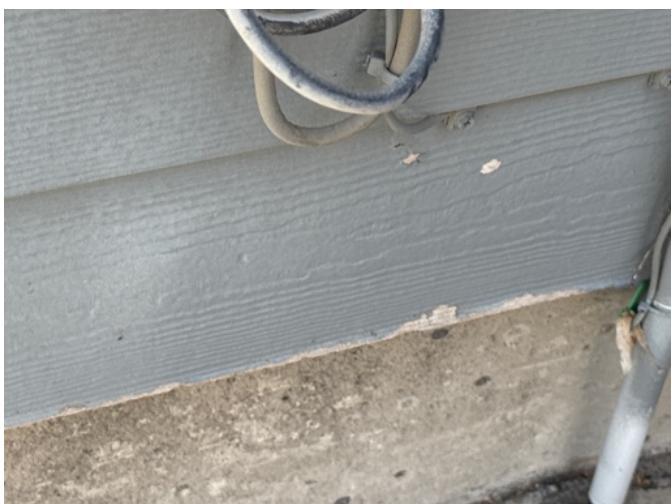
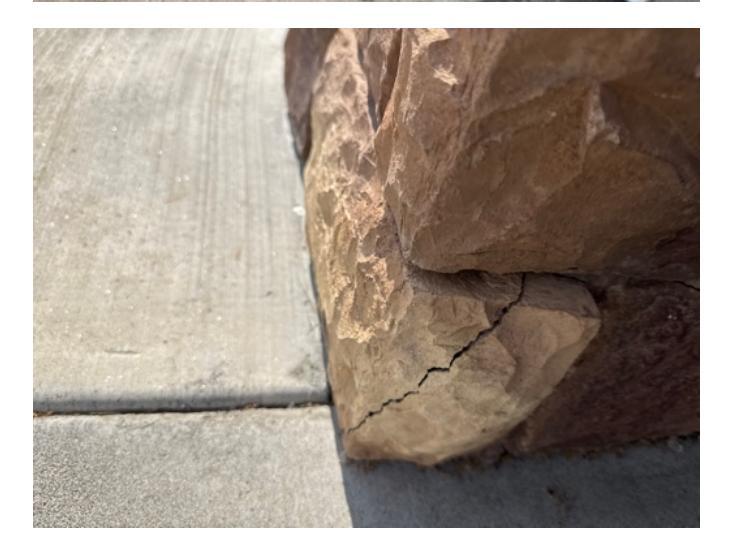
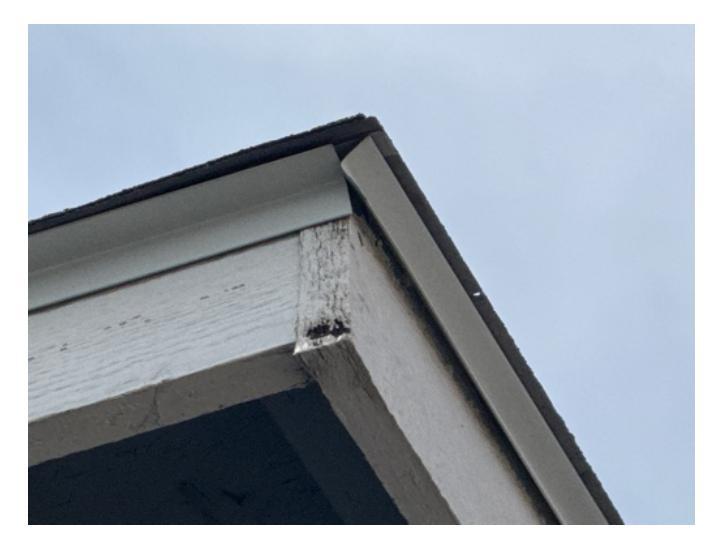
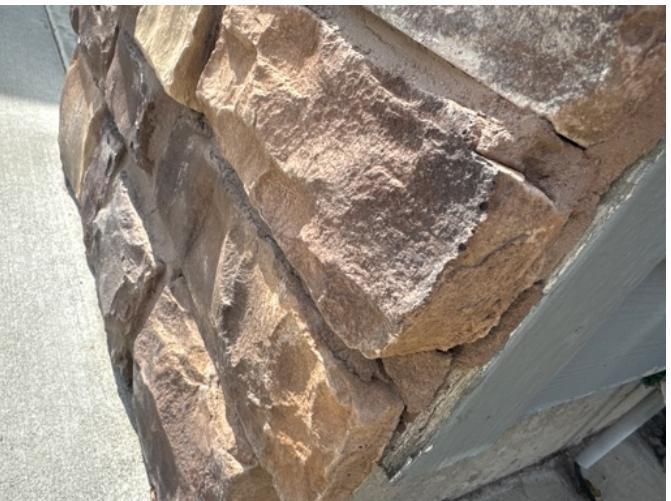
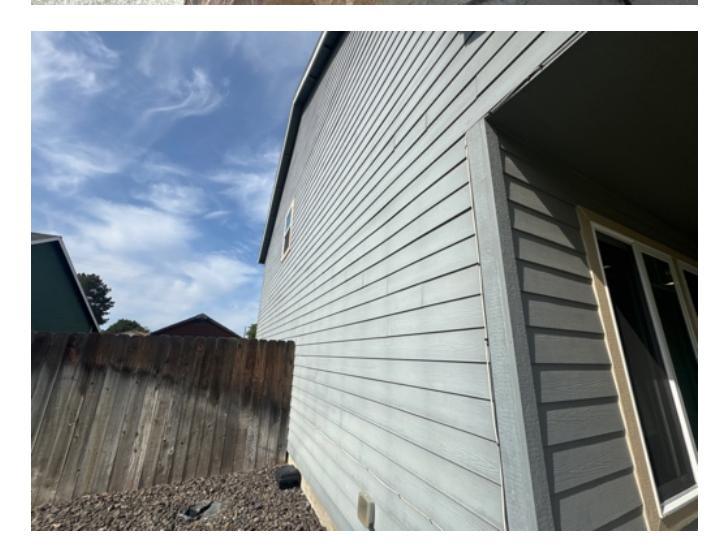
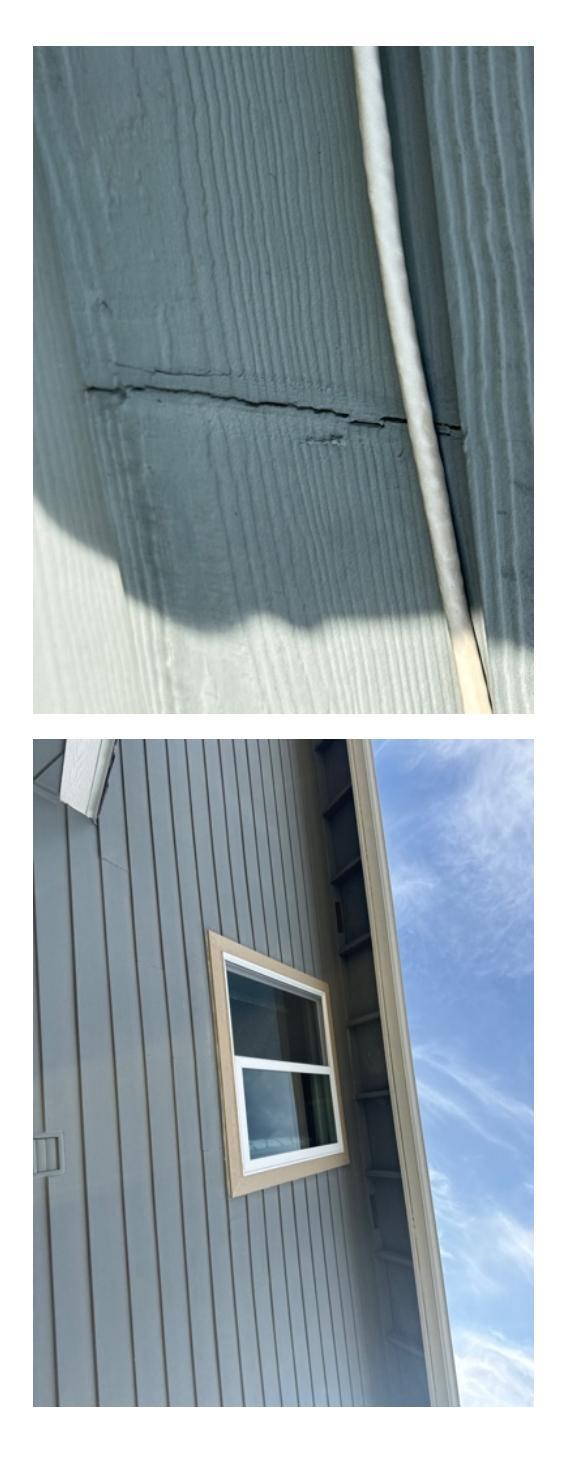
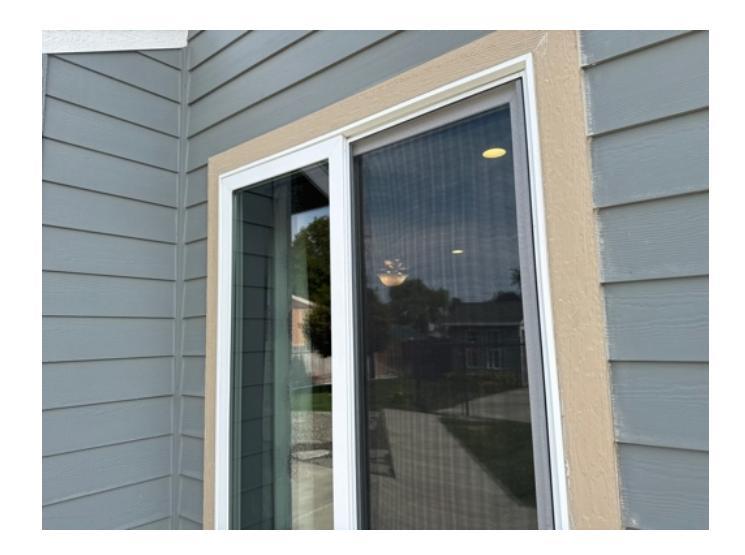
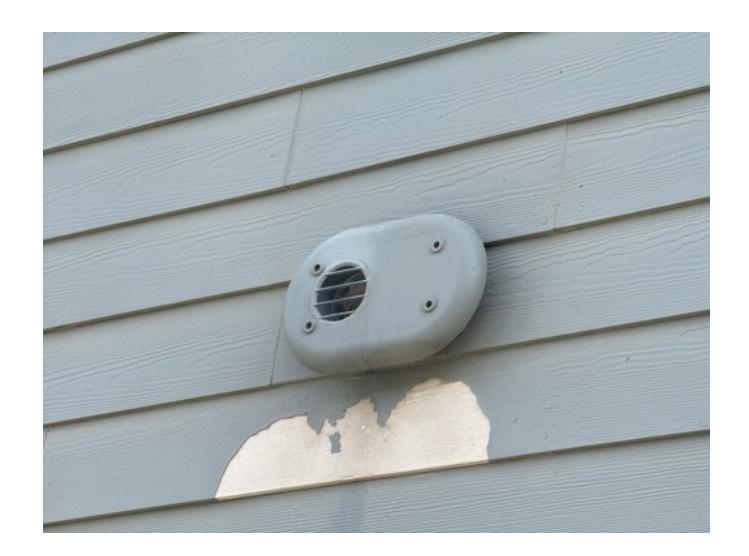
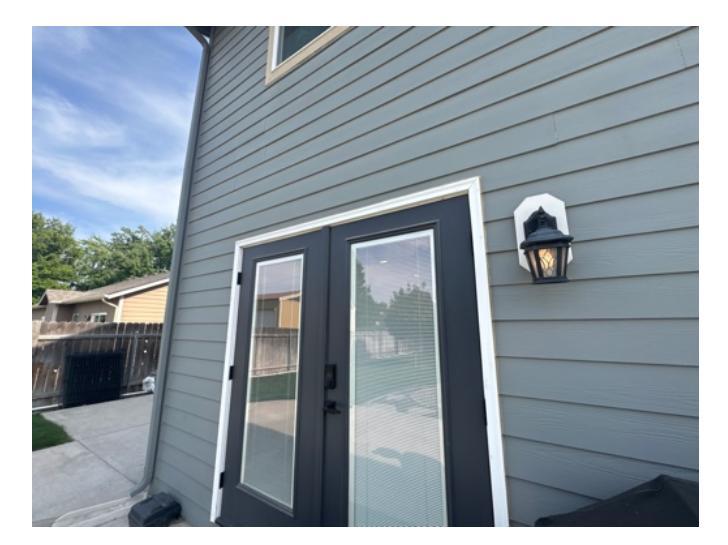
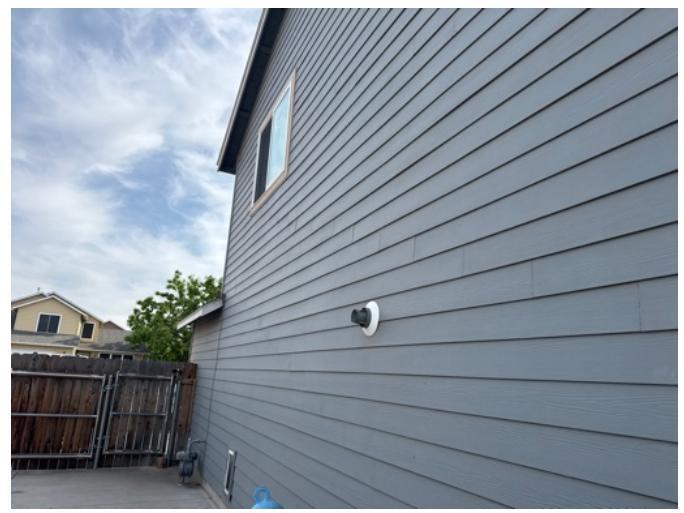
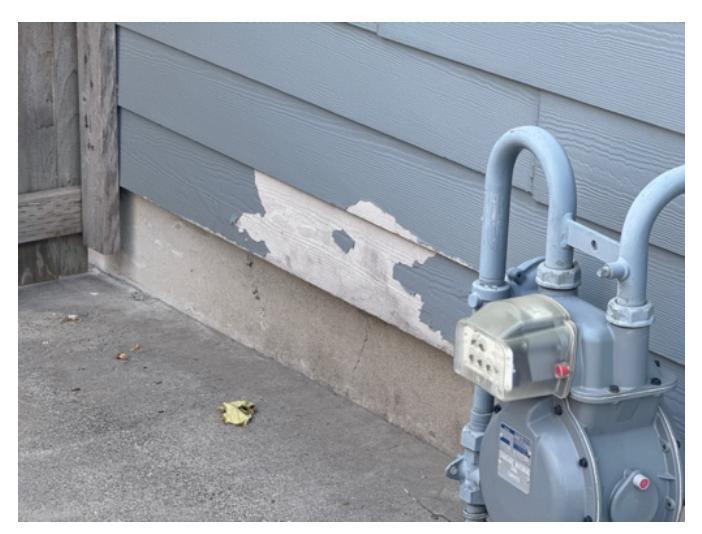
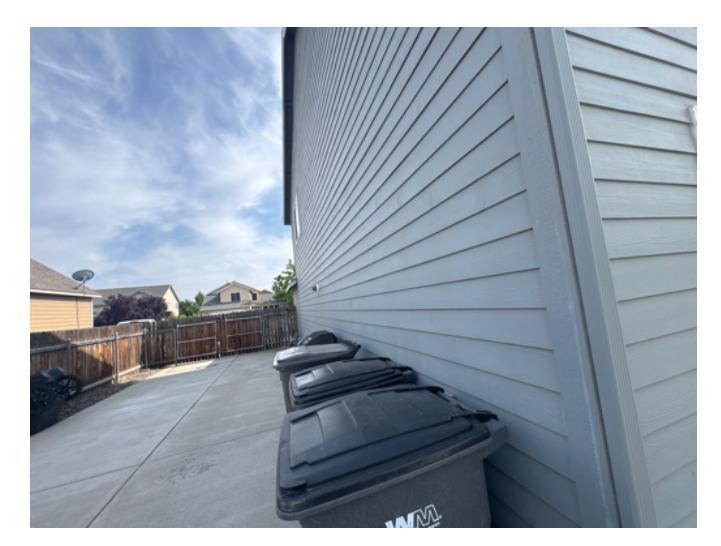
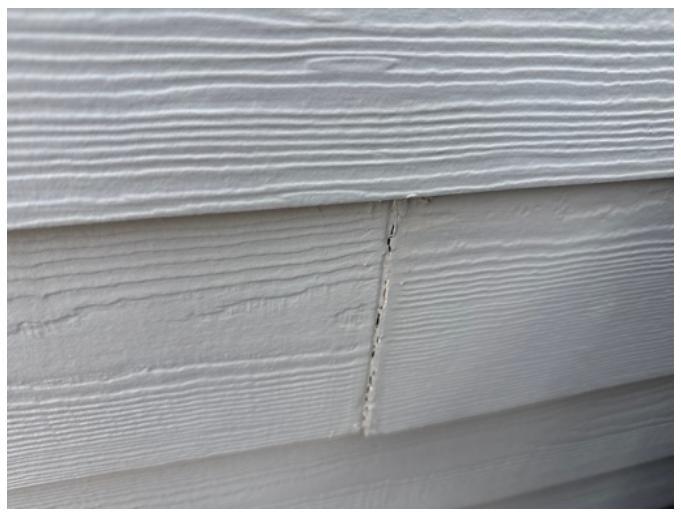
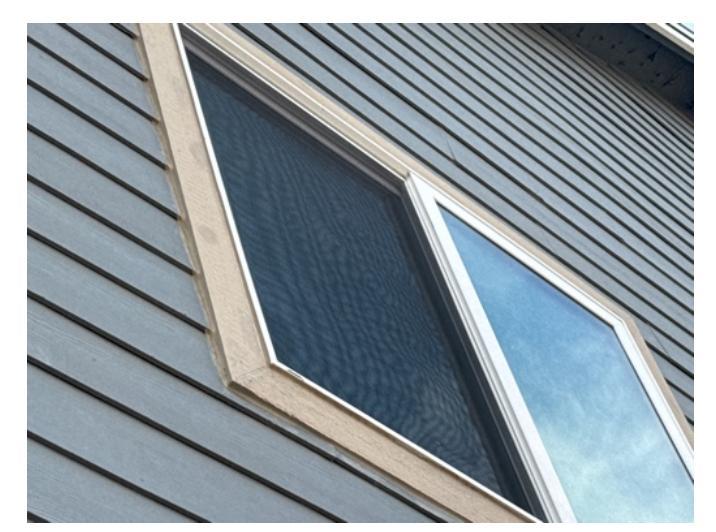
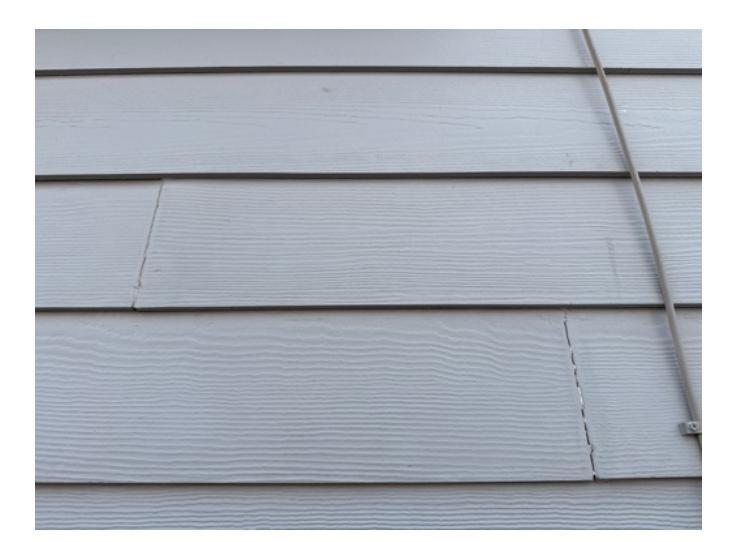
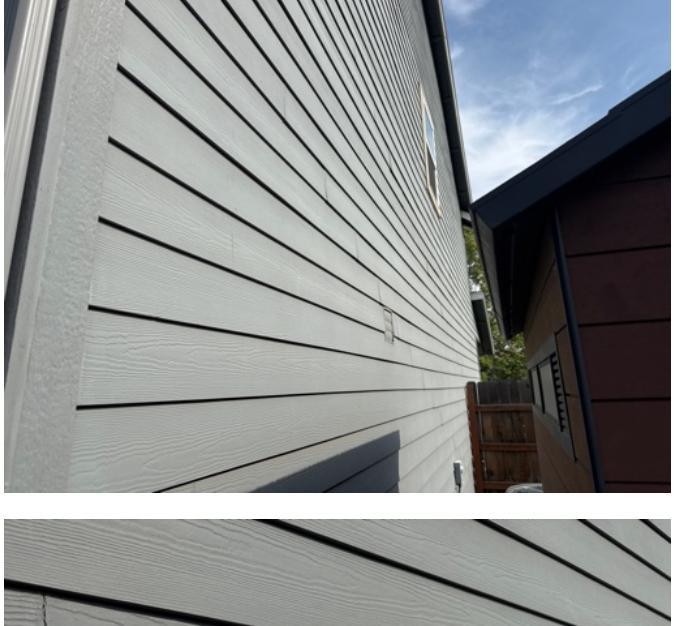
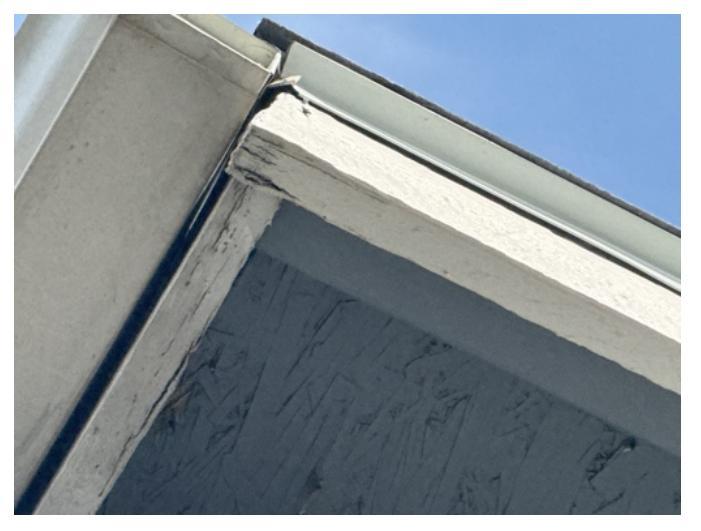
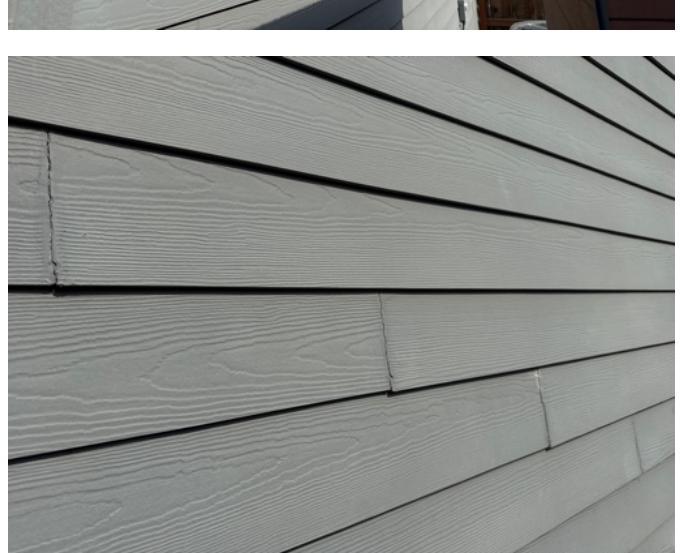
The trim around the exterior windows was unpainted. Recommend painting trim.

The mortar at the stone front pillars was slightly cracking. Recommend maintenance and repair as needed.

there were cracks at the stone at the front of the garage and some of the stone at the east side of the front of the garage appeared to be slightly loose. Recommend maintenance and repair.

The exterior paint at the trim around the garage doors was slightly weathered at the top piece of trim. Recommend maintenance as needed.

There was an area of peeling paint observed behind the fence at the east side of the home. Recommend maintenance/repainting.

There was an area of peeling paint at the siding below the vent for the furnace at the north side of the home. This exhaust does contain some moisture and may need periodic maintenance at this area.

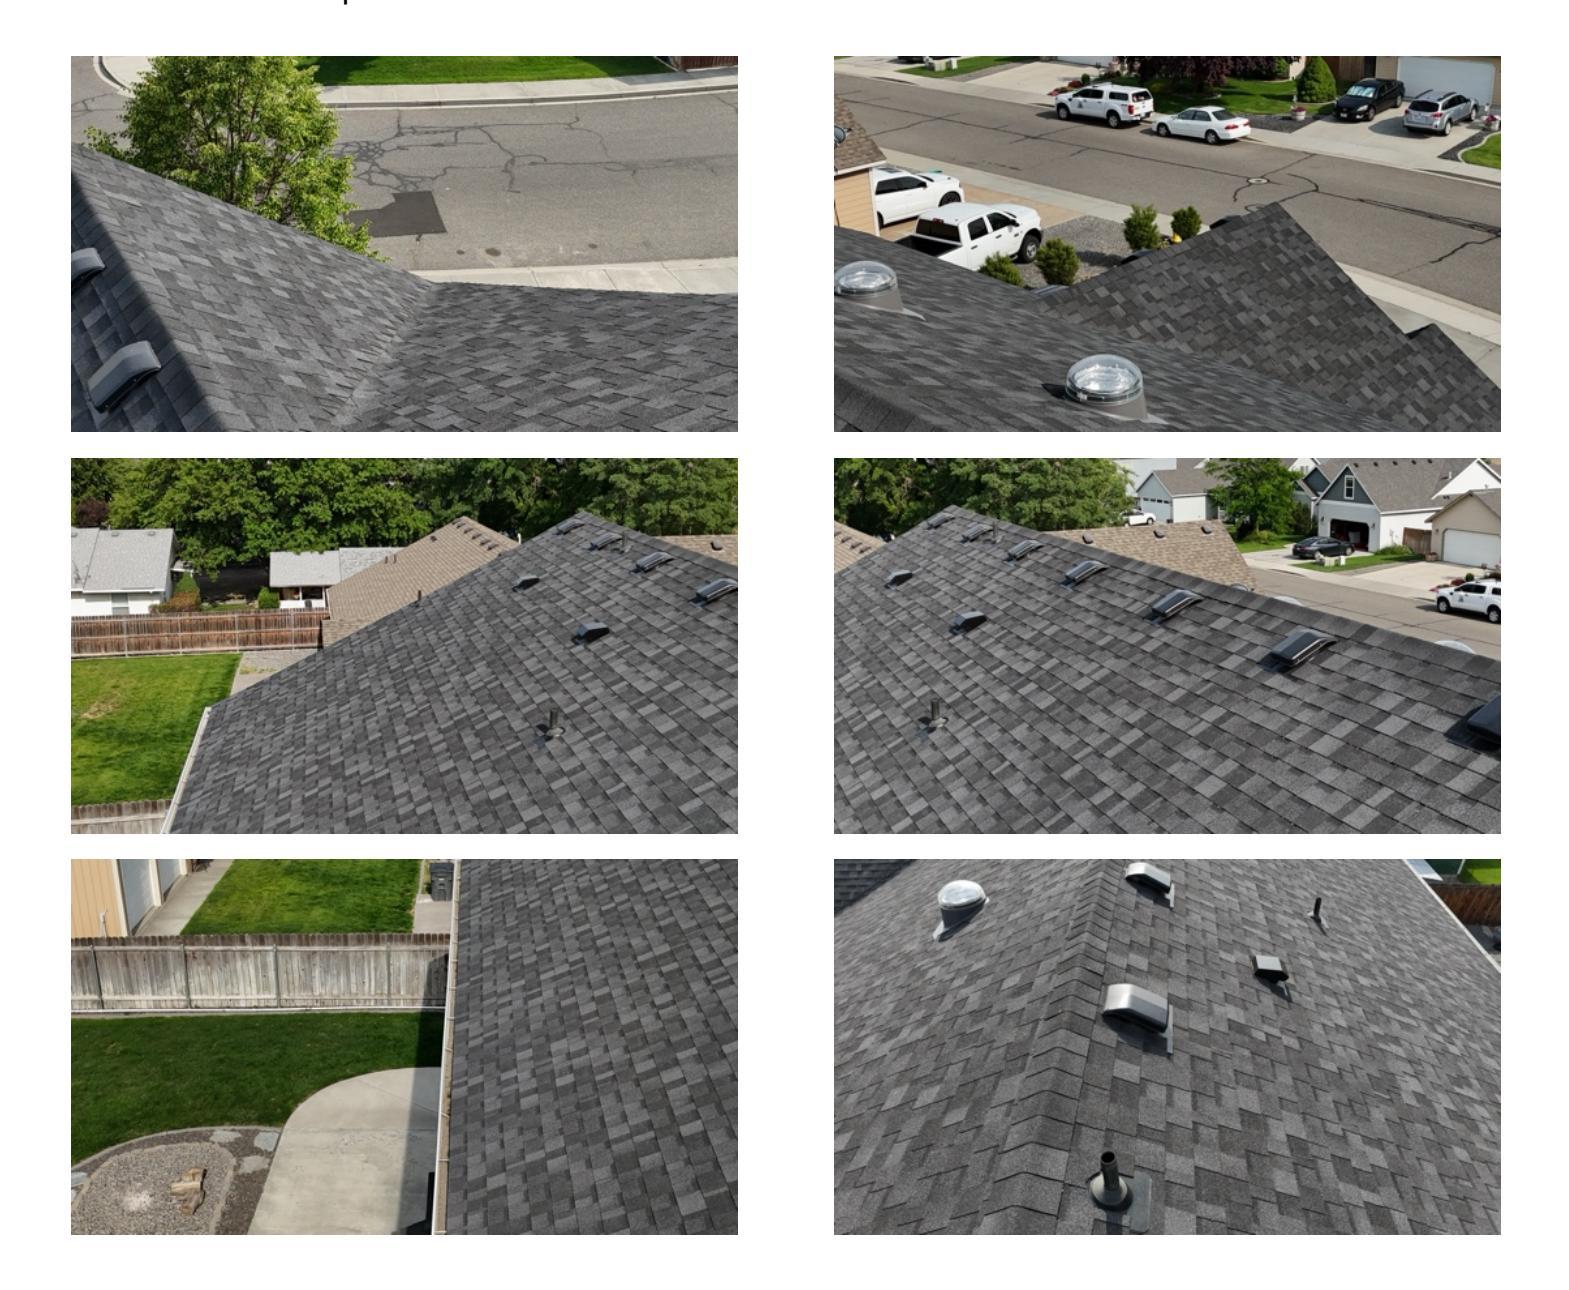
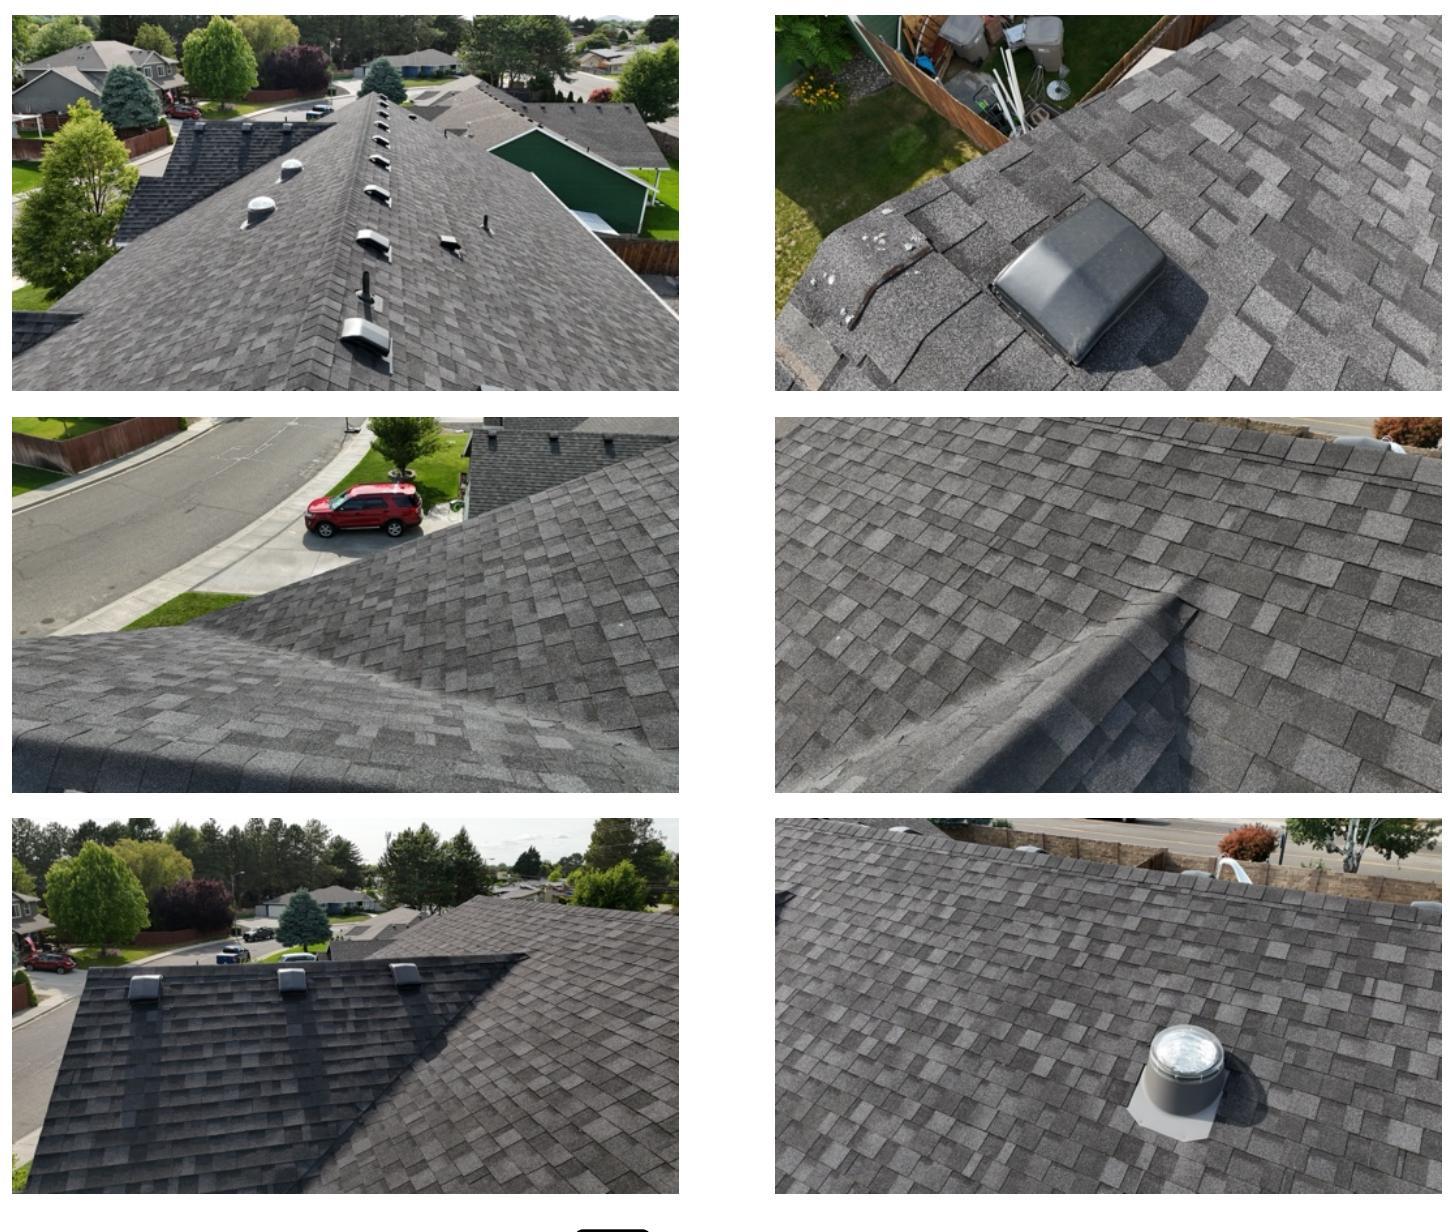
3.1) Roof Covering Condition

The roof covering shows normal wear for its age and appeared to be in serviceable condition at the time of the inspection.

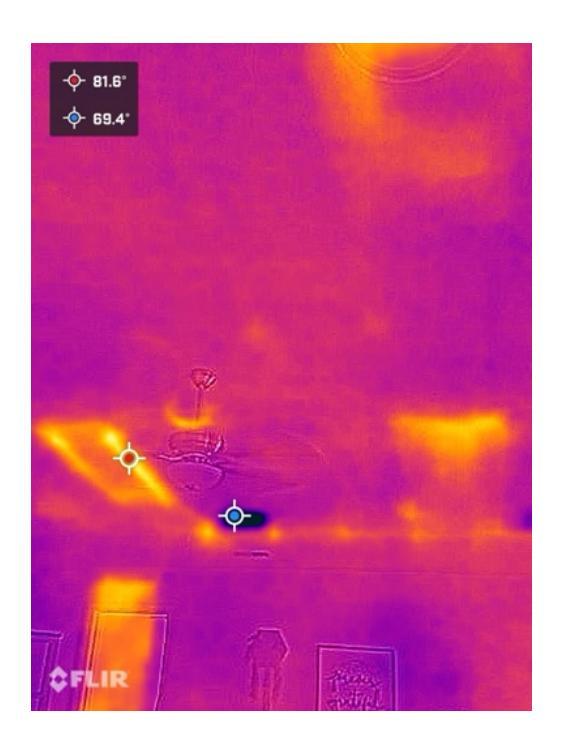
| Attic Ventilation Type | Ridge Vents.Soffit vents. |
|---|--|
| 3.5) Attic Insulation Condition | ns R |

When scanned with a thermal imaging camera, it appears that the insulation does not have as much coverage in the areas in the upstairs living room that have had large skylights removed. Recommend adding insulation at these areas.

The attic has blown-in insulation. The approximate depth of the insulation is 12+inches, which appears adequate.

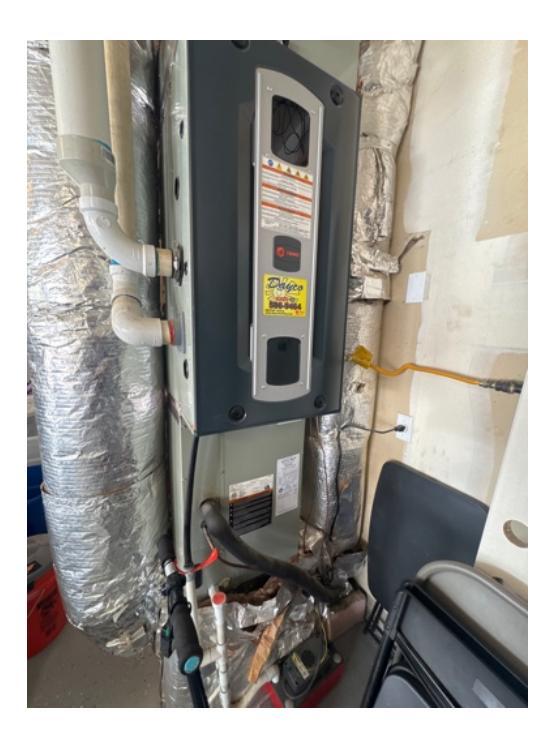
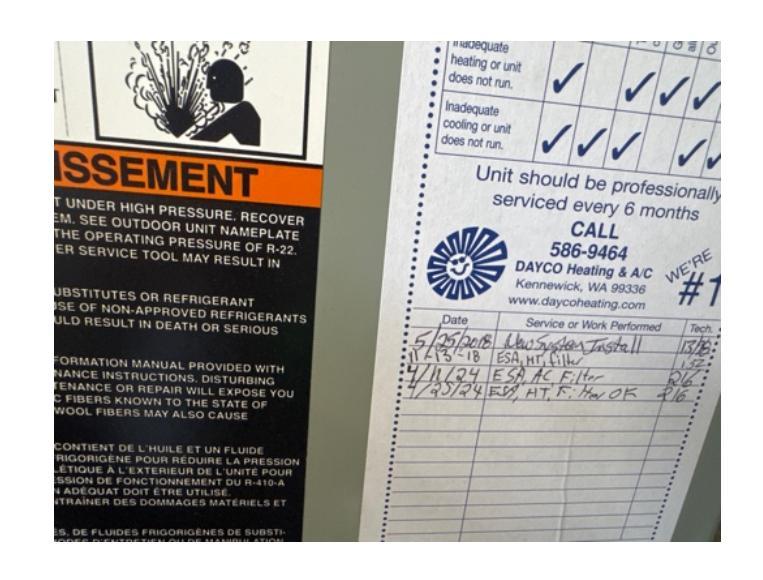
#### 4.1) Unit Conditions

The heating system was operational at time of inspection. This is not an indication of future operation or condition.

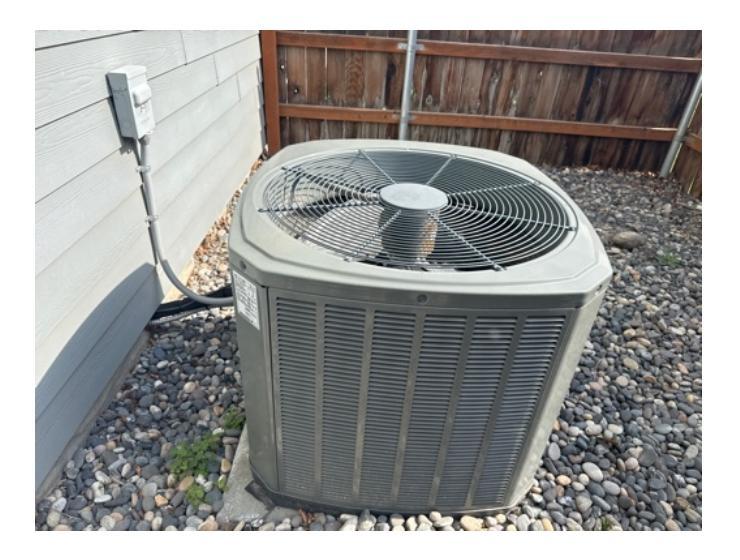
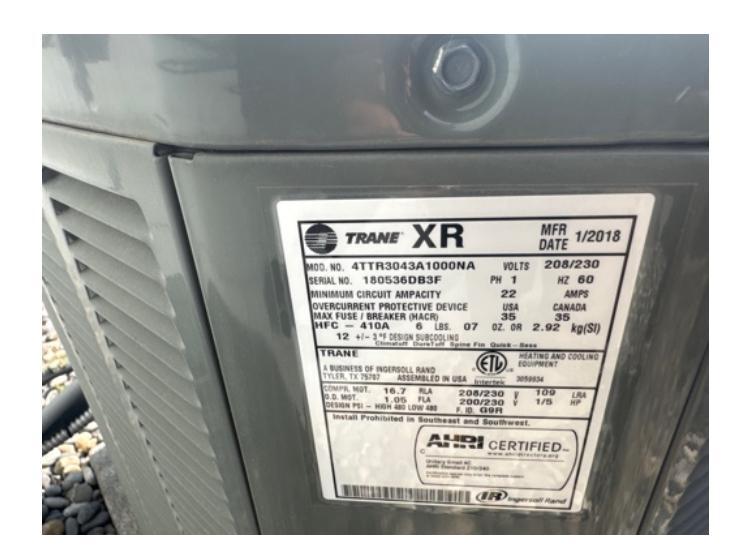
4.4) AC Unit Conditions

The AC unit was operational at the time of inspection. This is not an indication of future operation or condition.

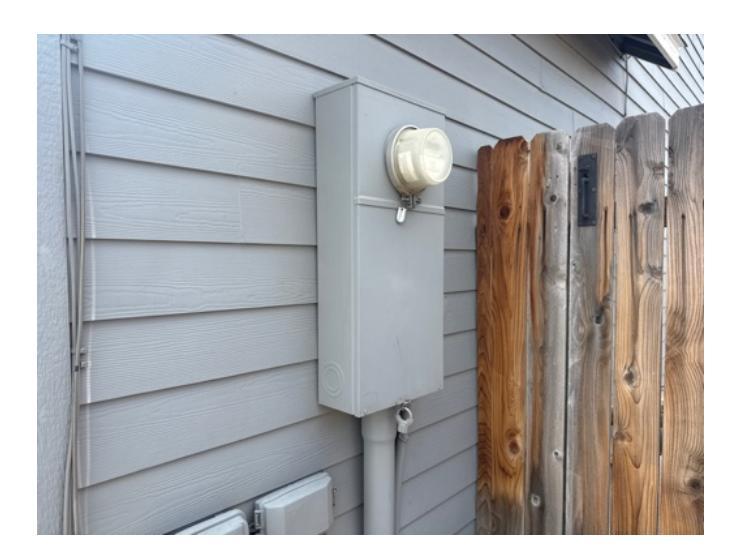
5.1) Electrical Service Conditions

The main service entry appeared to be in serviceable condition at the time of inspection.

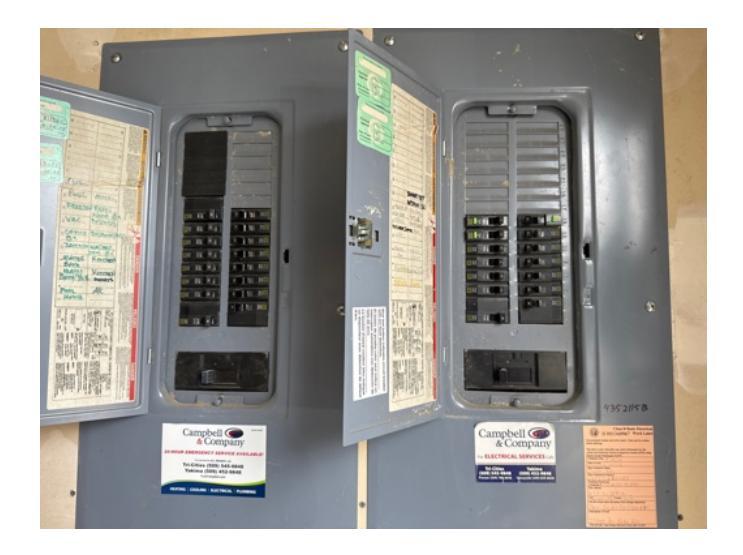
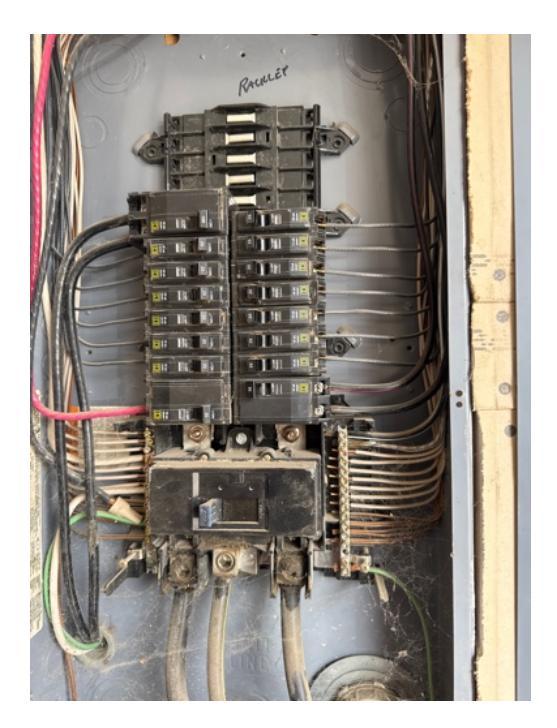
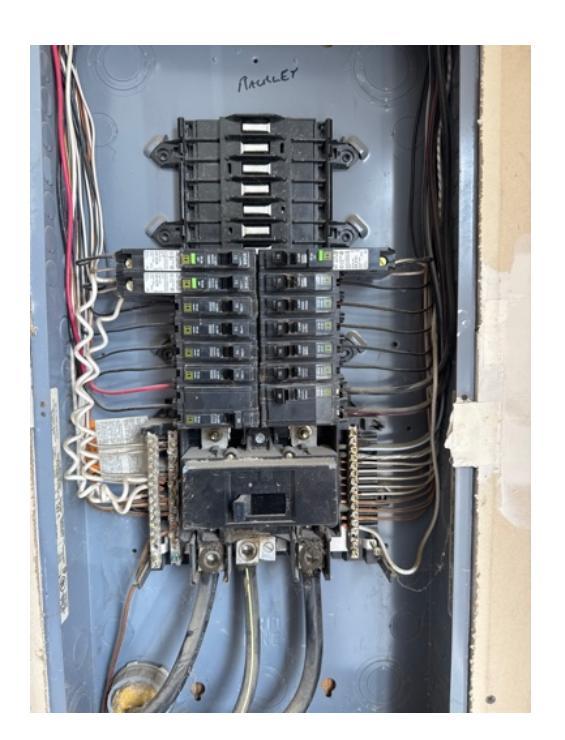
**5.3) Electrical Panel Conditions**

The main panels appeared to be in serviceable condition at the time of the inspection.
