# **Inspection Report**

# **G2** Home Inspections

Property Address 1824 W 28th Ave Kennewick Wa

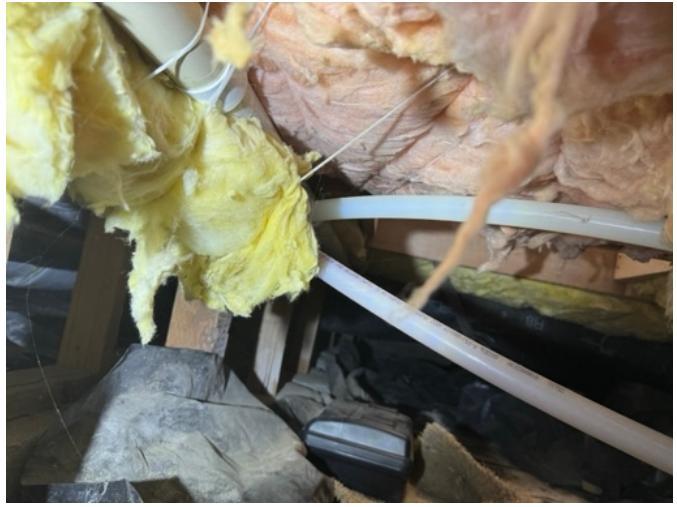
6.1) Main Line & Valve Conditions

It would be recommended to install insulation at the waterlines from the water softener in the garage to their connection to the main line in the crawlspace to prevent freezing.

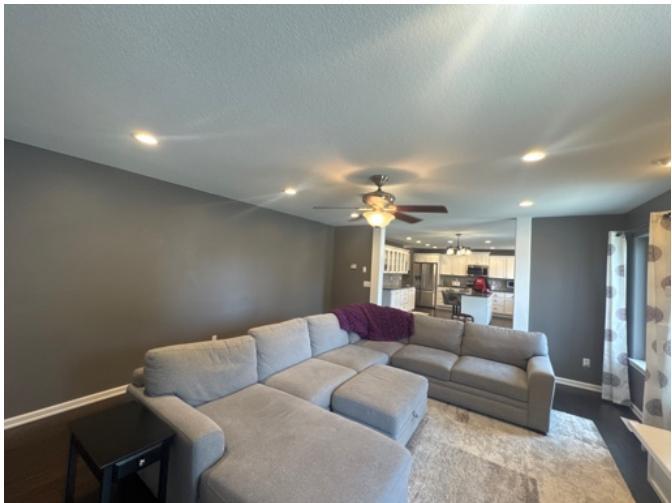
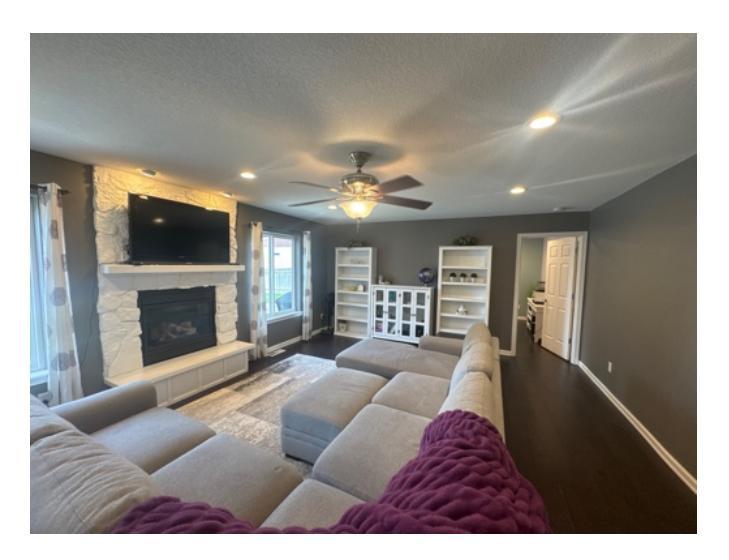
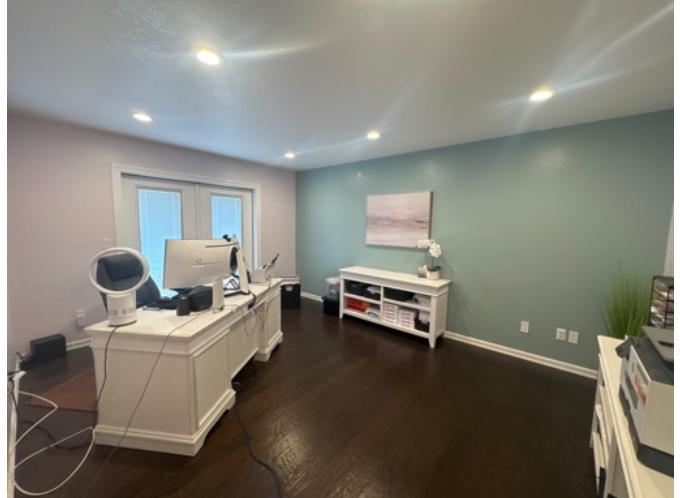
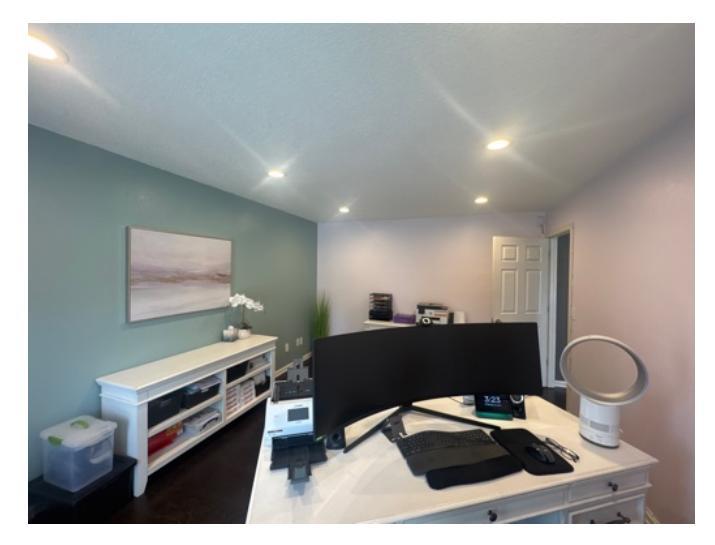
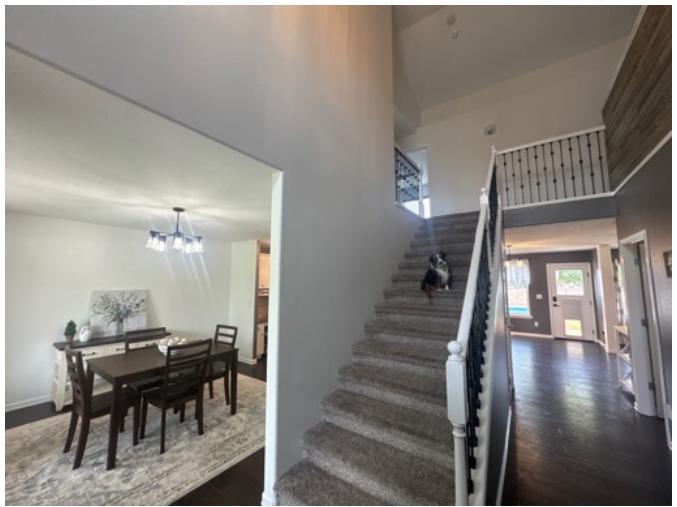
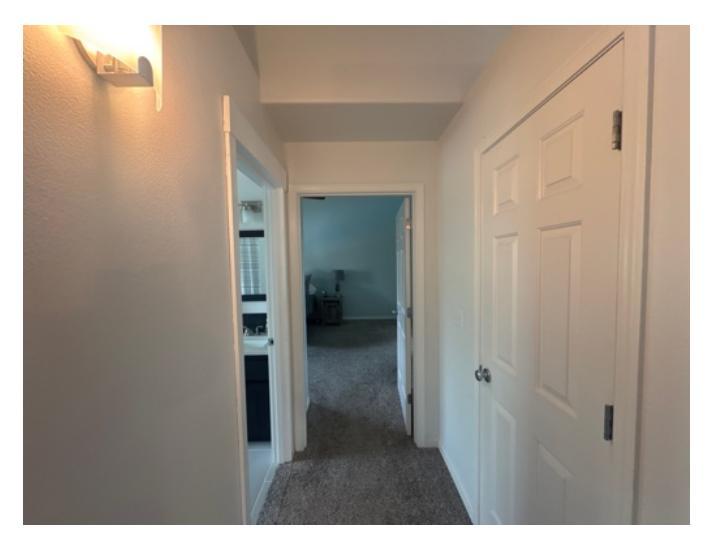
### 7.1) Wall Conditions

There were small cosmetic imperfections observed at the interior walls and trim. Recommend touchup/minor repairs as needed.

There were small partially finished drywall repair repairs at the back wall in the laundry area. Recommend repair as needed/desire.

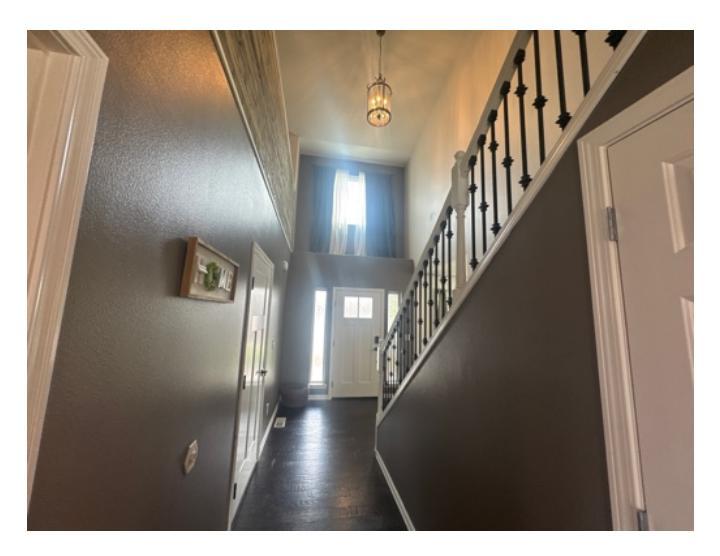
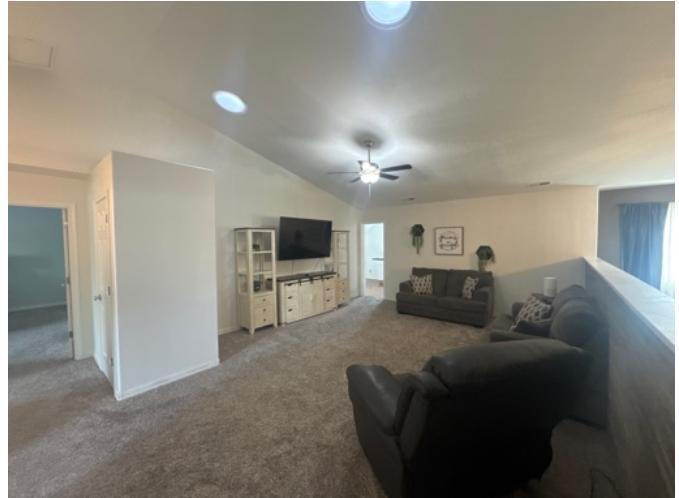
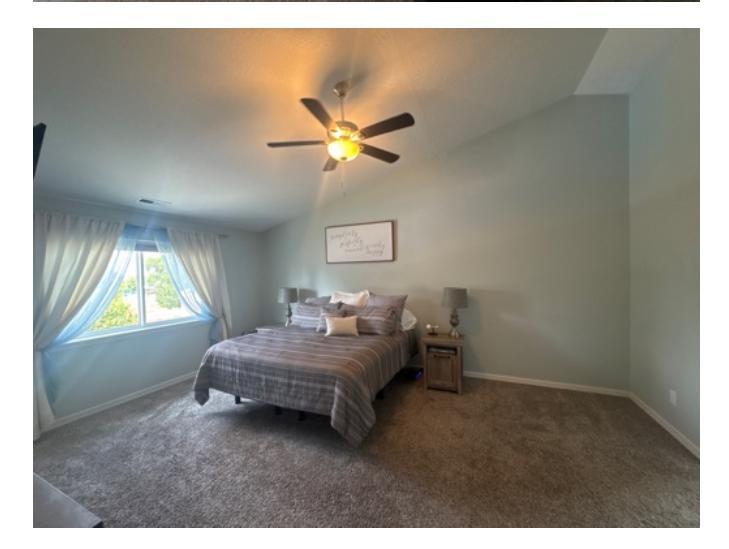
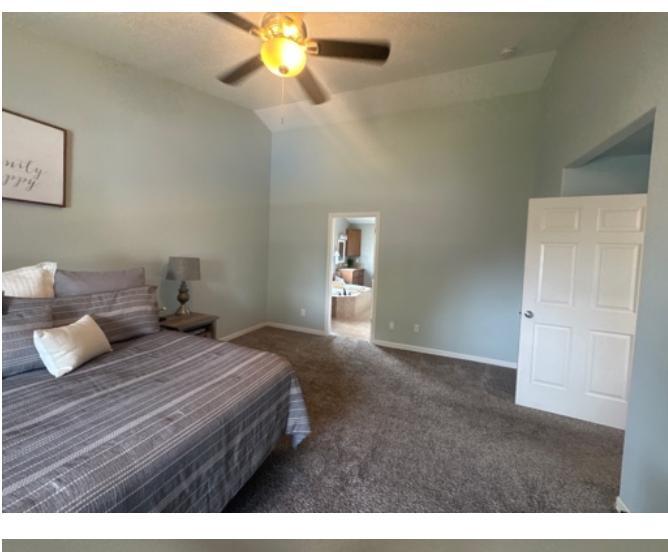
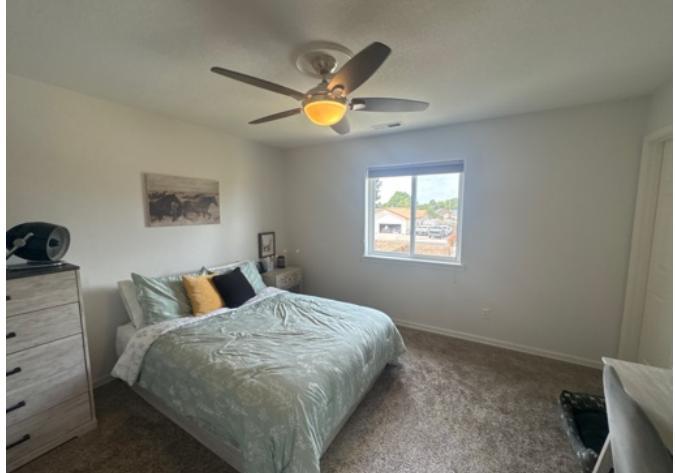
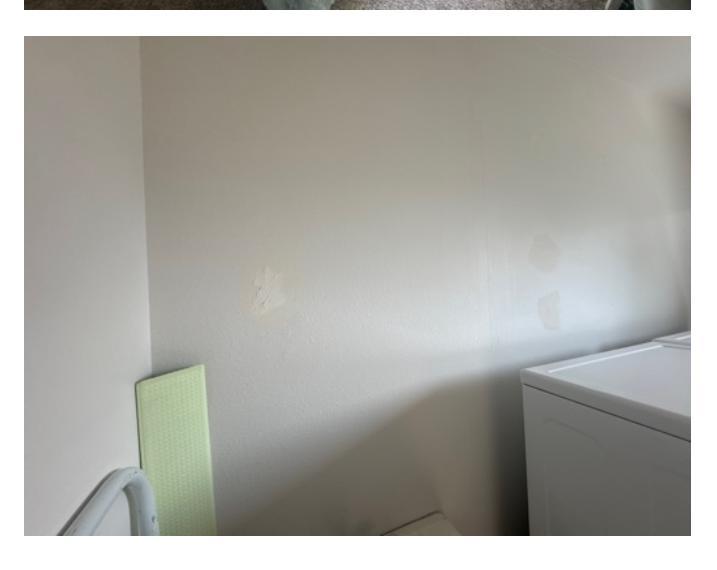
A drywall seam at the master bedroom ceiling appears to have been repaired, and the tape line has slightly cracked against the back wall. Recommend repair.

There were areas of drywall repair observed at the Ceilings in several areas around the home

including the powder room, ceiling, and upstairs living area ceilings. Recommend asking seller why these repairs were made.

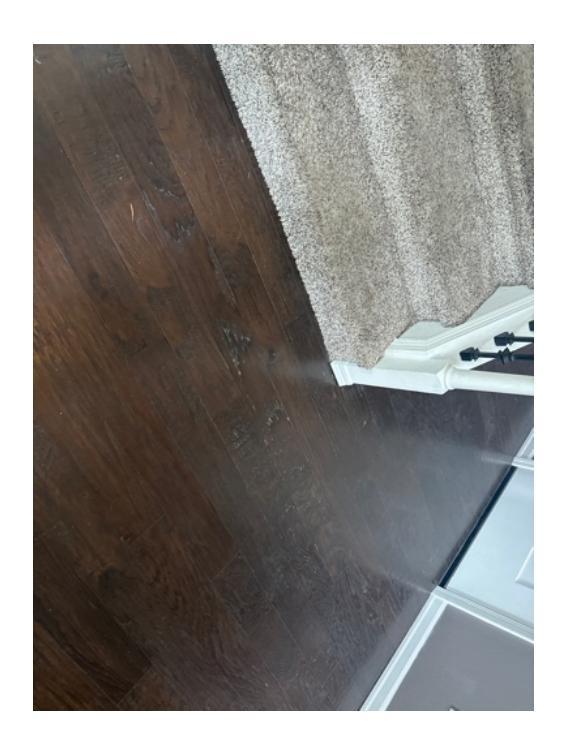
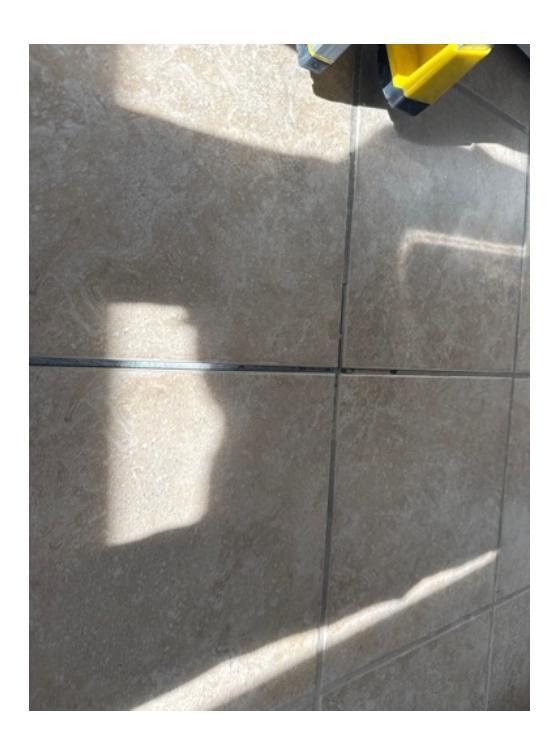
#### 7.3) Floor Conditions

There were areas minor wear observed at the hardwood floors and carpets. Recommend repairs as needed.

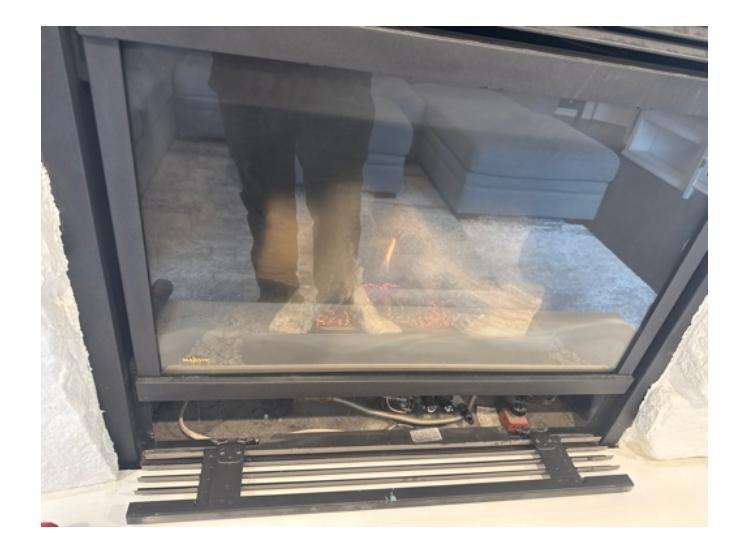
#### 7.10) Fireplace Conditions

The general condition of the visible and accessible areas of the fireplace appeared to be in serviceable condition at the time of the inspection.

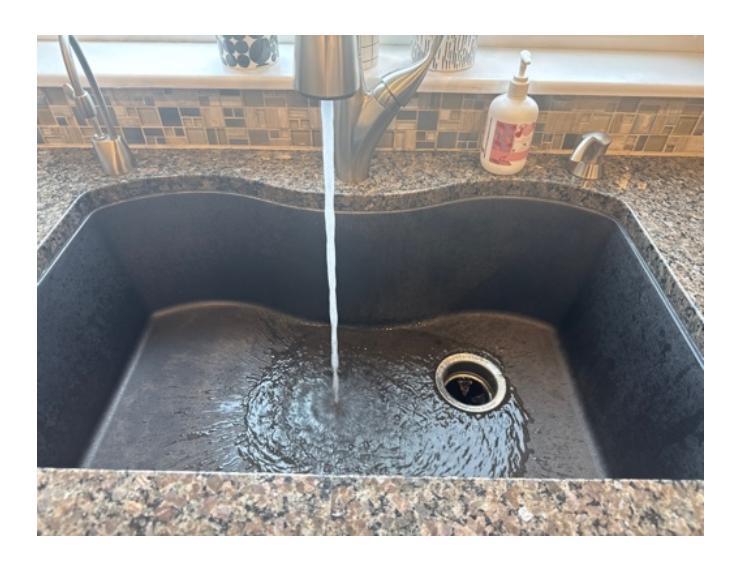
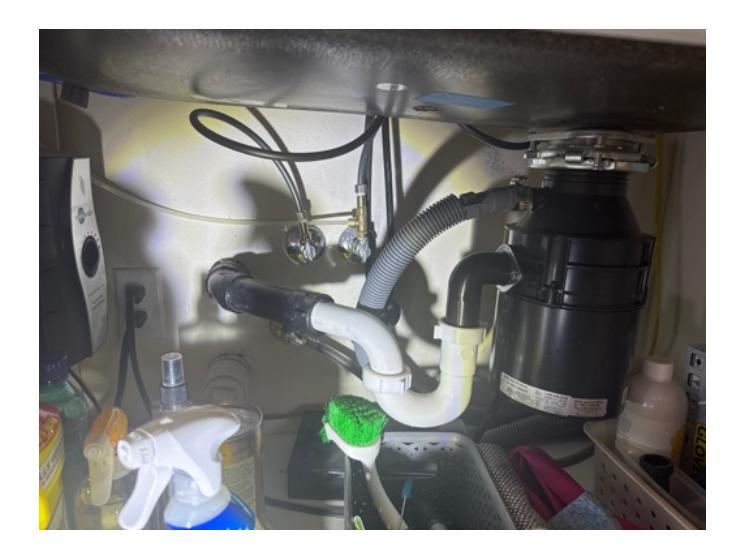
8.3) Sink Plumbing Conditions

The kitchen sink appeared to be in serviceable condition at the time of the inspection. The faucet appeared to be in serviceable condition at the time of the inspection. The visible areas of the plumbing under the kitchen sink appeared to be in serviceable condition at the time of the inspection.

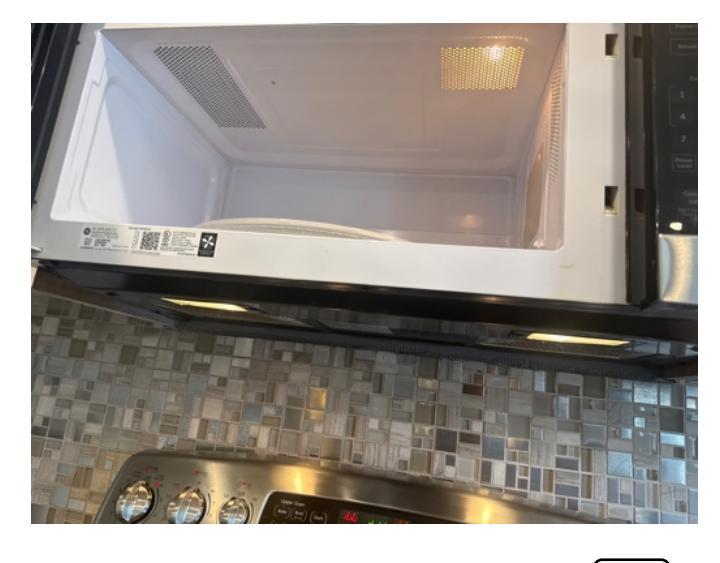
8.6) Hood Fan Conditions

The above range microwave was operational at the time of inspection.

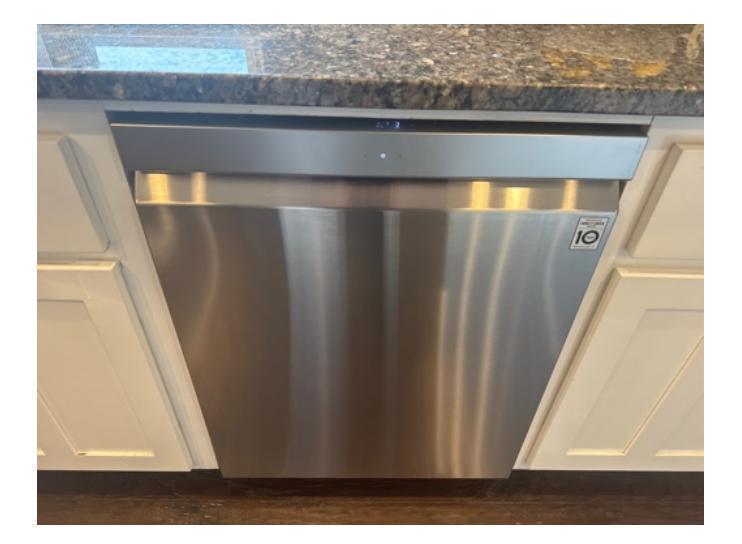
8.7) Dishwasher Conditions

The dishwasher appeared to be in serviceable condition at the time of the inspection. This does not however guarantee future performance or conditions.

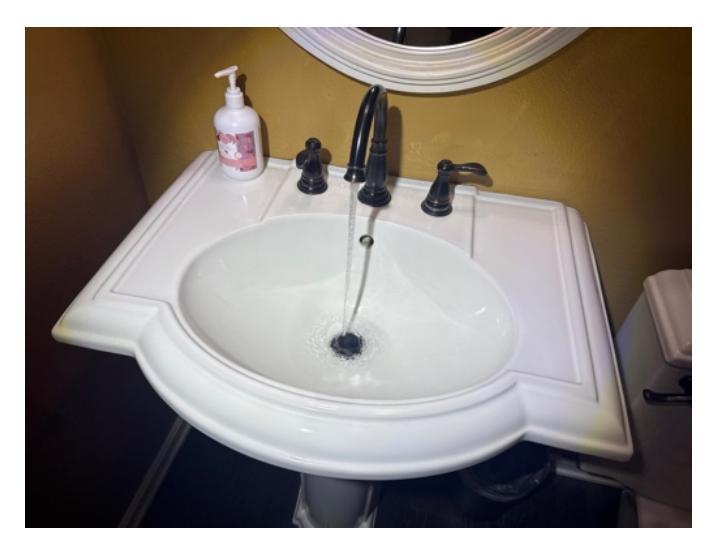
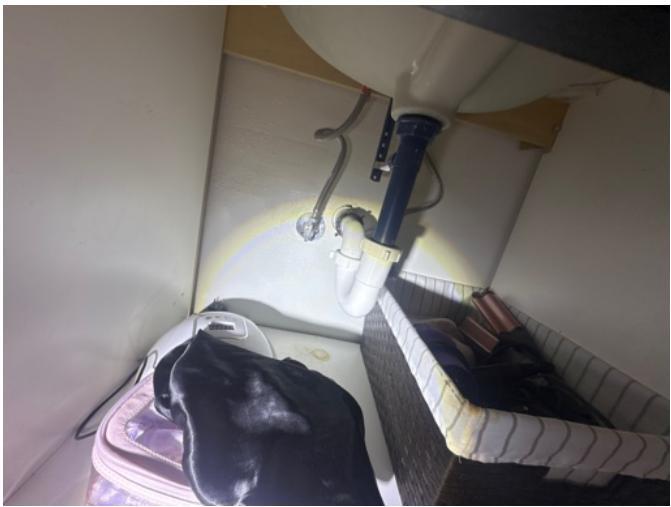
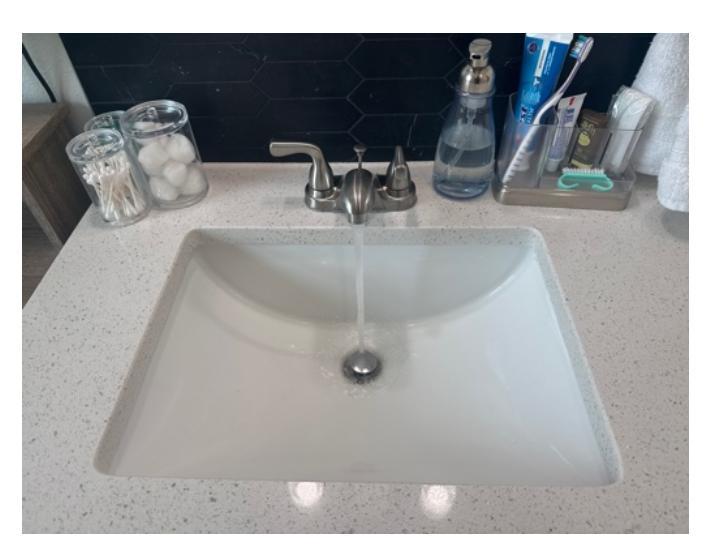
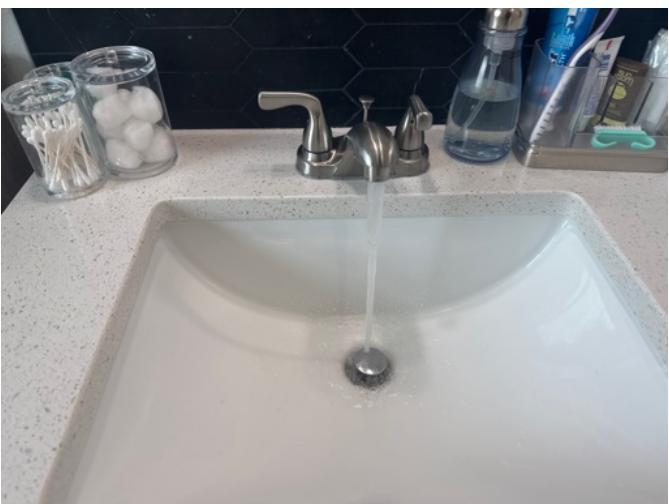
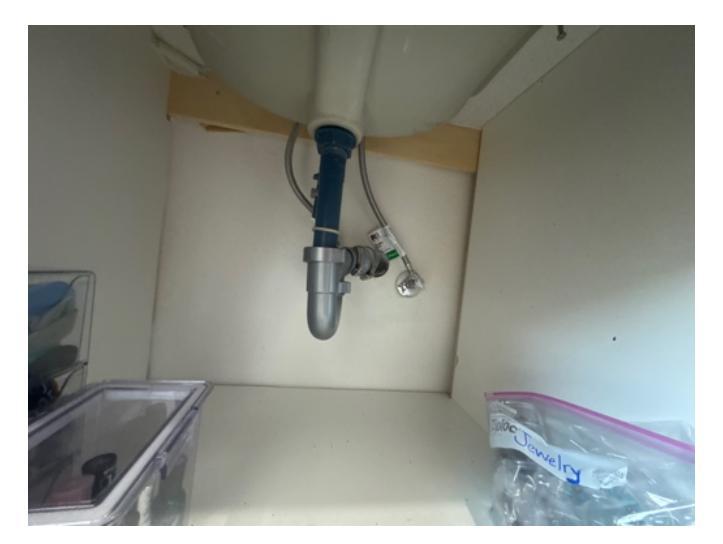
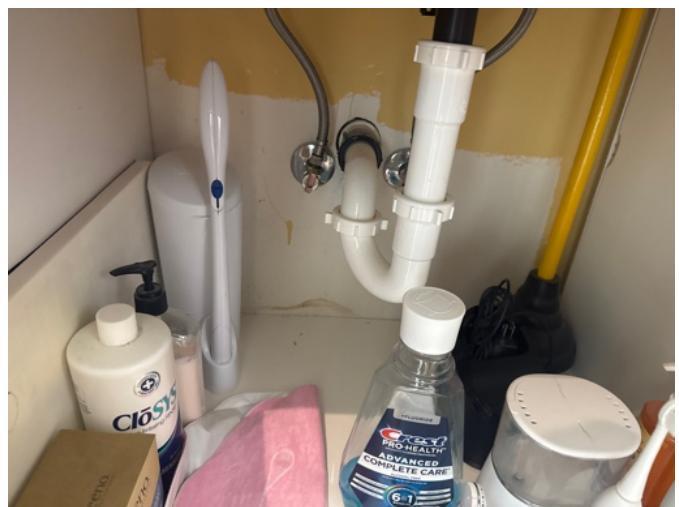
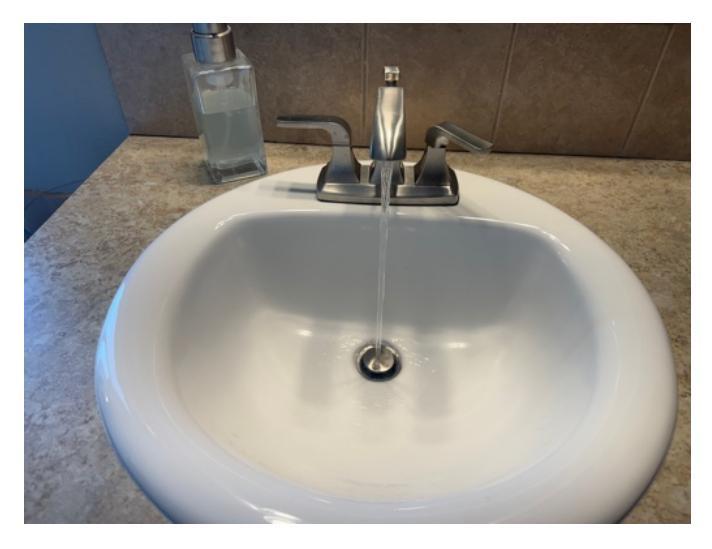
9.5) Sink Conditions

The sinks appeared to be in serviceable condition at the time of inspection

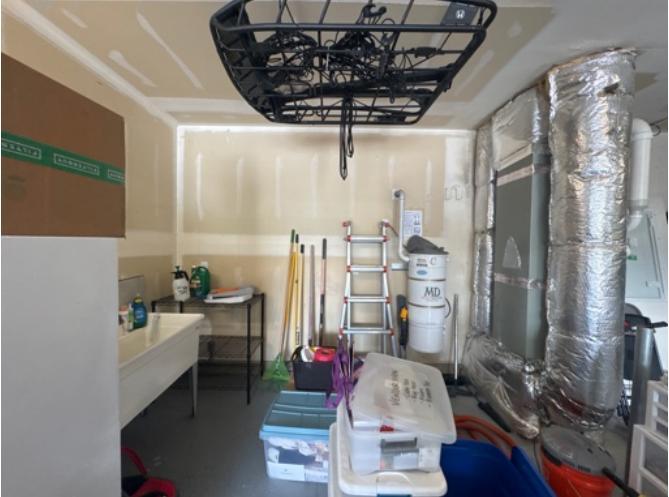
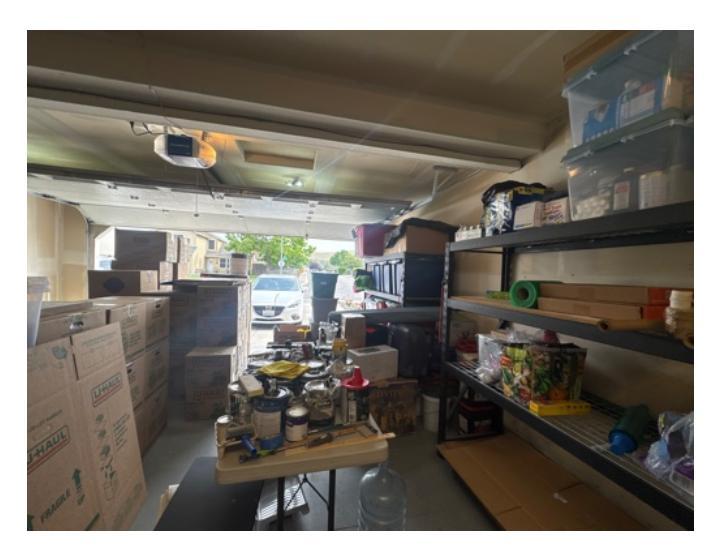
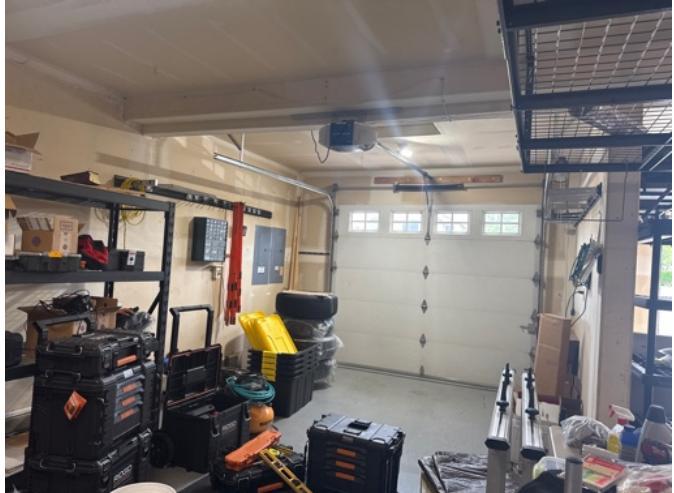
There were common drywall cracks in areas of minor damage, observed at the interior walls of the garage. Recommend maintenance and repair as needed. There were no immediate concerns observed at the time of inspection.

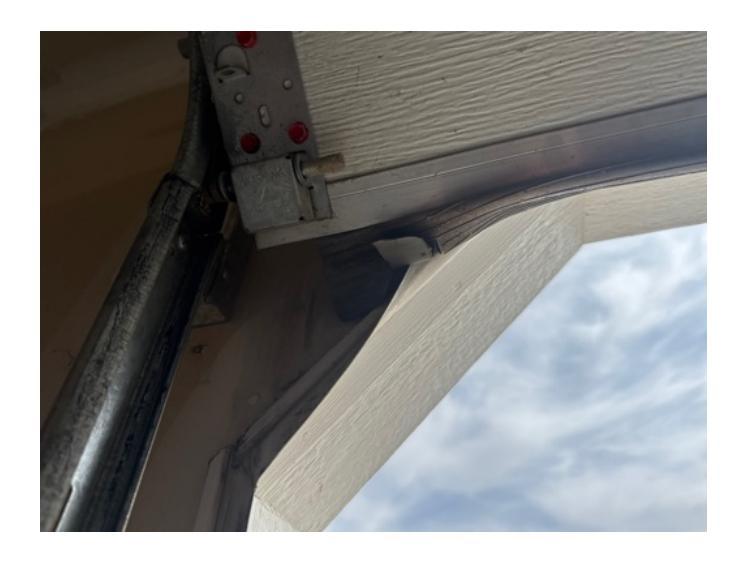
The weatherstripping at the bottom of the garage door was slightly damaged at the corners. It

appears that the weatherstripping rubs on the door frame when the door is fully opened. Recommend repair as needed.

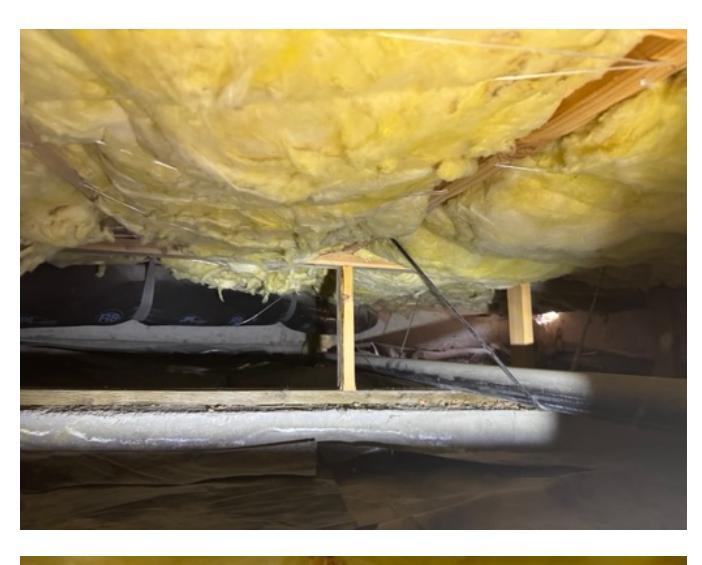
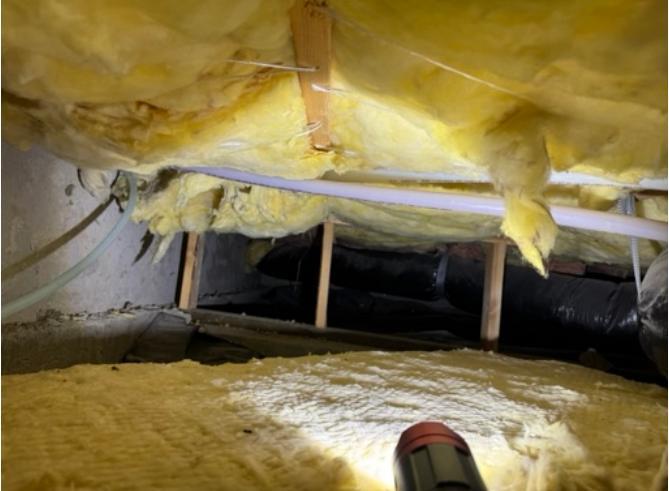
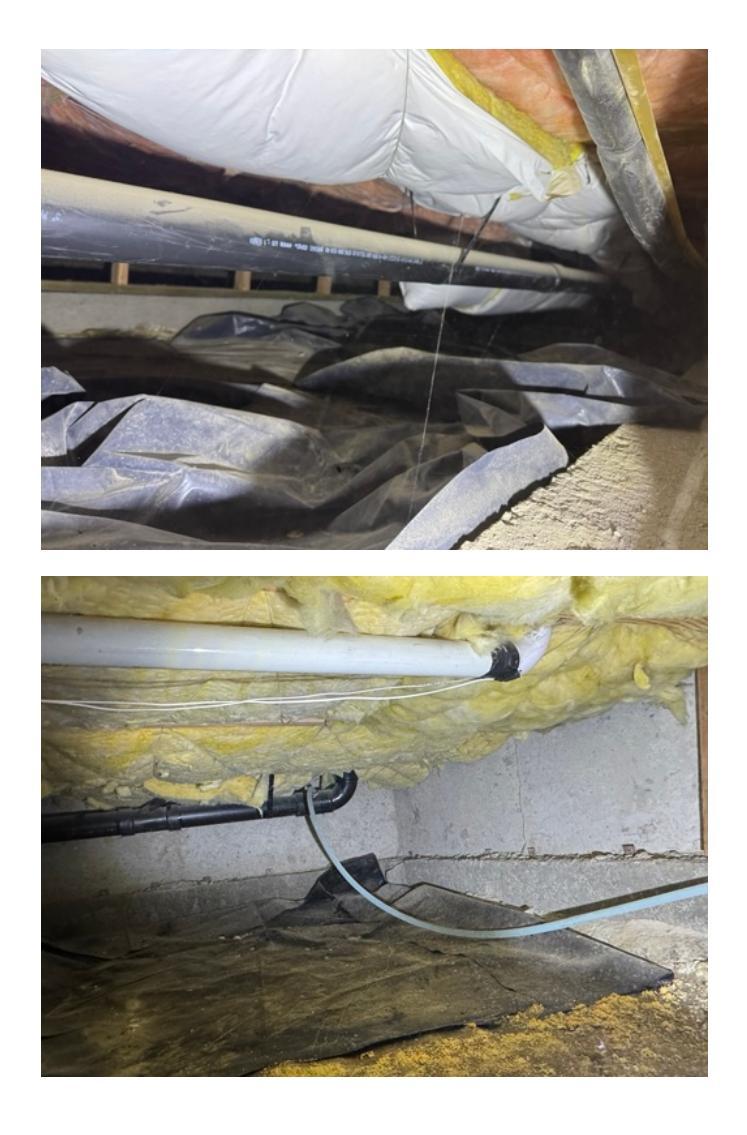
The visible and accessible portions of the foundation appeared to be in serviceable condition at the time of inspection.
