# INSPECTION REPORT

For the Property at:  
**14183 HIGHWAY 62**  
MADOC, ON

Prepared for: TEAM VANRAHAN  
Inspection Date: Tuesday, May 2, 2023  
Prepared by: David Sharman

RE: Report No. 4296  
14183 Highway 62  
Madoc, ON

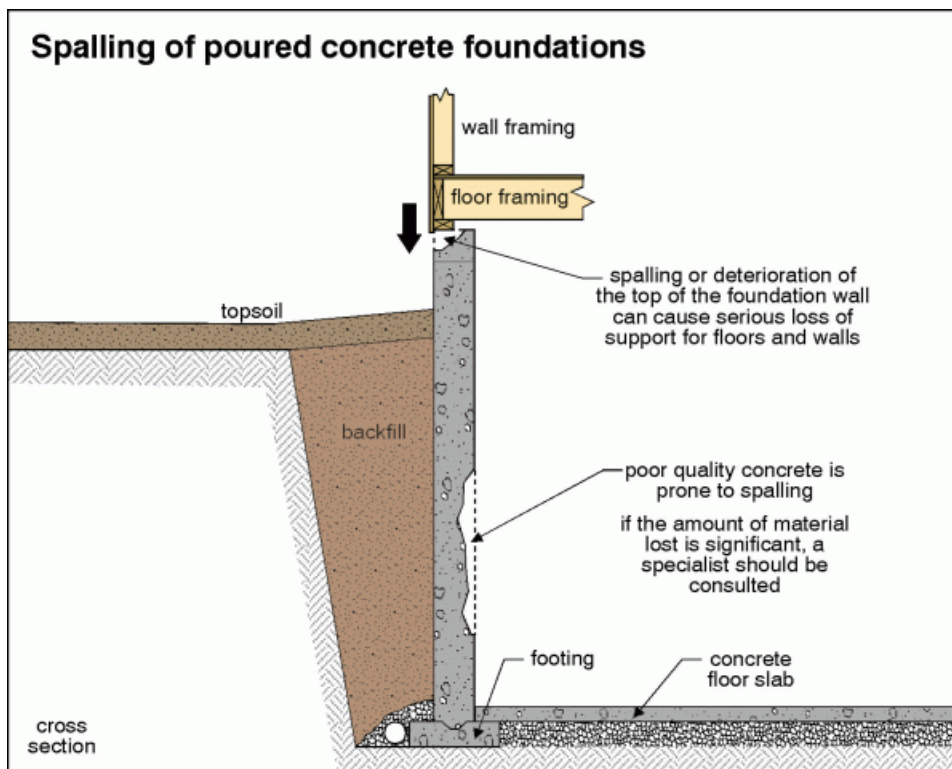
**3. Condition:** • Spalling, crumbling or broken material

**Implication(s):** Continued material deterioration, Weakened structure

**Task:** Repair
