# INSPECTION REPORT

For the Property at:  
**159 BOWEN DRIVE**  
PETERBOROUGH, ON K9H 0C1

Prepared for: TEAM VANRAHAN  
Inspection Date: Tuesday, April 11, 2023  
Prepared by: David Sharman

RE: Report No. 4253  
159 Bowen Drive  
Peterborough, ON  
K9H 0C1

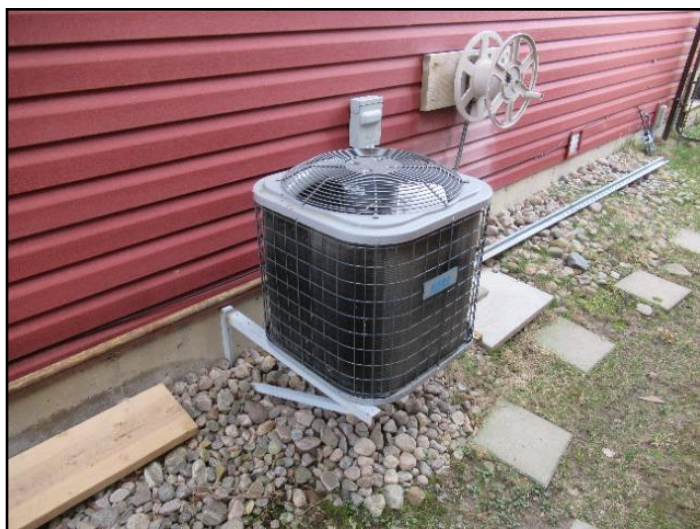
16. Air cooled

**10. Condition:** • Near end of life expectancy

**Implication(s):** Equipment failure | Reduced comfort

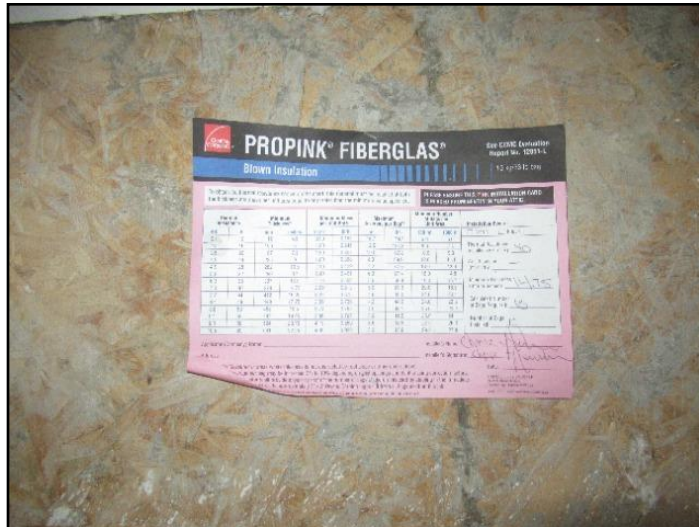
18. R-40

**11. Condition:** • Amount less than current standards

Although being below current standards is not a deficiency, the home may benefit from an increased level of insulation.
