Stucco Hard Coat Inspector: Lance Reid on 5/2/25

# Hard Coat Stucco Inspection

235 Foxley Way  
Roswell, Georgia 30075

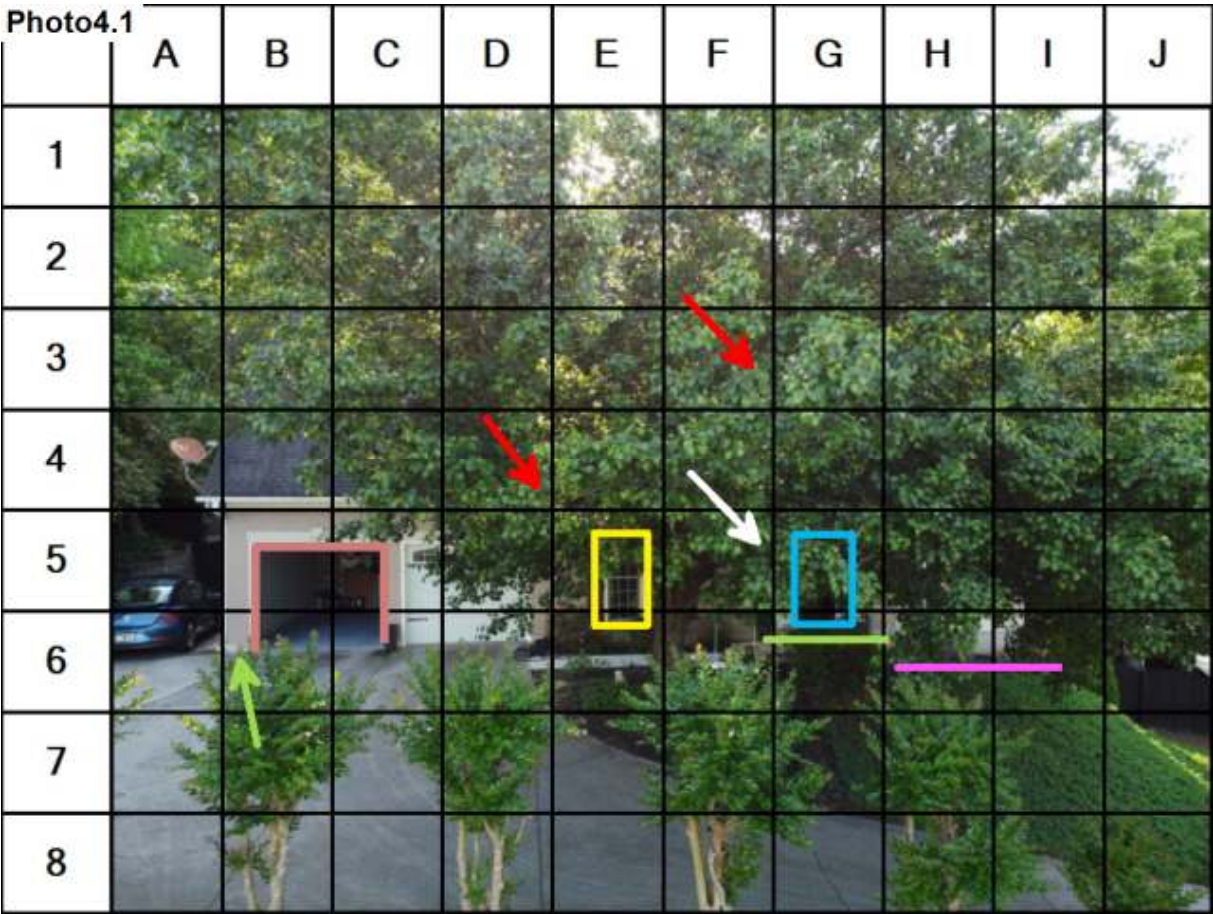
# Front Elevation

Item	Item Description	Observations / Comment
		All items outlined in this stucco report that are suggested to be applied or installed by a stucco contractor are in accordance with current industry standards.
D4, F3	Roof Terminations	A kick-out diverter is installed into the roofing terminations and the vertical soffit terminations below are sealed with a quality sealant.
B6, G6	Driveway & Stoop	The top edges of the driveway and front stoop are suggested to be sealed at the stucco with a Dow quality sealant.
B6-C6 (2)	Garage Doors	The perimeters of the garage doors and the jamb terminations at the concrete are sealed with a quality sealant.
E5 - All	Windows & Mitered Joints	The perimeters of the windows (all four sides) and the mitered joints are sealed with a quality sealant.
F5 - All	Light Fixture - Utility Penetrations	Light fixtures are classified as utility penetrations and all are sealed at the bases with a quality sealant.

G5	Entry Door/ Threshold	The perimeter of the entry door and the threshold, including the bottom edge, are sealed with a quality sealant.
H6-I6 - All	Ground Contact	The hard coat stucco system terminates on the poured foundation or slab with no insulation board, sheathing, metal lath or substrate framing exposed at grade.
All	Landscaping	Continue to manicure the landscaping to maintain a 18-24 inch barrier from the surface of the stucco to allow for adequate ventilation.

1. Page 4 of the report - The top edges of the driveway, front stoop and vertical sides are suggested to be taped off and caulk sealed at the stucco with a quality sealant. \$110.00

2. Page 4 of the report - The front of the home has the following damaged wood trim areas in detailed photos outlined in yellow suggested to be replaced using treated wood or PVC then sealed and painted back if required. Page 8 - 8.1, 8.2, 8.3, 8.4, 8.5, 8.6. Page 9 - 9.1, 9.2, 9.3, 9.4. \$1595.00

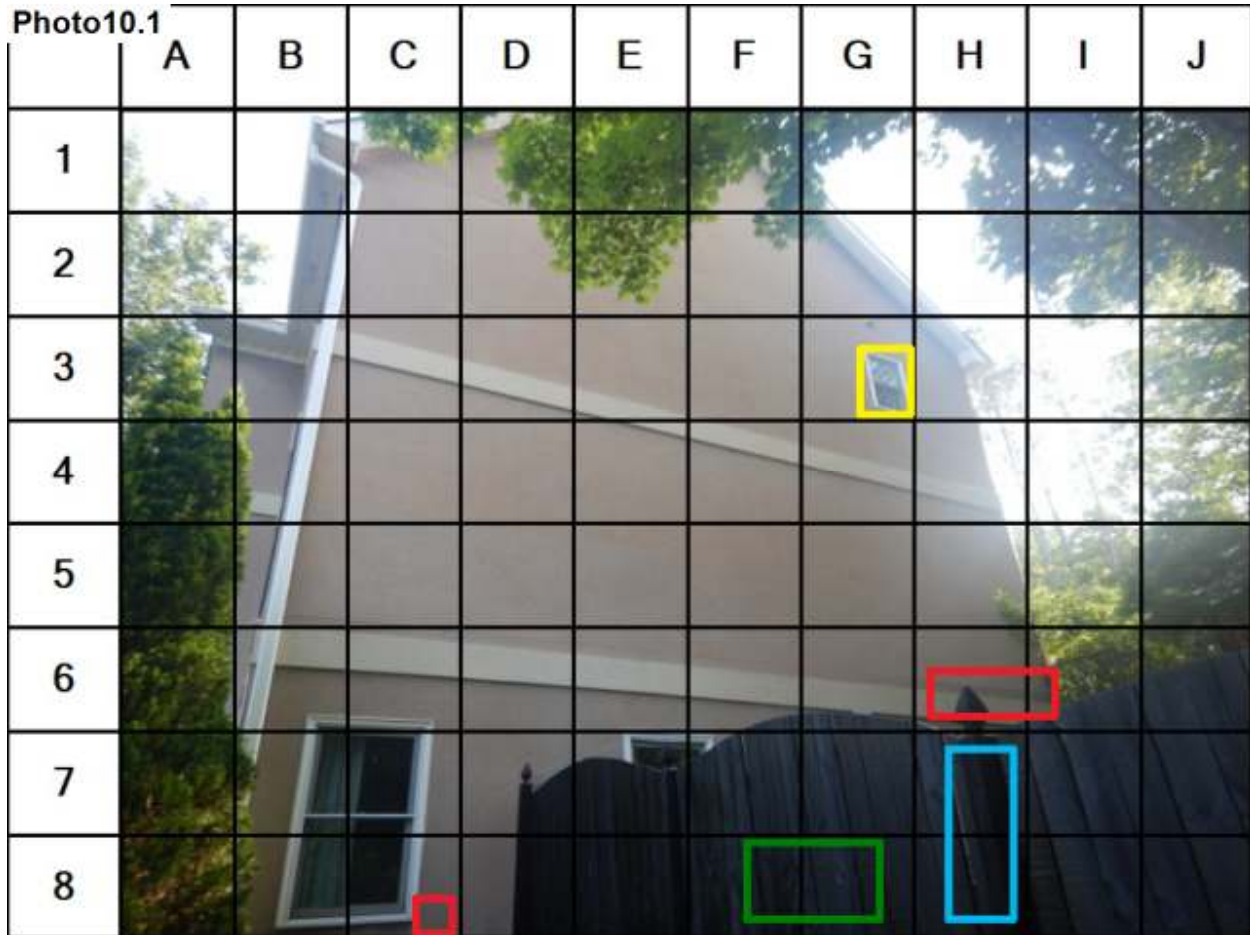
## Right Elevation

Item	Item Description	Observations / Comment
C8	Cracks	The identified settlement crack is suggested to be repaired by a stucco contractor due to exposed metal components and base coat.
G3 - All	Windows & Mitered Joints	The perimeters of the windows (all four sides) and the mitered joints are sealed with a quality sealant.
F8-G8 - All	Utility Penetrations	The perimeters of the utility boxes, line penetrations and the conduit fastener penetrations into the stucco are sealed with a quality sealant.
H7-H8	Entry Door/ Threshold	The perimeter of the entry door and the threshold, including the bottom edge, are sealed with a quality sealant.
H6-I6	Delamination	The wall section identified is delaminated (lost adhesion from the framing of the structure) and is suggested to be reattached to the framing and then repaired by a stucco contractor.

3. Page 10 of the report - The identified settlement crack is suggested to be repaired by a stucco contractor due to exposed metal components and base coat. See Detail Photo - Page 11 -11.3. Apply stucco base coat cement, reinforcement mesh, finish coat texture and paint back. \$150.00  
Note: Please have the current paint colors available to best match back replacements.

4. Page 10 of the report - H6-I6 - Red Outline at large wall area -The wall section identified is delaminated (lost adhesion from the framing of the structure) and is suggested to be reattached to the framing and then repaired. See Detail Photo - Page 12 -12.1. Remove delaminating stucco and secure back substrate or add new duroc, not to exceed 12 sq. feet. Apply stucco base coat cement, reinforcement mesh, finish coat texture and paint back. \$960.00

5. Page 10 of the report - The right side of the home has the following damaged wood trim areas in detailed photos outlined in yellow suggested to be replaced using treated wood or PVC then sealed and painted back if required. Page 12, 12.2, 12.3. \$580.00

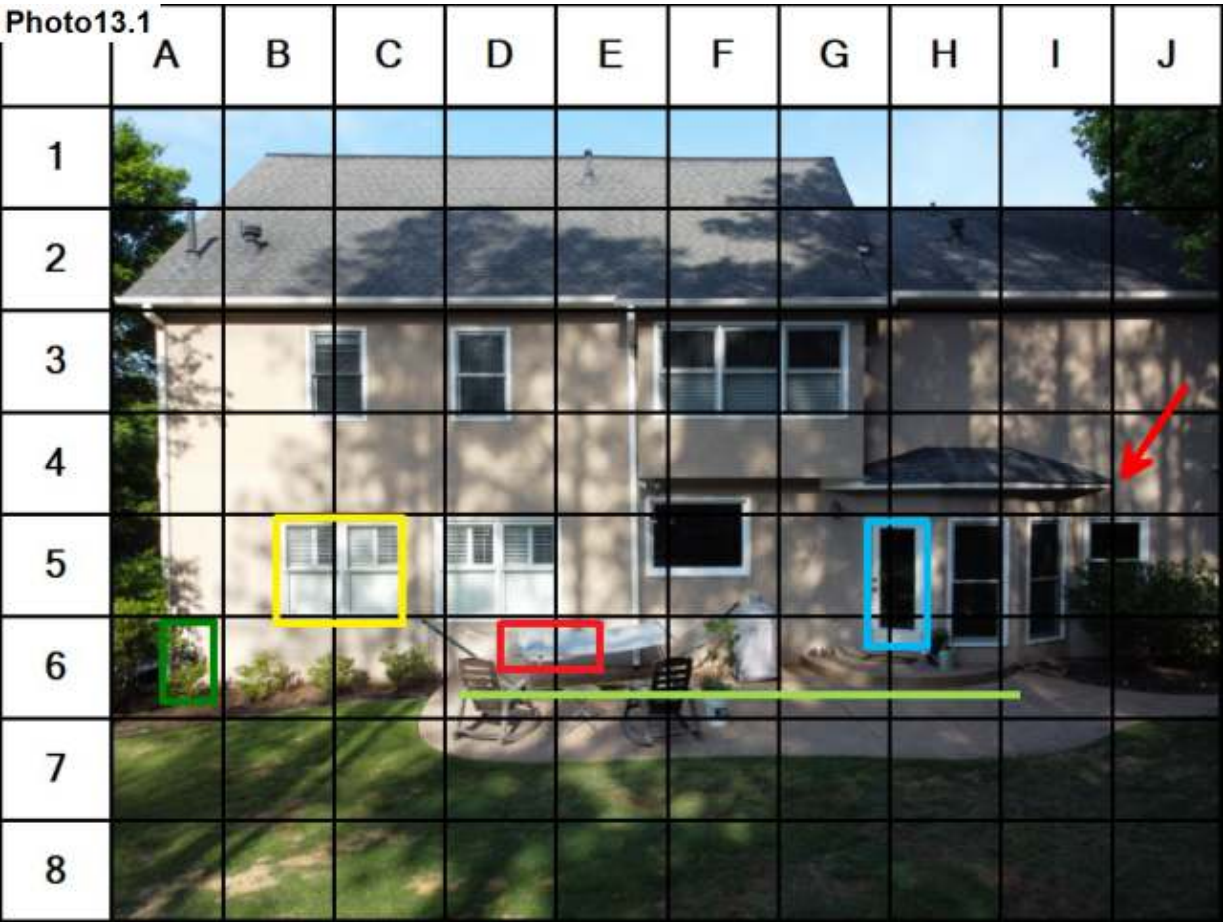
Rear Elevation

Item	Item Description	Observations / Comment
J4	Roof Termination	A stucco contractor is suggested to install a Raintek kick-out diverter into the roofing termination. The vertical soffit termination below is sealed with a quality sealant.
A6	Utility Penetrations	The perimeters of the utility boxes, line penetrations and the conduit fastener penetrations into the stucco are suggested to be sealed by a stucco contractor using a Dow quality sealant.
B5-C5 - All	Windows & Mitered Joints	The perimeters of the windows (all four sides) and the mitered joints are sealed with a quality sealant.
D6-E6	Cracks	The identified settlement crack is suggested to be repaired by a stucco contractor due to exposed metal components and base coat.
D6-I6	Patio	The top edges of the patio are suggested to be sealed at the stucco with a Dow quality sealant.
H5-H6	Entry Door/ Threshold	The perimeter of the entry door and the threshold, including the bottom edge, are sealed with a quality sealant.

All	Hairline Cracks	Hairline cracks are normal and considered cosmetic with hard coat stucco applications; no repairs necessary at the time of inspection. These cracks are a natural occurrence and unavoidable due to the expansion and contraction of the wood framing behind the stucco.

8. Page 13 of the report - The identified settlement crack is suggested to be repaired by a stucco contractor due to exposed metal components and base coat. See Detail Photo - Page 14, 14.3. Apply stucco base coat cement, reinforcement mesh, finish coat texture and paint back. \$150.00  
Note: Please have the current paint colors available to best match back replacements.

10. Page 13 of the report - The rear of the home has the following damaged wood trim areas in detailed photos outlined in yellow suggested to be replaced using treated wood or PVC then sealed and painted back if required. Page 16 - 16.1, 16.2, 16.3, 16.4, 16.5, 16.6. Page 17 - 17.1, 17.2, 17.3, 17.4, 17.5. \$1885.00

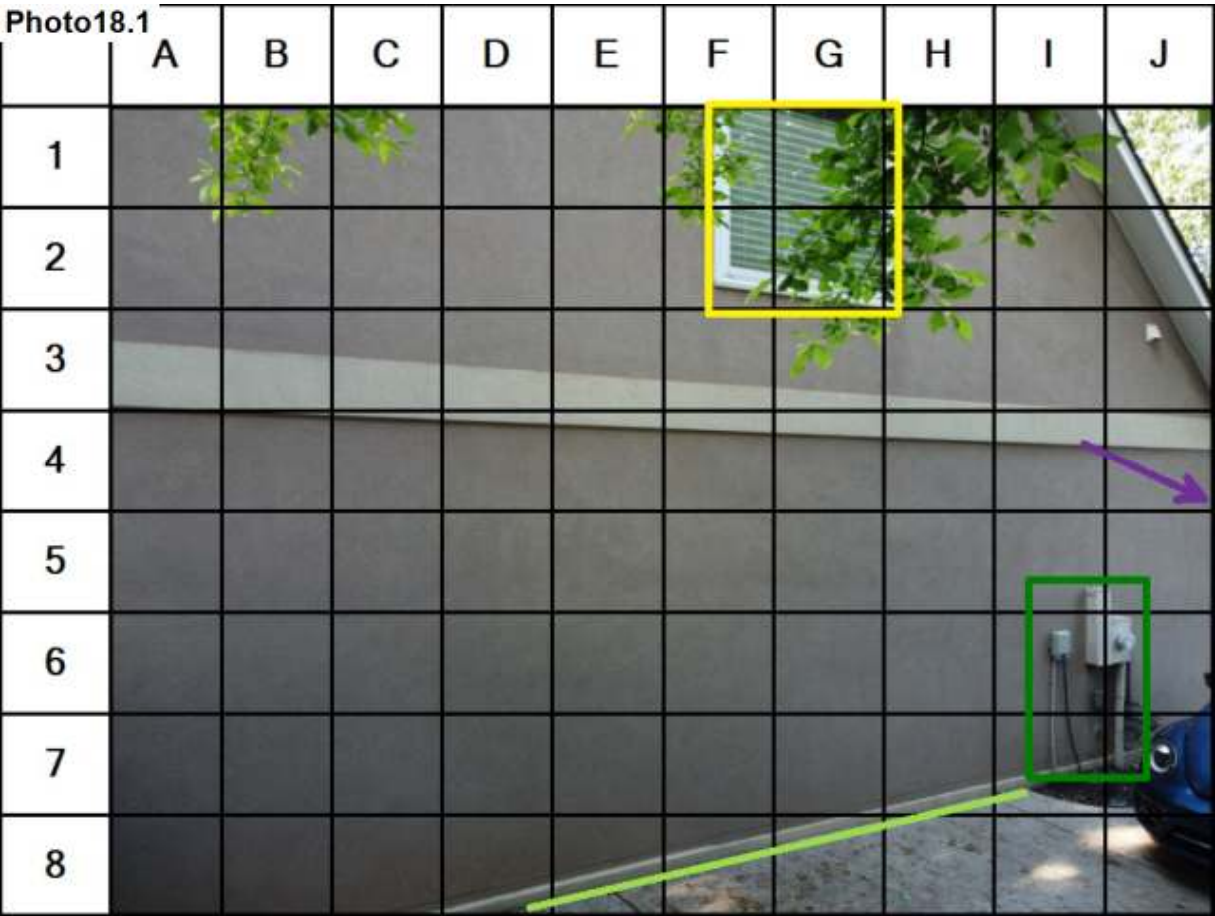
Left Elevation

Item	Item Description	Observations / Comment
F1-H3	Window & Mitered Joints	The perimeter of the window (all four sides) and the mitered joints are sealed with a quality sealant.
D8-I7	Driveway	The top edges of the driveway are suggested to be sealed at the stucco with a Dow quality sealant.
I5-J7	Utility Penetrations	The perimeters of the utility boxes, line penetrations and the conduit fastener penetrations into the stucco are sealed with a quality sealant.
J4 - All	Gutter Downspouts	The gutter down-spouts are securely fastened to the house but the strap penetrations are not sealed and suggested to be sealed with a Dow quality sealant.
