INSPECTION REPORT

For the Property at:
1217 KENNETH AVENUE
PETERBOROUGH, ON K9J 5P8

Prepared for: TEAM VANRAHAN
Inspection Date: Thursday, May 23, 2024
Prepared by: David Sharman

RE: Report No. 4815
1217 Kenneth Avenue
Peterborough, ON
K9J 5P8

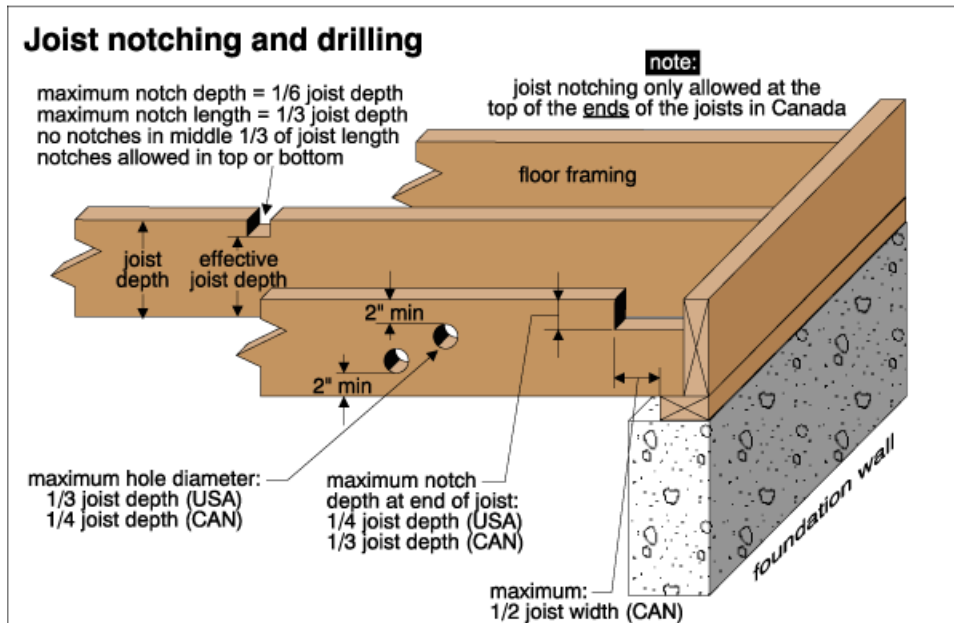
6. Condition: • Notches or holes

Task: Monitor

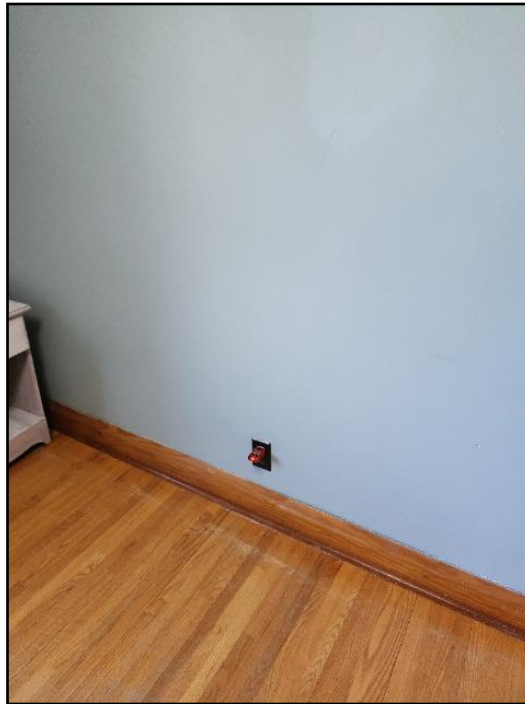
25.

9. Condition: • No GFCI/GFI (Ground Fault Circuit Interrupter)

Although not a deficiency in a home of this age safety may be improved by upgrading this receptacle.
