Siena del Lago  
Seattle, WA

Report #: 26109-4  
Beginning: January 1, 2024  
Expires: December 31, 2024

RESERVE STUDY  
Update "With-Site-Visit"

June 30, 2023

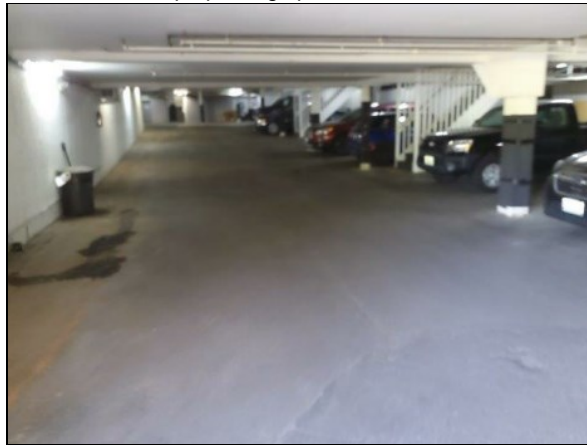
**Comp #: 590 Garage - Maintain/Repair**

Comments: Some cracking and efflorescence stains were observed.

Efflorescence is white staining on the concrete. As water from the exterior moves through the concrete, it dissolves salts and minerals from the concrete. When the water reaches the interior face of the concrete, the water can evaporate which leaves behind the salts and minerals as white stains. Typically, trying to waterproof the exterior surface of the garage is cost prohibitive. Less expensive interior surface remedies, such as epoxy coating and injections, may (or may not) help limit water penetration, and the resulting efflorescence.

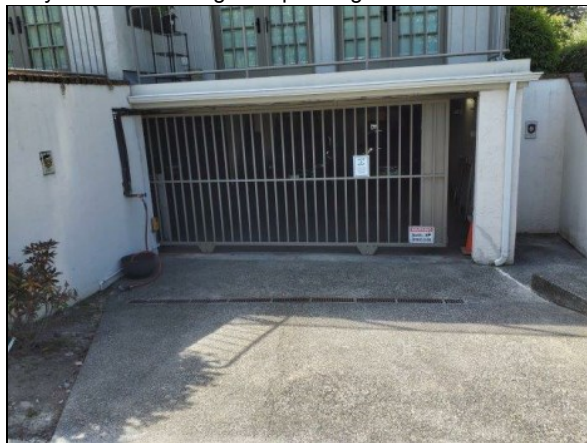
**Comp #: 605 West Garage Gate - Replace**

Comments: No obvious damage or excessive corrosion was noted. No problems were reported.

We recommend planning for the eventual replacement of the gates. Replacement is typically caused by vehicles or other damage not covered by insurance (or prohibitive due to a high deductible), and/or the failure of hinges and welds.

Inspect periodically, and repair locally as needed using the operating funds.

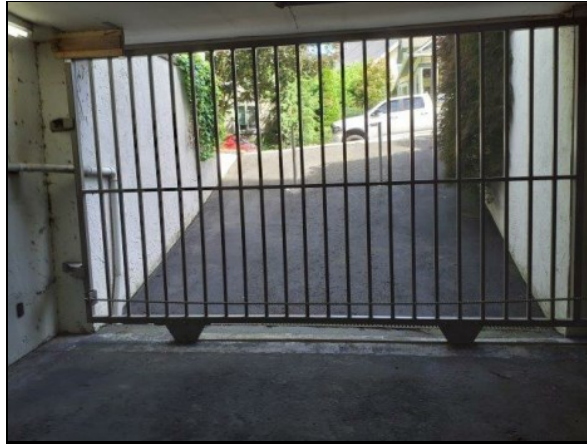
**Comp #: 606 North Garage Door - Replace**

With limited use, there is no predicable useful life at this time. Reserve funding may be included if conditions dictate.

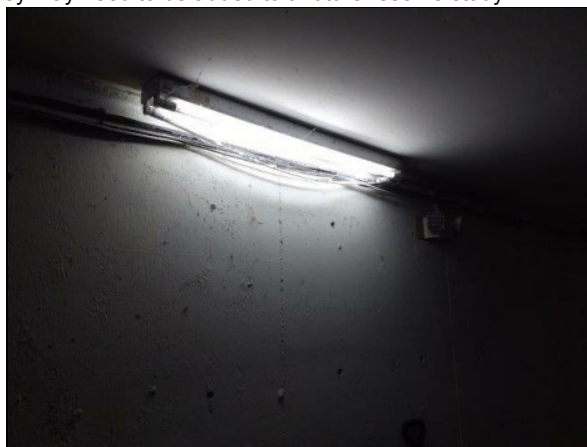
**Comp #: 615 Garage Lighting - Replace**

Location: The garage area.  
Funded?: No. No predictable large scale replacement projected  
History: LED upgrade 2018.

Maintain as needed - replace lamps (bulbs) and ballasts as required on an individual basis. Keep track of ballast expenses. If these costs are large enough, they may need to be added to a future reserve study.

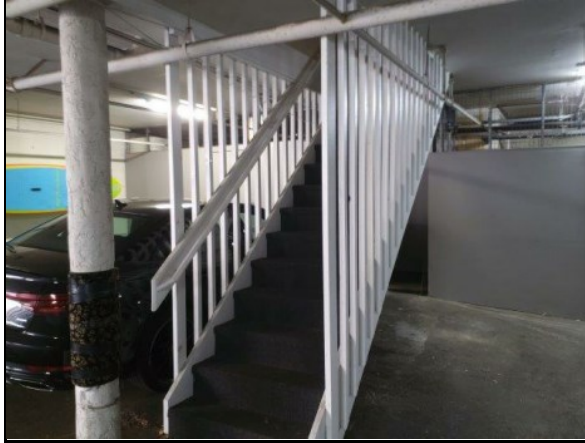
**Comp #: 620 Garage Unit Stairs - Replace**

Comments: No damage or unusual wear was noted at the garage interior wood stair sets. Railings are wood. It was reported the stairs were painted and carpet was replaced in 2018.

No predictable large-scale repairs or replacement at this time. Repair as needed using general maintenance funds. As stairs age, and repair needs become evident, funding can be added to future reserve studies.

As routine maintenance, inspect regularly to ensure safety and stability. Repair promptly as needed using general operating funds. Paint as part of an exterior paint project. Treat corroded metal with rusted inhibitor to extend useful life.

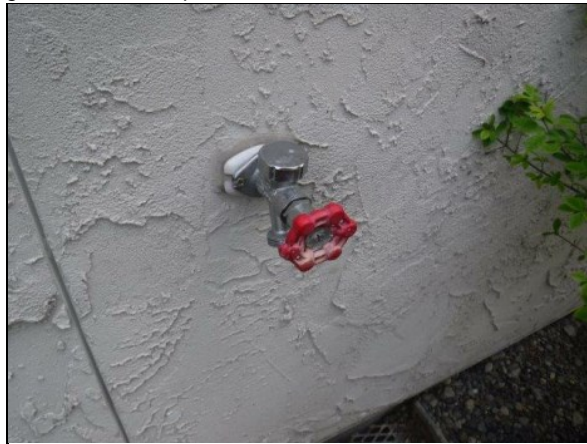
**Comp #: 901 Plumbing - Repair/Replace**

Comments: Plumbing systems are generally considered life limited by the engineering community. The costs for systems replacement can vary widely depending upon the specifications, site conditions, unit repairs after install, hazardous material handling, etc.

See the previous component for a recommended plumbing evaluation. Until a qualified engineering firm has performed an evaluation of your plumbing systems, and provided specific recommendations, there is no predictable basis for system replacement reserves funding at this time.

Treat minor repairs as an ongoing maintenance expense.
