Home Inspection Report

PROPERTY INSPECTED:
32 Chrisval Avenue
Quinte West, ON K8V 5P7

Date of Inspection: 05/23/2023

Inspection No. 141044-904

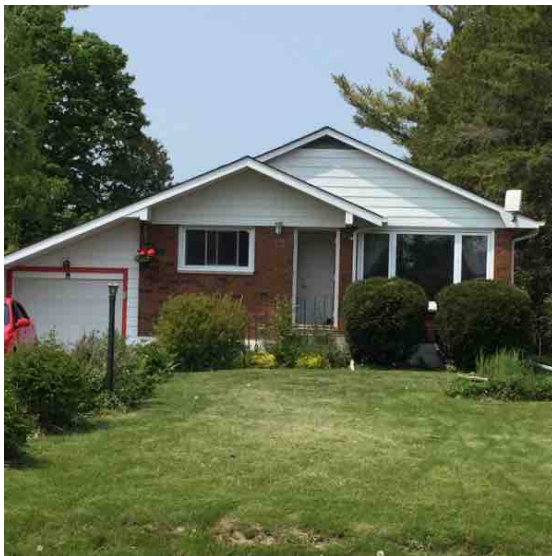
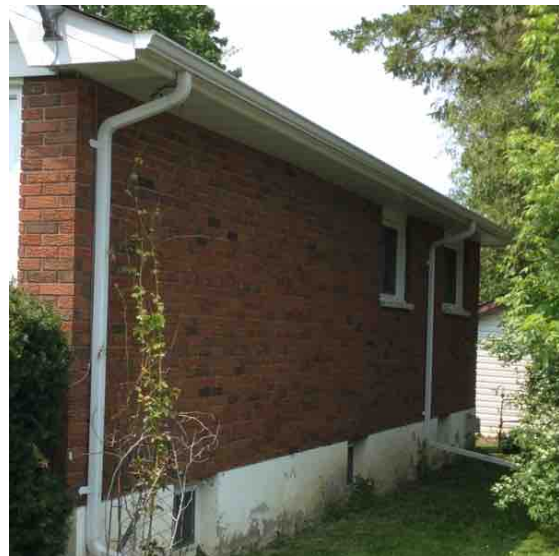
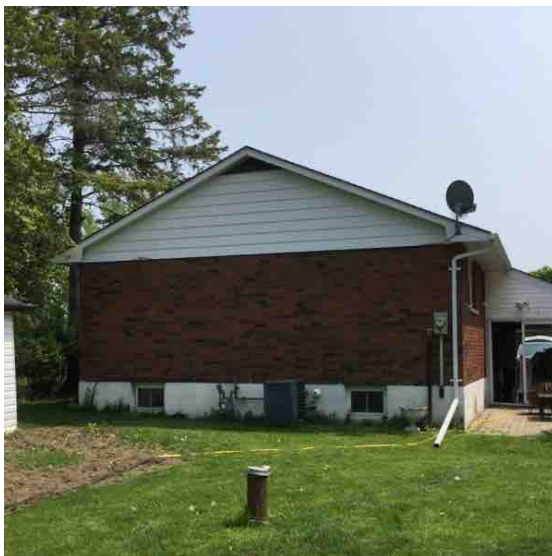
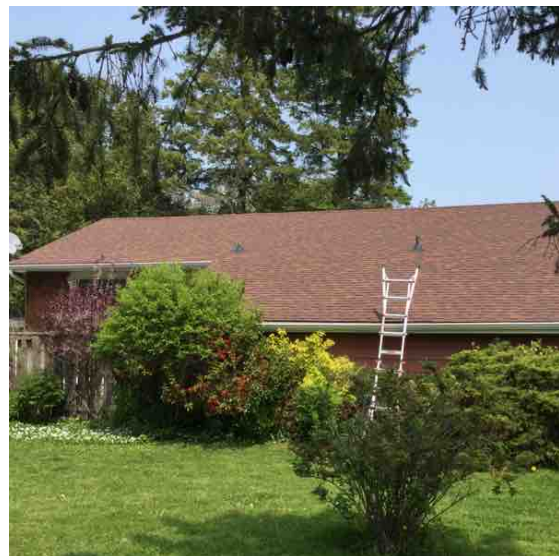
3.2.1 Exterior- As viewed all sides at time of inspection.

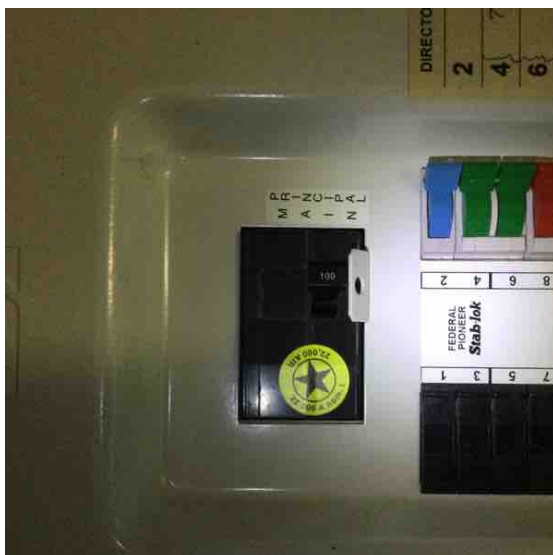
8.5.2 Image confirming amperage of the main disconnect (**Utility/Laundry Room**)

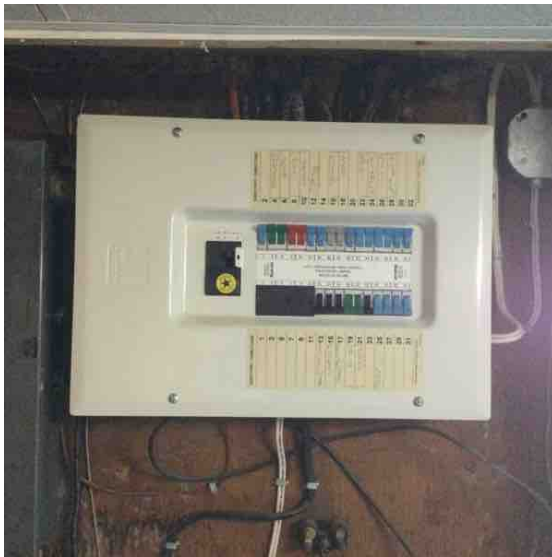
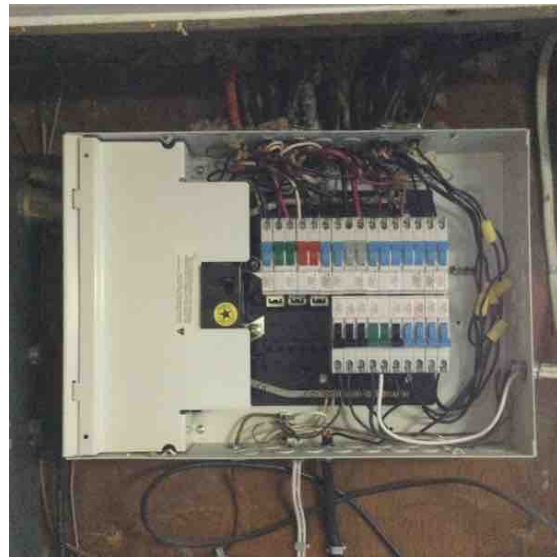
8.6.2 Image of the electrical panel, cover on.

Image of interior of the electrical panel (**Utility/Laundry Room**)

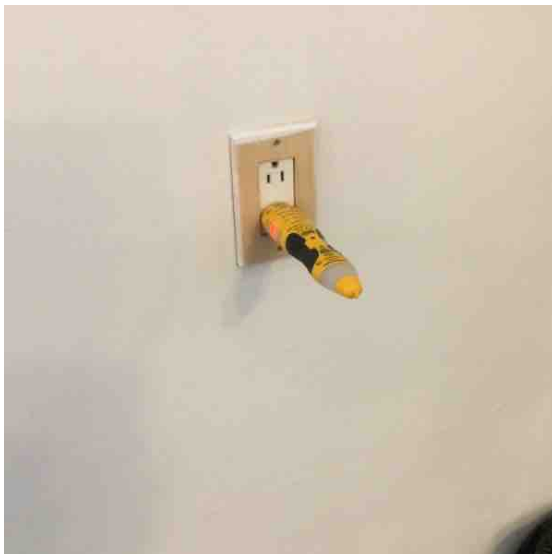
- Exterior Rear
- Kitchen

8.9.2 The receptacle(s) are mis-wired (hot neutral reversed) A qualified electrician should correct as required for electrical safety.

8.9.2 **The receptacle(s) are mis-wired (hot neutral reversed) A qualified electrician should correct as required for electrical safety.**

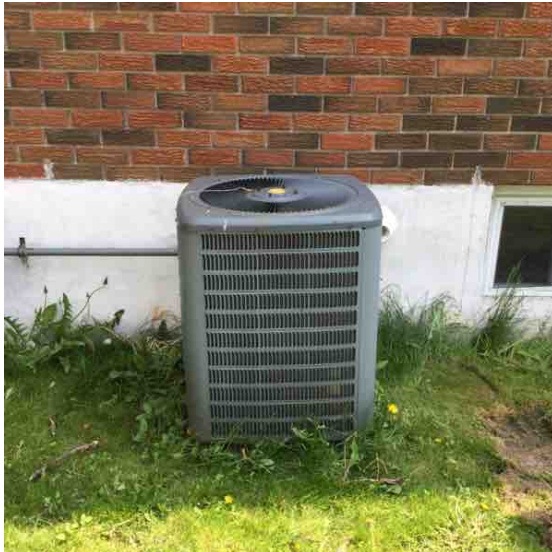
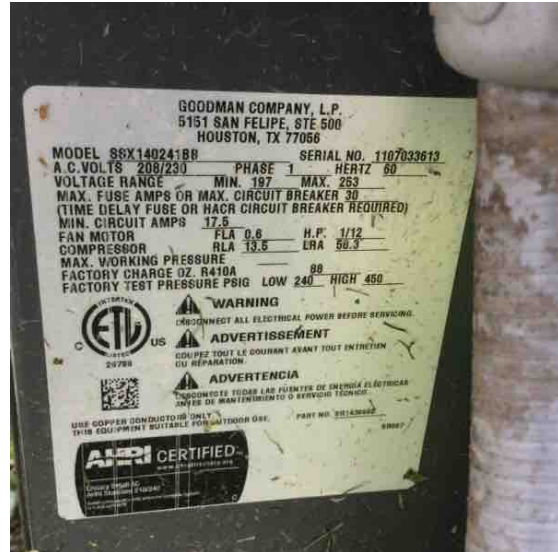
9.5.2 Image of the exterior air conditioner condenser.

Data plate confirms the date of manufacture, 2011 (Exterior Rear)

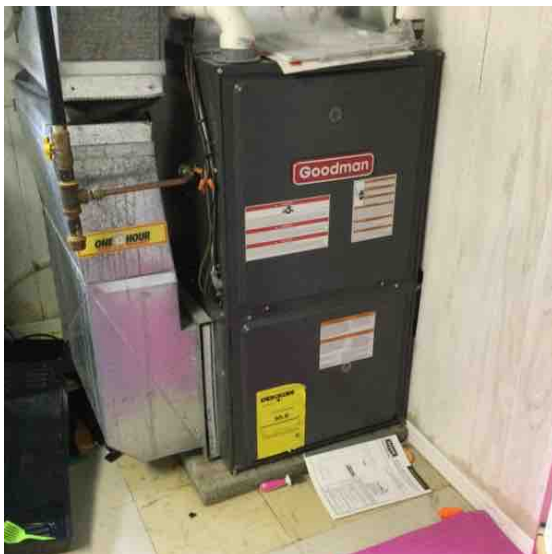
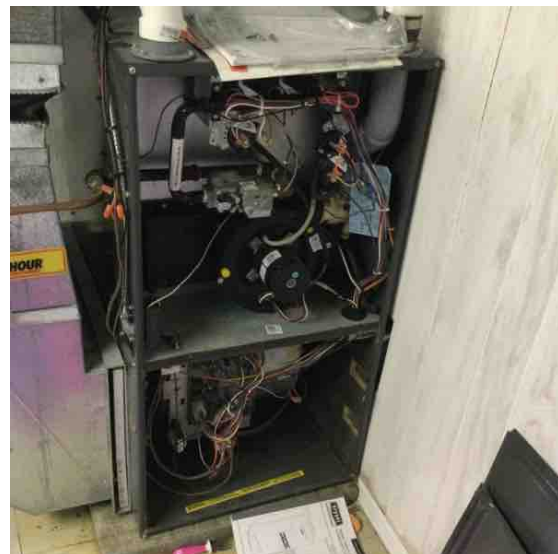
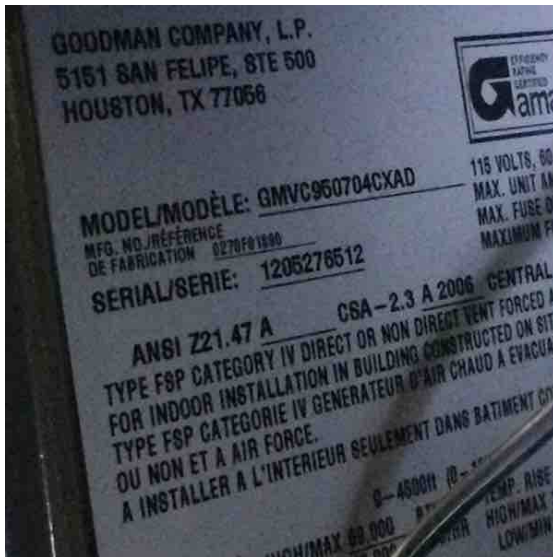
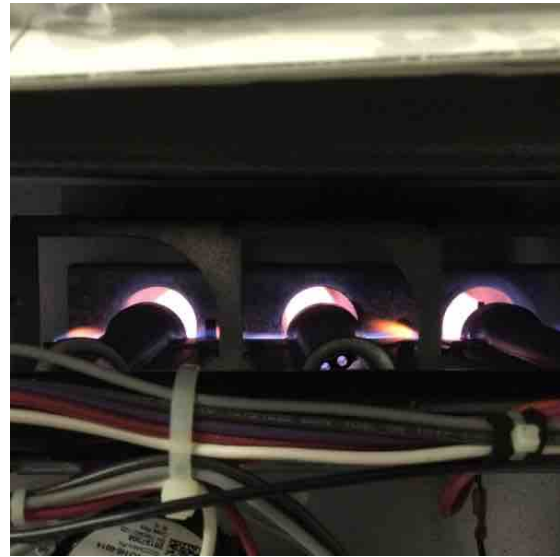
Data plate confirms the date of manufacture, 2012

The forced air furnace is dirty. A qualified HVAC contractor should service / clean the furnace to ensure optimal performance. (Utility/Laundry Room)

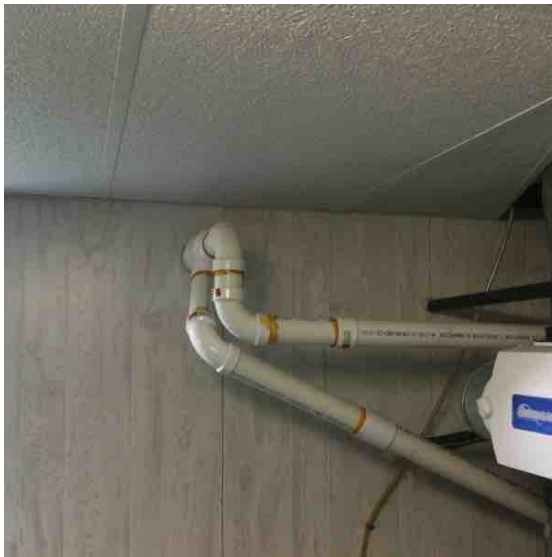
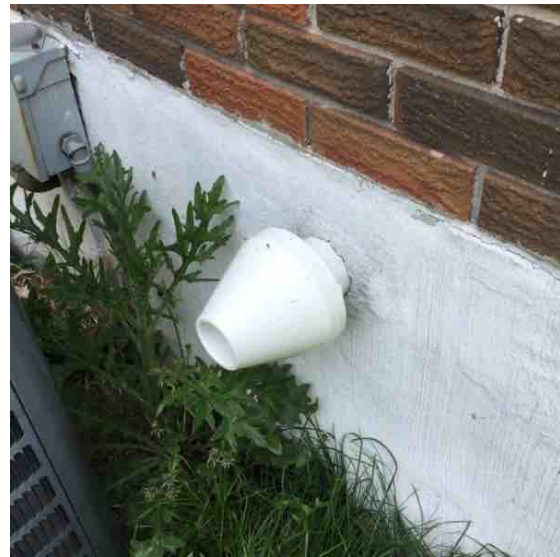
9.7.2 Interior venting images, no concerns

Exterior venting images, no concerns. **(Exterior Rear)**

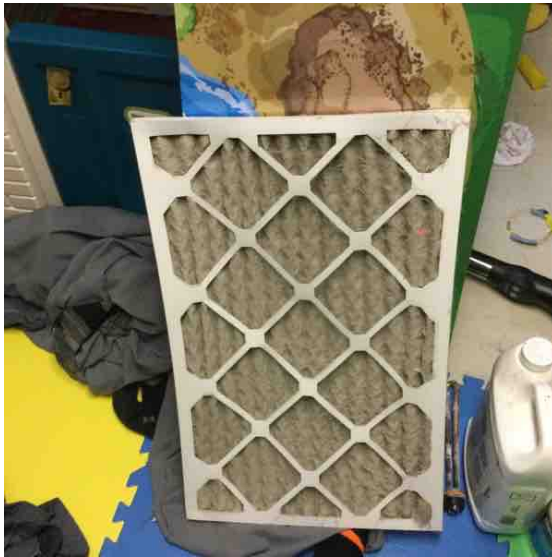
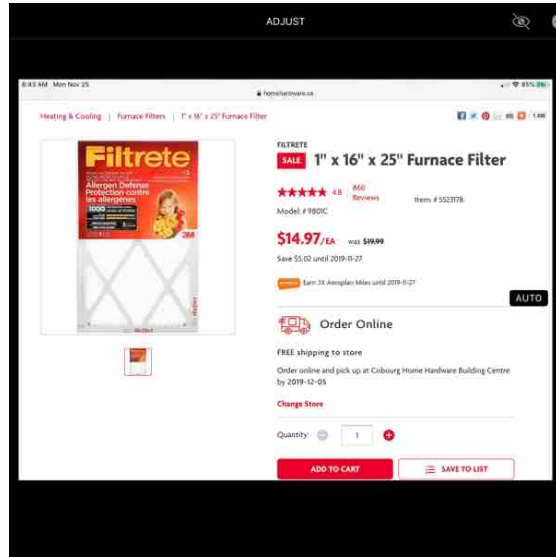
9.10.2 Image of the filter in use

Maintenance Tip: Recommend the use and regular replacement of this better quality filter, one that removes more and smaller particulate from the air. This can extend the life of aspects of the HVAC system, keep the house cleaner and the breathing more comfortable. **(Utility/Laundry Room)**

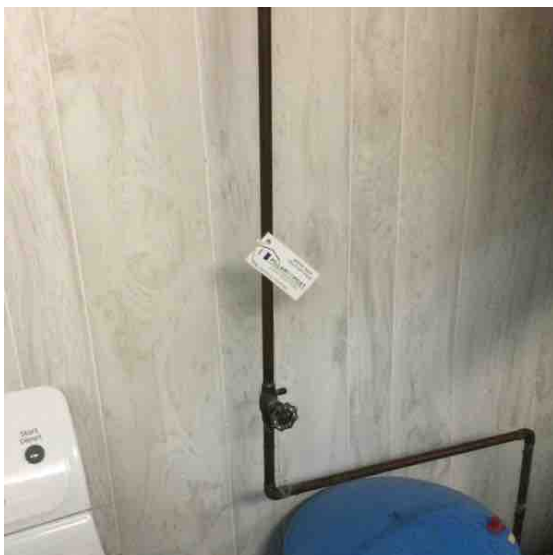
- ☉ Water main is plastic pipe.
- 10.3.1 Inspected the visible portion of the house water main.
- 10.3.2 Image of water main entry (**Utility/Laundry Room**)

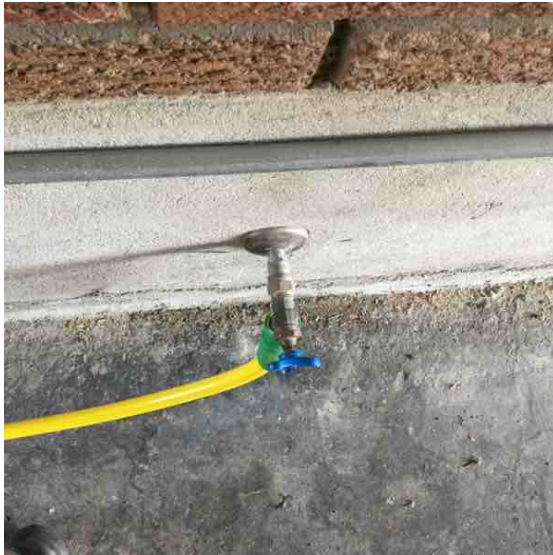
- Image(s) of interior winterizing valve(s) within the basement level for exterior garden hose bibb(s)

Request from the vendor the existence and the location of all interior winterizing shut-offs for convenience and protection against water related damages due to freezing pipes, none found at time of inspection (pictured here). **(Garage)**

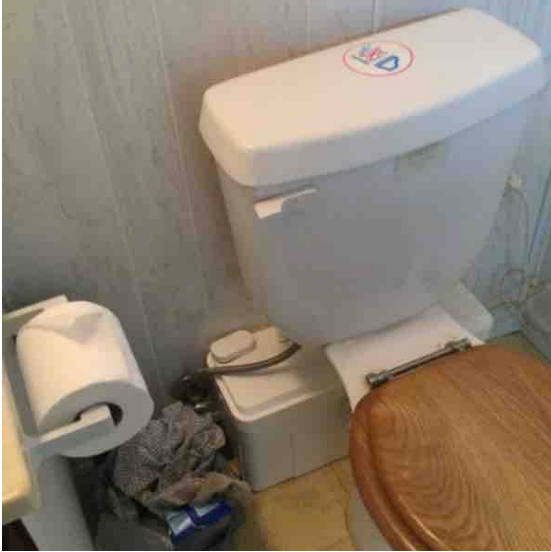
10.10.3 Sani-flo toilets do not have a bottom drain therefore not tested for floor leakage based on design. Visible drainage piping, pump had no visible leaks or concerns at time of inspection.
(Basement Half Bathroom)

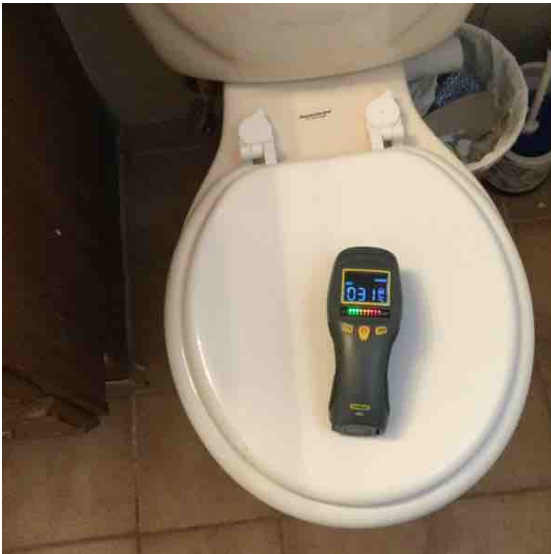
10.10.4 Images of toilet moisture meter test level between the floor and the toilet, floor level. (Main Floor Bathroom)

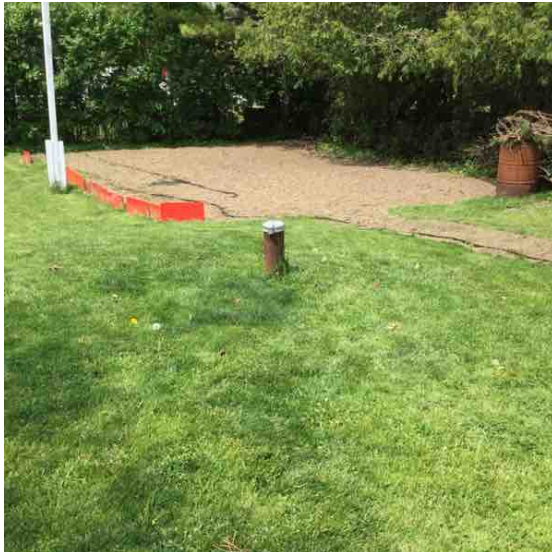
10.14.2 The well system was not inspected. Contact a qualified well technician to determine functionality and performance. **(Exterior Rear)**

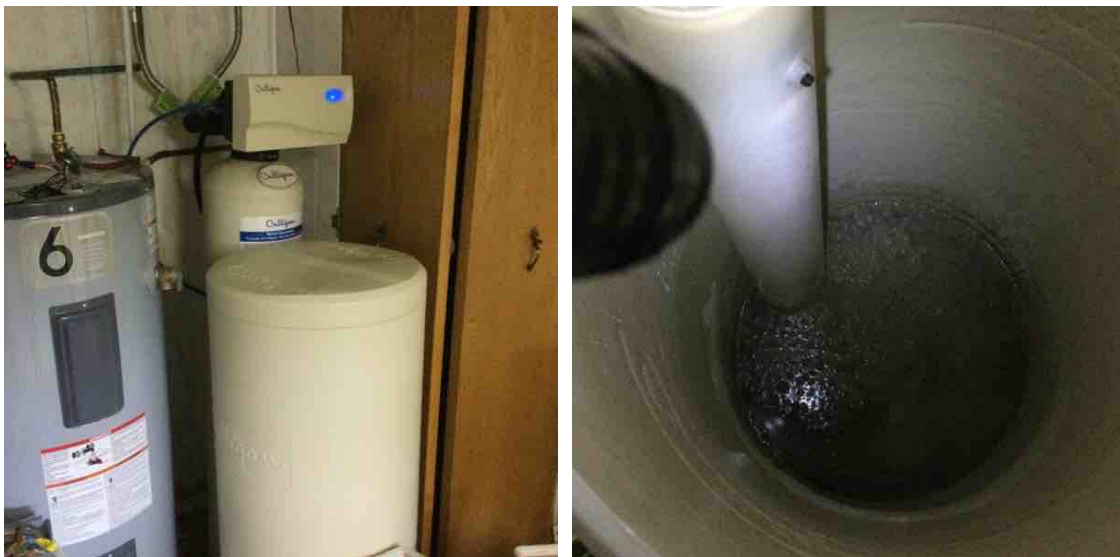
10.16.2 Water softener systems are not part of this inspection. The objective of our limited water system inspection is to determine if equipment in the home may benefit from a more thorough inspection by a qualified water supply specialist. The scope of our inspection includes a limited visual inspection of the equipment for leakage, deterioration and safety, but it is not tested for full functionality.
