INSPECTION REPORT

For the Property at:
1180 PULPIT ROAD
PETERBOROUGH, ON K9J 7M7

Prepared for: TEAM VANRAHAN
Inspection Date: Thursday, August 31, 2023
Prepared by: David Sharman

RE: Report No. 4472
1180 Pulpit Road
Peterborough, ON
K9J 7M7

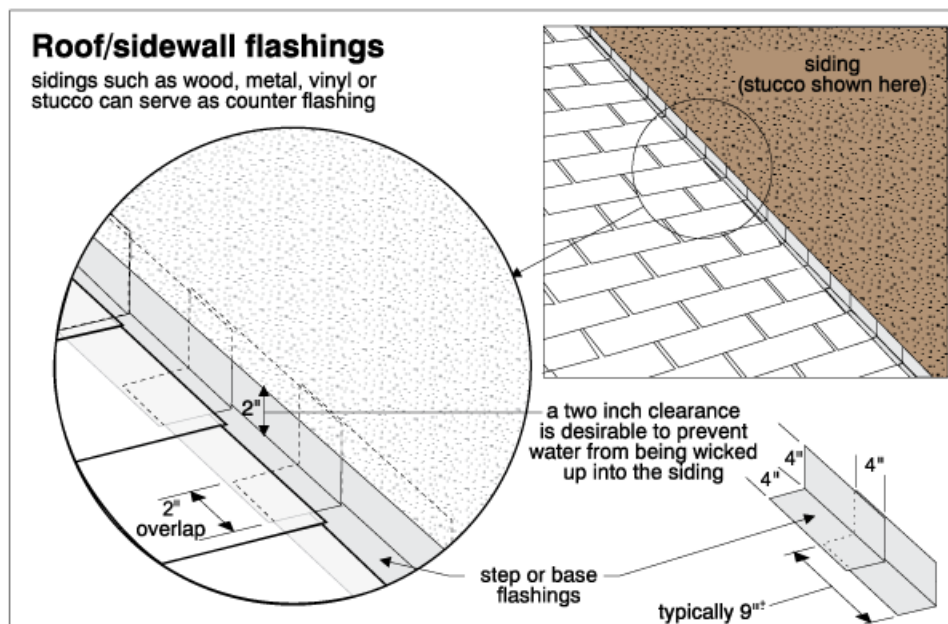
1. Condition: • No step or counter flashings

Implication(s): Chance of water damage to structure, finishes and contents
