# Inspection Report

5135 Parker St  
Omaha NE 68104

**AmeriSpec Inspection Services**

<b>Date:</b> 5/8/2025	<b>Time:</b> 08:00:00 AM	<b>Report ID:</b> 42560
<b>Property:</b> 5135 Parker St Omaha NE 68104	<b>Customer:</b> Chris Holbeck	<b>Real Estate Professional:</b>

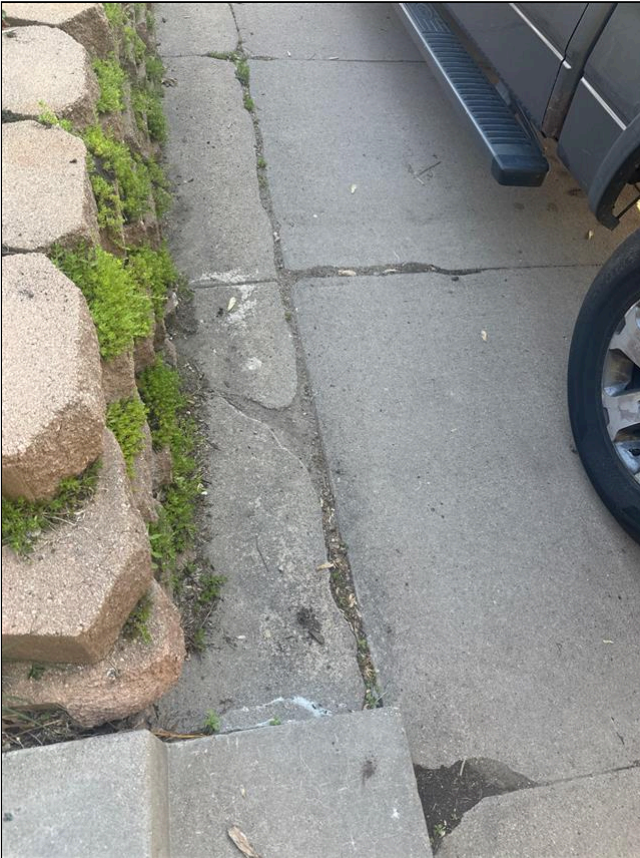
Settlement noticed at the concrete driveway. We suggest repairs as needed to prevent further damage.

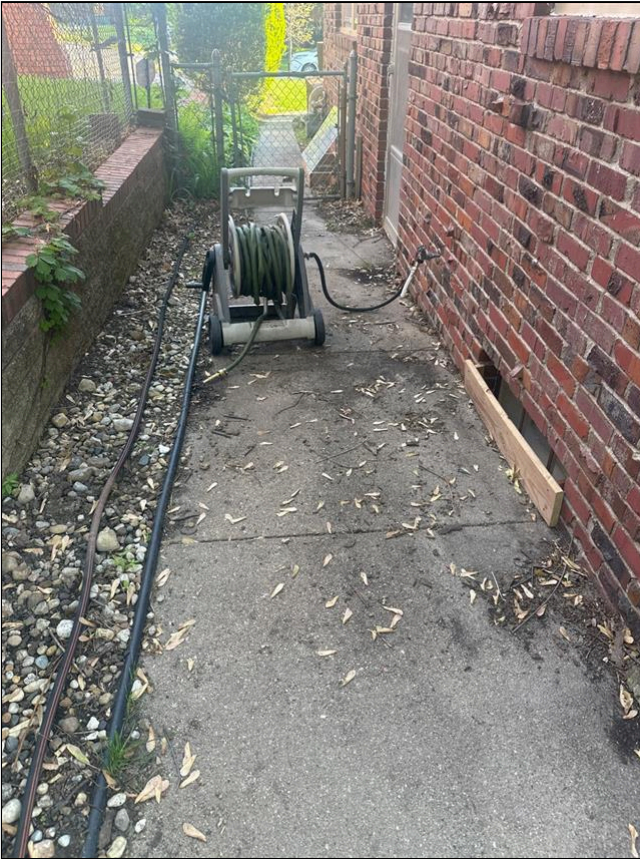
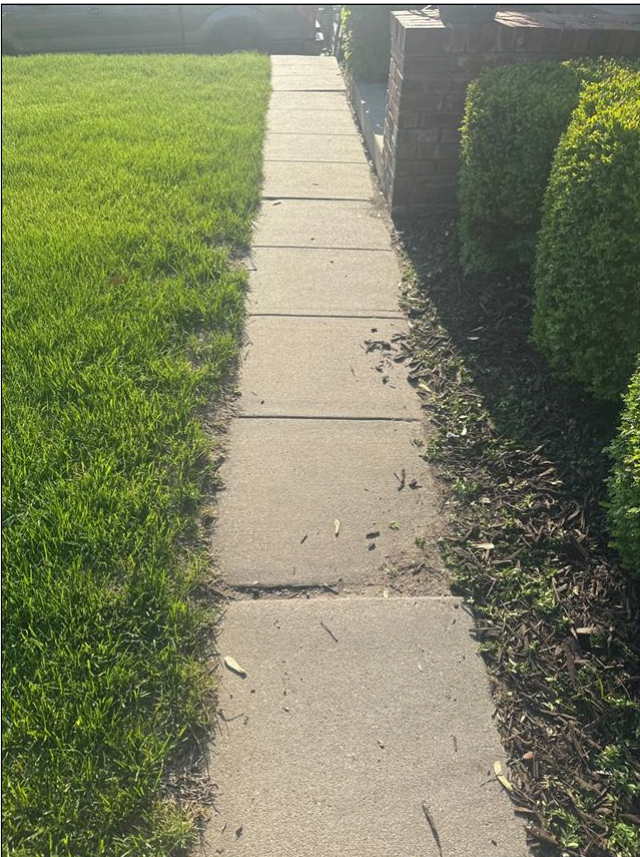
#### 1.1 Walkways

Settlement noticed at the concrete walkways. Recommend repairs needed to prevent further damage and possible pooling near the foundation and possible trip hazards.

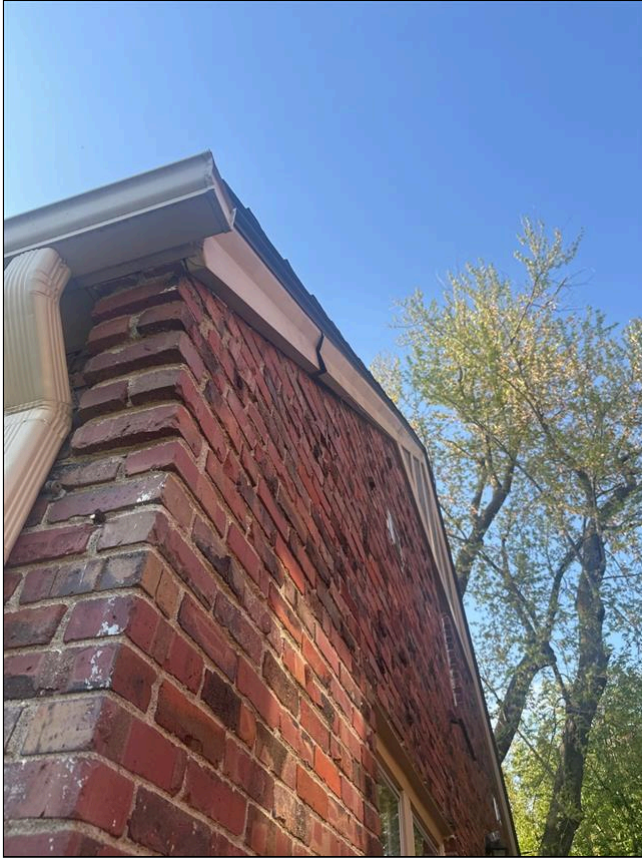
(1) Loose fascia noticed. We suggest repairs/adjustments as needed.

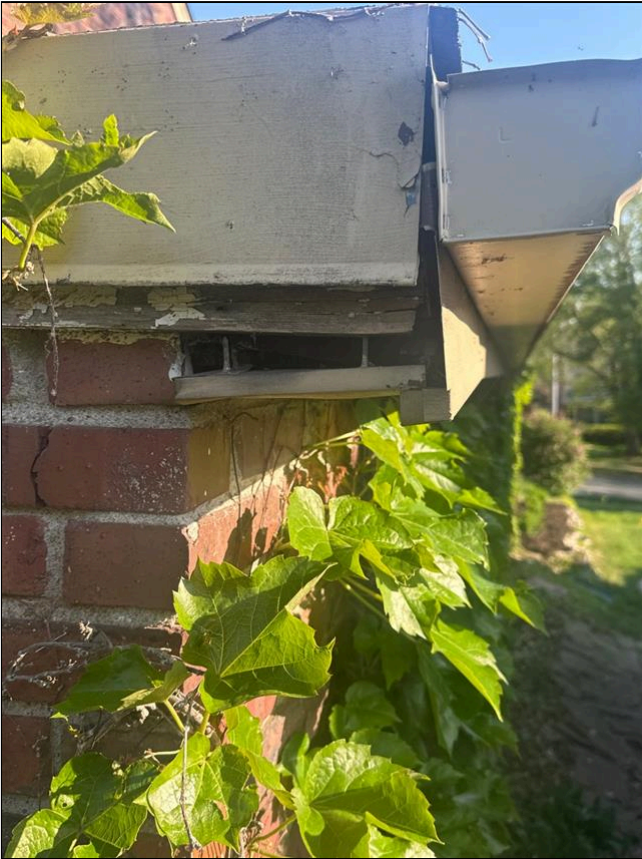
(2) Gap notice at the rear fascia and soffit. We suggest repair/adjustments needed to prevent possible pest intrusion.

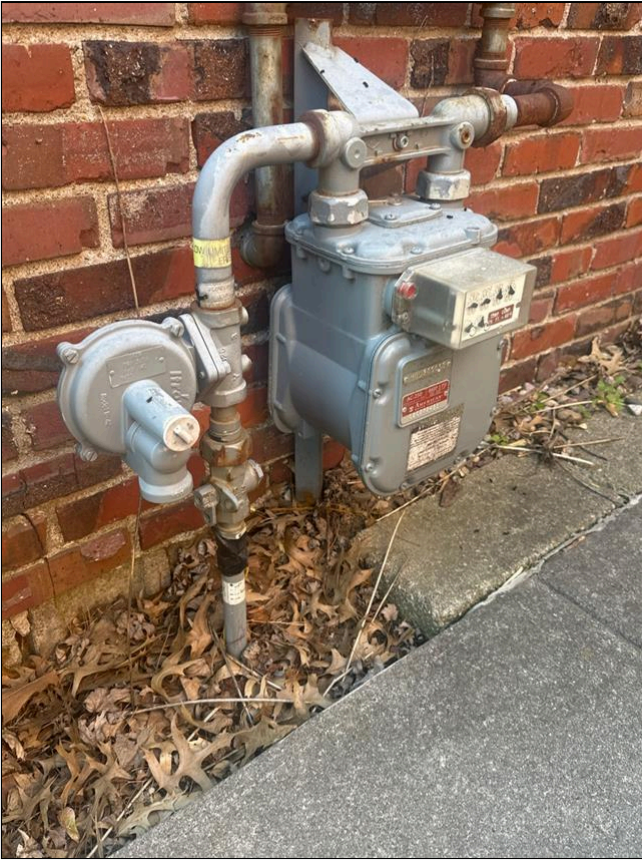
Main gas meter to the home. This is for clients information only.

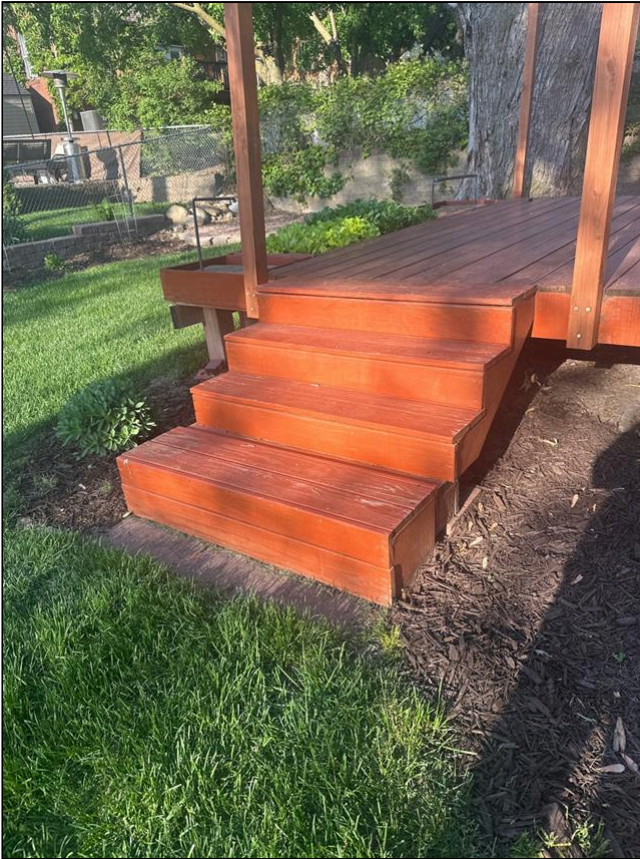
(1) No hand railings noted on steps at rear of home, recommend installing hand rail for safety. When ever four or more risers are present a handrail is usually required.

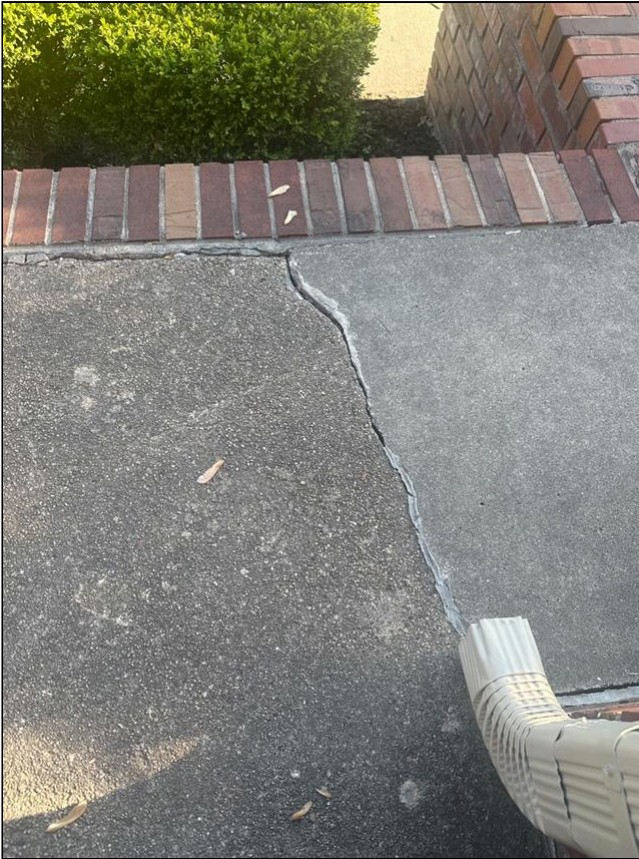
Cracking/settlement noticed at the front concrete stoop. We recommend repairs needed to prevent further damage.

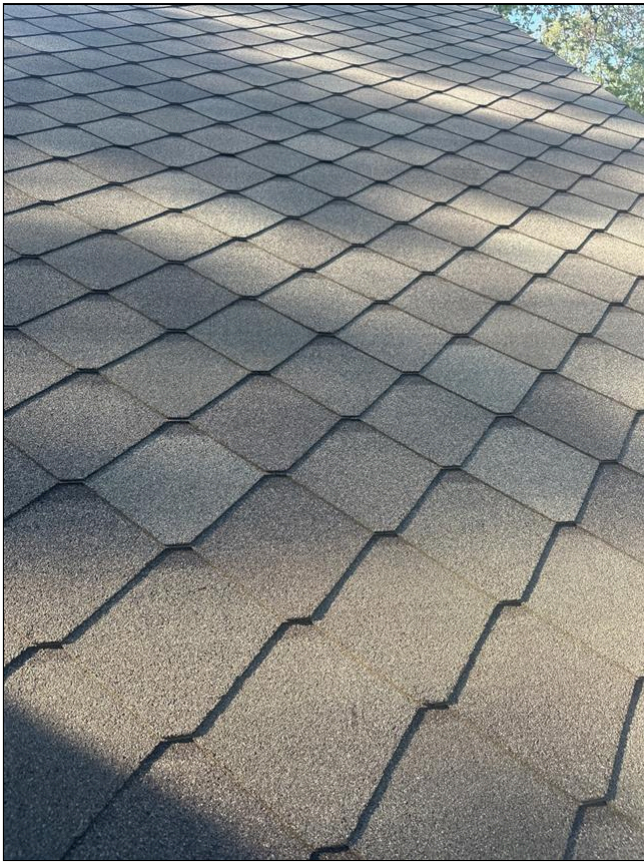
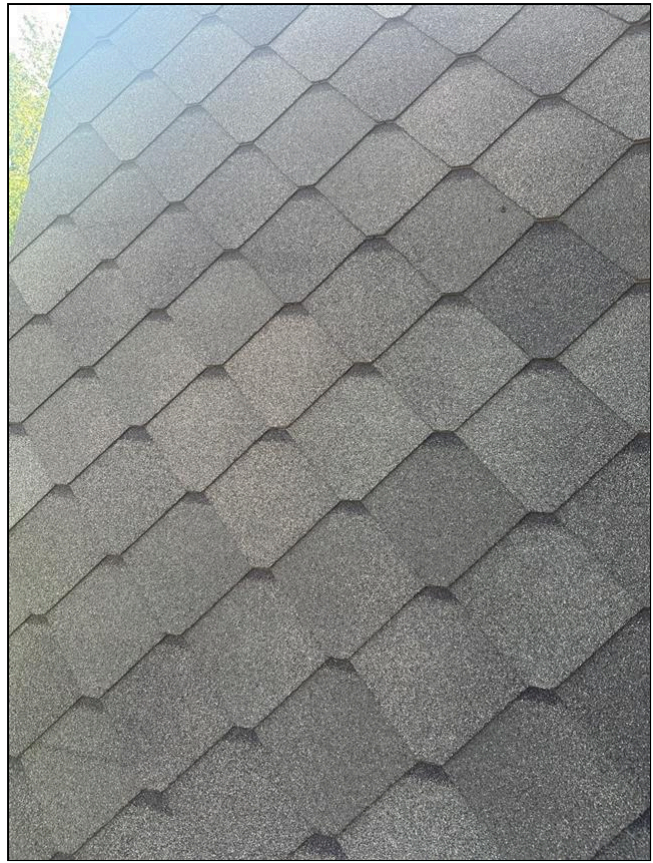
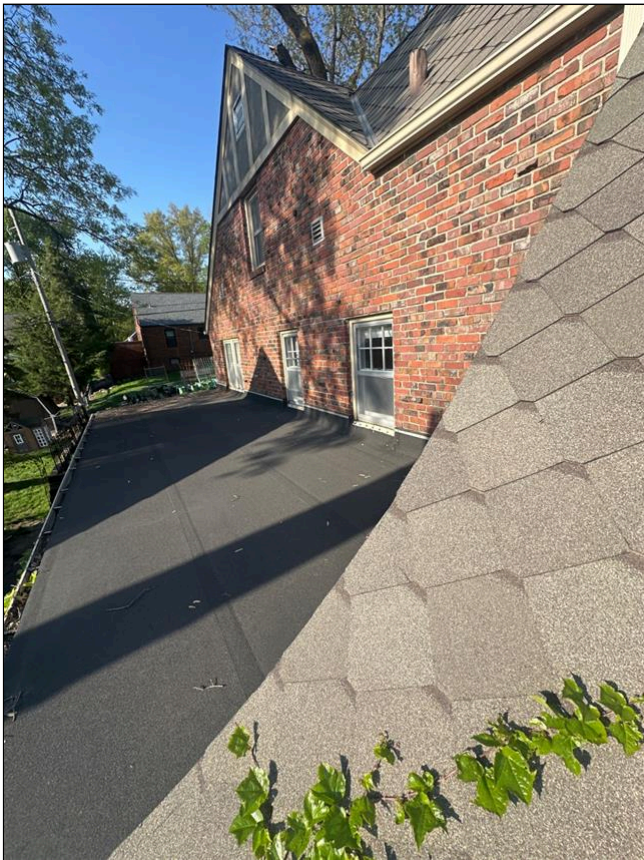
### 2.0 Roof Conditions

Roof shows normal wear for its age and type. No damaged, deteriorated, or missing roofing materials were

observed; it appears to be in serviceable condition at time of inspection.

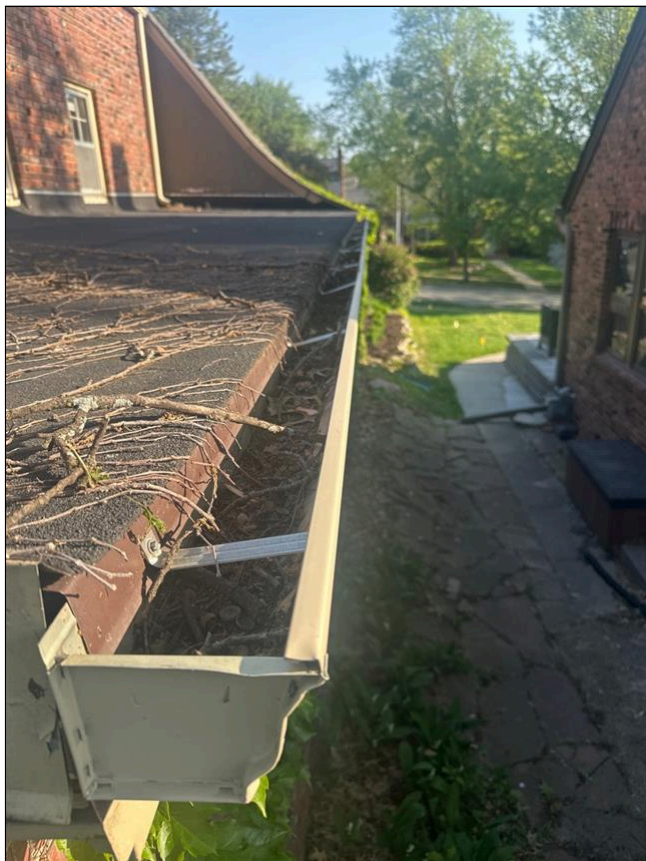
**2.2 Roof Drainage Systems (Gutters/Downspouts)****Marginal**

Gutters and downspouts are an integral part of a home's storm water management system and should be monitored on a regular basis for proper operation. It is recommended that the gutters and downspouts be cleaned and flushed as part of routine maintenance to reduce the potential for water backup and resultant damage to roofing materials and concealed portions of the home.

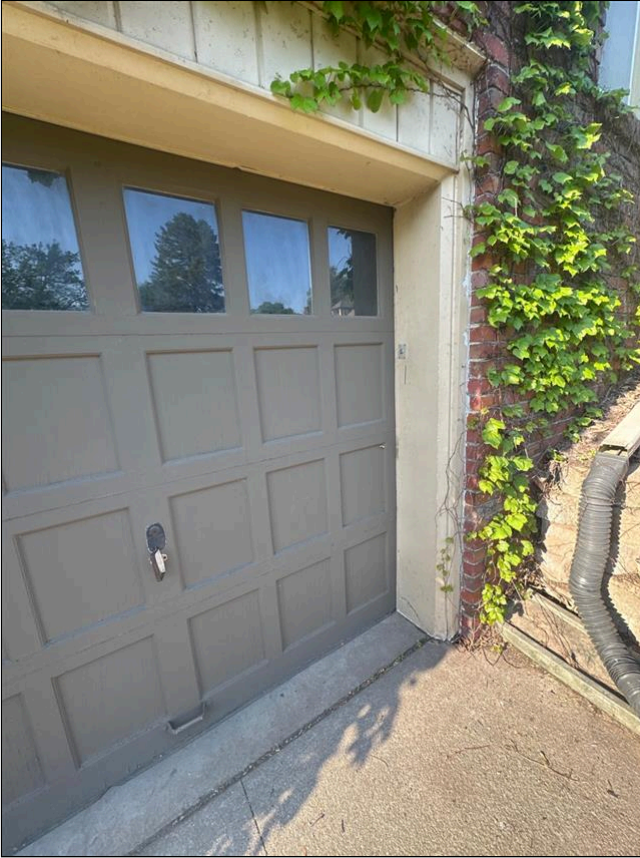
Weather strips are missing around the exterior garage overhead door. We recommend installing weather strips as needed to prevent possible pest/moisture intrusion.

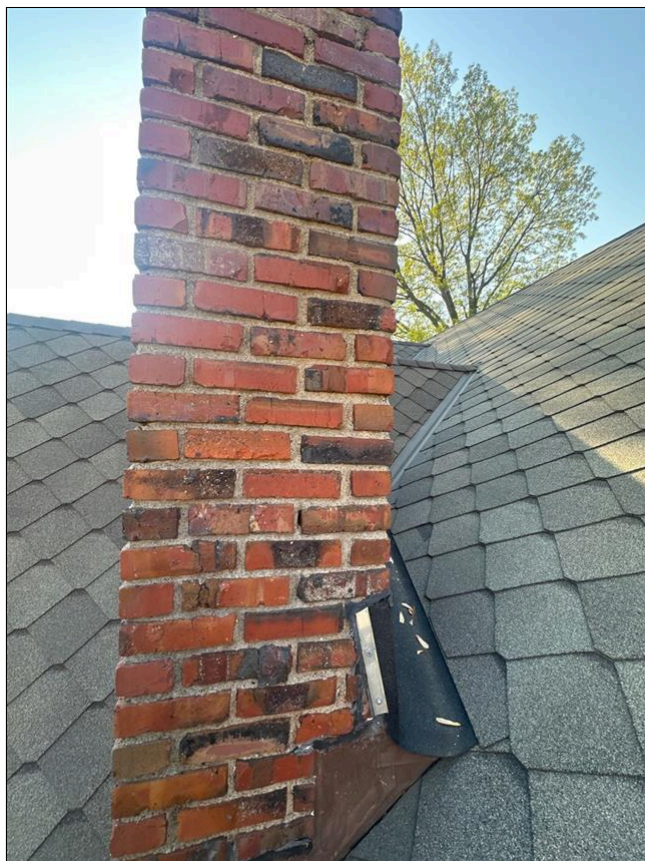
### 4.0 Chimney Conditions

Chimney is serviceable

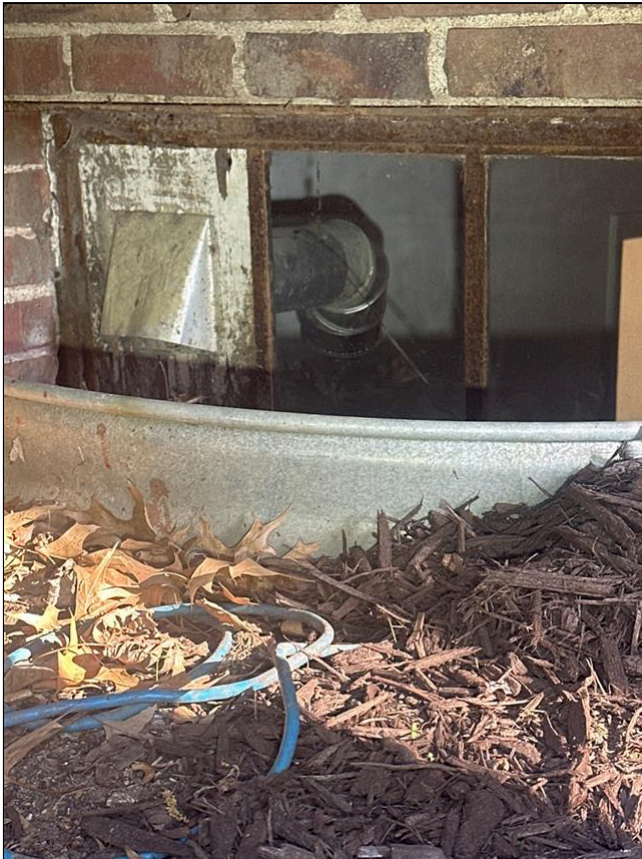
Multiple cracked basement windows found. We recommend repairs/replacements needed to prevent further damage.

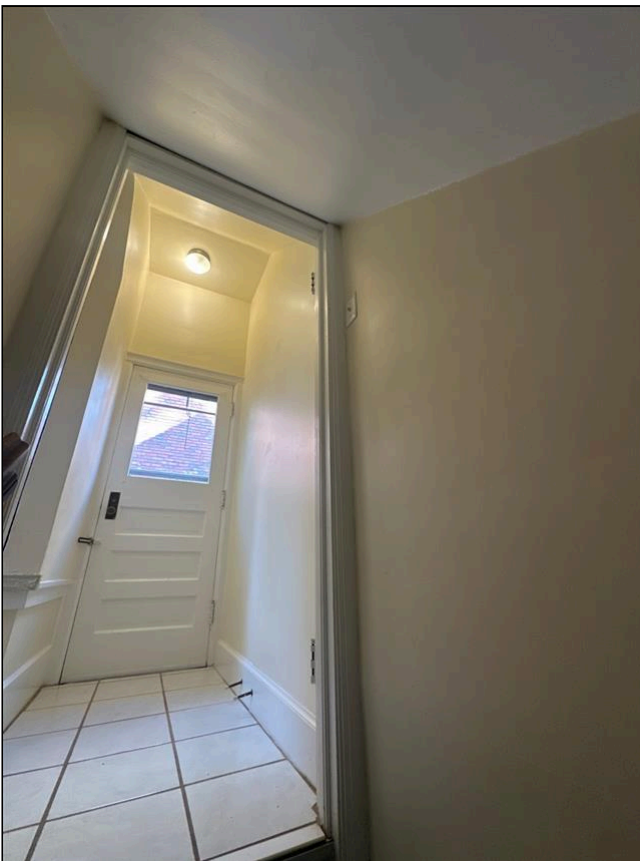
(1) Upstairs light switch was inoperable. We recommend repairs needed by a qualified electrician.

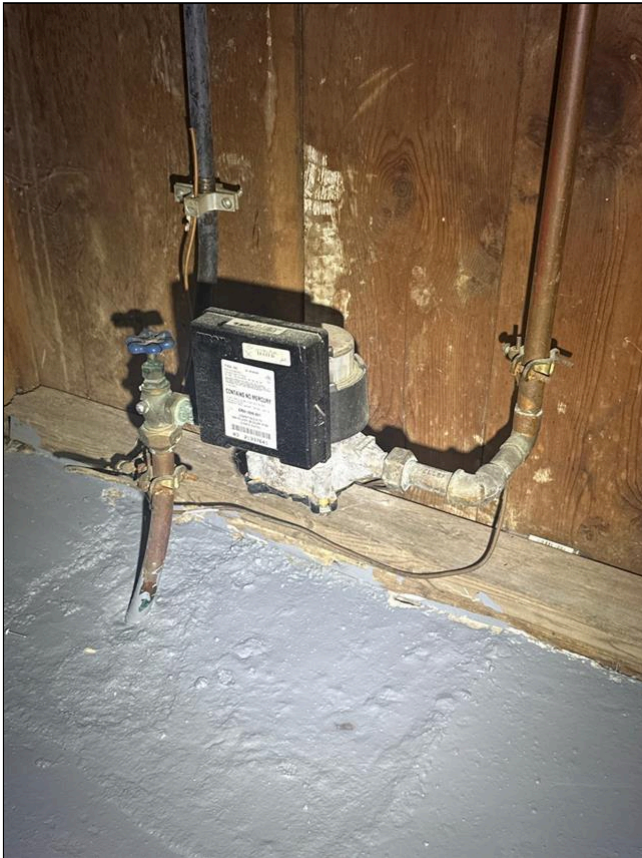
(1) Main water shut off to the home. This is for client's information only.

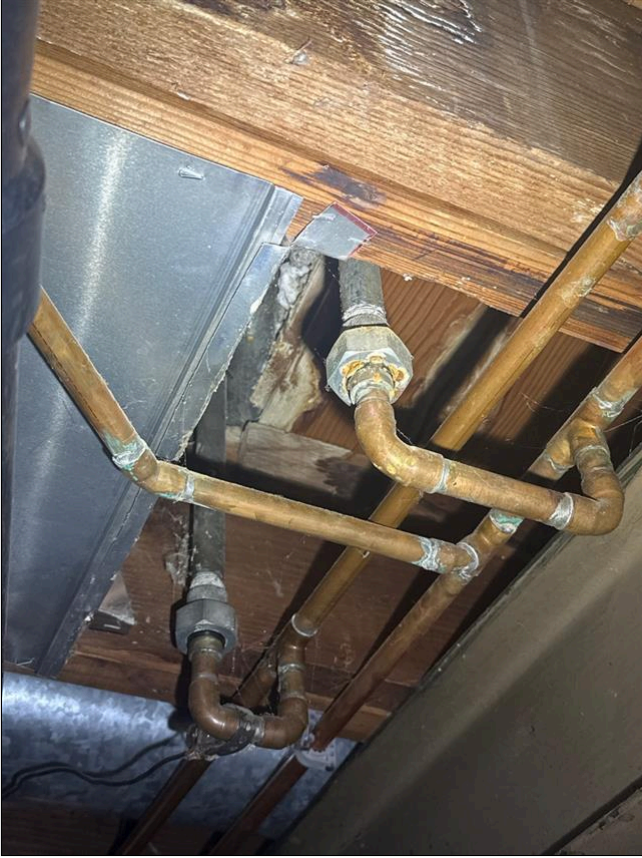
- **Galvanized water lines rust from the inside out and can become restricted over time. When low water flow is noted at plumbing fixtures, some restriction may have occurred. We suggest further review by a qualified licensed plumbing contractor prior to closing for repairs/replacement as needed to ensure proper water flow.**

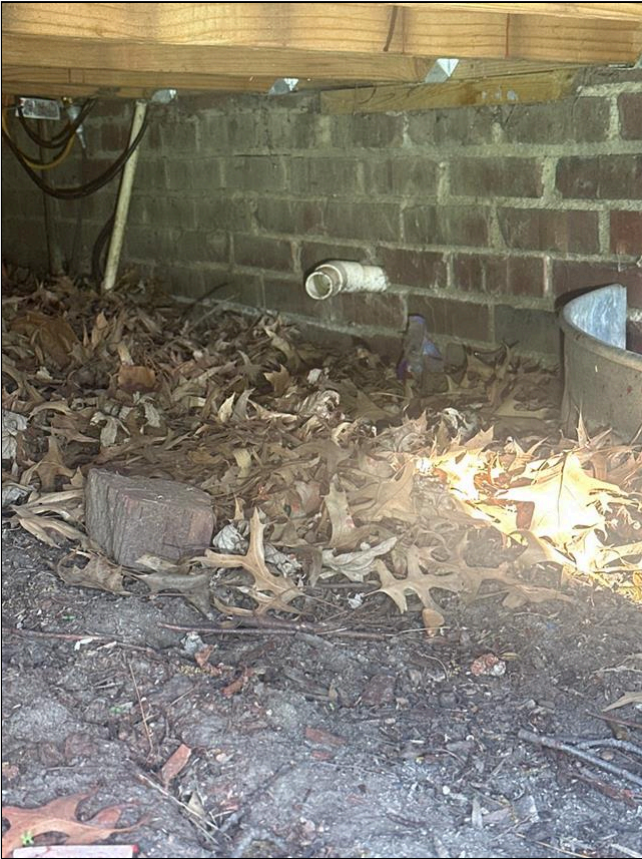
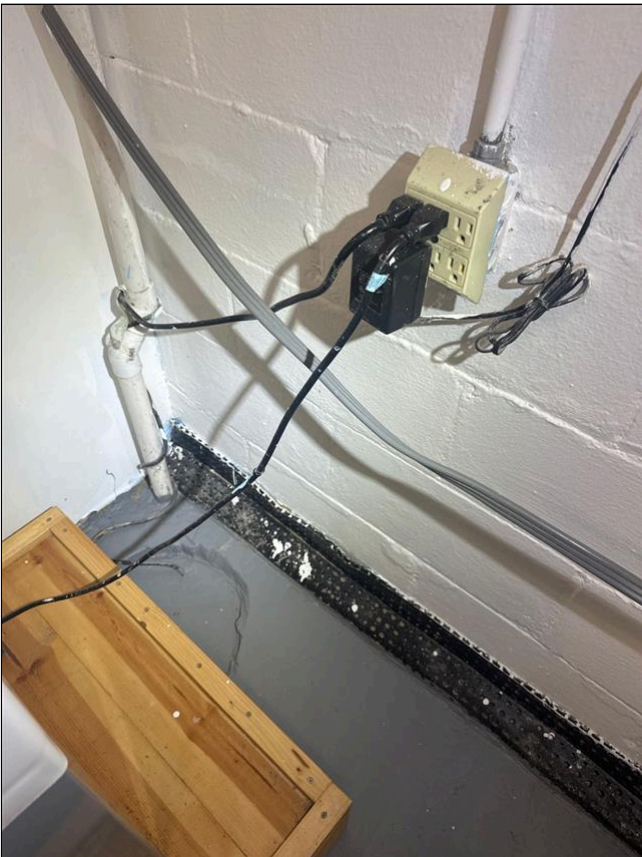
Extension hose is missing at the sump pump, plumbing, unable to verify conditions of the sump pump. Pit has been sealed. We suggest further review for proper operation.

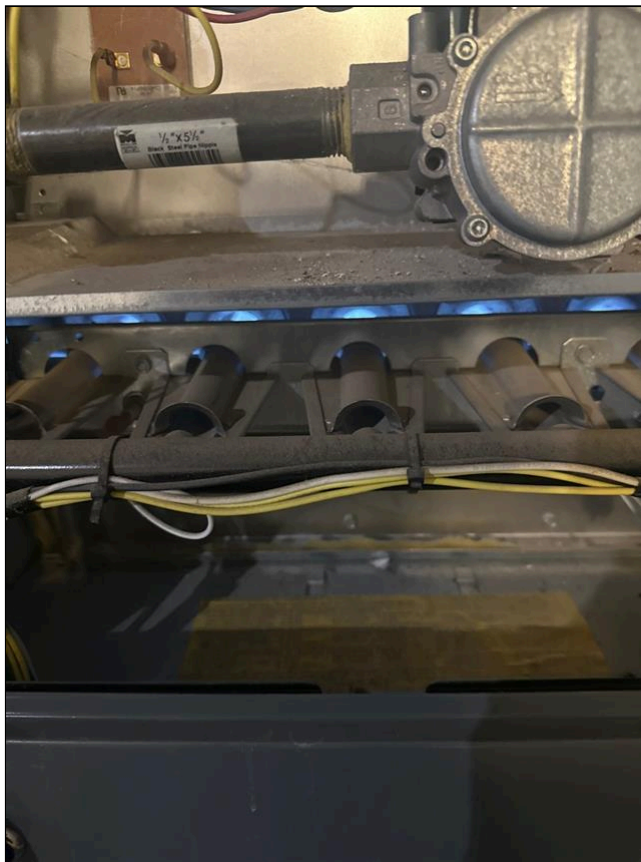
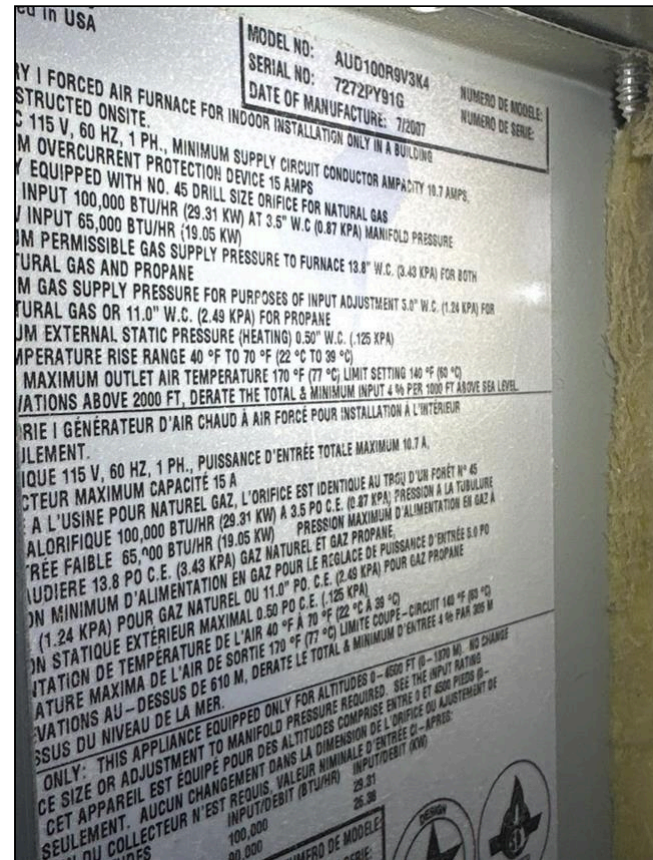
#### 8.0 Heating Equipment Condition

The gas furnace was tested using normal operating controls and functioned properly at time of inspection. Due to inaccessibility of many of the components of this unit, the review is limited. Holes or cracks in the heat exchanger (if applicable to this type system) are not within the scope of this inspection as heat exchangers are not visible or accessible to the inspector. Unit was operated by the thermostat. As with all mechanical equipment the unit can fail at anytime without warning. Inspectors cannot determine future failures. If a detailed inspection is desired, a licensed heating contractor should be consulted prior to closing to ensure proper and safe operation of this unit.

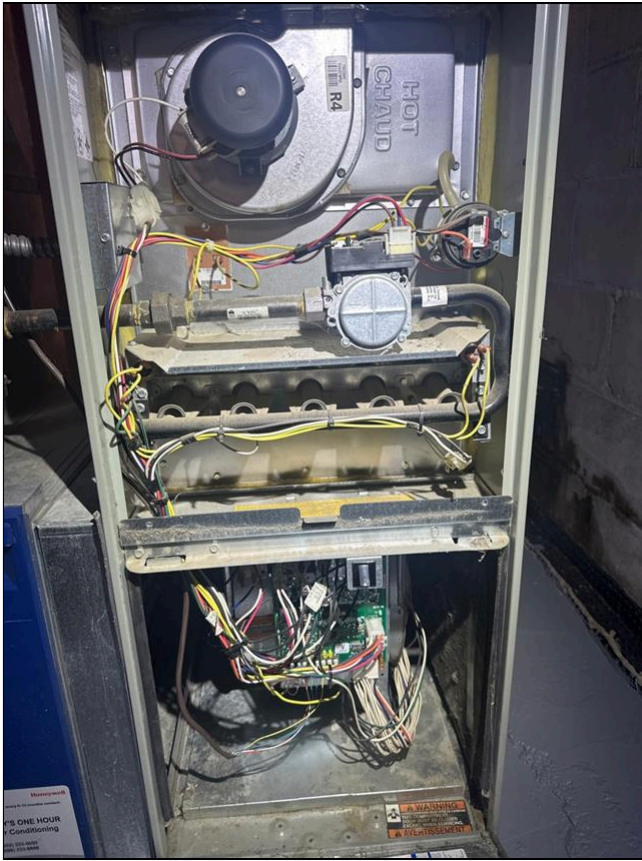
Manufactured 2007

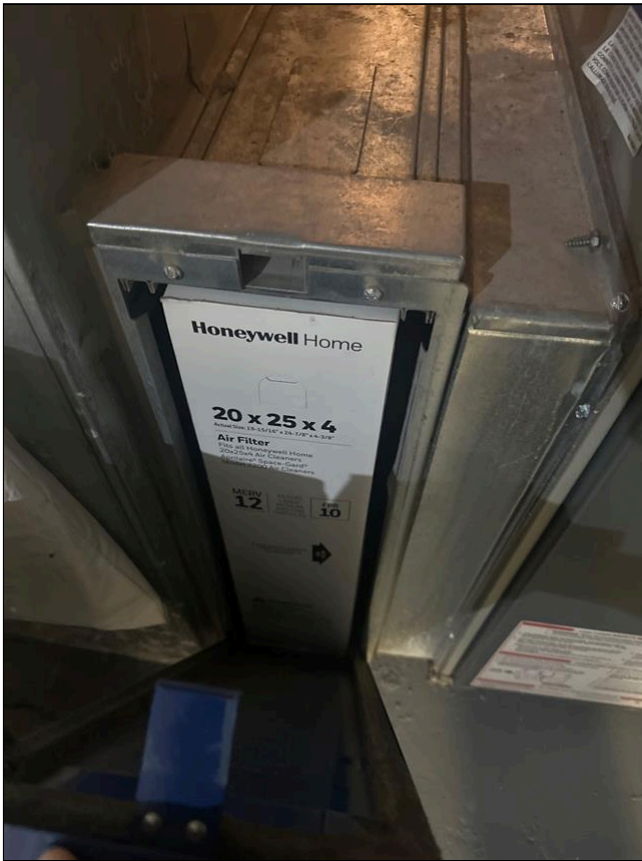
We recommend cleaning/replacing the furnace/AC filter on a regular basis to optimize the unit's operating efficiency and life expectancy. We recommend that the client commence an annual maintenance, cleaning, and parts replacement program with the local utility company or qualified heating contractor in order to keep the heating/cooling equipment in optimum and safe working order.

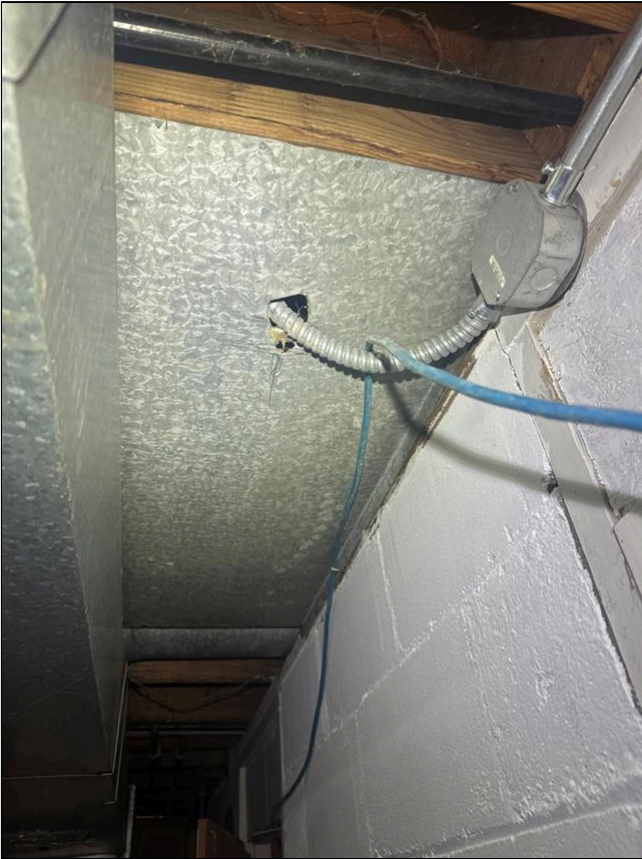
(1) Electrical has been inserted through ductwork. This is not allowed. We recommend further review/repairs needed by a qualified contractor.

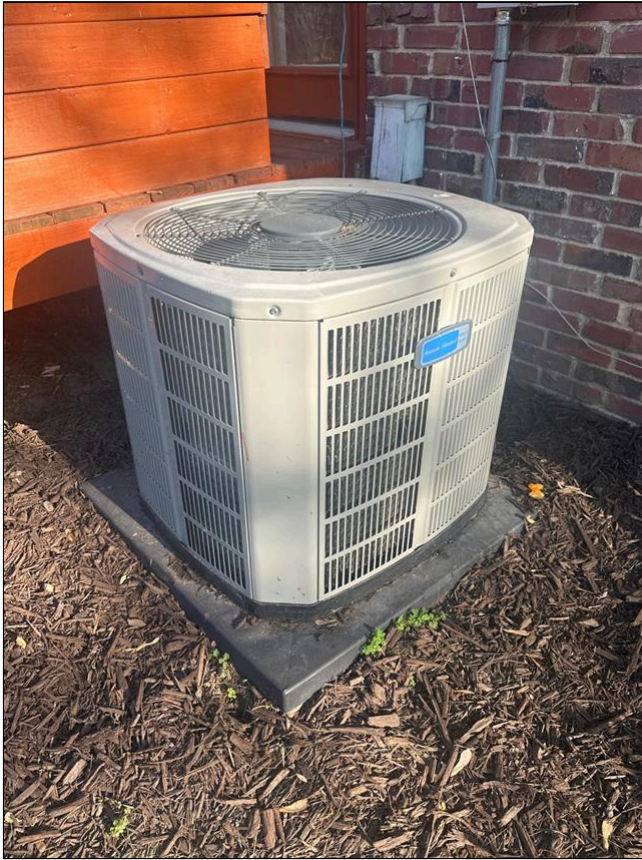
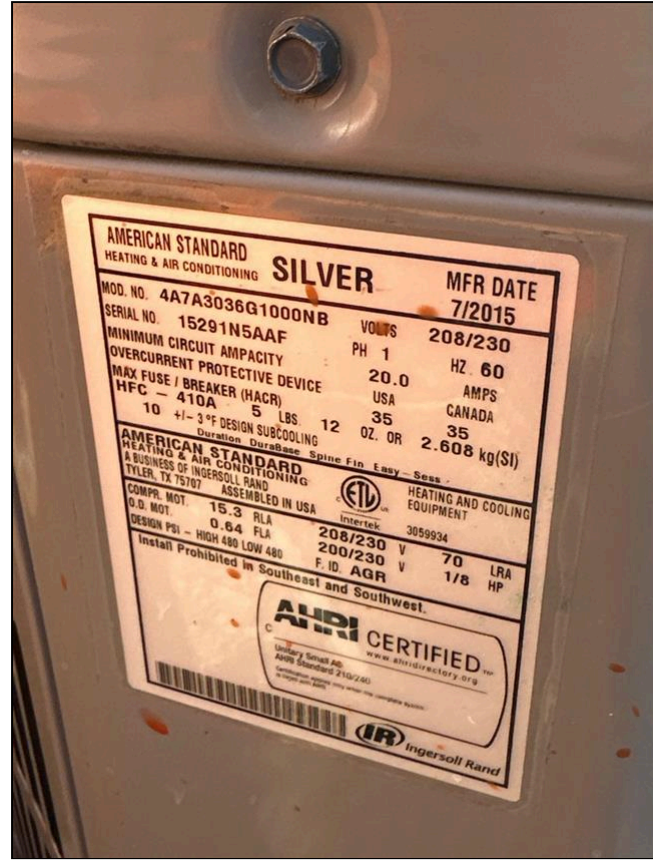
#### 9.0 Cooling and Air Handler Equipment Condition

The air conditioner was activated to check the operation of the motor and the compressor, both of which are in serviceable condition. As a detailed review of the cooling capacity of this unit is beyond the scope of this inspection, we make no warranty as to the system's adequacy.

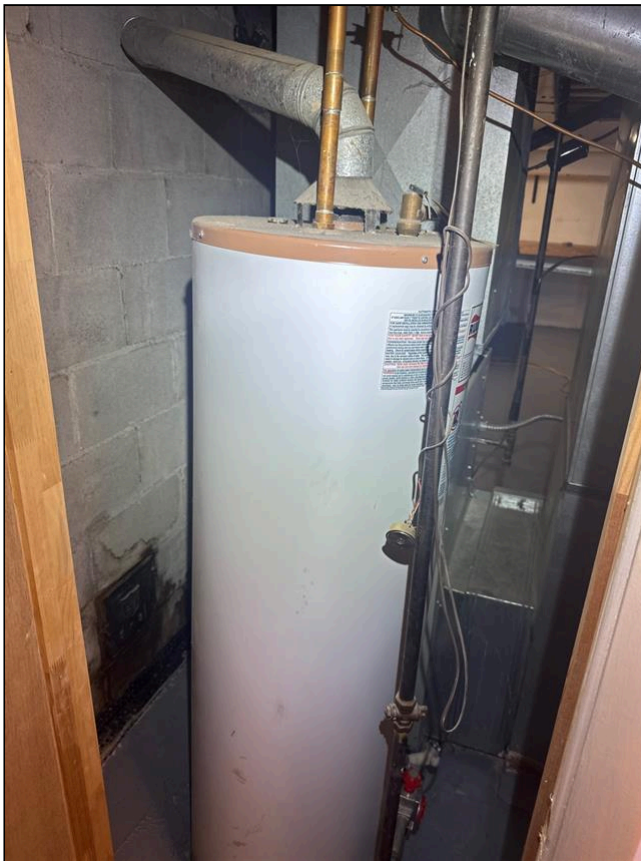
#### 10.0 Water Heater Condition

Low water temperature noticed at time of inspection. Units typically last 5-10 years. We suggest replacing when needed.

The water temperature at time of inspection was 90 degrees, which is not within the normal operating range of 120 to 130 degrees. Recommend checking with sellers as to the settings. Many homeowners lower the temperature for a variety of reasons. This could also indicate an issue with the water heaters performance if the water heater is set at the normal temperature. A licensed plumbing contractor should review and make any corrections needed if the thermostat has not been set low intentionally.

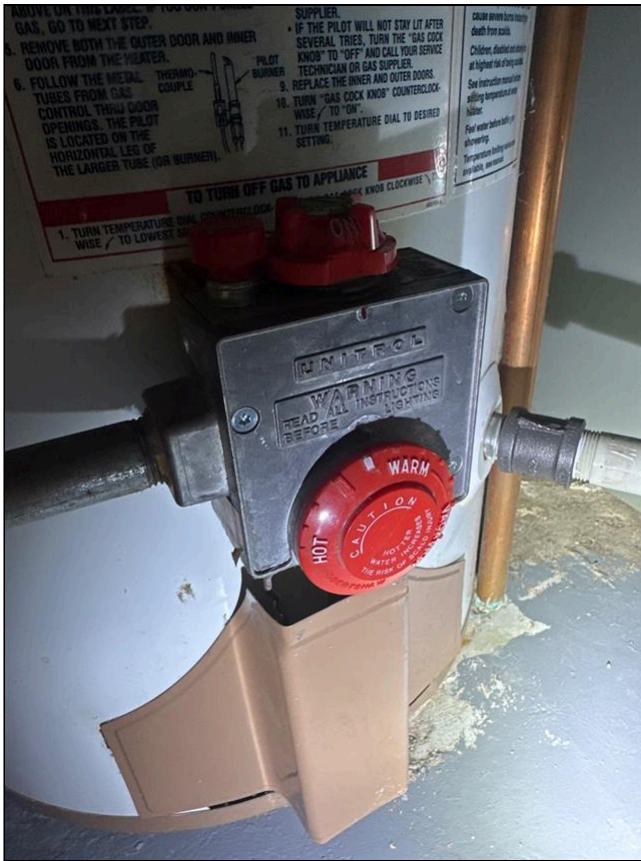
Manufactured 1995

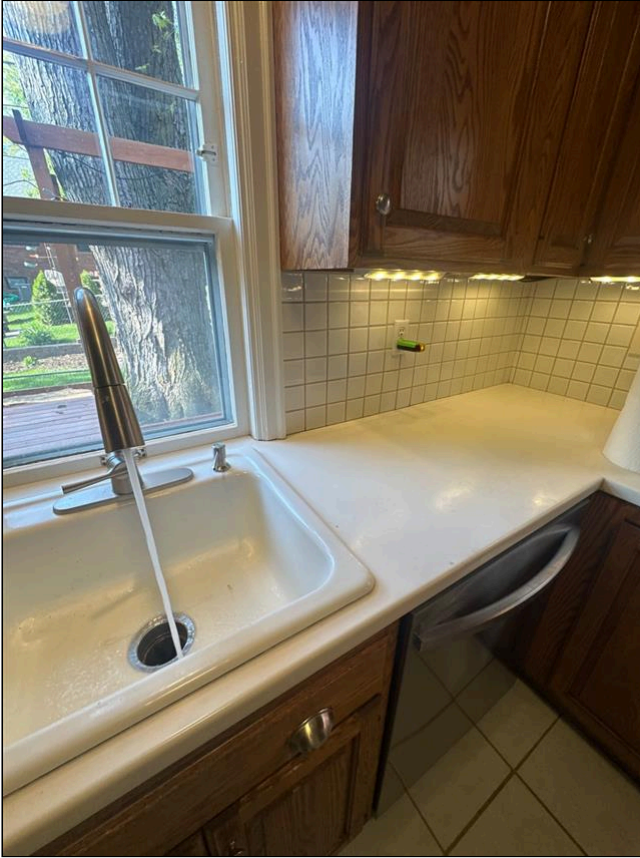
Kitchen outlets 6 feet within the water source are not GFCI protected, ground fall circuit interrupters may not have been required when this home was built. We recommend installing GFCI outlets as needed for enhanced safety. This is typically a buyer improvement.

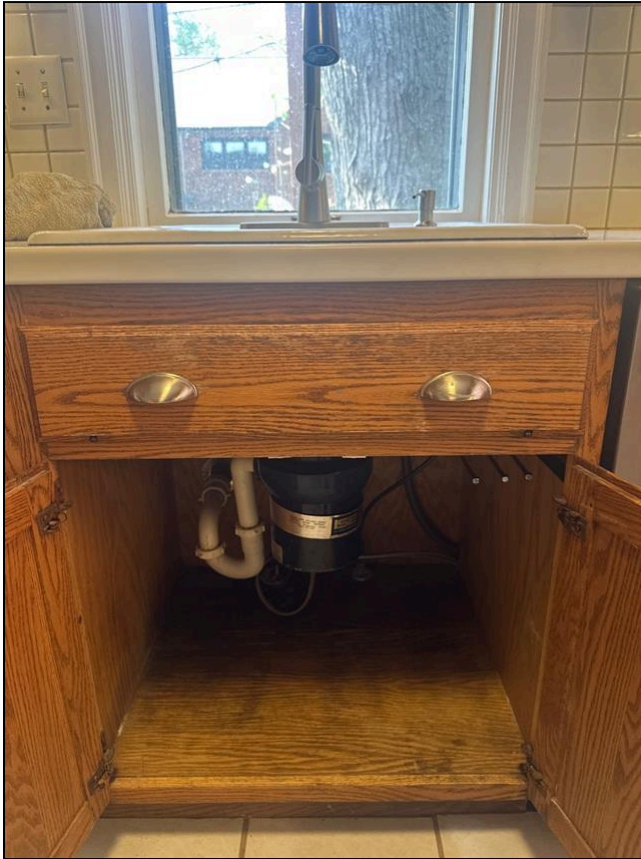
Obstruction noticed at the kitchen disposal. We recommend repairs/cleaning as needed to prevent possible damage and proper function.

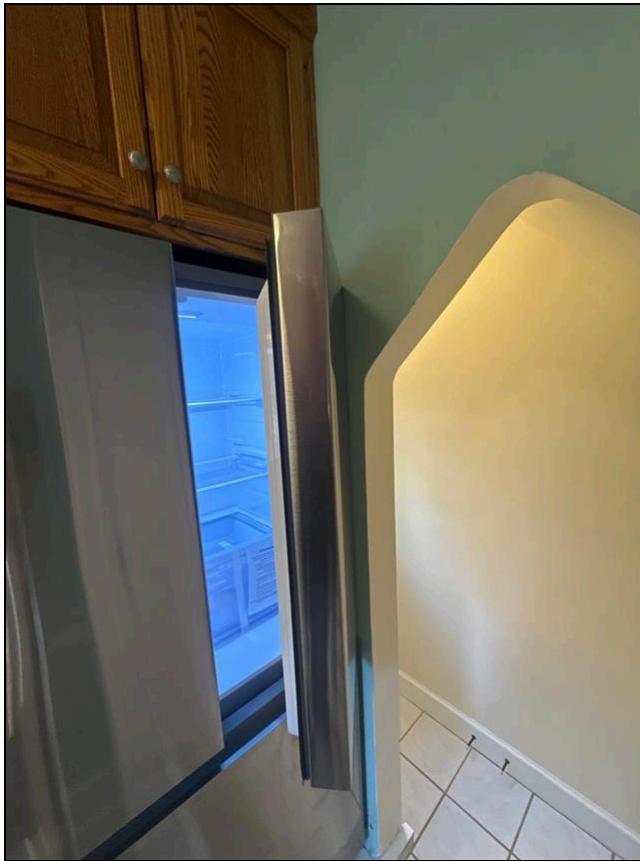
Refrigerator door cannot fully open due to wall. We suggest repairs/adjustments as needed.

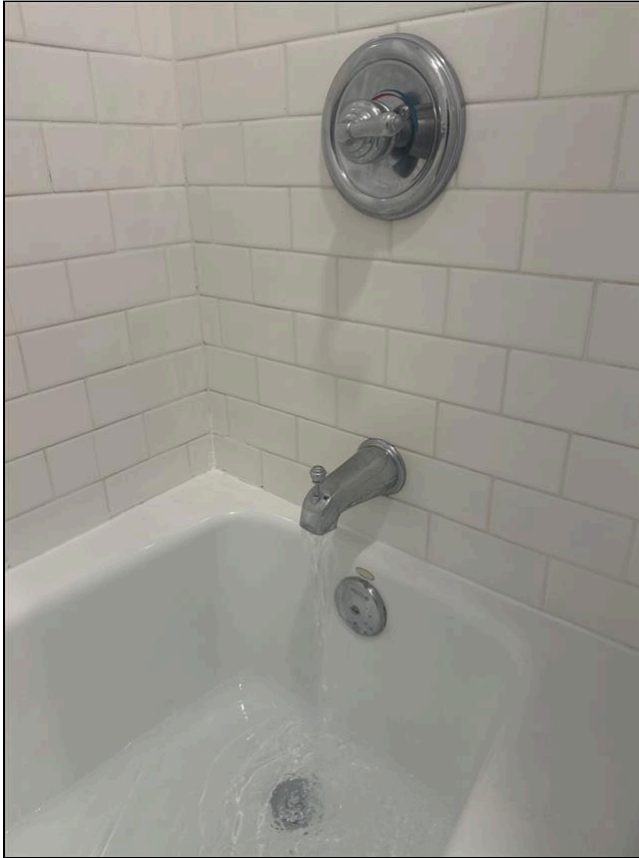
(1) Upstairs bathroom, diverter valve does not function properly, no water comes out of the showerhead. We recommend further review/repairs needed by a qualified contractor.

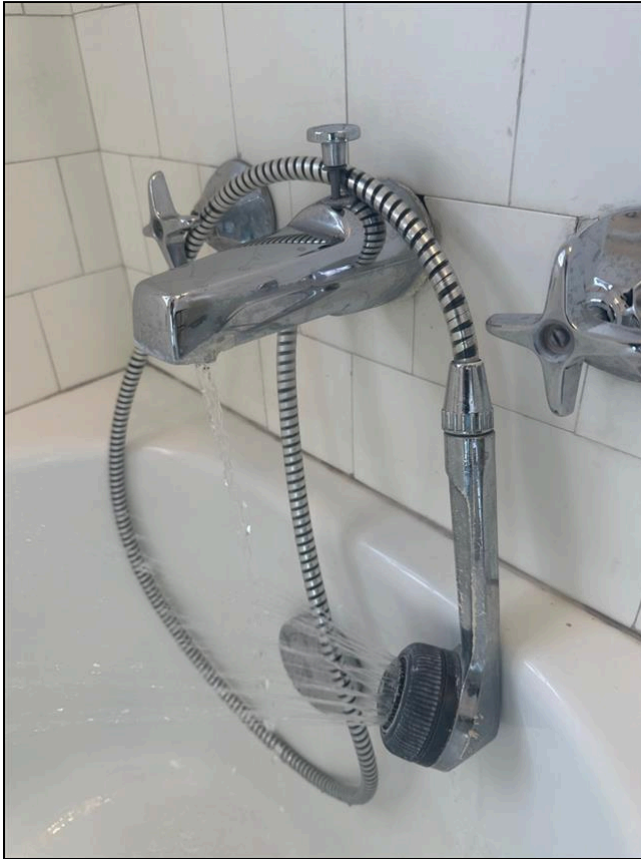
(2) Main hallway, bathroom shower diverter valve does not fully engage. We suggest repairs/adjustments as needed.

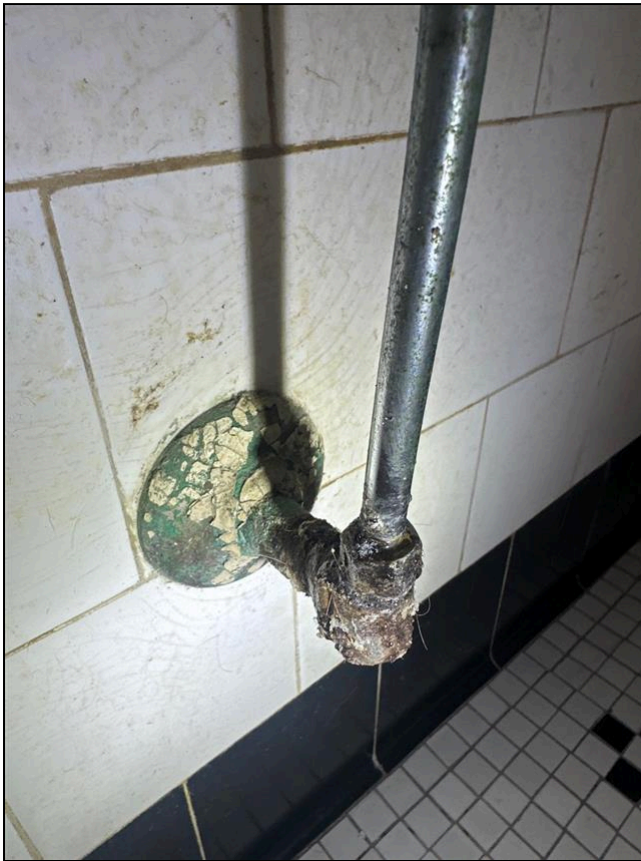
(1) Leak and/or deterioration observed at the toilet water supply line in the hall bathroom. Recommend review by Licensed/Qualified plumber for repair or replacement as necessary.

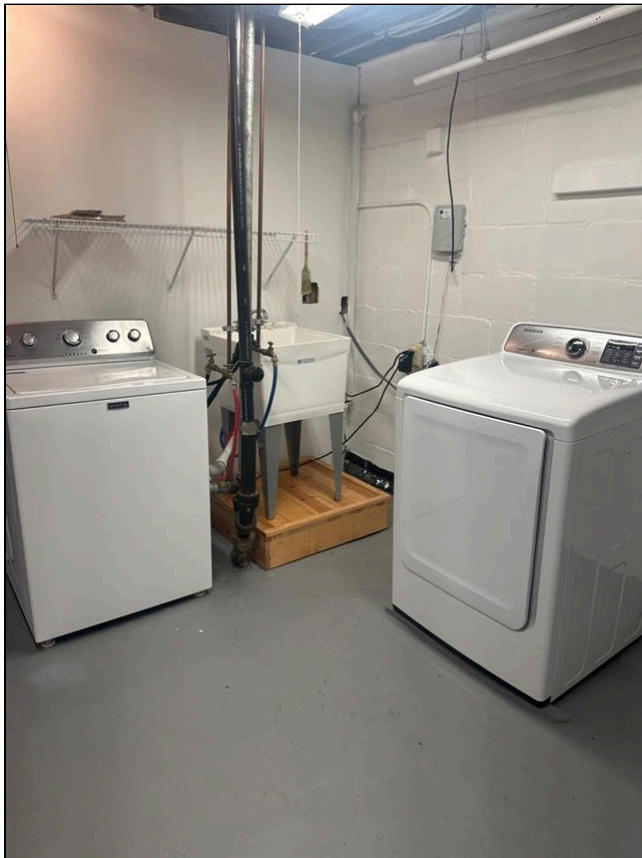
Laundry units were not tested, this is beyond the scope of inspection. We suggest referring back to the seller if units are staying and operational.

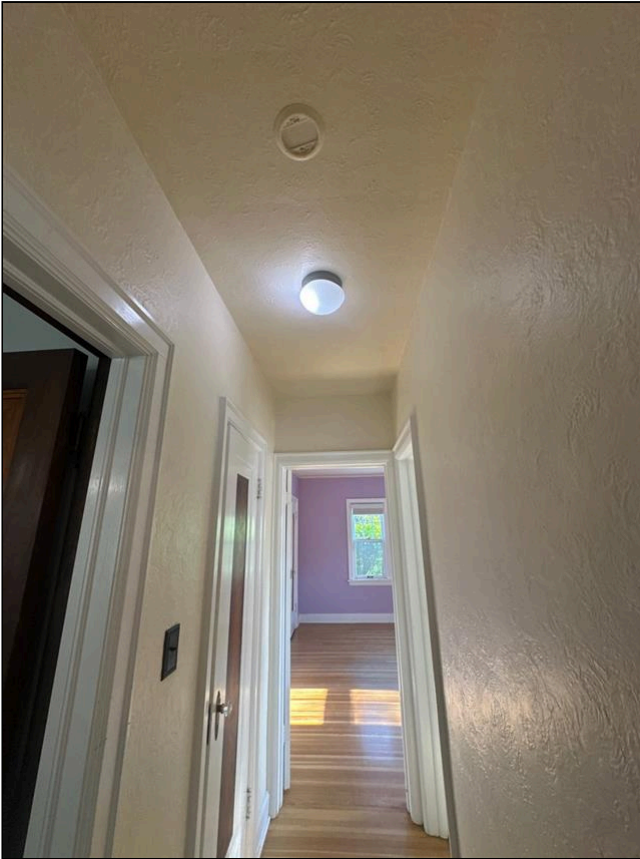
Hallway light bulb flickers. We recommend replacing light and testing prior to closing for proper operation.

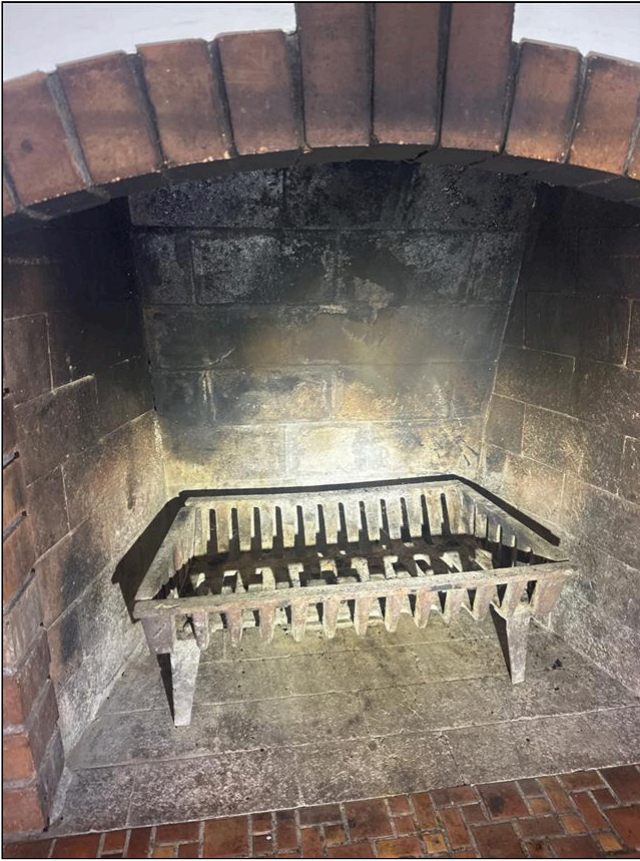
(1) Creosote build-up was observed in the fireplace located in the living room. Creosote is a naturally produced flammable by-product of combustion. Its presence is a limiting factor on a visual review. We suggest having cleaned and inspected by a fireplace and chimney specialist to assure safe operation prior to close.
