# Inspection Report

5135 Parker St  
Omaha NE 68104

**AmeriSpec Inspection Services**

<b>Date:</b> 5/8/2025	<b>Time:</b> 08:00:00 AM	<b>Report ID:</b> 42560
<b>Property:</b> 5135 Parker St Omaha NE 68104	<b>Customer:</b> Chris Holbeck	<b>Real Estate Professional:</b>

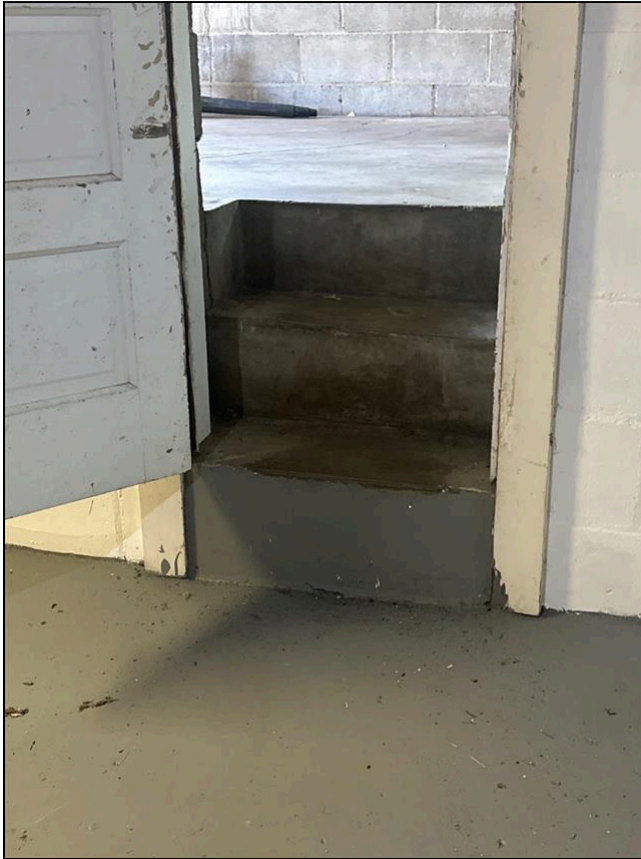
**14.10 Stairways**

Steep steps noticed at the basement entering the garage. We suggest repairs as needed to prevent possible trip hazard.

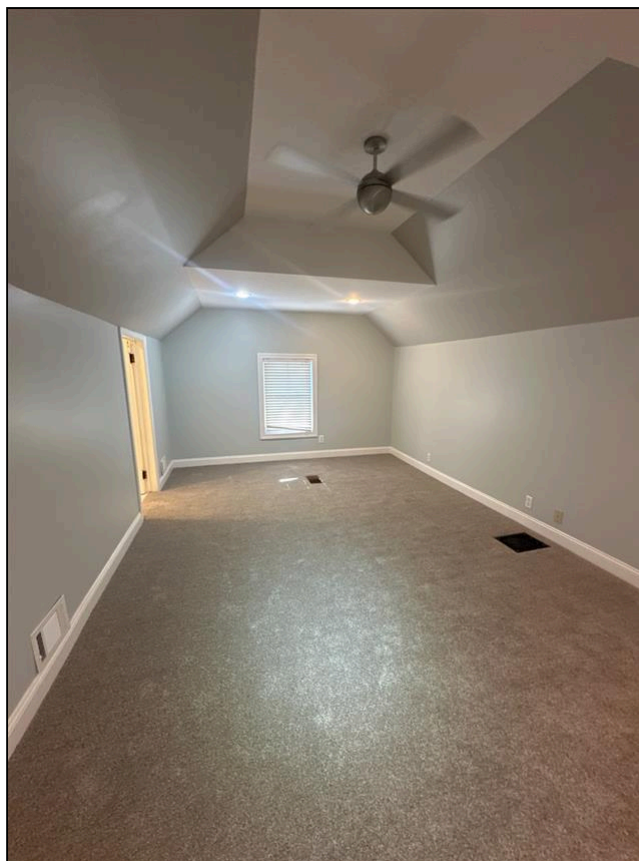
Possible temperature difference noticed at the upstairs attic room. If client has concerns, we suggest further review/repairs needed by a qualified HVAC professional.

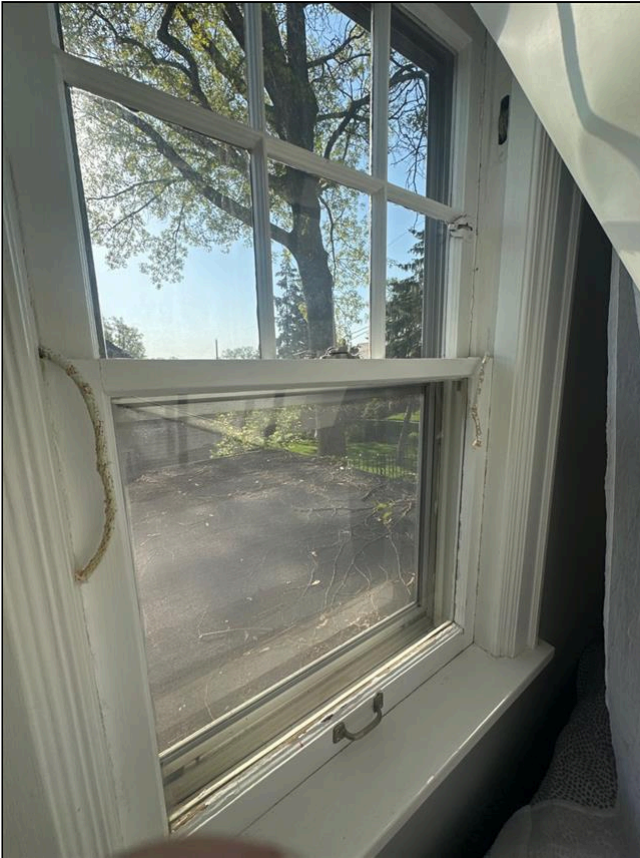
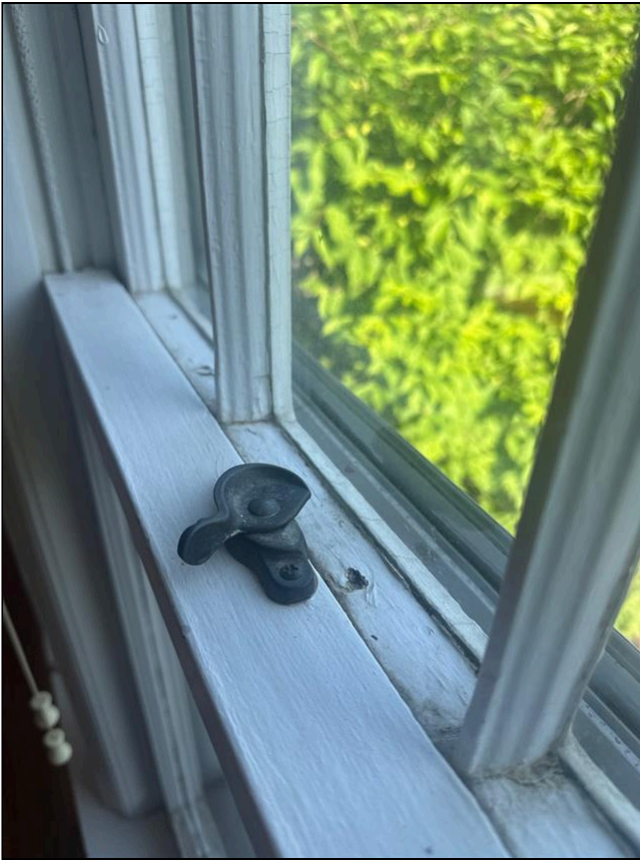
Multiple windows are missing components. We suggest repairs/replacements as needed for proper function.

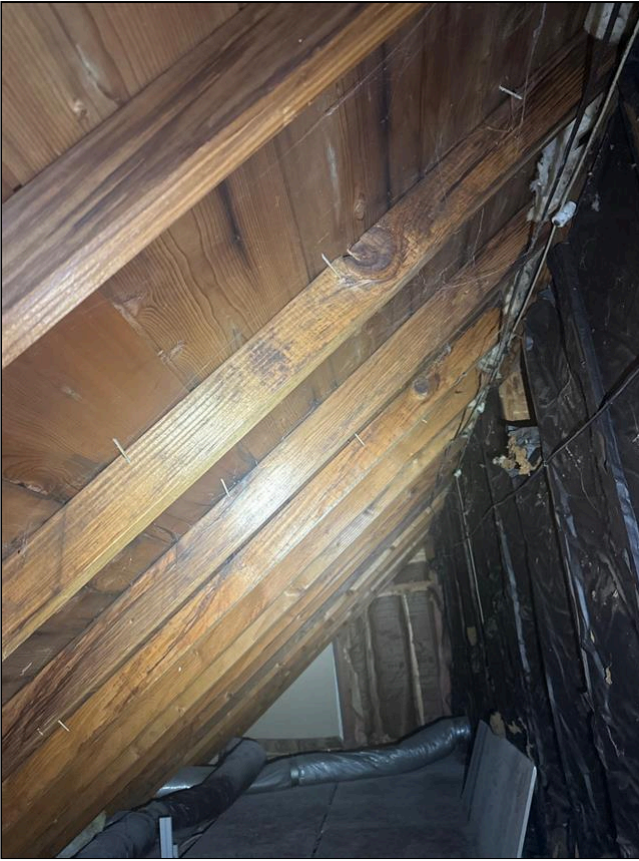
Rafters are serviceable

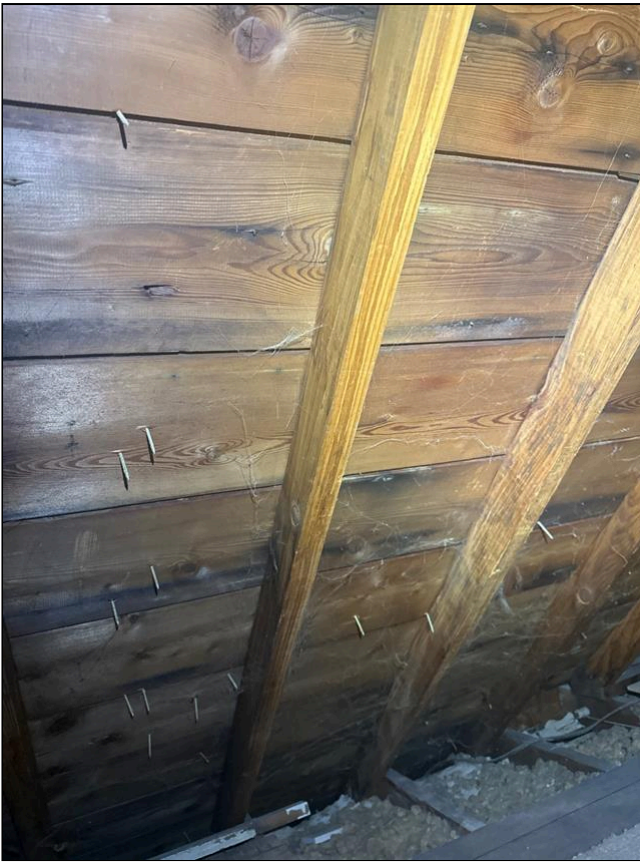
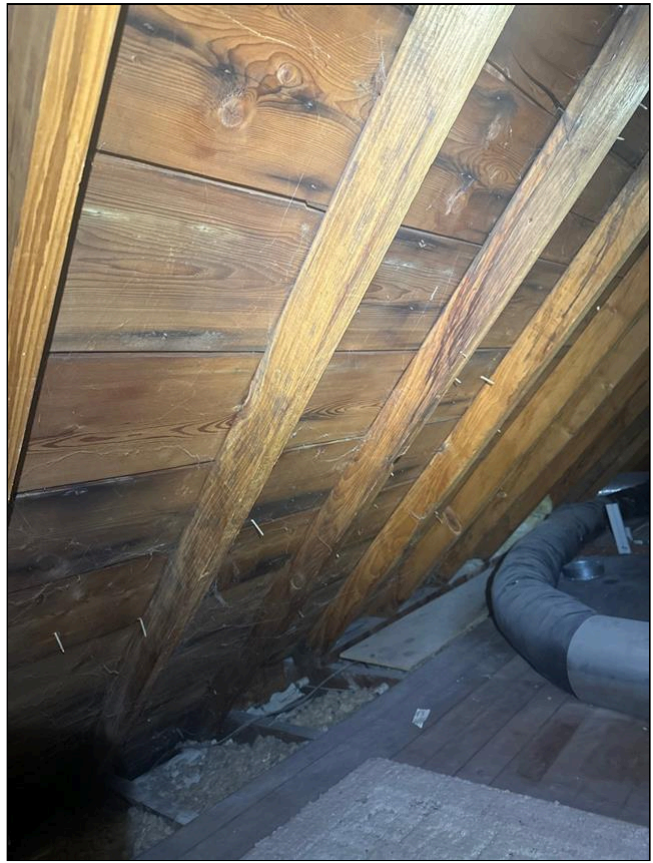
## 16.2 Attic Sheathing

Wood slat decking serviceable

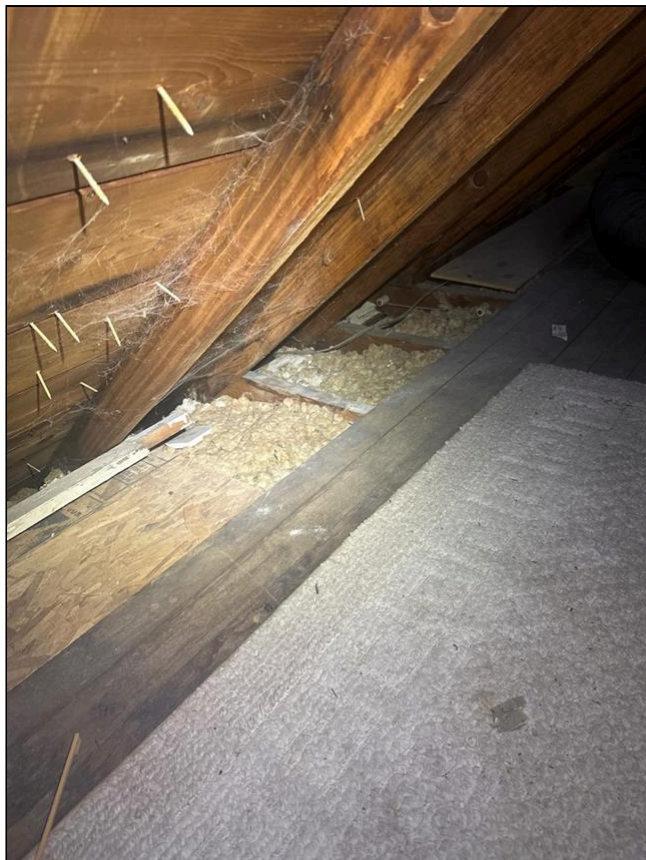
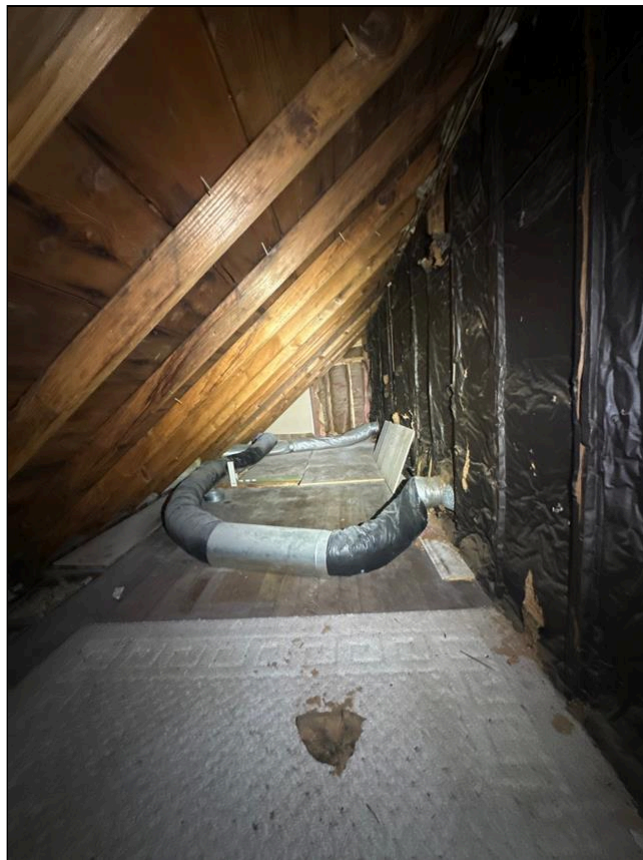
### 16.3 Attic Insulation

Insulation is serviceable where visible, limited review due to flooring.

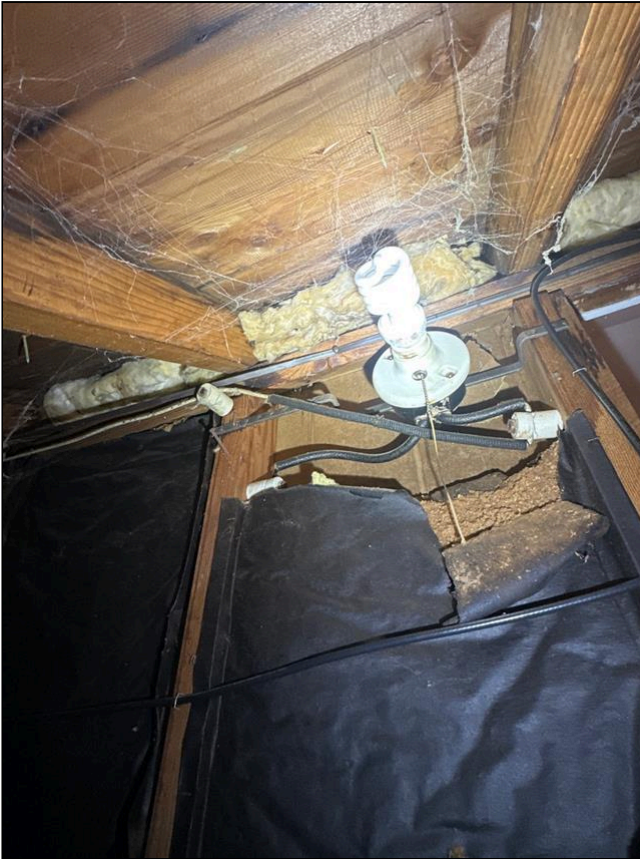
**16.6 Electrical Wiring, Switches and Fixtures**  
Repair or Replace

Knob and tube wiring found, knob and tube can exist in walls and insulation. We recommend further review/repairs needed by a qualified electrician for enhanced safety.

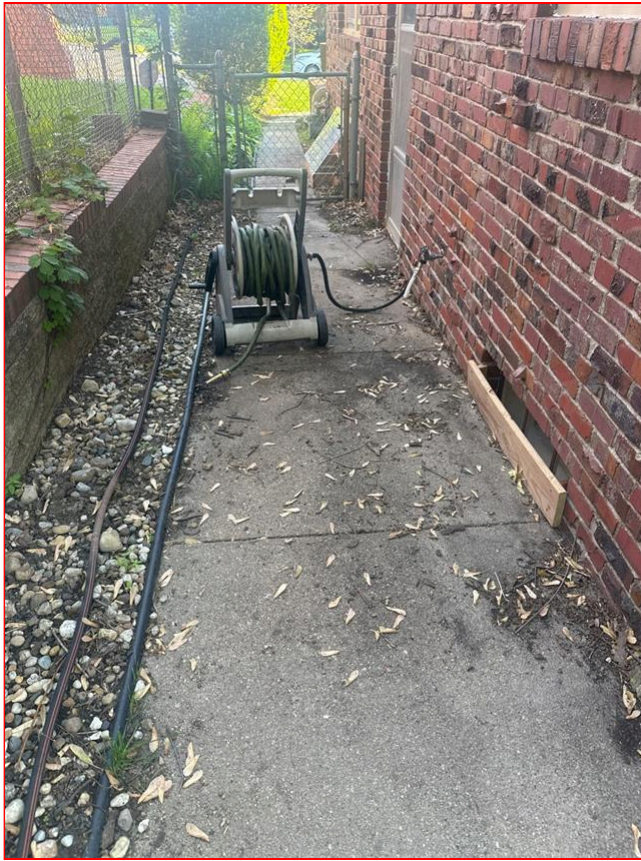
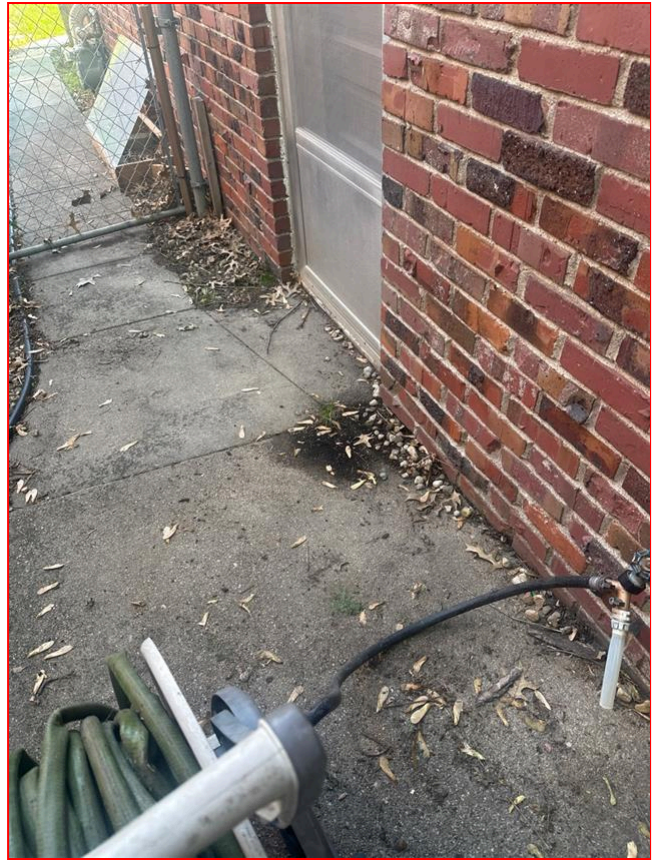
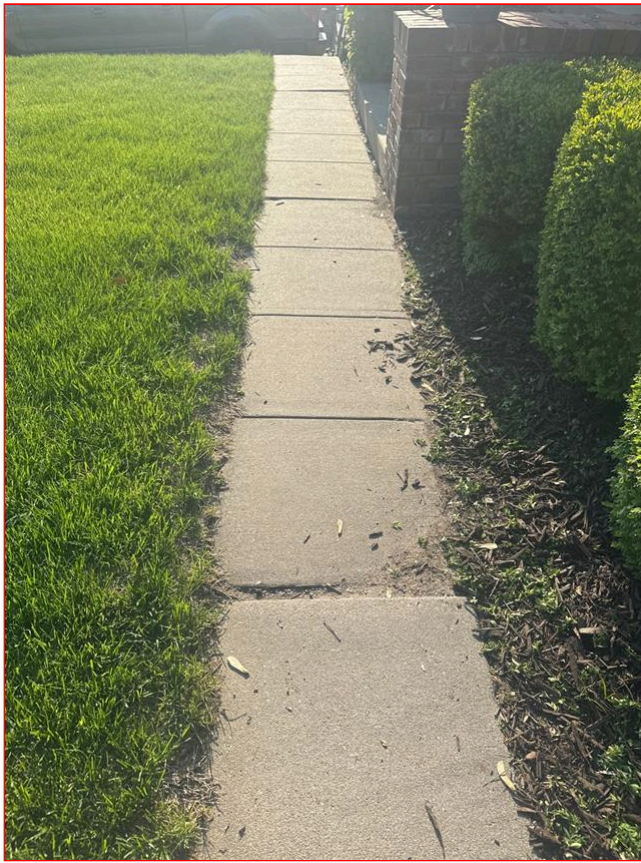
Settlement noticed at the concrete walkways. Recommend repairs needed to prevent further damage and possible pooling near the foundation and possible trip hazards.

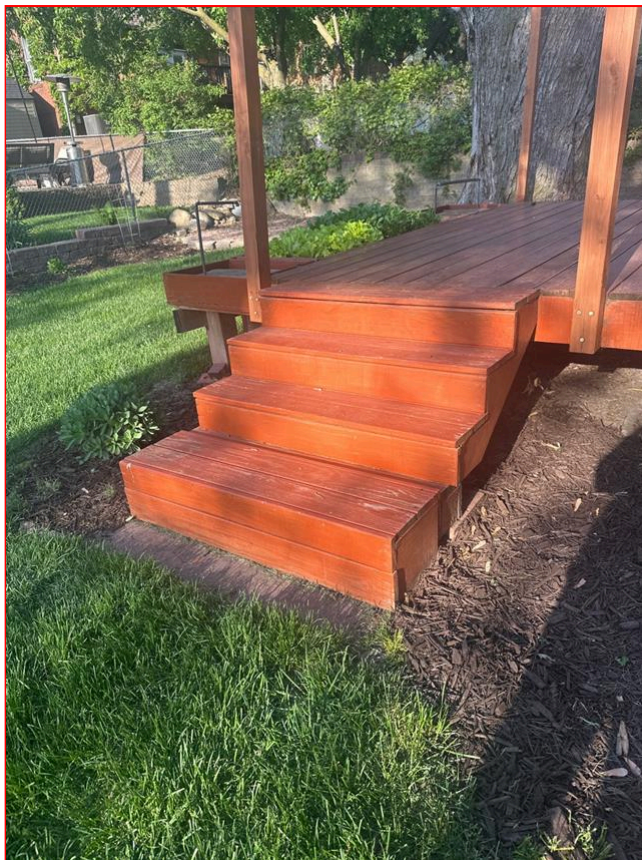
(1) No hand railings noted on steps at rear of home, recommend installing hand rail for safety. When

ever four or more risers are present a handrail is usually required.

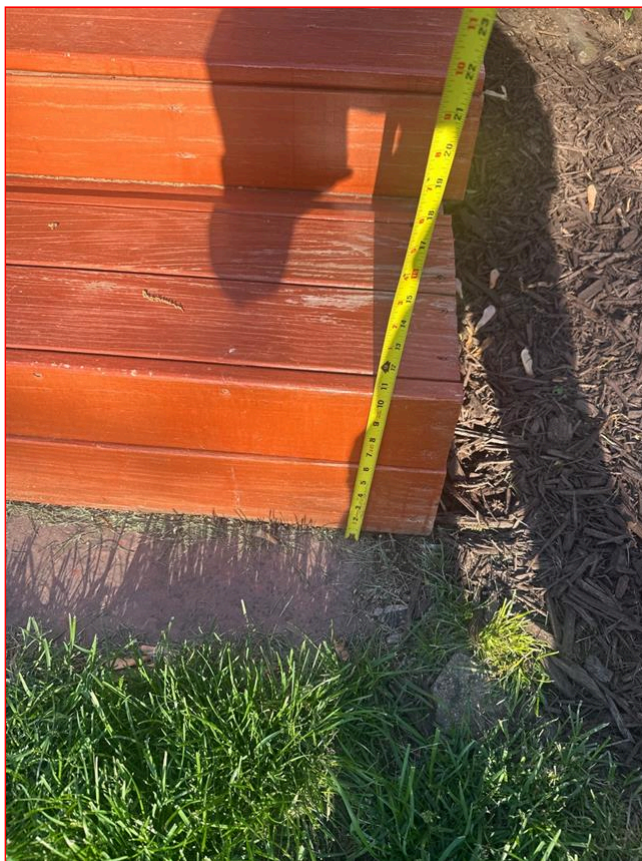
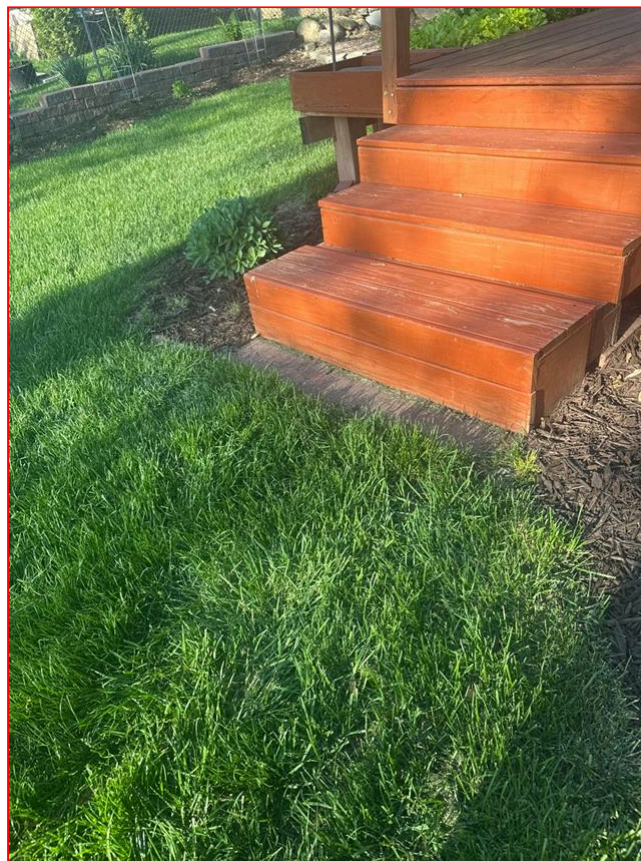
(2) Steep step noticed at the rear of the home. We recommend repairs as needed to prevent possible trip hazards.

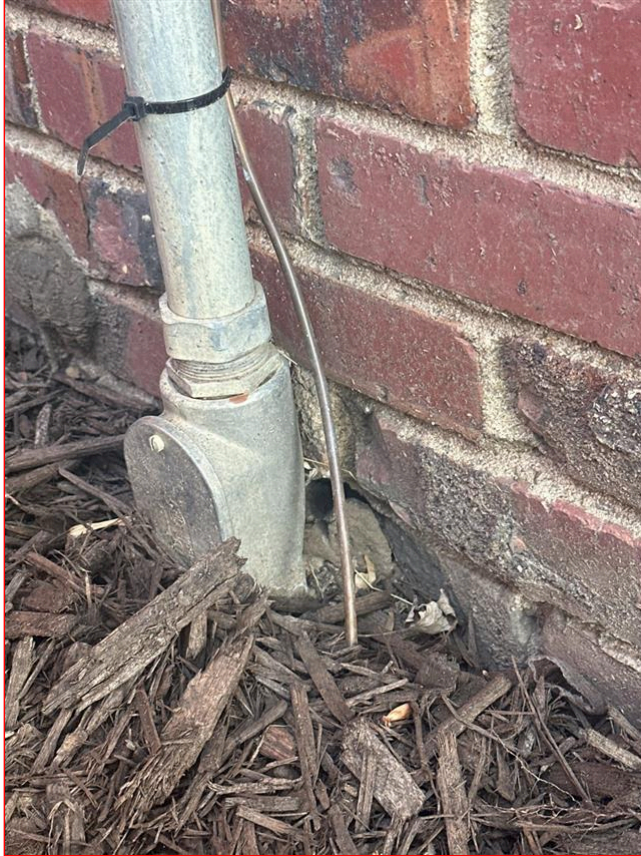
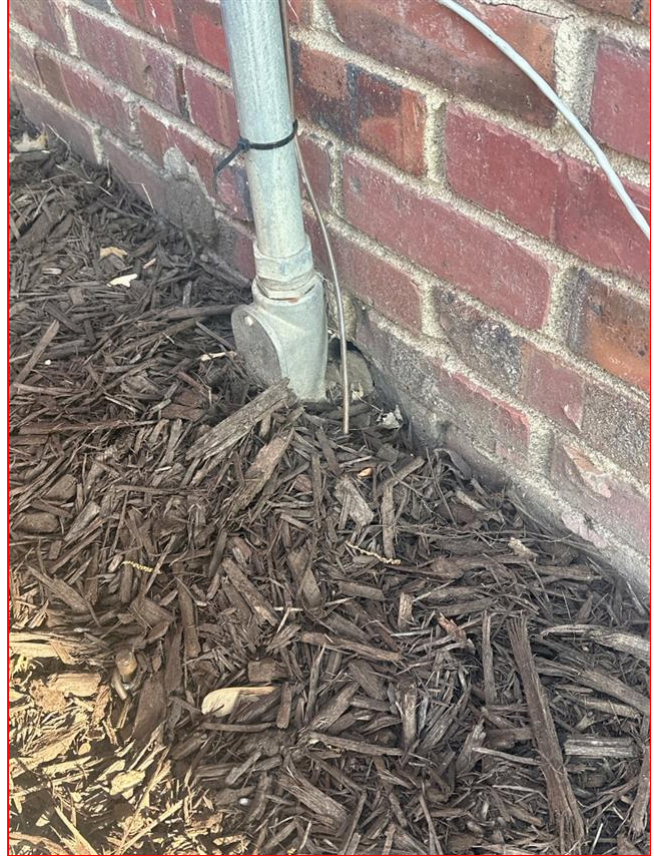
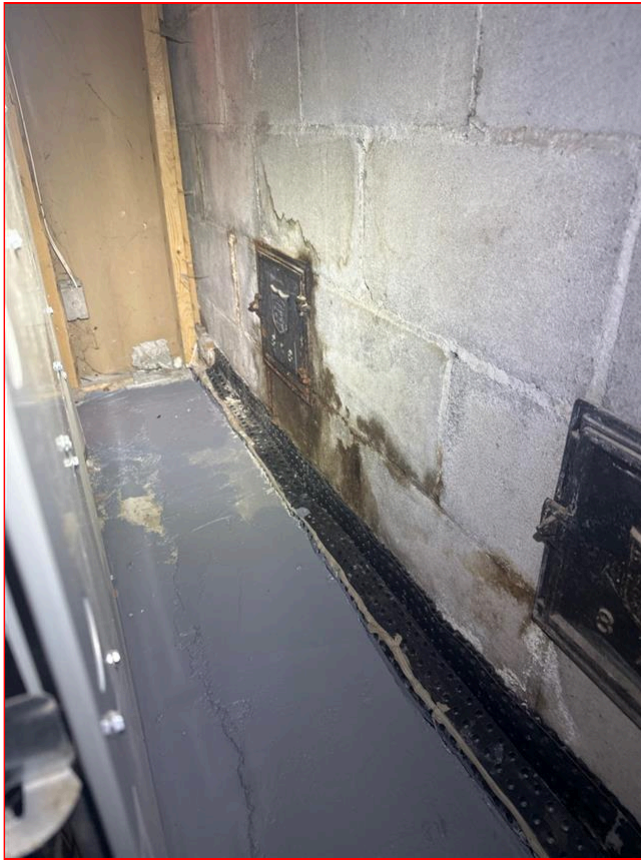
(1) Gaps noticed at the lower foundation, staining noticed near the coal shoot. We recommend further review/repairs needed by a qualified contractor.

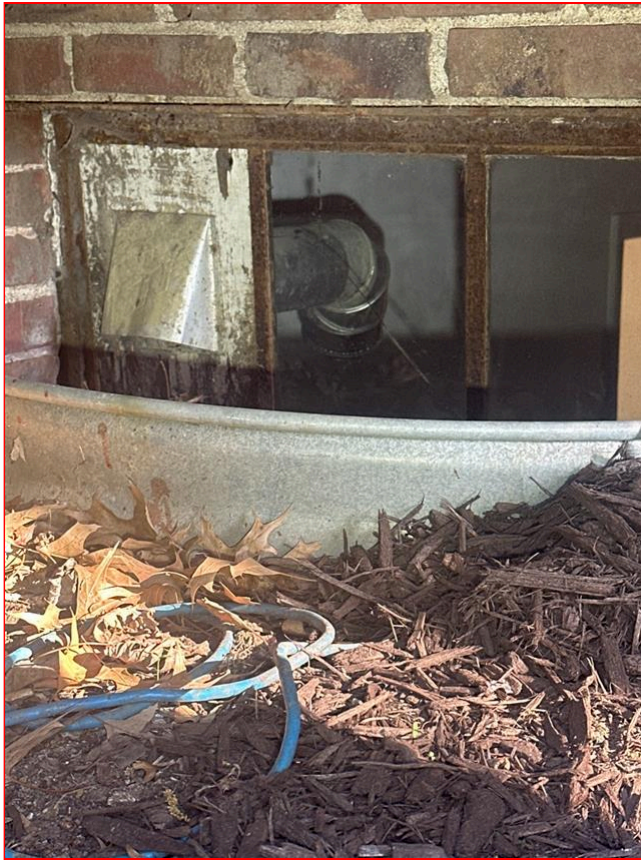
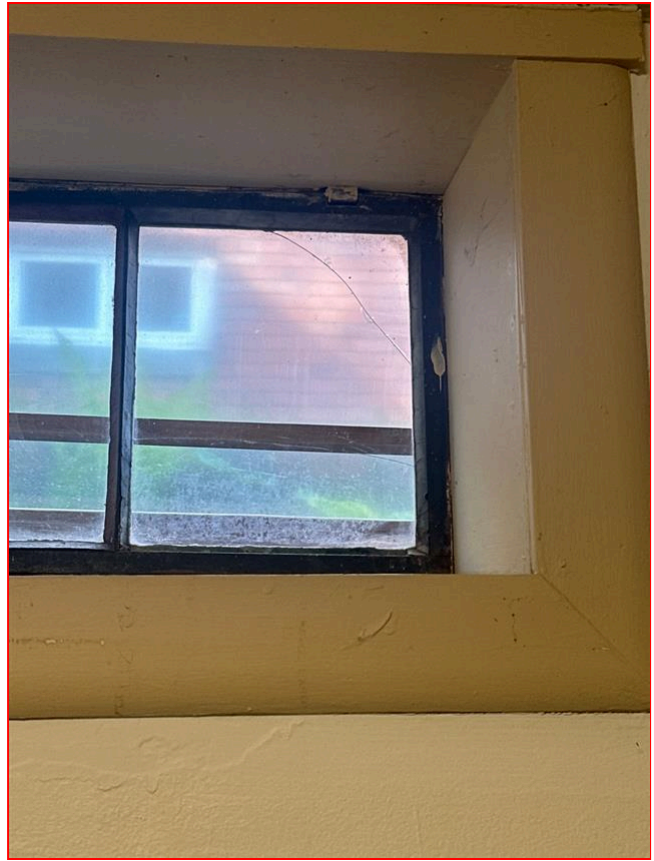
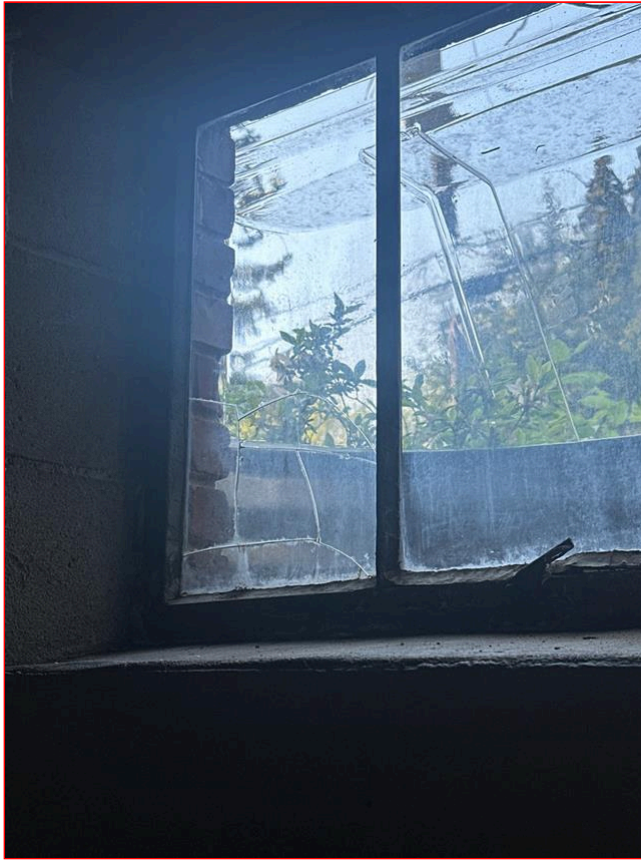
## 5.9 Windows (Basement)

Multiple cracked basement windows found. We recommend repairs/replacements needed to prevent further damage.

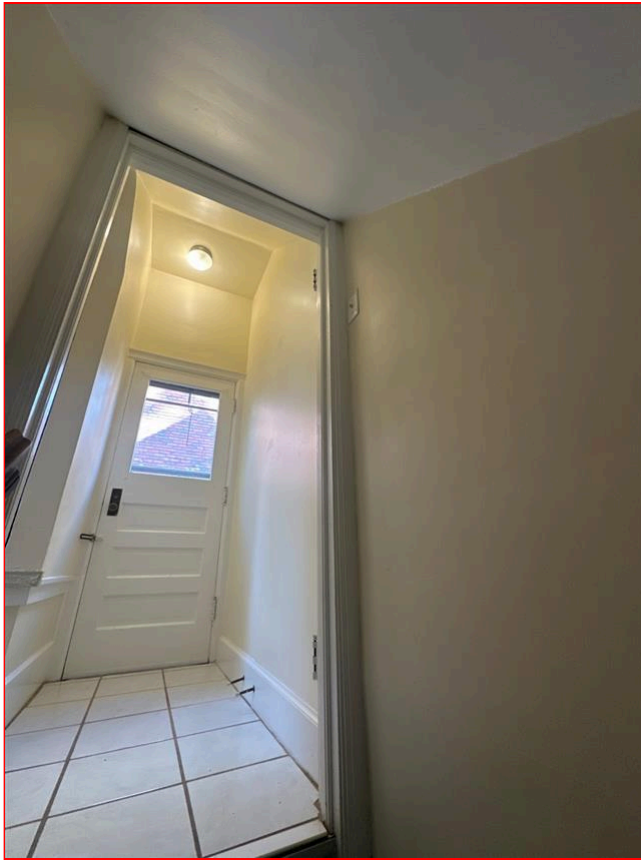
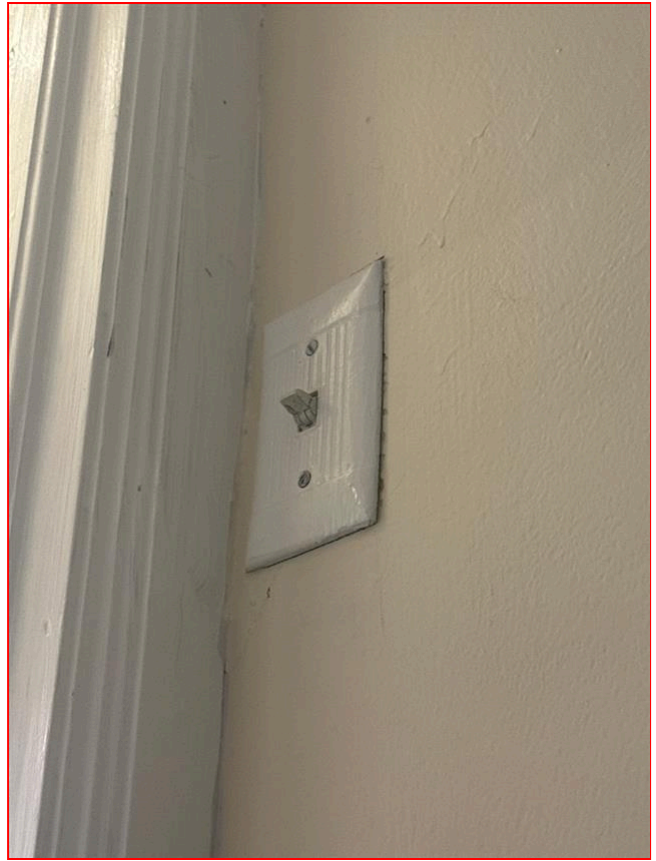
(1) Upstairs light switch was inoperable. We recommend repairs needed by a qualified electrician.

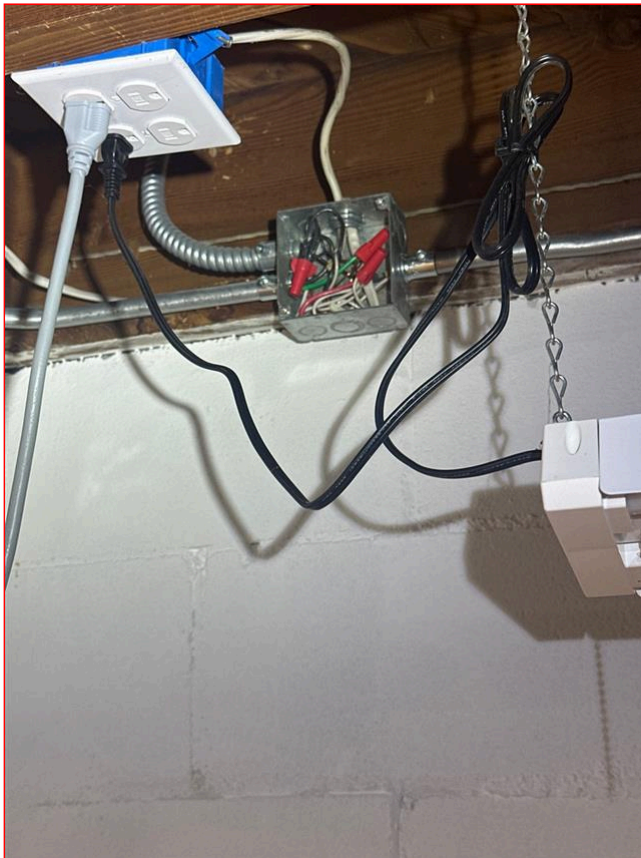
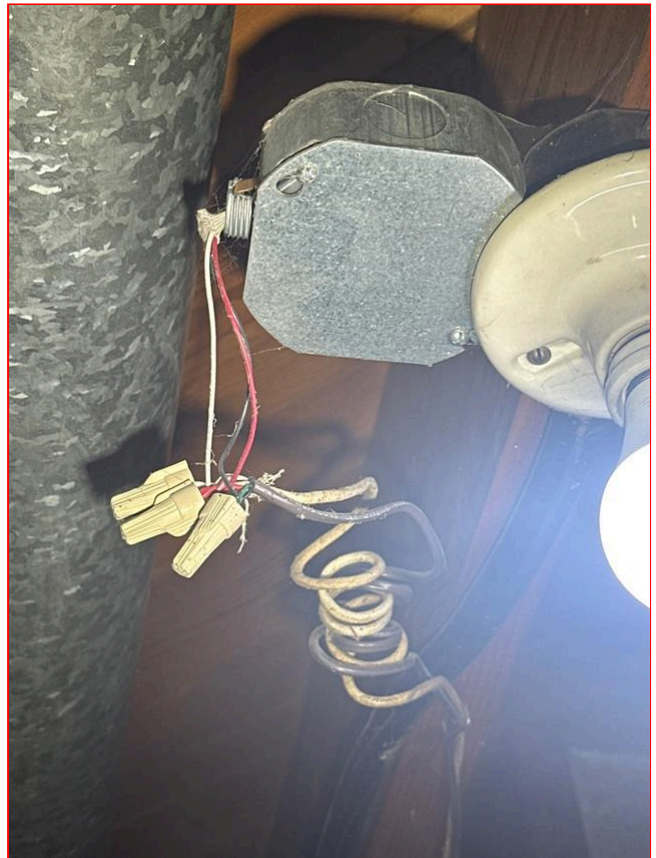
(2) Open splices were observed in the basement. This is a "Safety Concern". Whenever an electric wire is cut and reconnected, the "splice" should be encased in a covered "junction box" to prevent shocks and separation of the splice. Client is advised to consult with a licensed electrician prior to closing for repairs/replacement as needed to ensure safety.

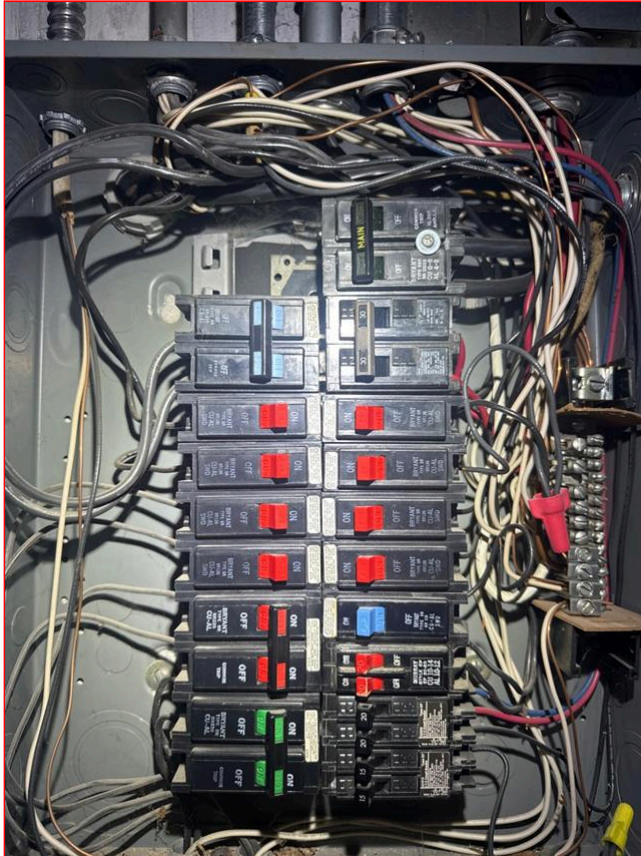
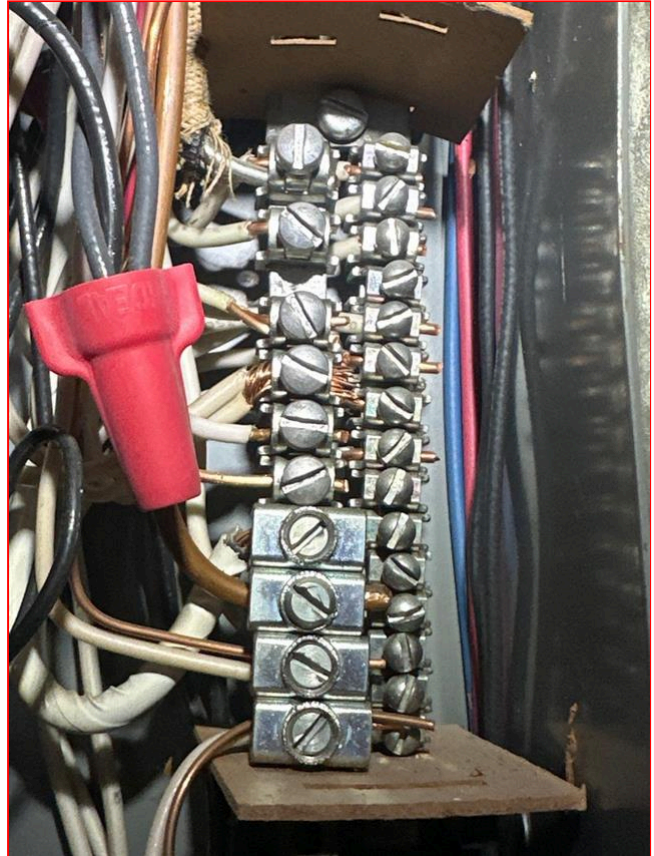
### 7.2 Main Electrical Panel Condition

Doubled up neutrals and grounds were observed in the main panel. The connection of a neutral and equipment-grounding conductor creates a significant problem. One of the objectives of a correct arrangement of bonding jumpers, neutrals and equipment grounds is to allow circuit isolation while keeping the equipment grounding conductor still connected to the grounding electrode. A licensed electrician is needed to review the panel and make all corrections necessary for safe and proper operation of the system.

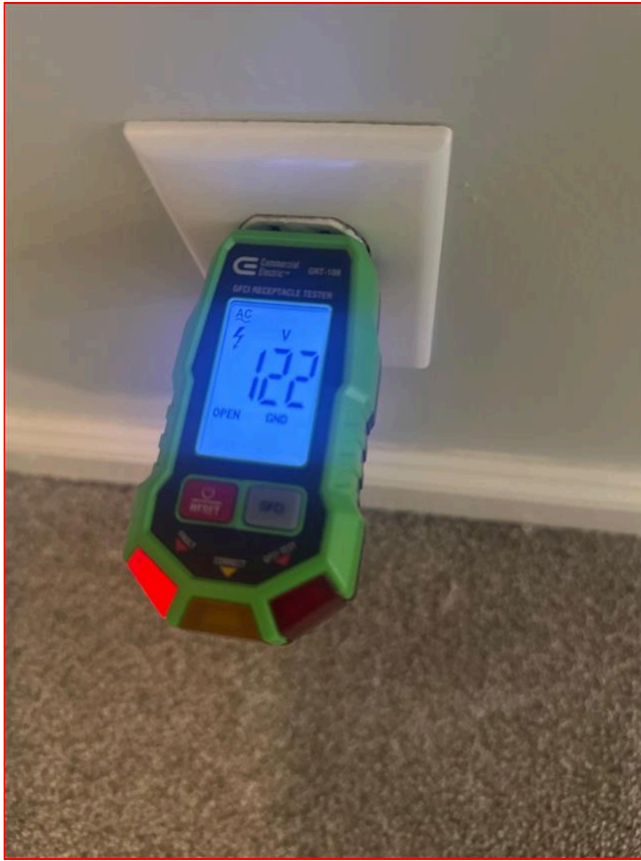
### 7.4 Wiring

Multiple ungrounded outlets found throughout the home. This may not have been required when the home was built, however, we suggest installing grounding wire or adding GFCI outlets, enhanced safety.

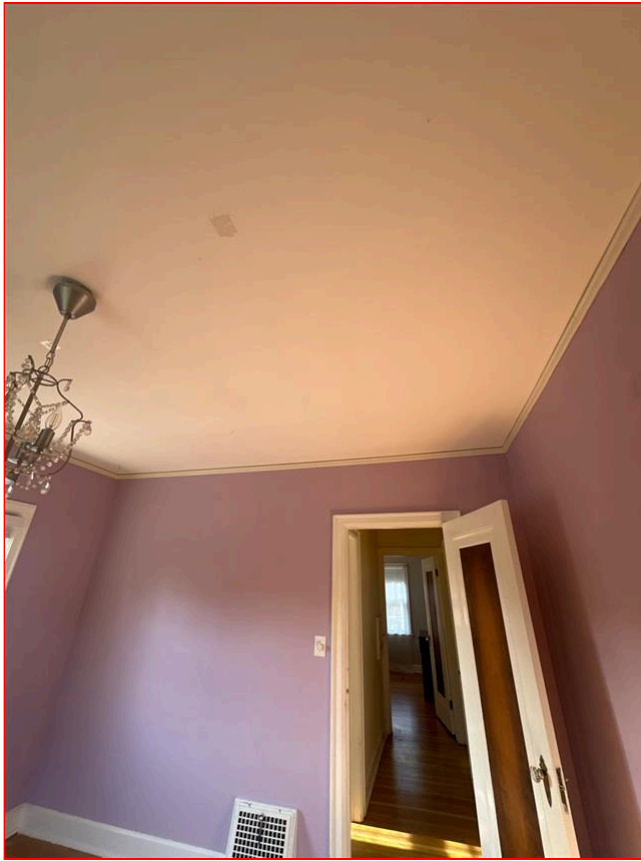
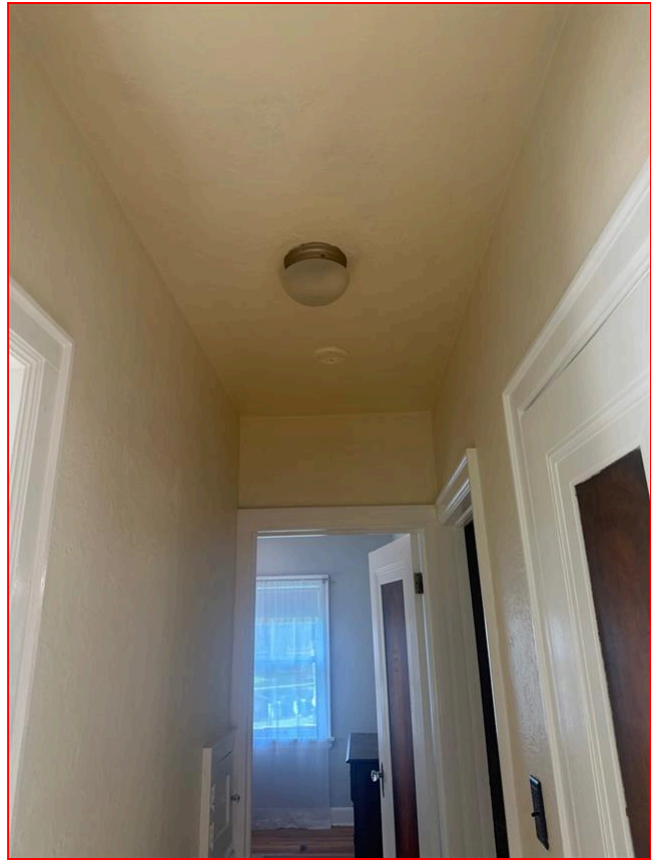
## 7.7 Smoke Alarms

The smoke alarms should be added tested upon moving in to home, smoke alarms should be installed to any rooms that will be bedrooms. We recommend installing monoxide detectors where needed and periodically testing alarms for enhanced safety.

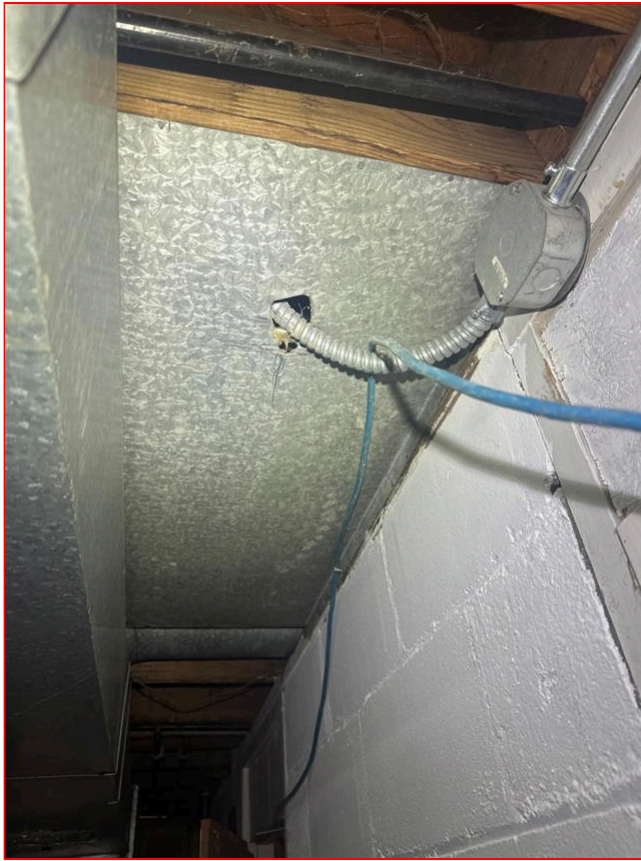
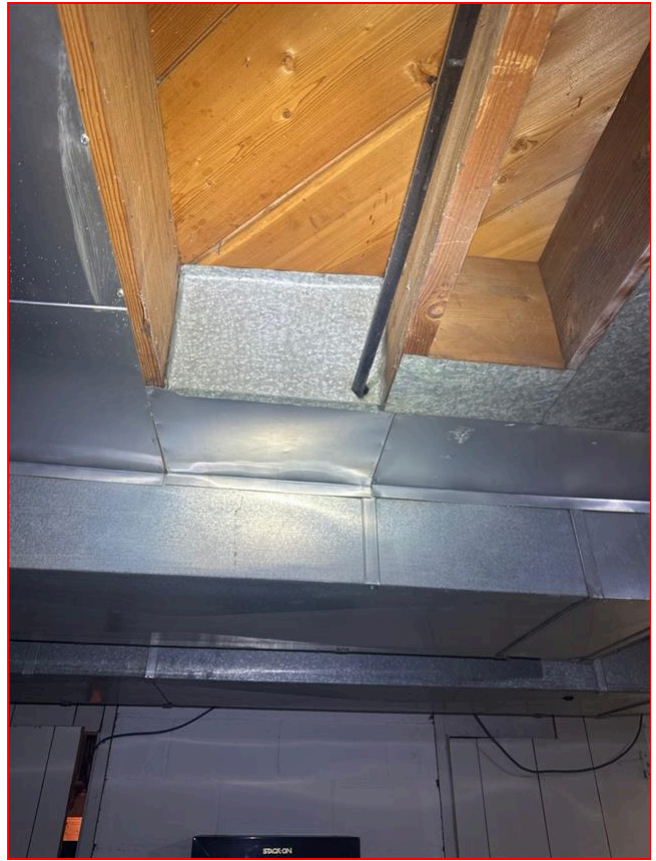
(1) Electrical has been inserted through ductwork. This is not allowed. We recommend further review/repairs needed by a qualified contractor.

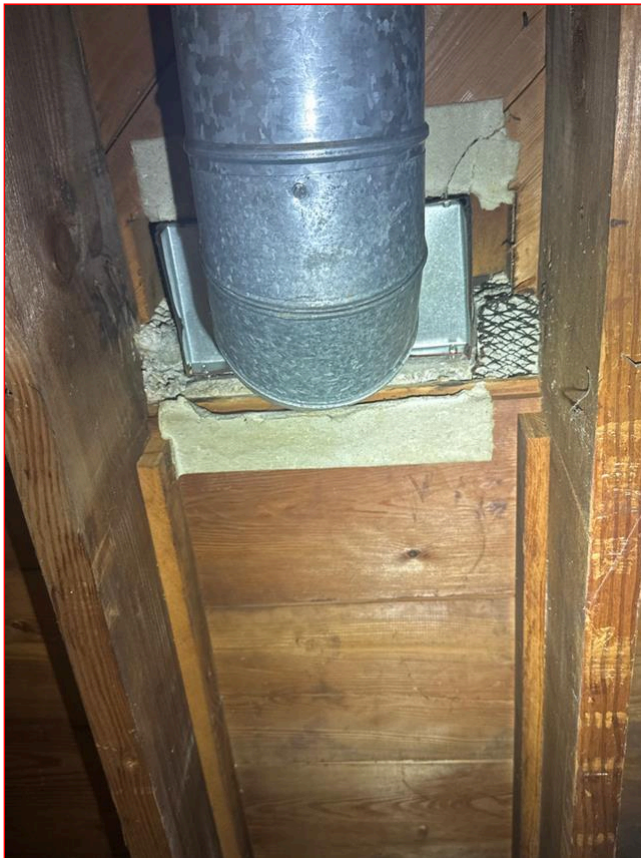
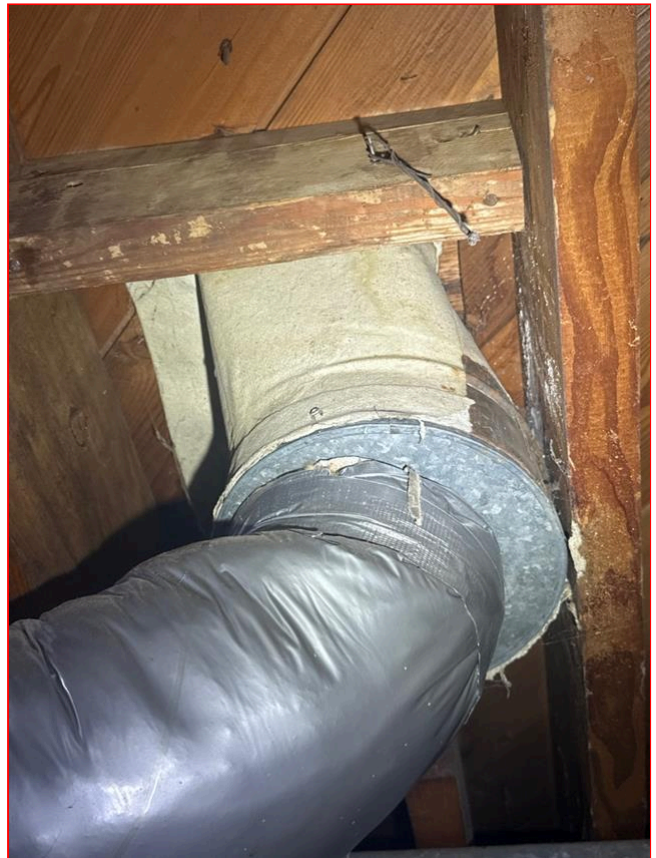
(2) Possible asbestos materials observed. The materials appeared to be intact at the time of inspection. Asbestos materials are considered safe by the EPA if they are not disturbed, torn, ripped, or damaged. No torn, ripped, or damaged materials were observed. If client has any concerns regarding asbestos materials, an asbestos testing lab should be consulted for further review to ensure safety.

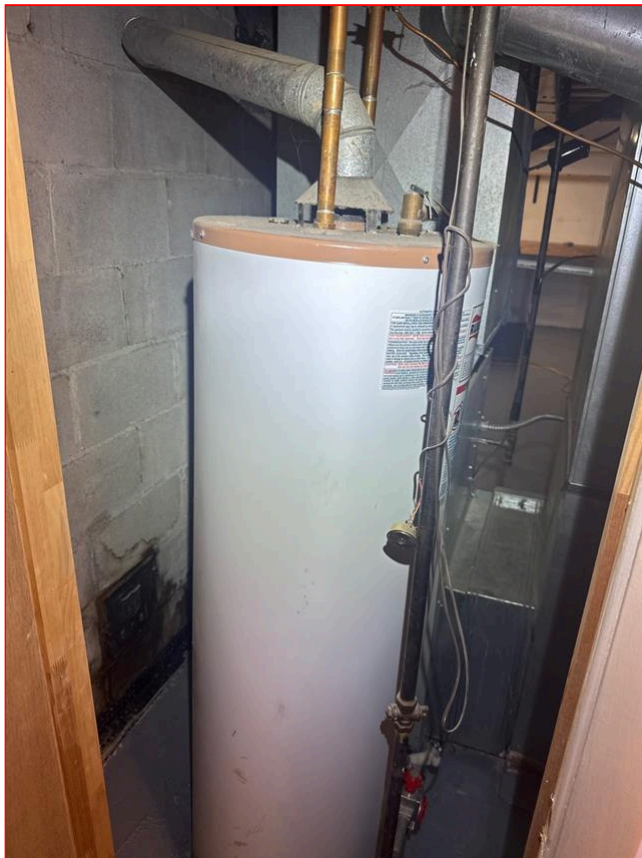
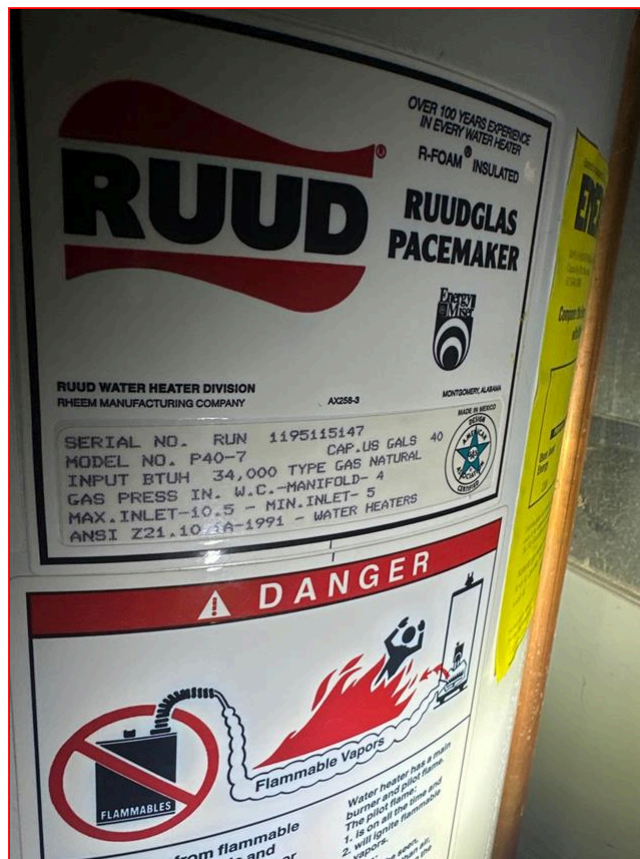
### 10.0 Water Heater Condition

Low water temperature noticed at time of inspection. Units typically last 5-10 years. We suggest replacing when needed.

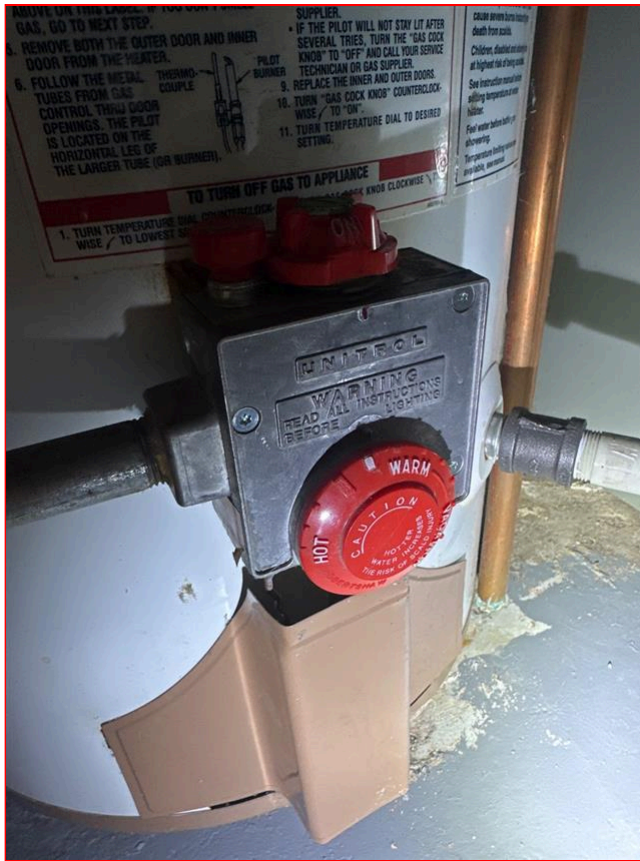
Manufactured 1995
