# Inspection Report

5135 Parker St  
Omaha NE 68104

**AmeriSpec Inspection Services**

<b>Date:</b> 5/8/2025	<b>Time:</b> 08:00:00 AM	<b>Report ID:</b> 42560
<b>Property:</b> 5135 Parker St Omaha NE 68104	<b>Customer:</b> Chris Holbeck	<b>Real Estate Professional:</b>

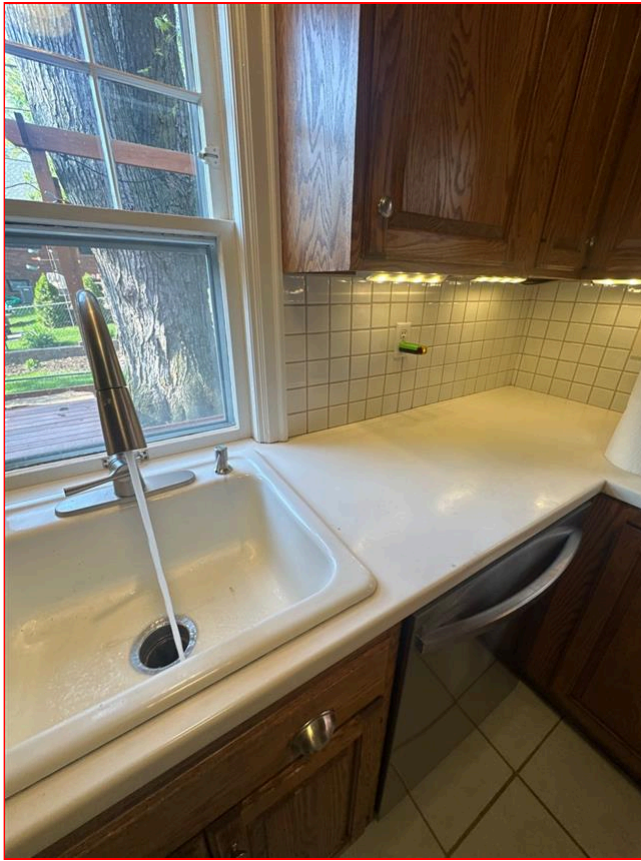
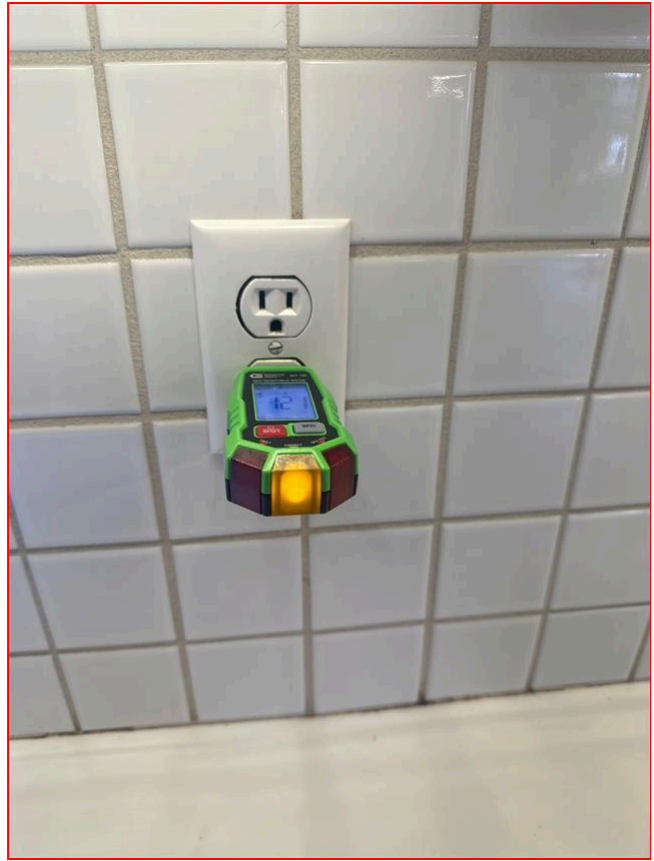
Kitchen outlets 6 feet within the water source are not GFCI protected, ground fault circuit interrupters may not have been required when this home was built. We recommend installing GFCI outlets as needed for enhanced safety. This is typically a buyer improvement.

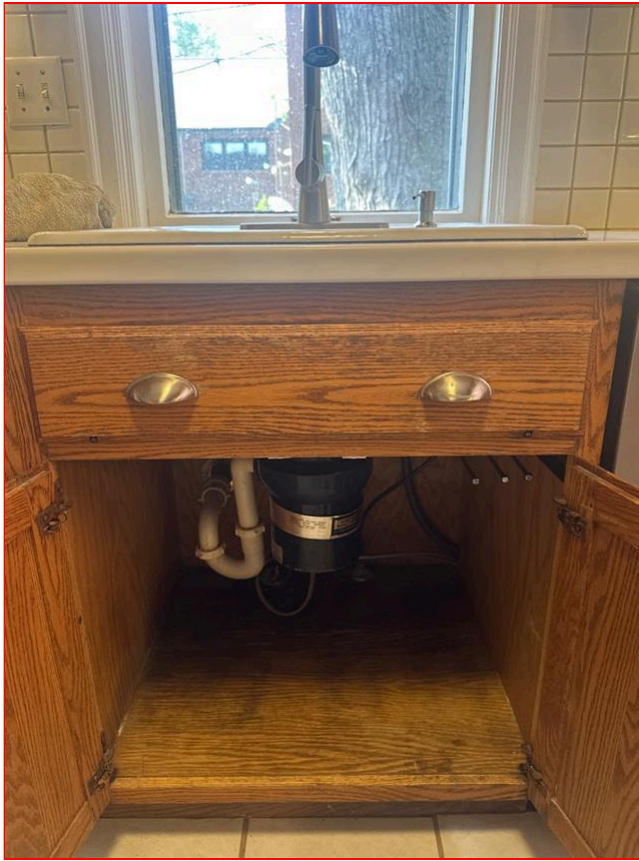
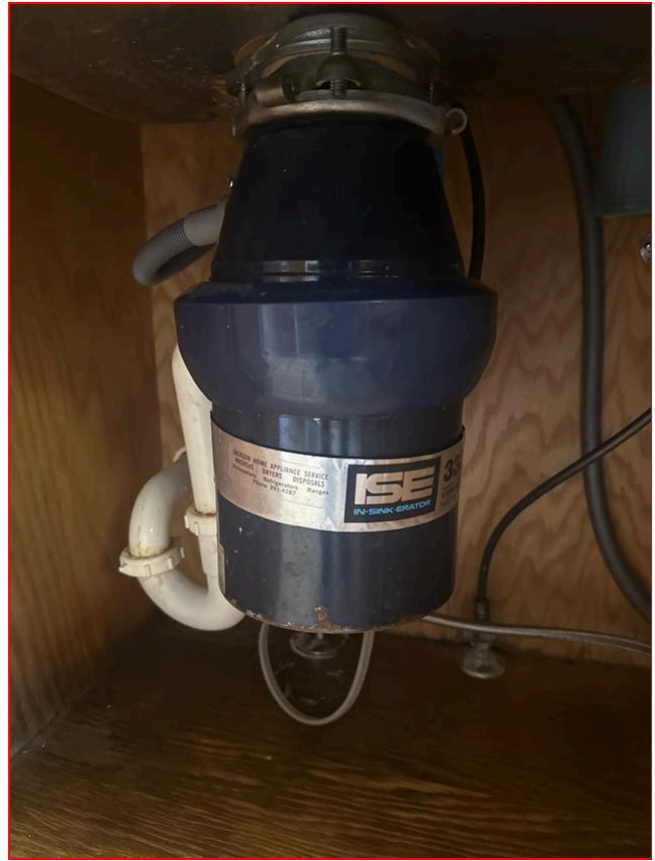
Obstruction noticed at the kitchen disposal. We recommend repairs/cleaning as needed to prevent possible damage and proper function.

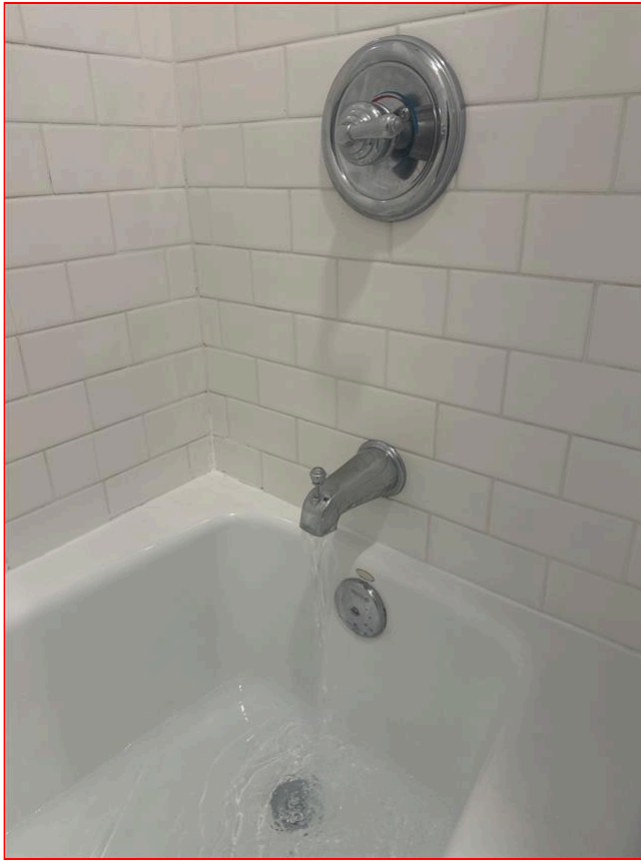
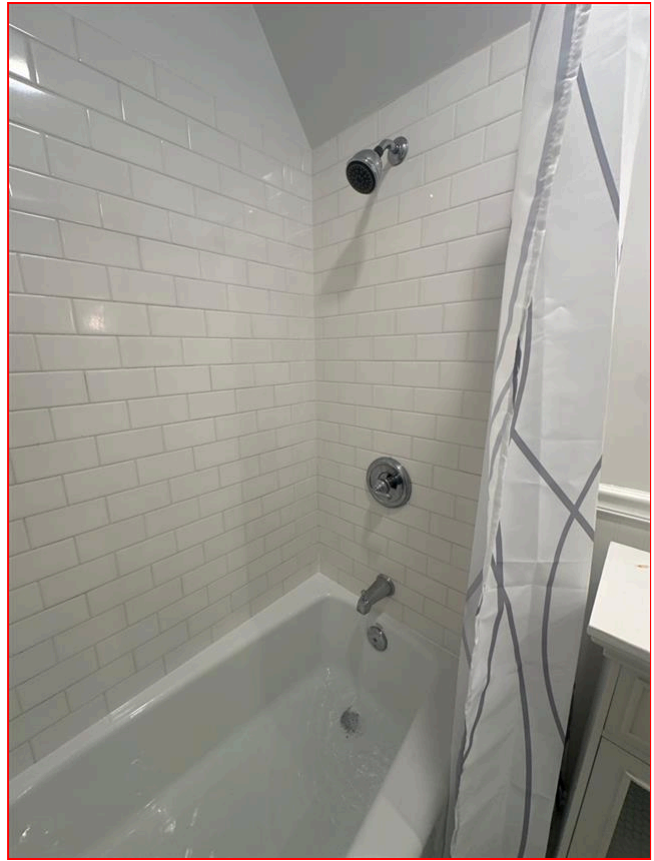
### 12.10 Shower

(1) Upstairs bathroom, diverter valve does not function properly, no water comes out of the showerhead. We recommend further review/repairs needed by a qualified contractor.

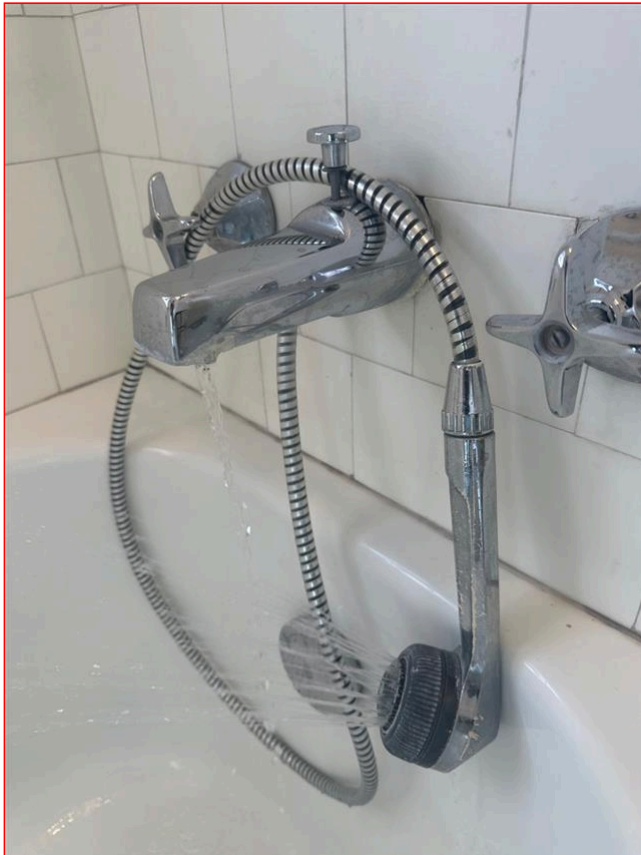
(2) Main hallway, bathroom shower diverter valve does not fully engage. We suggest repairs/adjustments as needed.

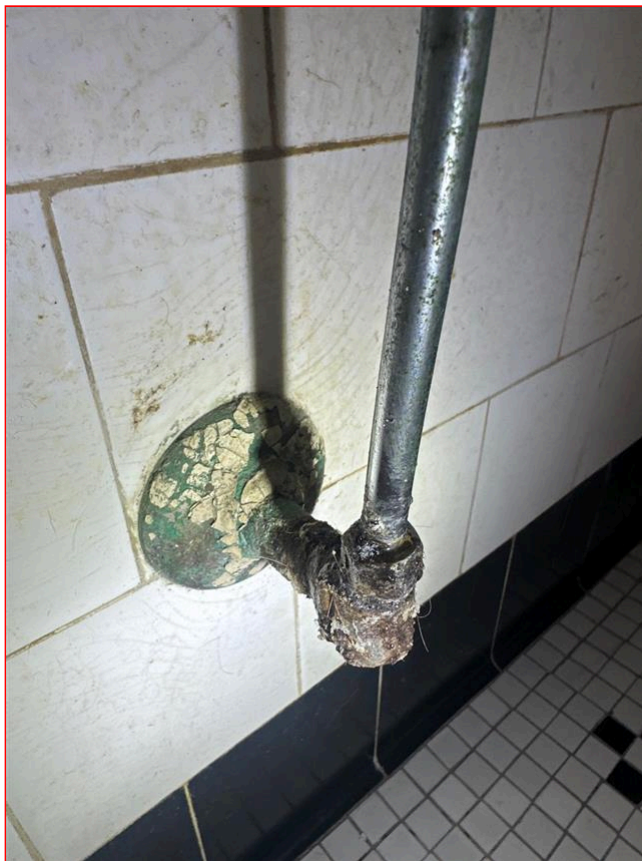
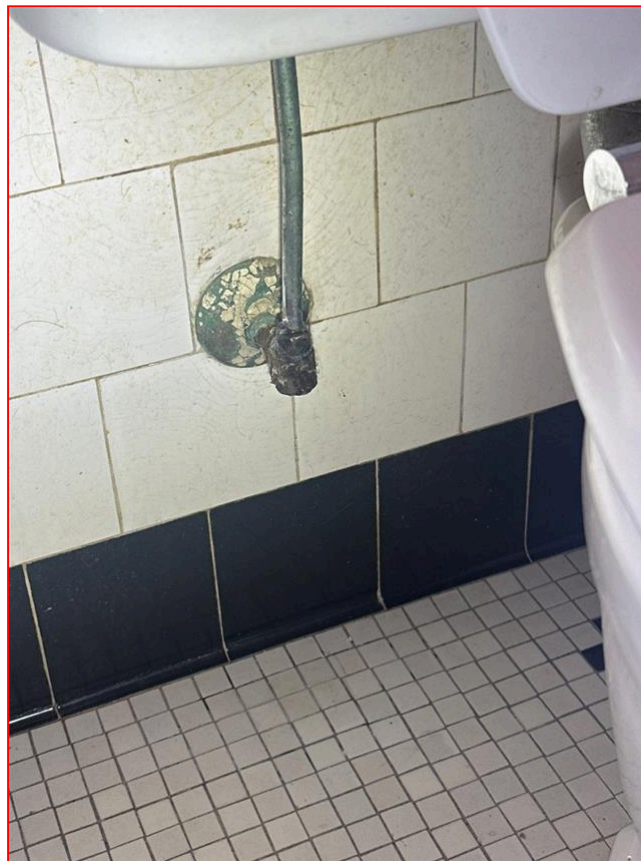
## 12.12 Toilet

(1) Leak and/or deterioration observed at the toilet water supply line in the hall bathroom. Recommend review by Licensed/Qualified plumber for repair or replacement as necessary.

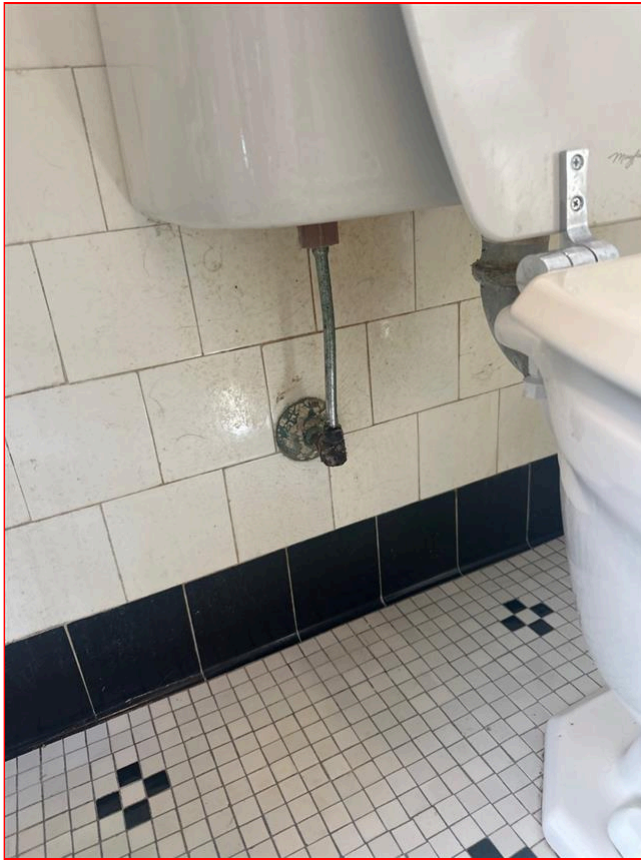
(2) No shut-off valve observed to the toilet in the hall bathroom. Shut off valves may not have been required when fixture was installed, recommend shut-off valve be installed as a plumbing up-grade.

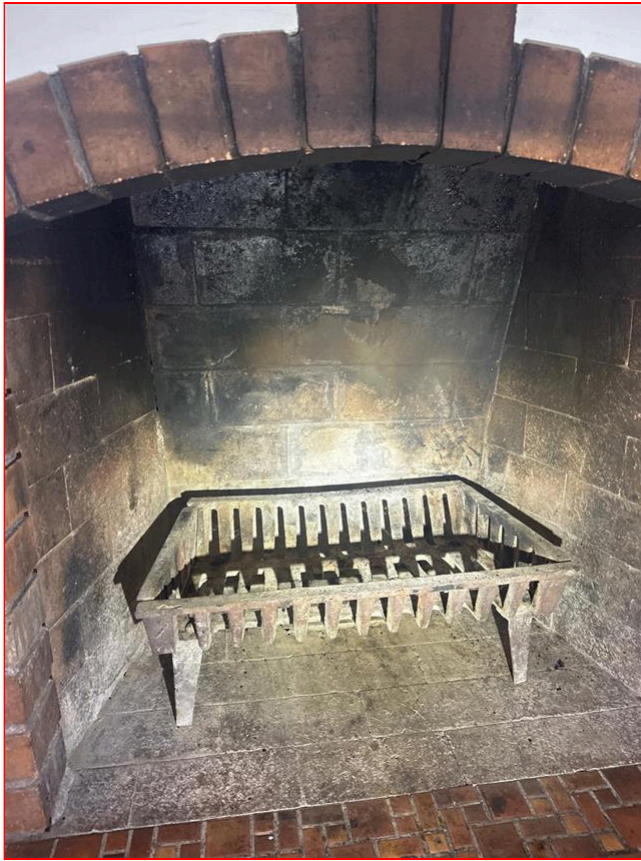
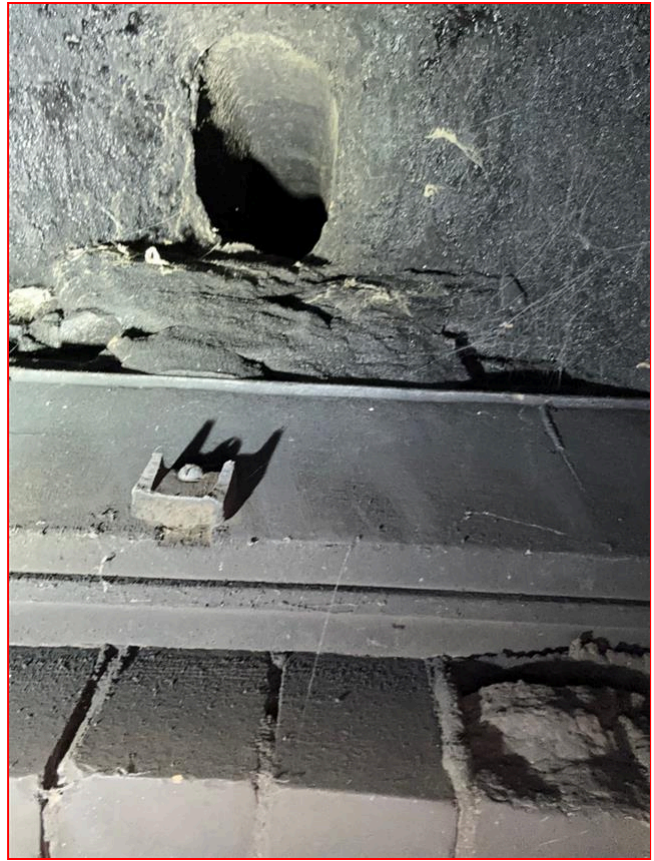
### 14.9 Fireplaces and Woodstoves

(1) Creosote build-up was observed in the fireplace located in the living room. Creosote is a naturally produced flammable by-product of combustion. Its presence is a limiting factor on a visual review. We suggest having cleaned and inspected by a fireplace and chimney specialist to assure safe operation prior to close.

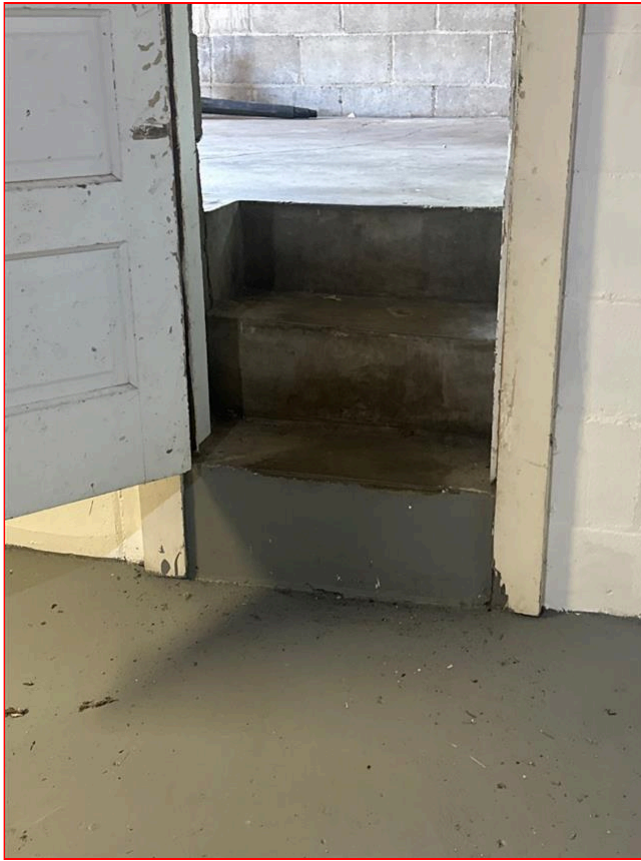
#### 14.10 Stairways

Steep steps noticed at the basement entering the garage. We suggest repairs as needed to prevent possible trip hazard.

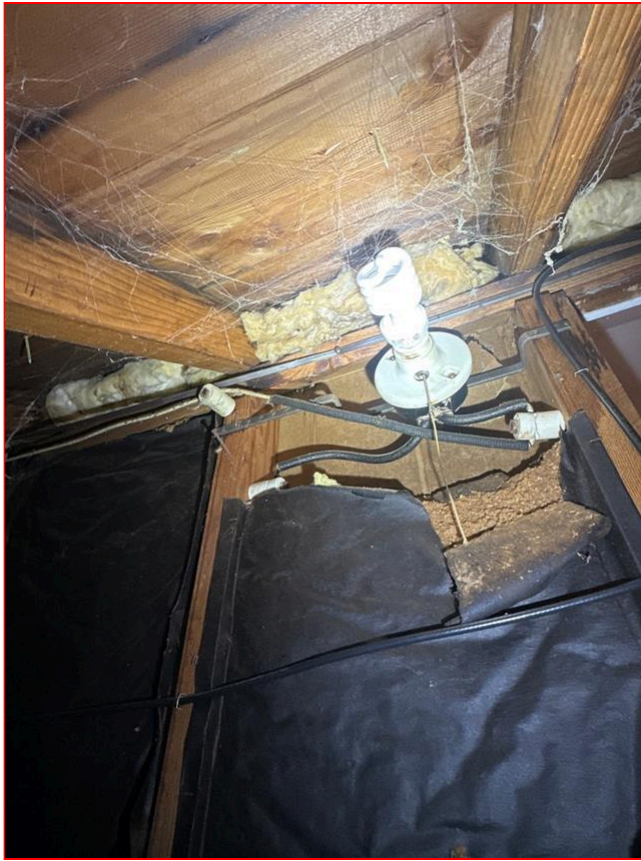
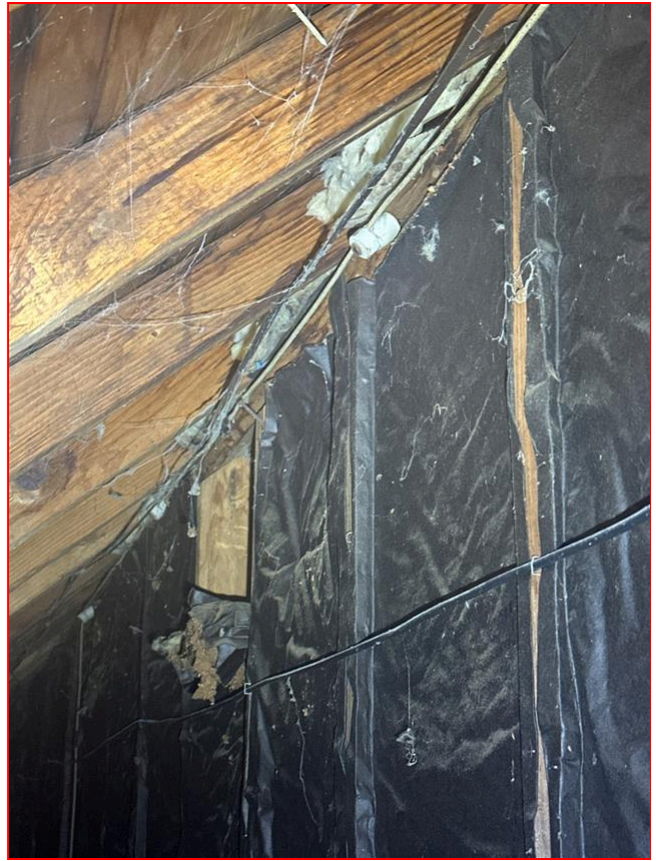
### 16.6 Electrical Wiring, Switches and Fixtures

Knob and tube wiring found, knob and tube can exist in walls and insulation. We recommend further review/repairs needed by a qualified electrician for enhanced safety.
