INSPECTION REPORT

For the Property at:
1598 COLLEGE PARK DRIVE
PETERBOROUGH, ON K9K 2G9

Prepared for: TEAM VANRAHAN
Inspection Date: Tuesday, June 17, 2025
Prepared by: David Sharman

RE: Report No. 5335
1598 College Park Drive
Peterborough, ON
K9K 2G9

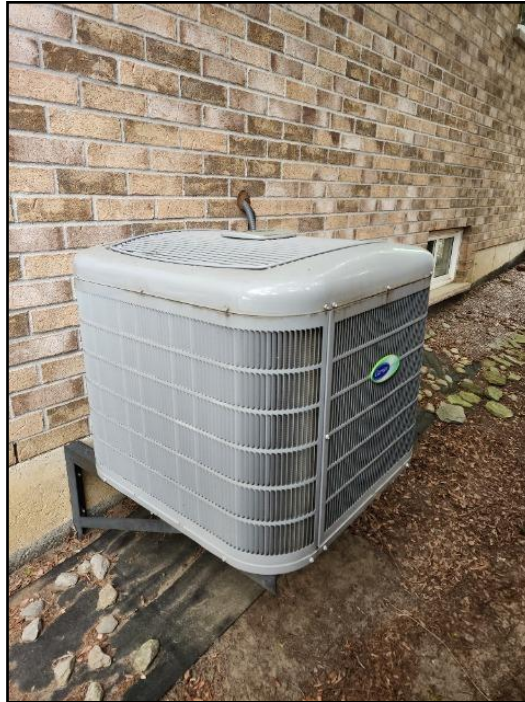
22. Air cooled

9. Condition: • Near end of life expectancy

Implication(s): Equipment failure | Reduced comfort

Budget to repair or replace as and when required

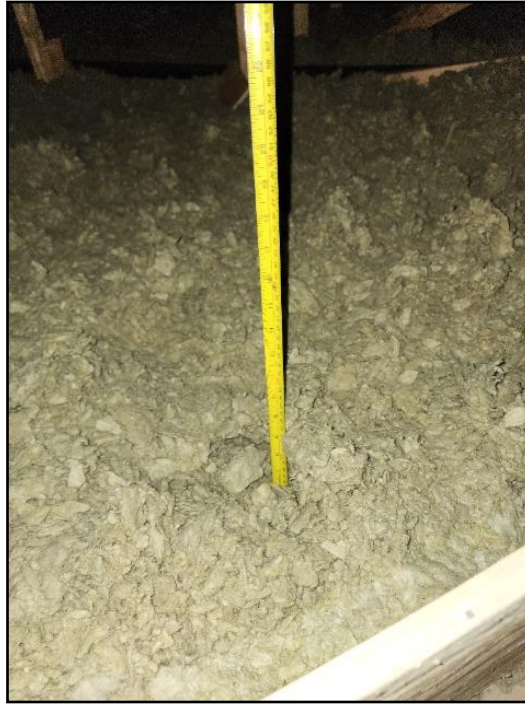
24. 8 inches

10. Condition: • Amount less than current standards

Although being below current standards is not a deficiency, the home may benefit from an increased level of insulation.

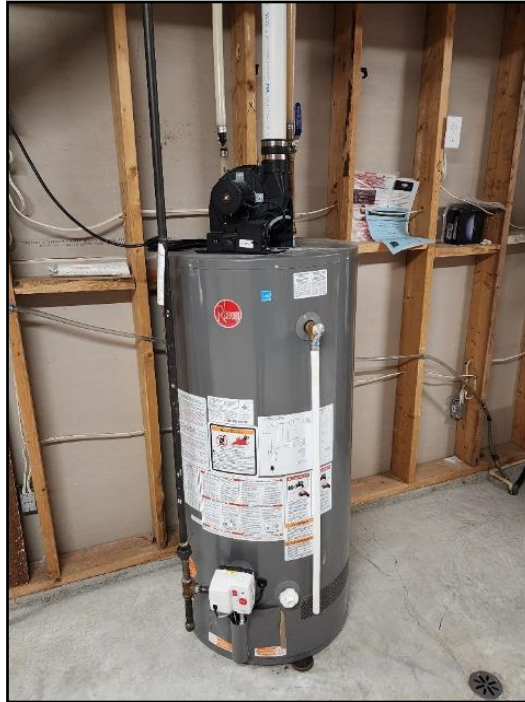
27. Gas

Water heater failure probability: • High

11. Condition: • Near end of life expectancy

Task: Replace
