# INSPECTION REPORT

For the Property at:  
**1243 7TH LINE**  
SELWYN, ON

Prepared for: TEAM VANRAHAN  
Inspection Date: Thursday, August 28, 2025  
Prepared by: David Sharman

RE: Report No. 5423, v.2  
1243 7th Line  
Selwyn, ON

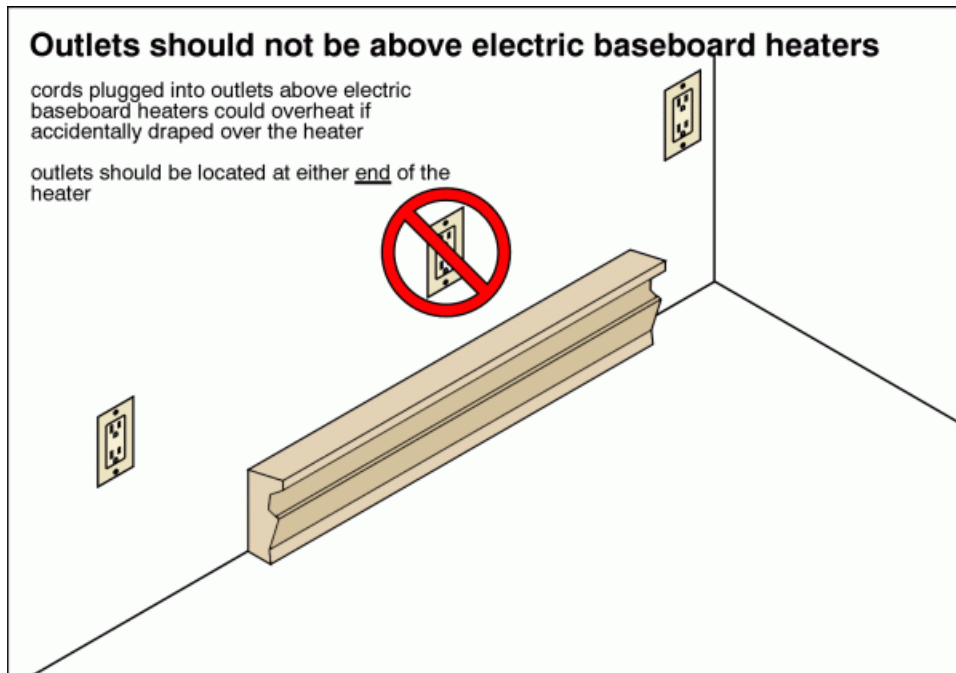
**11. Condition:** • Electrical receptacle above heater

cords plugged into outlets above electric baseboard heaters could overheat if accidentally draped over the heater

outlets should be located at either end of the heater
