# INSPECTION REPORT

For the Property at:  
**1087 BARNARDO AVENUE**  
PETERBOROUGH, ON K9H 5W9

Prepared for: TEAM VANRAHAN  
Inspection Date: Tuesday, July 29, 2025  
Prepared by: David Sharman

RE: Report No. 5391  
1087 Barnardo Avenue  
Peterborough, ON  
K9H 5W9

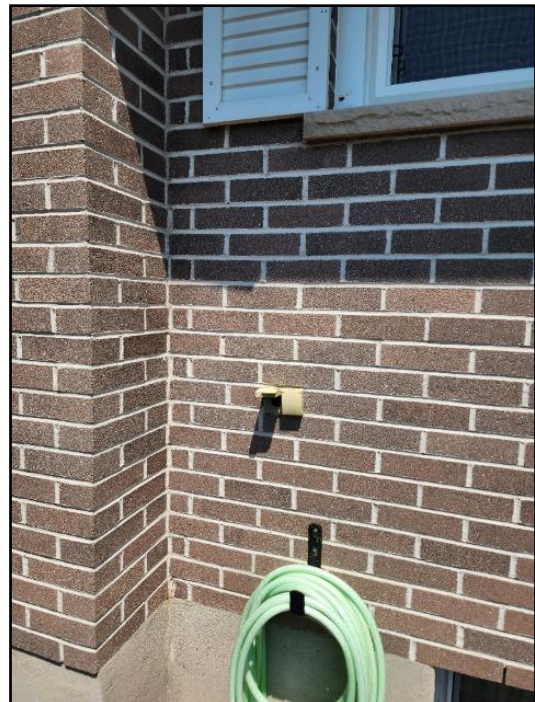
8.

**5. Condition:** • No GFCI/GFI (Ground Fault Circuit Interrupter)

Although not a deficiency in a home of this age, safety may be improved by upgrading these receptacles

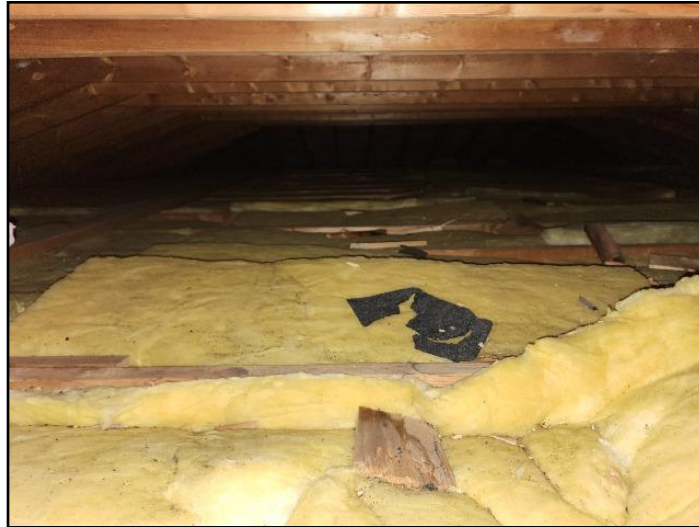
15. Glass fiber

**8. Condition:** • Amount less than current standards
