# INSPECTION REPORT

For the Property at:  
**1307 MONAGHAN ROAD**  
PETERBOROUGH, ON K9J 5L9

Prepared for: TEAM VANRAHAN  
Inspection Date: Saturday, September 30, 2023  
Prepared by: David Sharman

RE: Report No. 4516  
1307 Monaghan Road  
Peterborough, ON  
K9J 5L9

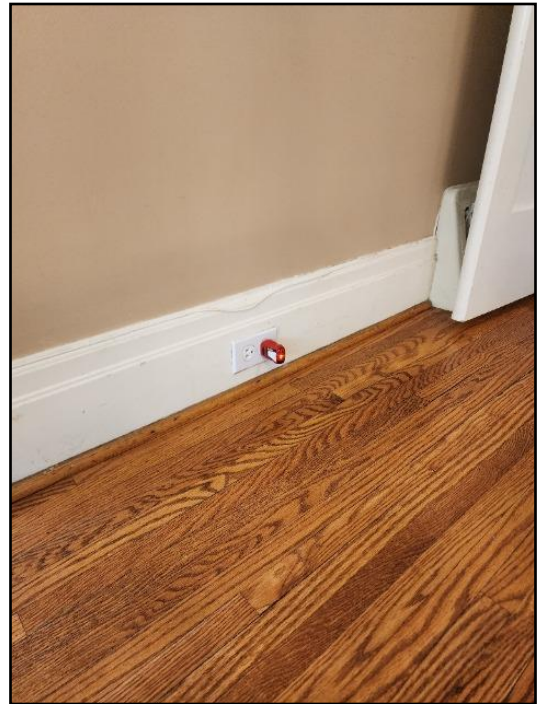
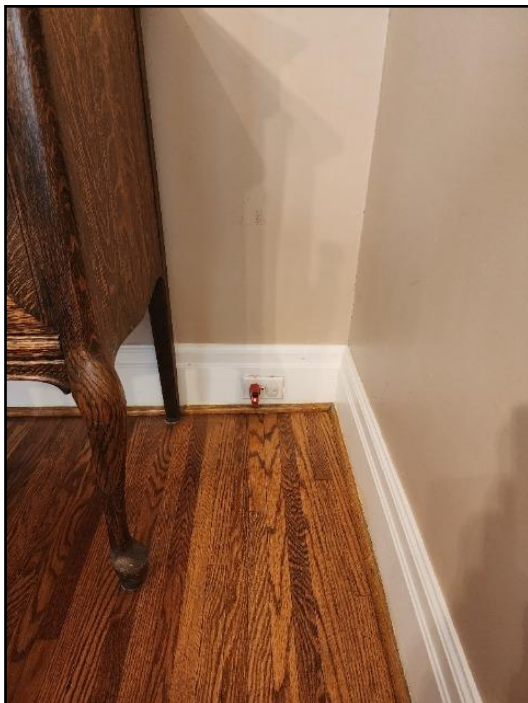
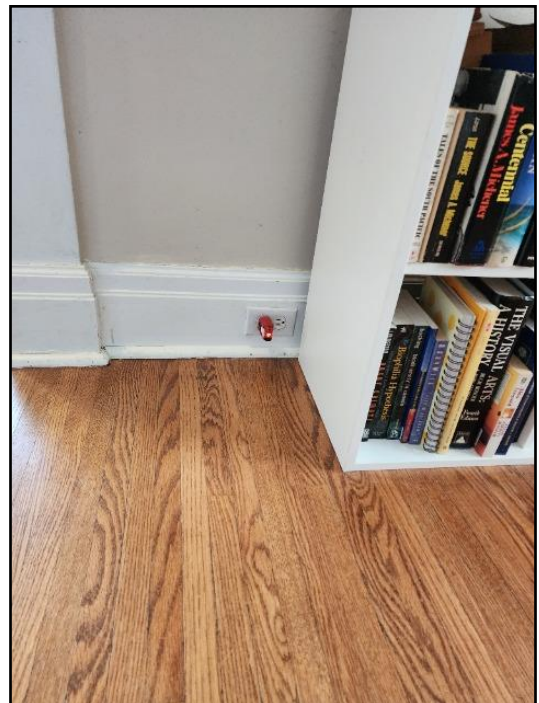
**9. Condition:** • No GFCI/GFI (Ground Fault Circuit Interrupter)

Although not a deficiency in a building of this age, safety may be improved by upgrading this receptacle

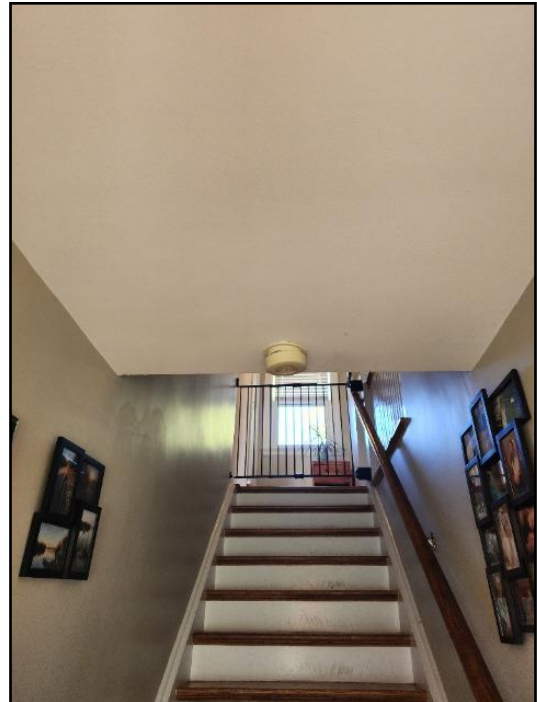
21.

**10. Condition:** • More than 10 years old

**Implication(s):** Life safety hazard

**Task:** Replace
