HOME INSPECTION REI 7-6

20808 Silverbell Ln
Pflugerville, TX 78660

PROPERTY INSPECTION REPORT FORM

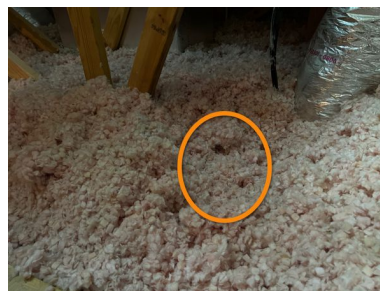
Rodent tunnels in the insulation

Owners Notes: Traps removed and no new activity.

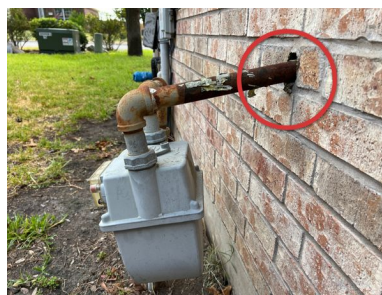
The gas piping system is not bonded to the grounding electrode system. Where metal piping servicing the house is capable of being energized, it should be bonded to the grounding electrode system. This is reflected in the 2012 International Residential Building Code as follows: E3609.7 Bonding other metal piping. Where installed in or attached to a building or structure, metal piping systems, including gas piping, capable of becoming energized shall be bonded to the service equipment enclosure, the grounded conductor at the service, the grounding electrode conductor where of sufficient size, or to the one or more grounding electrodes used. The bonding conductor(s) or jumper(s) shall be sized in accordance with Table E3908.12 using the rating of the circuit capable of energizing the piping. The equipment grounding conductor for the circuit that is capable of energizing the piping shall be permitted to serve as the bonding means. The points of attachment of the bonding jumper(s) shall be accessible.

Gas pipe is not bonded

Owners Notes: Gas pipe is bonded.
